Citation: Corradi, Marco, Tedeschi, Cristina, Binda, Luigia and Borri, Antonio (2008) Experimental evaluation of shear and compression strength of masonry wall before and after reinforcement: Deep repointing. *Construction and Building Materials*, 22 (4). pp. 463-472. ISSN 0950-0618

# **Experimental evaluation of shear and compression strength of masonry wall before and after reinforcement: deep repointing**

M. Corradi<sup>\*1</sup>, C. Tedeschi<sup>2</sup>, L. Binda<sup>3</sup> and A. Borri<sup>4</sup>

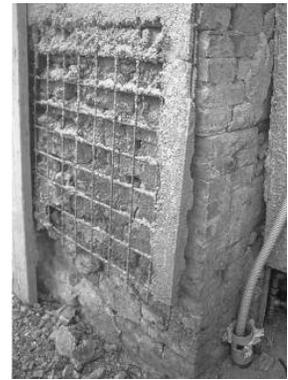
Figure 3 Only some spots were injected in the case of this wall with a very low percentage of voids.

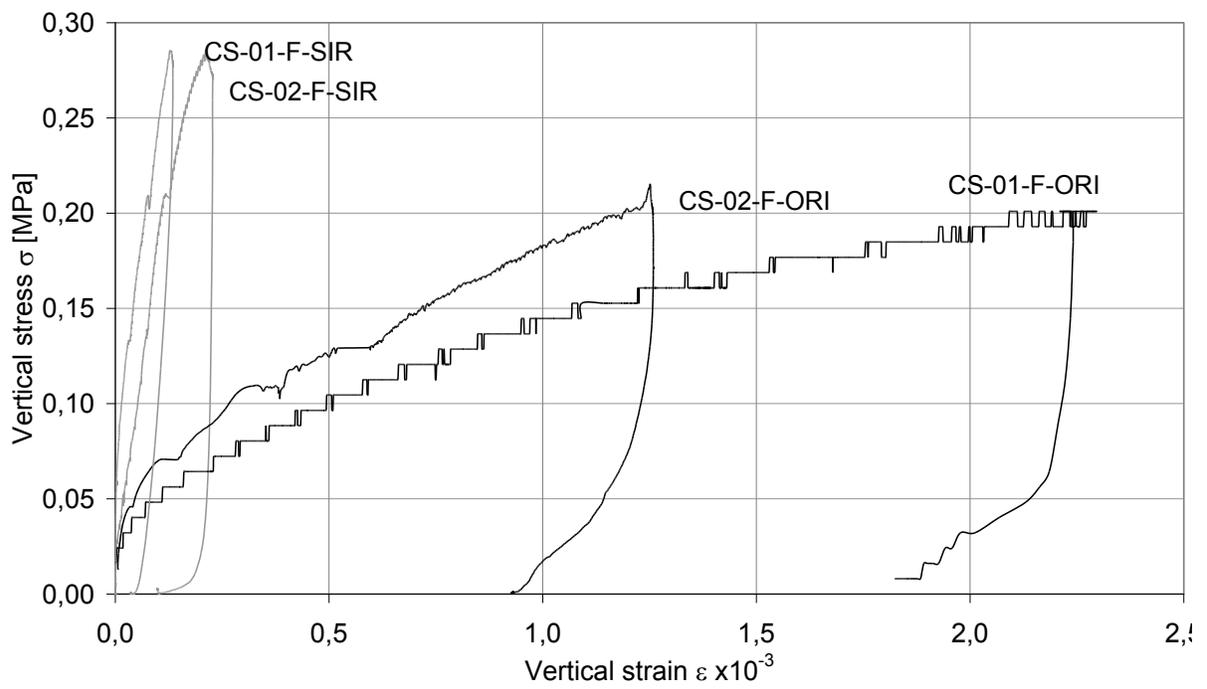
In Table 2 the detailed results of the simple compression test before and after repair are given. In Fig. 11 the stress-strain results of the same tests are presented. It can be easily seen that the increase in elastic modulus was respectively 32 and 5.69 times. Nevertheless high scatter in the results was found, as expected from such irregular masonry.

Figure 11 Compression tests: vertical stress vs strain.

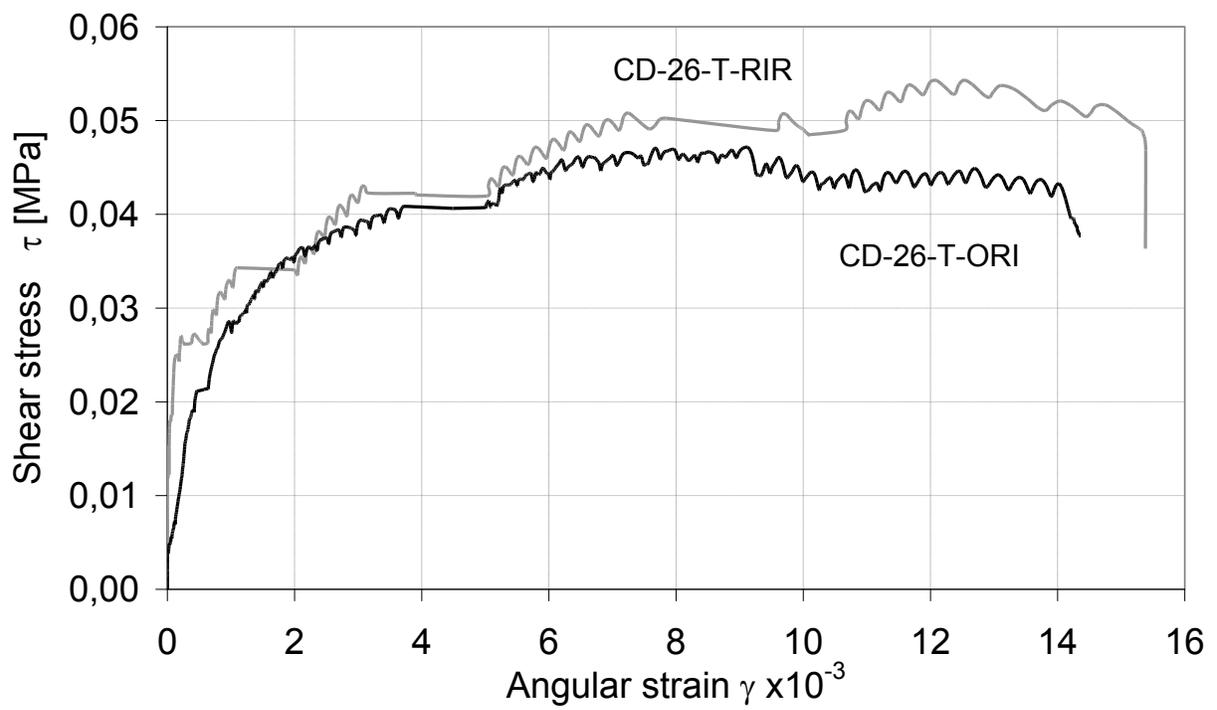
Finally the last two diagonal tests were carried out on the Trevi building (CD-26-T-ORI, CD-26-T-RIR). The panel with a thickness of 670 mm was only repaired by deep repointing in order to check the influence of the technique when used alone. The results are also reported in Table 4. In this case the shear strength change from the un-repaired panel to the panel after repair, is from 0.045 N/mm<sup>2</sup> to 0.054 N/mm<sup>2</sup>, which is only a very small increase in value. On the contrary, the shear stiffness changed from 79.60 N/mm<sup>2</sup> to 231.56 N/mm<sup>2</sup>. Figs. 12 and 13 show the comparison of the stress-strain curves of the panels in Trevi and Ponte.

From these results, a clear tendency is shown: the deep repointing alone can increase the shear stiffness of the masonry, while a significant increase in shear strength can be obtained by the synergic effect of repointing and grout injection. It is nevertheless important before using the grout injection technique to accurately examine its applicability. In fact when the technique was applied by the authors always a study of masonry injectability was carried out [4]. A certain percentage of voids must be present in the masonry and no loose material or clay must be found inside the masonry section, in order to have a successful injection. The results obtained for the diagonal compression tests carried out on panels repaired by means of injection and deeprepointing showed significant high increases both in terms of shear strength and stiffness. However, it must be pointed out that the presence of cracks (these cracks were caused by the initially tests on the same un-strengthened panels) facilitated the distribution of the injected grout within the panels.

Figure 12 Angular strain vs shear stress for the Trevi panel before and after reinforcement.

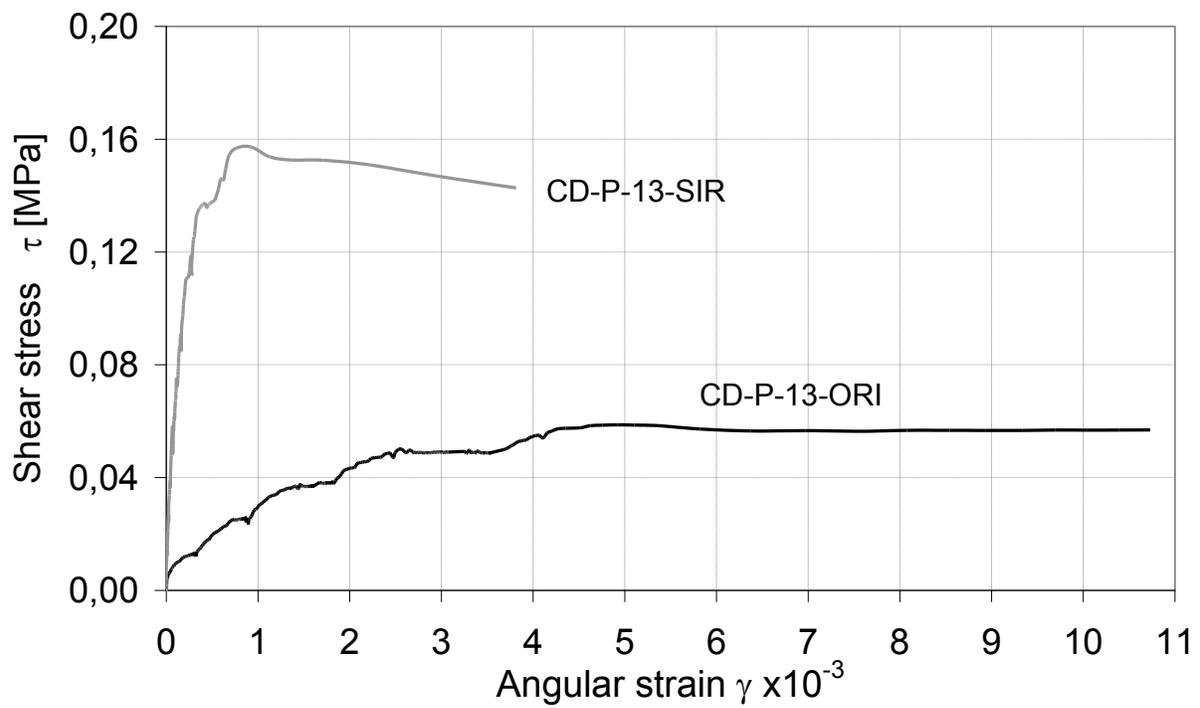
These tests were carried out in the two buildings of Ponte and Trevi. The first two tests were performed on the Ponte building where a masonry panel was subjected to the diagonal tests before reinforcement (CD-13-P-ORI). The values are reported in Table 4. The shear strength was  $0.059 \text{ N/mm}^2$ , while the shear modulus was  $37 \text{ N/mm}^2$ . After repair by deep repointing and

injection (CD-13-P-SIR) the two values became, respectively, 0.157 and 731 N/mm<sup>2</sup>. The high increase both in strength and stiffness is evident.

Figure 13 Angular strain vs shear stress for the Ponte panel before and after reinforcement.

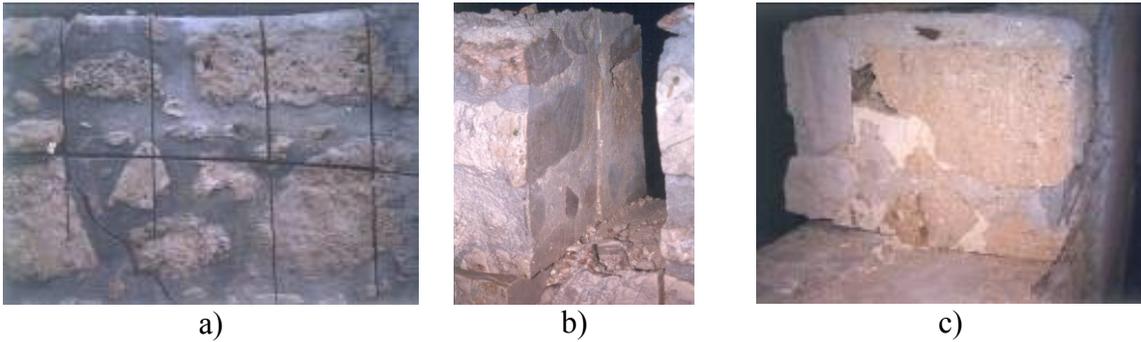
After testing of the repaired panels, some of them were cut from the wall and taken to the laboratory in order to control the penetration and diffusion of the repointing and of the injection. Fig. 14a shows the cutting of the panel in different portions which were carefully examined to check the penetration and bonding of the repointing. Fig. 14b and c show, respectively, the depth of penetration and the good bond between the new and the existing mortar. It seems that the deep repointing technique has a higher probability of being successful than the injection technique. Of course the two can be complementary.

Figure 14 a) Cutting of the panel in different portions; b) depth of penetration; c) good bond between the new and the existing mortar.
