# Microstructural analysis of thermal fatigue damage in 316L pipes

Report EUR 26445 EN

*This report summarizes the data and main conclusions derived from microstructural characterisation of 316L pipes subjected to thermal fatigue with a peak temperature of 550°C. TOFD measurements are compared with measured crack depths from cut segments, and fracture mode and corrosion have been assessed by SEM and EDX, respectively.*

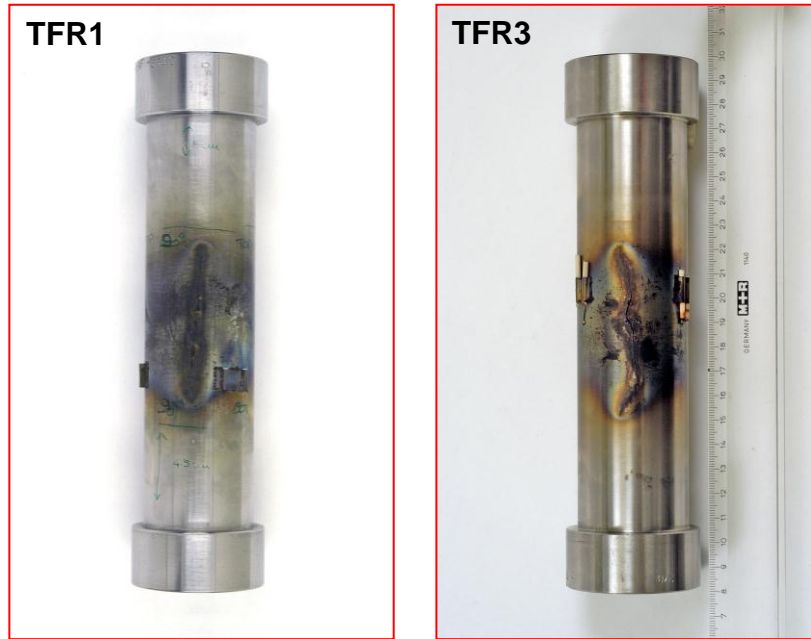
Two components subjected to the same nominal thermal fatigue loading, namely TFR1 and TFR3, have been used for visual examination and comparison with TOFD data. The test parameters are listed in Table 1. Both components failed by axial through-wall cracking (Figure 1) at different lifetimes (46000 cycles for TFR1 and 90000 for TFR3).

**Fig 1.** Failed components TFR1 and TFR3 with axial cracks

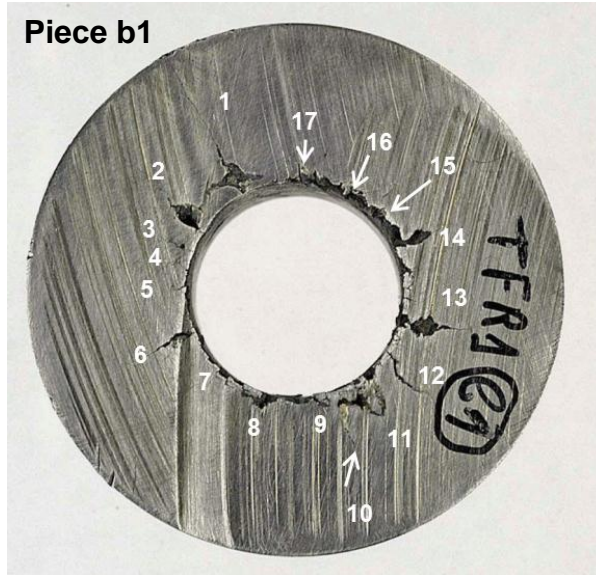
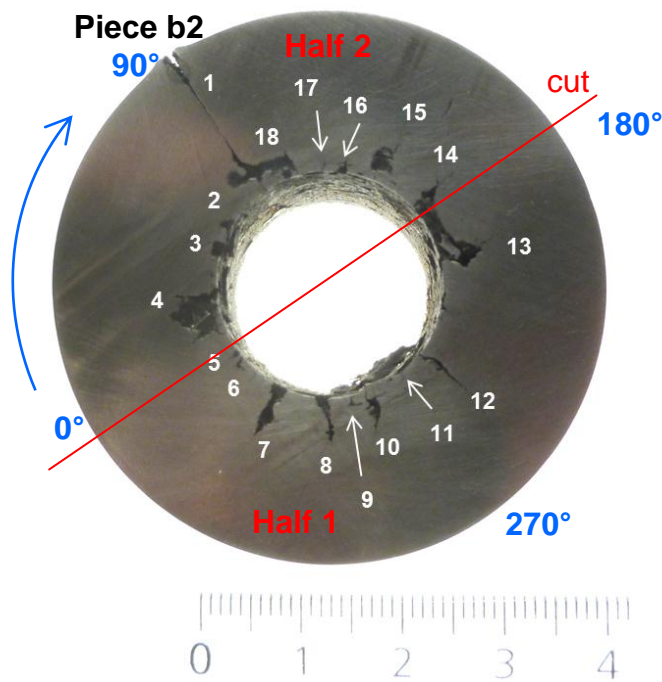
Figure 3 shows the two horizontal cross sections and measured crack depths for the axial cracks. Figure 4 shows the vertical cross sections and the measured circumferential crack depths. The red line drawn in Piece b2 in Figure 3 indicates the plane along which the piece was cut for visualizing circumferential cracks, and the degrees in blue indicate the TOFD angles of measurement. Note that the distance between the two horizontal cross-sections is 3 cm. Seventeen out of the 18 cracks on b2 were also seen on b1, which means that the length of these cracks was at least 30 mm. For the cracks measured from the vertical cuts we would expect that the same circumferential crack depths were measured. Indeed, the difference is smaller than for the axial cracks but they are not equal. There are two possible reasons for this: i) some material is lost during the cutting so the two surfaces do not completely match; ii) the cutting and the surface preparation may induce some artifacts.

Crack number	Crack depth (mm)	
	Piece b1	Piece b2
1	14	14
2	7.86	1.43
3	2.36	1.51
4	1.19	4.68
5	1	1.11
6	5.07	1.49
7	1	6.41
8	2	4.4
9	1	0.97
10	10	5.43
11	4	0.88
12	6	9.79
13	6	4.96
14	4	3.87
15	1.36	5.84
16	1.18	1.62
17	2	1.4
18	-	2.74

**Fig. 3.** Left: Top view of the side closer to the center of pieces b1 and b2 of TFR1, together with crack numbering for each piece. Right: Table summarizing the depth of each crack.

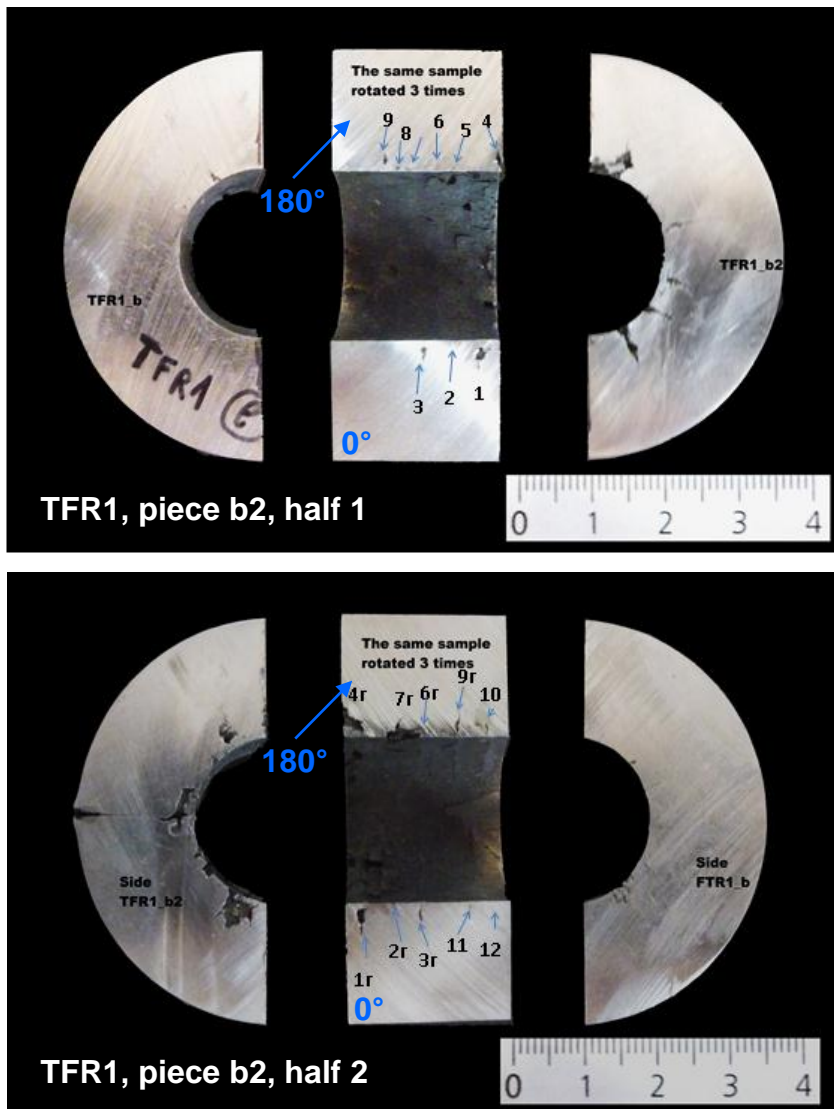
Crack number	Crack depth (mm)	
	Half 1	Half 2 (r numbers)
1, 1r	4.72	4
2, 2r	0.91	1
3, 3r	4.16	4.45
4, 4r	4.19	3.87
5	1.22	-
6, 6r	1.6	1.41
7, 7r	1.6	2.73
8	0.9	-
9, 9r	3.7	6.31
10	-	1.74
11	-	1
12	-	0.86

**Fig. 4.** Left: Image of the two halves of piece b2, each half rotated three times, together with crack numbering for each half. r-numbers in half 2 indicate the cracks that are repeated and seen in both halves. Right: Table summarizing the depth of each crack.

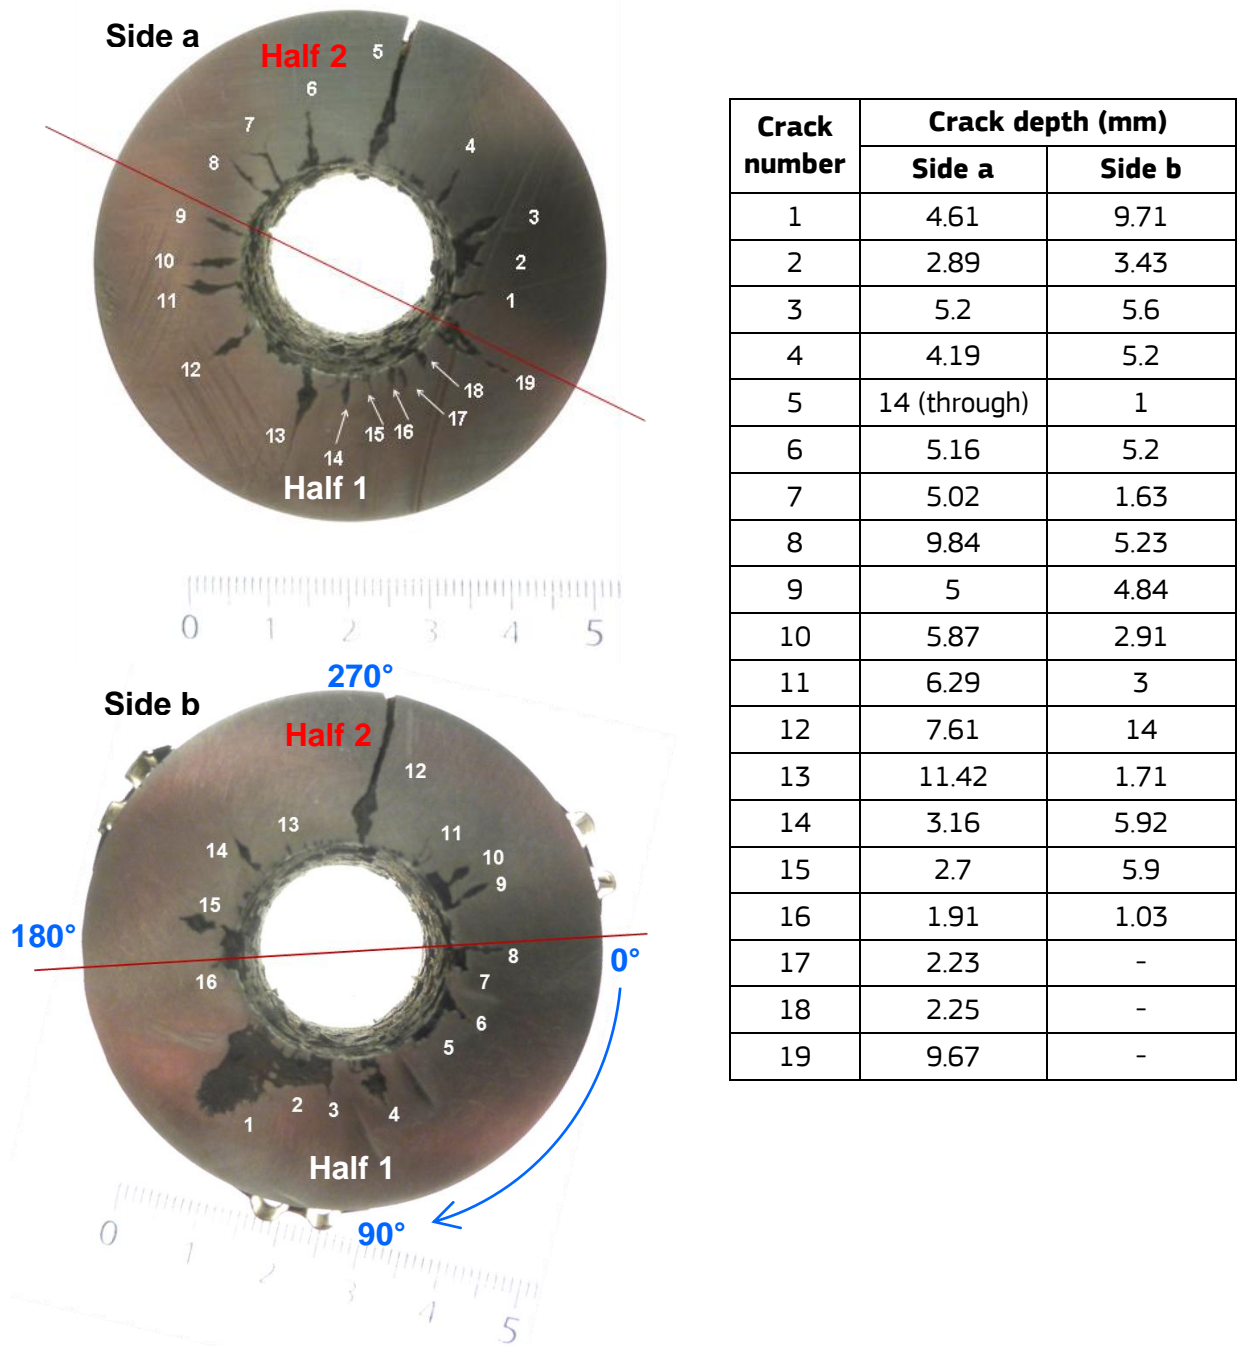
Figures 5 and 6 show the measurements of axial and circumferential cracks, respectively. The red lines drawn in Figure 5 indicate the plane along which the piece was cut for visualizing circumferential cracks, and the degrees in blue indicate the TOFD angles of measurement.

**Fig. 5.** Left: Top view of both sides of the central piece of TFR3, together with crack numbering for each side. Right: Table summarizing the depth of each crack.

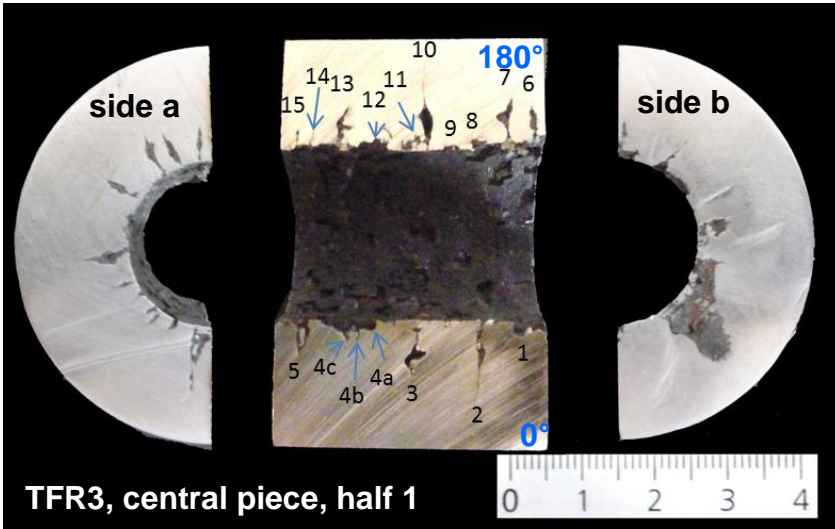
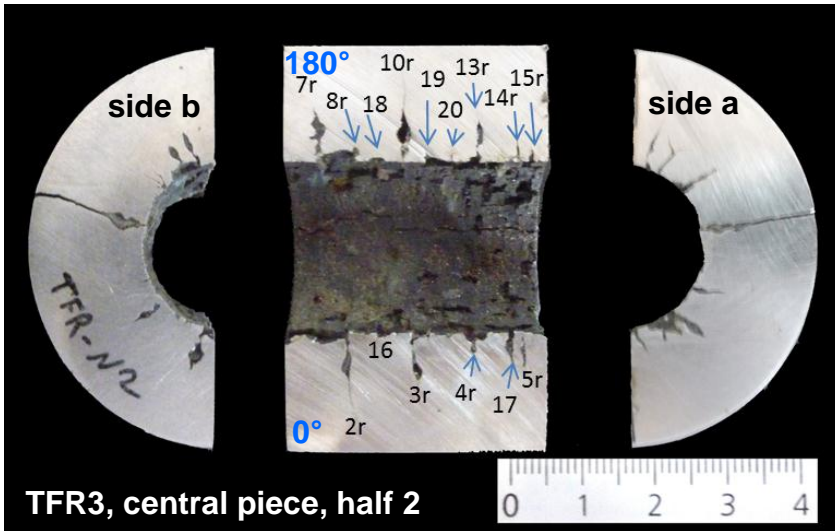
Crack number	Crack depth (mm)	
	Half 1	Half 2 (r numbers)
1	1.44	-
2, 2r	11	10.9
3, 3r	6.8	7.31
4, 4r	1.8, 2.7, 2.71	2.56
5, 5r	4.25	5.4
6	4.76	-
7, 7r	5.6	6.63
8, 8r	1.45	1.72
9	0.84	-
10, 10r	8.48	12.83
11	2.13	-
12	3.14	-
13, 13r	5.78	5.34
14, 14r	3.13	3.48
15, 15r	2.88	1.95
16	-	1.33
17	-	5.4
18	-	0.83
19	-	2.08
20	-	1.31

**Fig. 6.** Left: Image of the two halves of the central piece of TFR3, each half rotated three times, together with crack numbering for each half. r-numbers in half 2 indicate the cracks that are repeated and seen in both halves. Right: Table summarizing the depth of each crack.

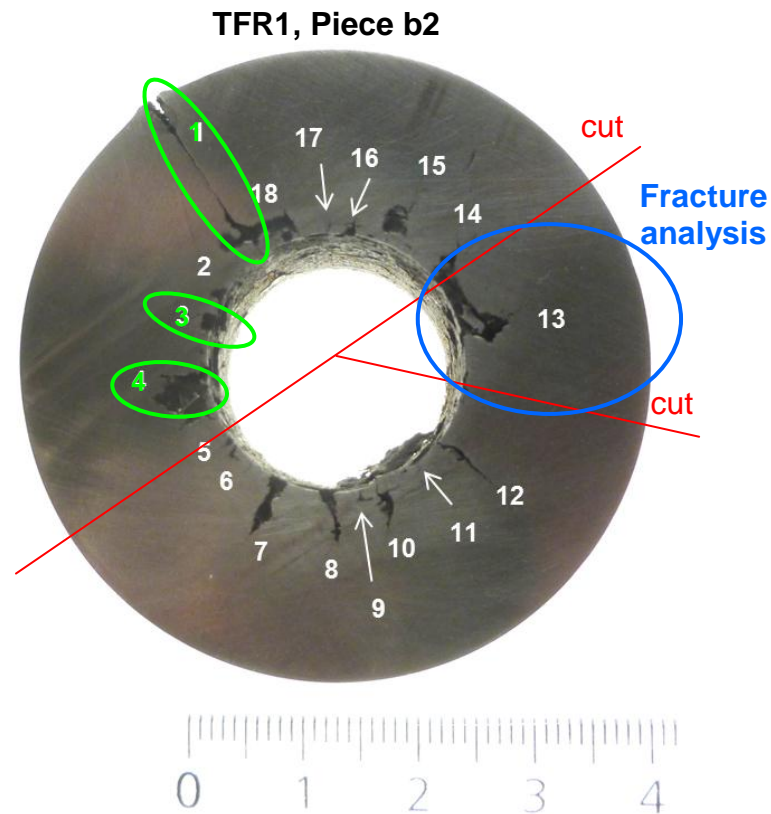
**Fig. 7.** Image of piece b2 of TFR1 showing the cracks analysed (cracks 1, 3 and 4), and the part taken for fracture mode analysis (blue circle).

All these regions are close to the inner or outer surface. In [1] we also looked at deeper non-surface breaking cracks (e.g. crack 12 in Figure 7), which did not reveal any corrosion.

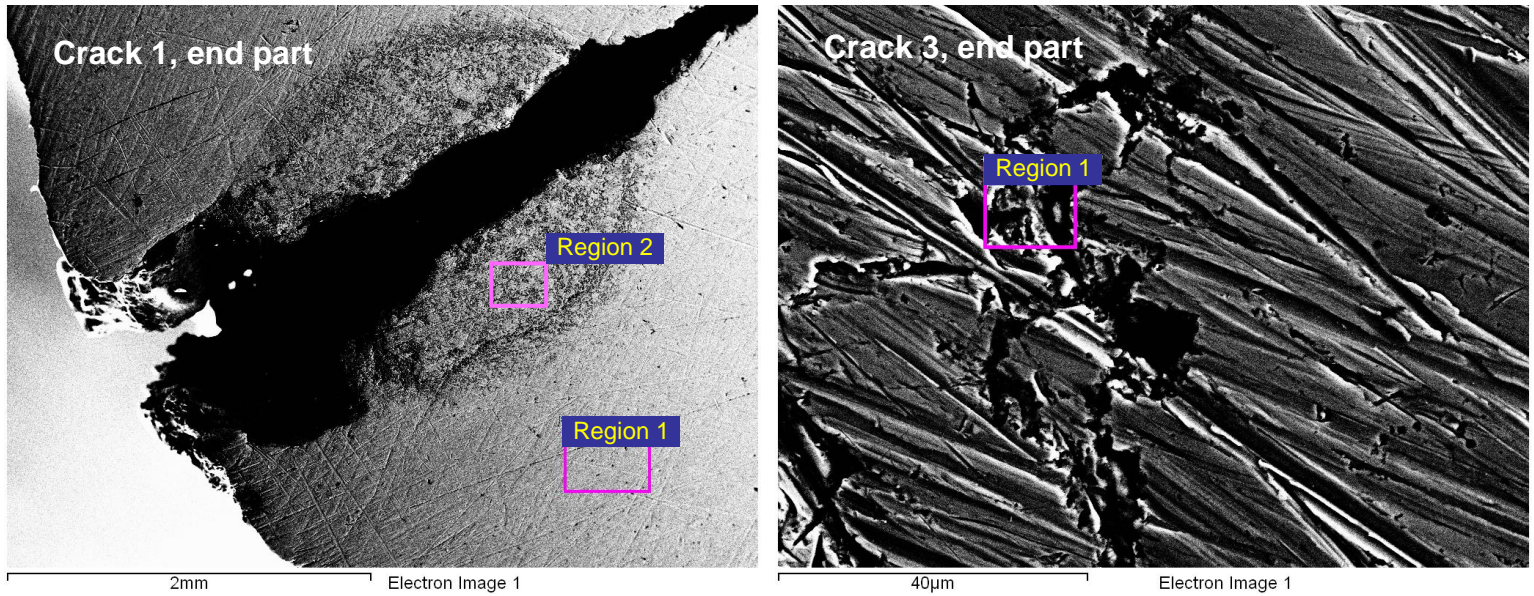
Composition cracks 1, 3 (wt.%)										
		O	Si	P	S	Cl	Ca	Cr	Mn	Fe	Ni	Mo
Crack 1	Region 1	-	0.77	0.01	0.03	0.15	-	18.29	2.12	62.76	13.23	2.65
	Region 2	9.67	0.49	0.03	0.02	-	-	20.02	2.54	54.53	10.80	1.90
Crack 3	Region 1	12.10	0.76	0.10	0.59	0.09	0.23	20.44	1.71	50.69	10.45	2.85

**Fig. 8.** Elementary concentration (in wt.%) of different regions of crack 1 and 3

A region enriched in O and Cr, but slightly reduced in Fe and Ni is found at the end of Crack 1 (Region 2). A region containing O was also found inside Crack 3 (Region 1), indicating that the surface nearby the crack is partly oxidized. As compared to the nominal 316L composition, the region has a significant increase in P, S, and slight increase in Cr but poor in Mn, Fe and Ni, suggesting that it might be associated to chromium oxide, which is consistent with the passivation behaviour of stainless steels. Similar results were obtained from the EDX of Region 2 at Crack 1 (nearby the crack) confirming that the formation of chromium oxide is likely to occur.

The presence of Ca detected in the particle of Crack 3 suggests that it comes from the water during the fatigue test. The content of P and S is about 10 and 6 times higher, respectively, than for the nominal composition suggesting that these elements also come from the water.

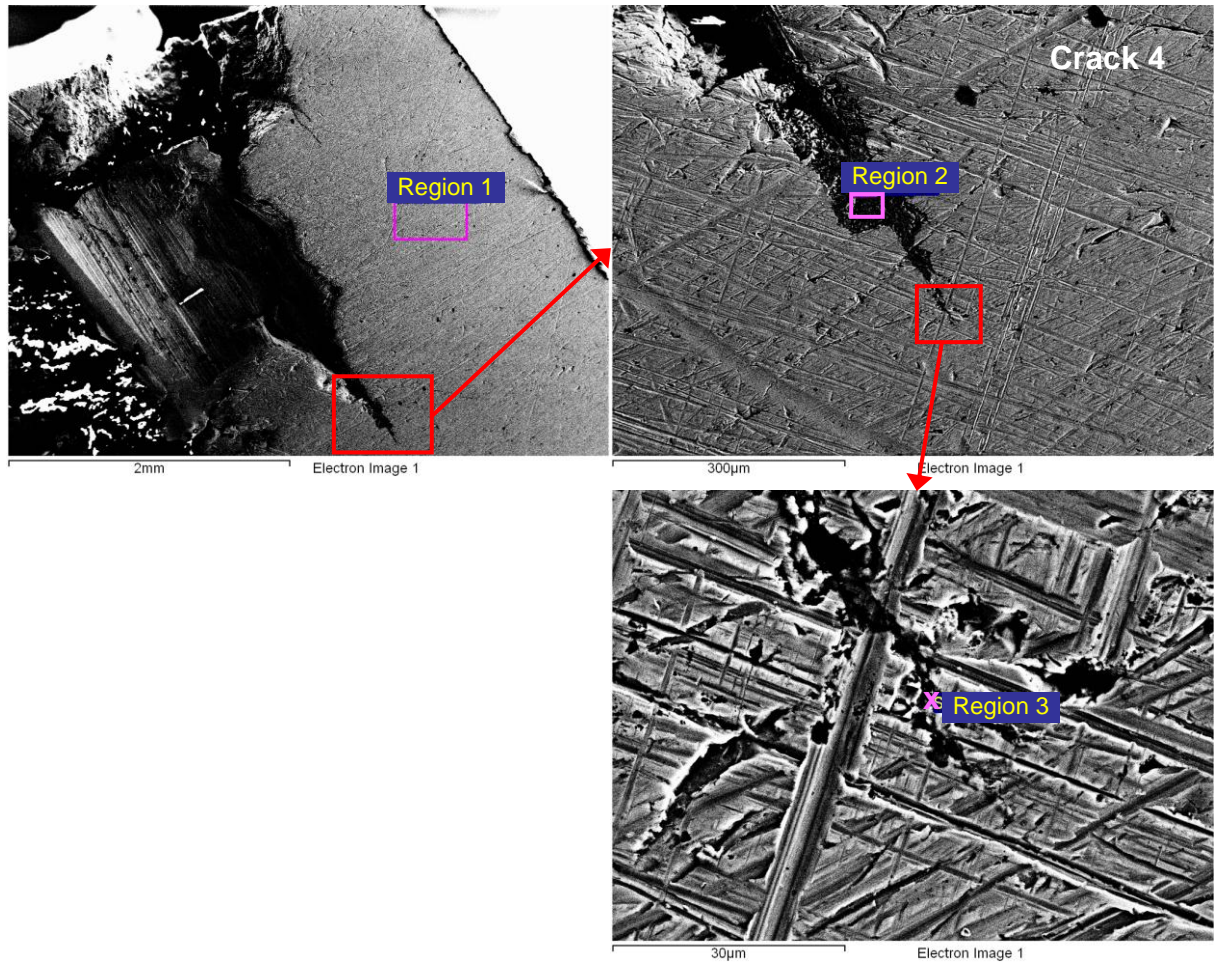
The elemental composition in crack 4 follows the same trend as for Crack 1 and 3. Inside cracks the composition presents the following features compared to the bulk material:

- High O content,
- Enrichment of the level of S and P, and reduction in Fe and Mn,
- Similar content of Si and Ni,
- Slight increase in P, Cl and K.

Composition crack 4 (wt.%)												
	<b>O</b>	Si	P	S	Cl	Ca	K	Cr	Mn	Fe	Ni	Mo
<b>Region 1</b>	-	0.85	0.01	0.12	-	-	-	17.99	1.94	63.29	13.63	2.18
<b>Region 2</b>	<b>24.19</b>	0.52	0.03	4.43	0.21	-	0.15	20.37	0.39	32.77	14.85	2.10
<b>Region 3</b>	<b>23.44</b>	0.50	0.08	0.87	0.39	0.23	-	18.68	0.73	43.77	8.88	2.44

**Fig. 9.** Elementary concentration (in wt.%) of different regions of Crack 4

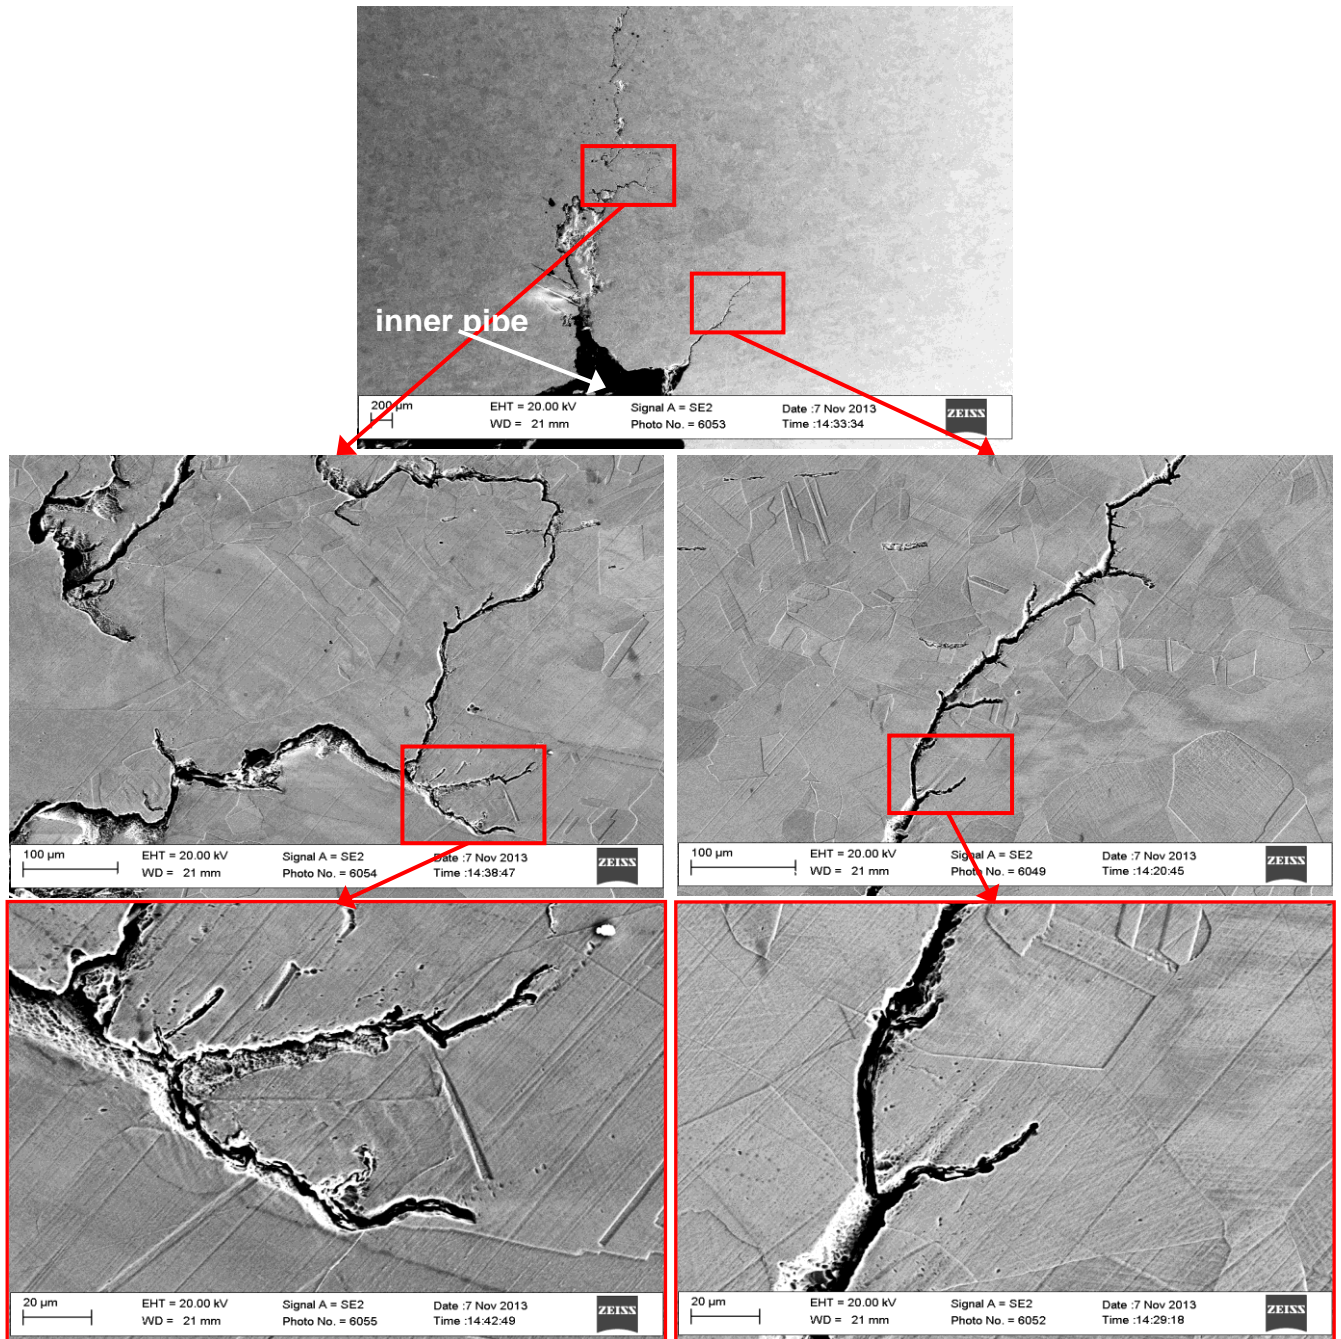
The enlarged pictures of the axial cracks presented in Figure 10 are from regions further than 1 mm from the inner pipe wall. At this distance the cracks propagate transgranularly across the grains.

**Fig. 10.** Transgranular fracture at the end of axial cracks

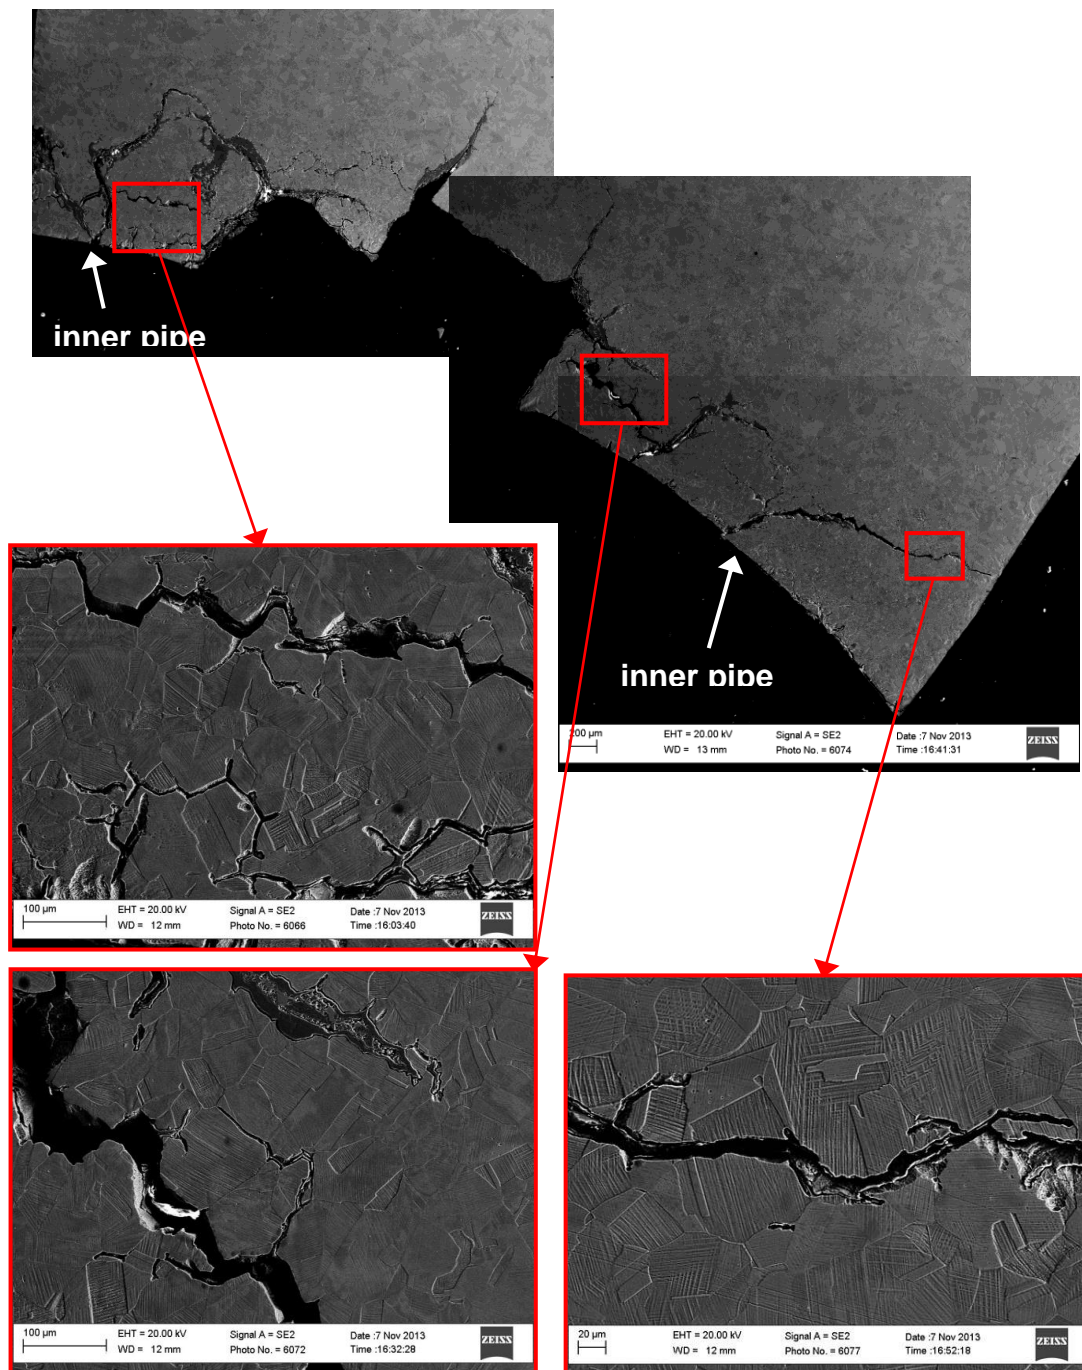
The enlarged images of the circumferential cracks taken in regions close to the inner pipe wall (left side, Figure 11) show intergranular crack propagation, while at distances a bit further from the inner surface the cracks already propagate in a transgranular mode.

**Fig. 11.** Intergranular (left) and transgranular (right) fractures in circumferential cracks.

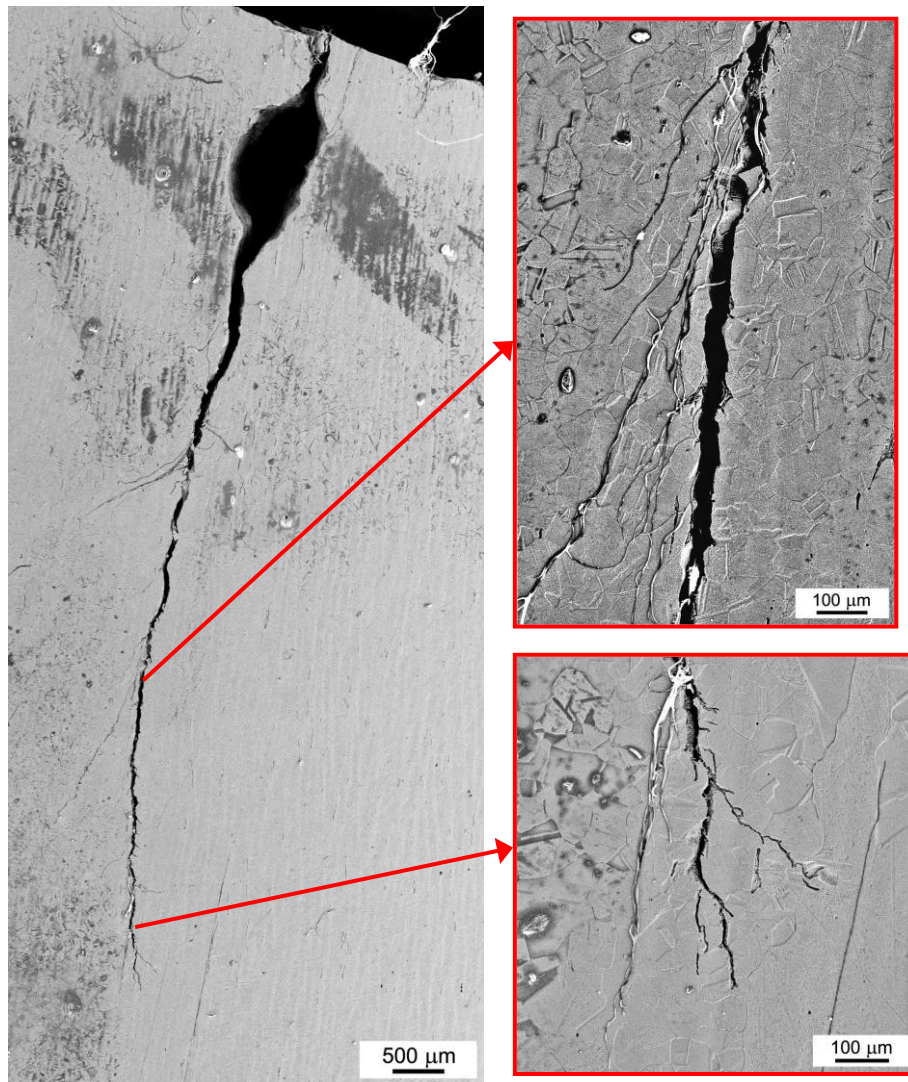
For non-surface breaking axial cracks (e.g. crack 12 in Fig. 7) the crack propagation was mainly transgranular, but there could also be local regions with mixed intergranular and transgranular crack propagation as shown in Figure 12. Figure 13 shows a deep circumferential crack which also propagated mainly in transgranular mode.

**Figure 12.** Deep non-surface breaking crack (Crack 12) with mainly transgranular fracture mode of main crack and with crack branching at crack tip with mixed intergranular and transgranular mode.

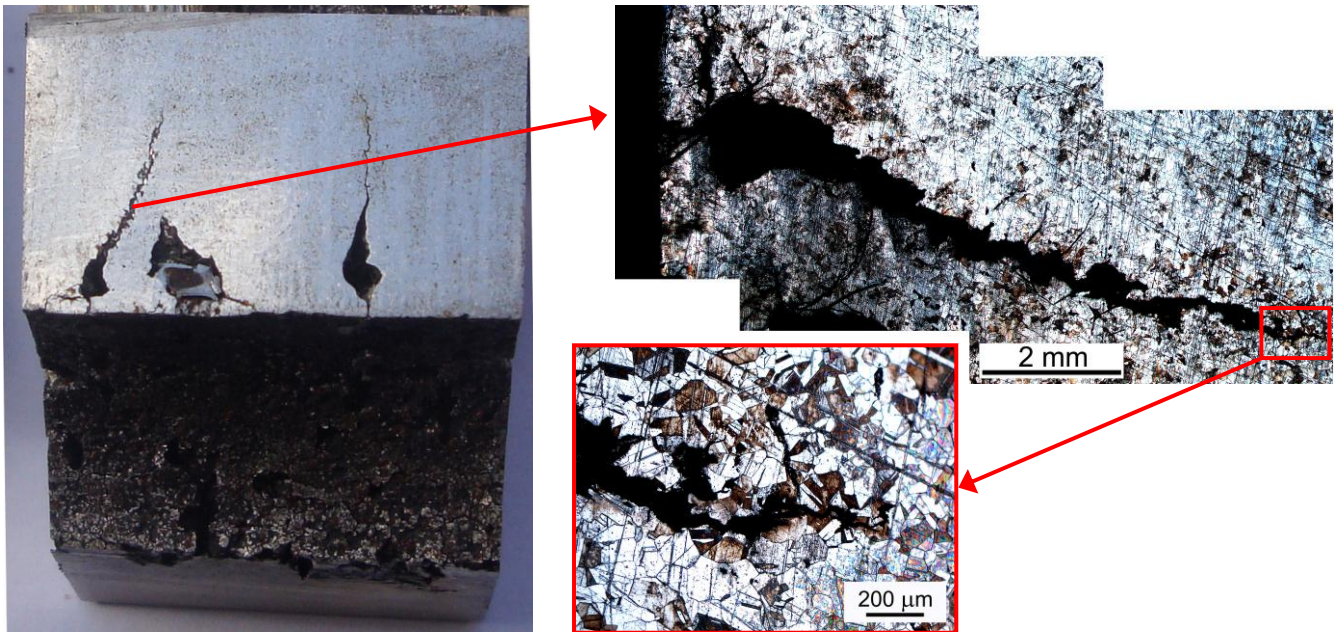
**Figure 13.** Circumferential deep crack at different magnifications showing transgranular growth.
