Citation: Corradi, Marco, Speranzini, Emanuela and Alessio, Molinari (2022) A repair method of cracked shear walls with stainless steel. *Composite Structures*, 293. p. 115739. ISSN 0263-8223

A repair method of cracked shear walls with stainless steel rods and fibres

Marco Corradi^{a,b,*}, Emanuela Speranzini^b, Alessio Molinari^b

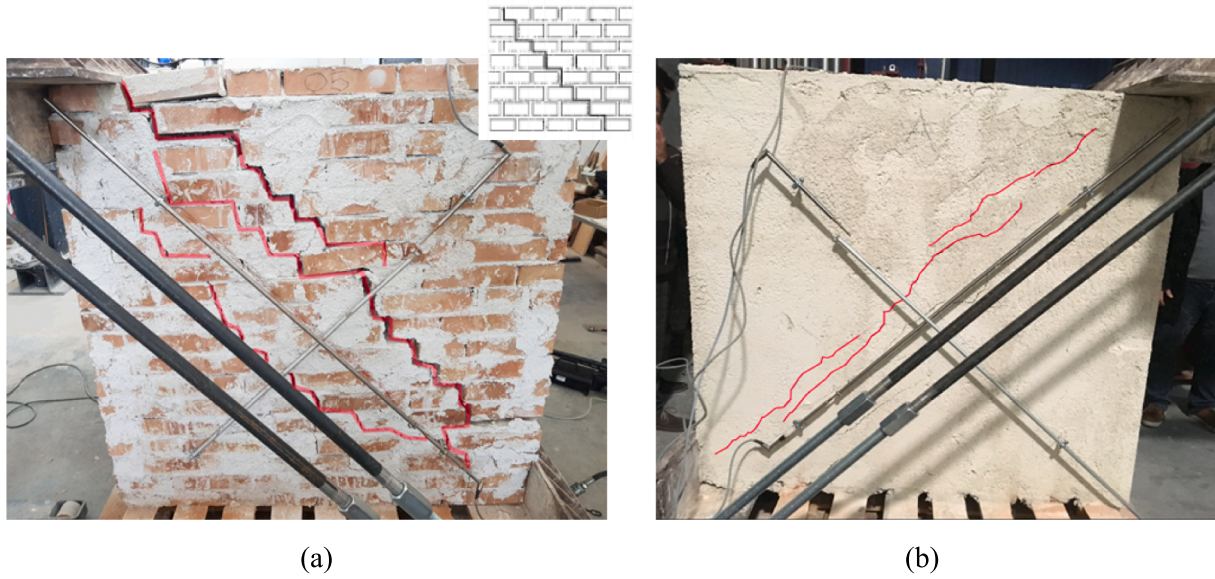
Fig. 3. Failure mode of wall panels tested in the first phase of the experimental work: (a) unreinforced specimens, (b) reinforced with FRCM (rigid GFRP grid embedded into a mortar coating).

pattern and only involved the mortar joints (mortar tension failure or cracking at interface block-to-mortar). For brickwork panels a very small number of bricks (typically 3 or 4 for the entire wall made of about 153

bricks) cracked. For reinforced walls, this was accompanied by cracking and crushing phenomena of the mortar coating and deboning of the GFRP reinforcement along the panel's compressed diagonal. Fig. 3

shows the typical failure mode of both reinforced and unreinforced wall panels.

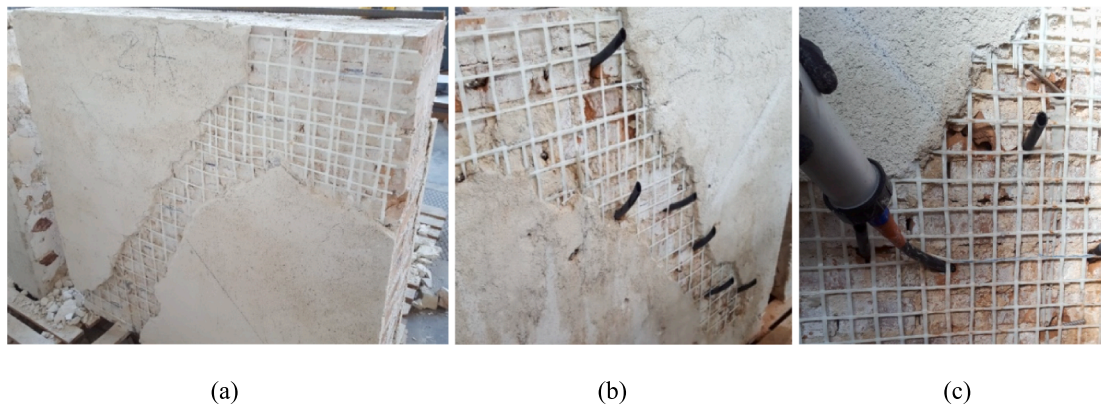
Fig. 4. Repair of damaged walls by grout injections: (a) removal of the mortar coating along the diagonal crack, (b) application of the plastic tubes for the injections, (c) manual pump used for grout injections.

For previously-reinforced specimens, the mortar coating of the FRCC system was initially removed along the diagonal crack, taking care not to damage the fiberglass grid (Fig. 4a). The width of the removed layer of coating was about 20–25 cm. Plastic tubes were subsequently applied in holes drilled across the crack. These tubes have been used to inject a lime grout: injection was carried out manually at low pressure (1 atm) not to damage further the wall panels. Fig. 4b and 4c shows this preliminary repair method, used for all walls.

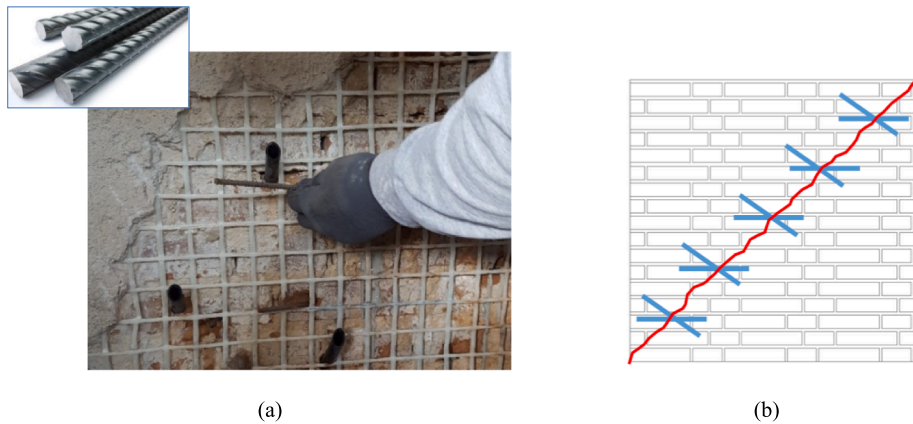
Fig. 5. Repair of damaged walls with stainless steel anchors: (a) application of the stainless steel rebar into the grouted tubes, (b) Arrangement of the stainless steel ribbed rebar used to bridge the diagonal crack.

In addition, several panels have been repaired with stainless steel anchors (ribbed rods), very similar to the ones normally used for reinforced concrete (Fig. 5). These anchors have been inserted in inclined

holes, drilled diagonally across the crack and filled with the grout.

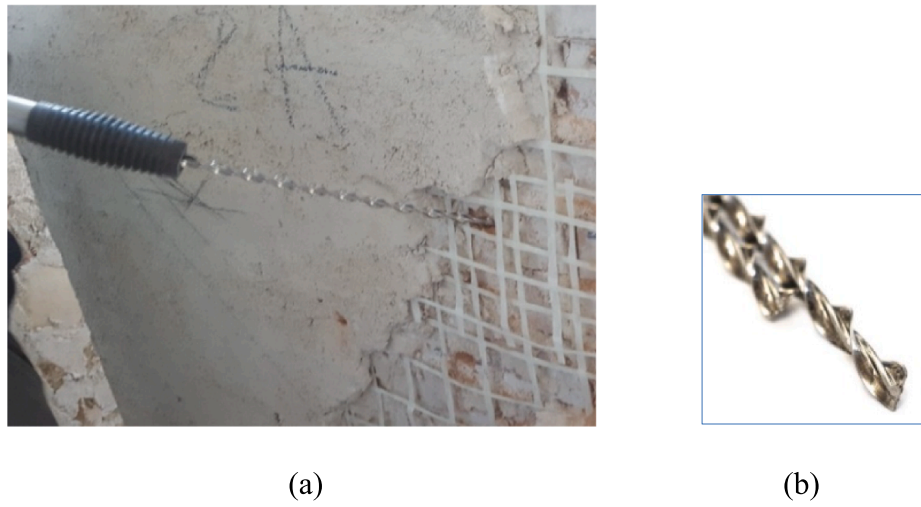
Fig. 6. Repair of damaged walls with “dry” (no-mortar) helical rods: (a) application of the stainless steel rod into the grouted tubes, (b) Detail of the rod (10 mm outer diameter).

Alternatively, other wall panels have been repaired using helical stainless steel rods (with an outer diameter of 6 mm), applied in a similar way to the ribbed rods, but without filling the holes with the grout (dry application, Fig. 6).

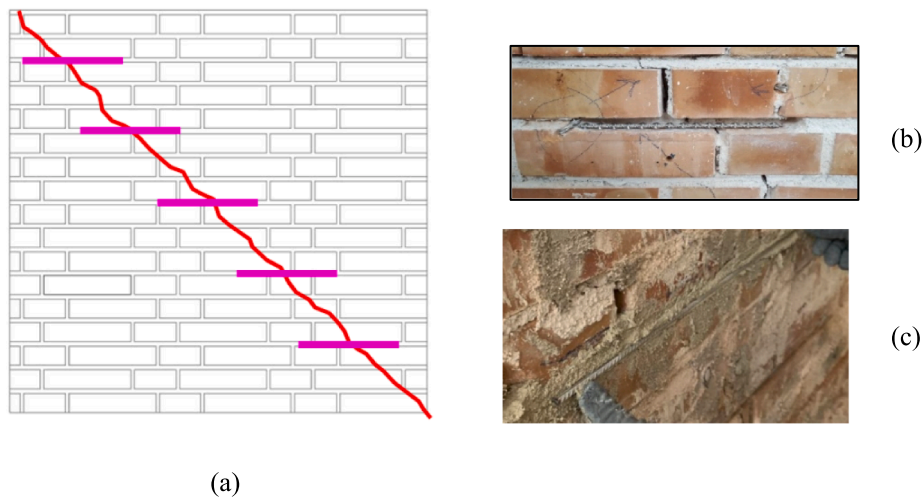
Fig. 7. Repair of damaged walls: (a) Stainless steel rods embedded in the horizontal mortar joints, diameter $\Phi = 6$ mm, length $L = 200$ mm, (b) Helical rods, (c) Ribbed rods.

With regard to “surface mounted” repair methods, stainless steel ribbed rods and helical stainless steel rods (identical to the ones used for “inside” repair) have been installed into the horizontal bed joints to bridge the diagonal crack (Fig. 7). After the application of the steel rods (length = 200 mm), the mortar joints have been finally repointed with new mortar.

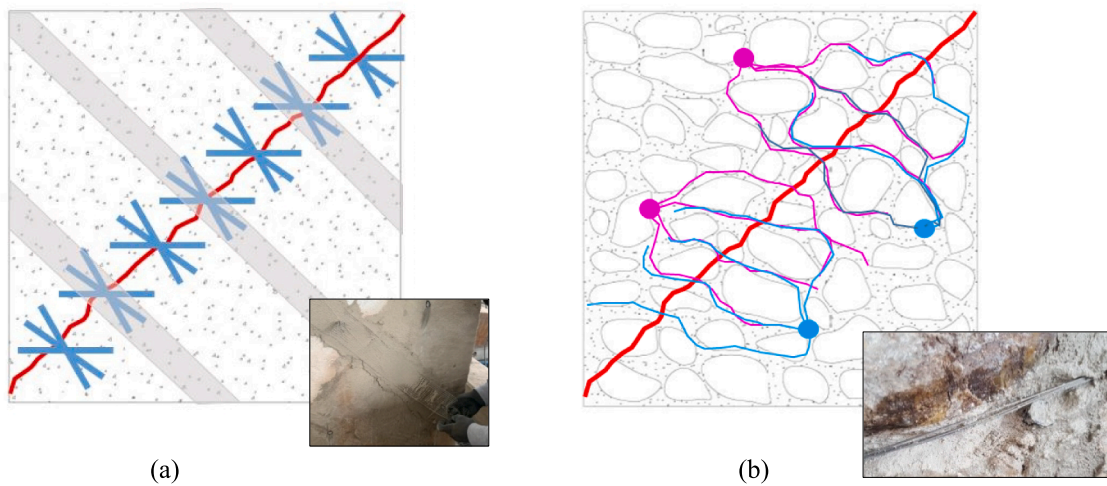
Fig. 8. Repair methods: (a) using unidirectional steel fibres sheets (grey) and stainless rods (blue) , (b) embedding the steel cords into the mortar joints (blue and pink).

Steel fibres (SRG method) have been also used to repair the walls: steel fibres were applied perpendicularly to the diagonal crack on the surface of the wall in such a way to bridge the crack (Fig. 8a). For reinforced panels, SRG was applied under the form of unidirectional sheet applied diagonally (along the tensile diagonal) over the mortar coating, while, for unreinforced walls, the steel fibres have been embedded into the mortar joints with new mortar: this was necessary in order to preserve the fair face aspect of the masonry (Fig. 8b).

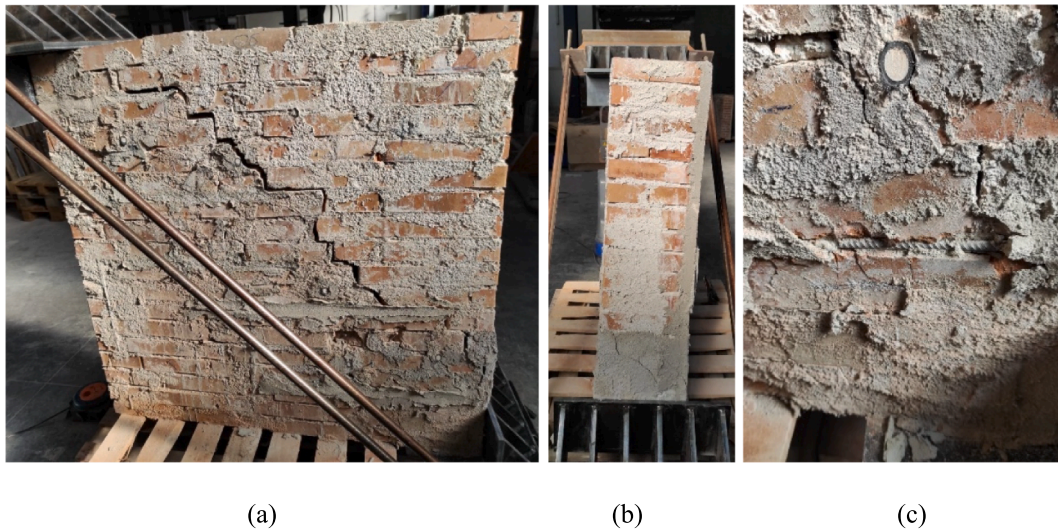
the un-reinforced side (on both sides for MAT-01-U, and on a single side for MAT-03-S and MAT-06-S). The lateral load capacity decreased of 33.6% (from 67 to 45.9 kN - MAT-01-U, and from 100.3 to 64.5 kN - MAT-03-S) for brickwork wall panels repaired with helical rods, while it increased of 31.2% (120.9 to 158.6 kN – MAT-06-S). The typical failure mode at the unreinforced side was due to ejection of mortar cover near the stainless steel rods and subsequent re-formation of the diagonal crack (Fig. 10).

Fig. 10. Repaired MAT-06-S wall (unreinforced side): (a) Failure mode, (b) Lateral view, (c) detail of the ejection of the mortar cover near the stainless steel bars.
