Citation: Corradi, Marco, Castori, Giulio, Sisti, Romina, Borri, Antonio and Pesce, Giovanni (2019) Repair of Block Masonry Panels with CFRP Sheets. *Materials*, 12 (15). ISSN 1996-1944

Repair of Block Masonry Panels with CFRP Sheets

Abstract: In the 1980s, block masonry started to be widely used for new constructions in Italy's earthquake prone areas. However, recent seismic events demonstrated that block masonry buildings may need to be repaired after earthquakes due to cracking. Construction defects are the main cause for cracking of block work masonry. Carbon fiber reinforced polymer (CFRP) sheets have been used as a local repair method for non-defective and defective wall panels. An experimental program was formulated to investigate the shear behavior of block masonry walls repaired with CFRP sheets. A total of six wall panels were constructed in the laboratory and tested in shear (in-plane lateral loading). It was found that, although the control (non-defective) wall panels had a high ultimate load capacity, the use of CFRPs reduces the effects of construction defects and restores the lateral load capacity in non-defective walls. Overall, this research suggests that the use

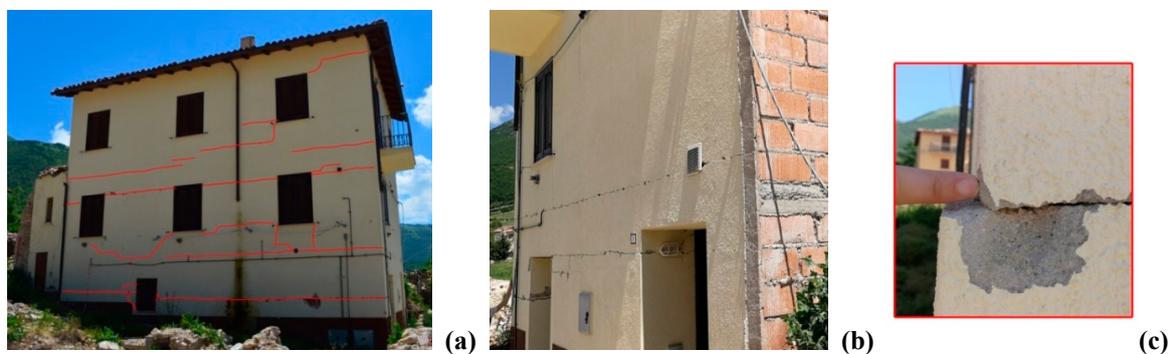
The earthquake in 2016 caused various damage to this building. Figure 5 shows the crack pattern where horizontal cracks opened along the mortar bed joints of the URM hollow load-bearing block masonry. These cracks were mainly concentrated near the joint block masonry—ring beam—floor. The main cause for this is likely to be the stress concentration, induced by the inertial seismic forces, transmitted by the horizontal diaphragms. These are typically very heavy (the dead load alone is about 9–11 kN/m²).

Figure 5. Crack pattern (red lines) of Building No. 1. (a) Horizontal cracks from the north; (b) horizontal cracks from the east, near the floor and (c) detail of the horizontal sliding.

Figure 5b shows detail of the horizontal sliding (20 mm) at the ground floor of the building. Relative displacements are smaller near the 1st and 2nd level joints. It is worth noting that this crack pattern has never been observed for this particular masonry type.

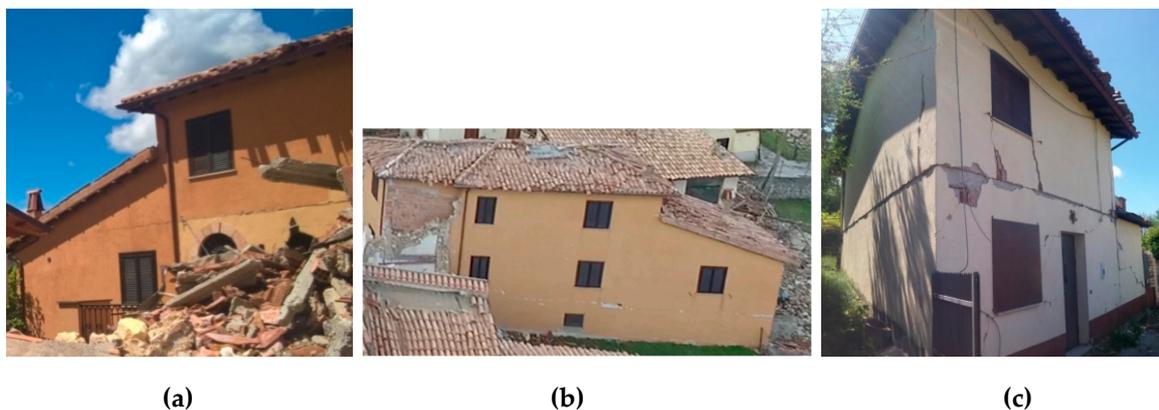
The second construction is a 3-story building. This building has external dimensions of 17.55 m × 4.8 m and it was reinforced in 1986 by demolishing several stonework walls. These were re-constructed with hollow blocks. The only un-demolished pre-existing stone wall was the one shared with the adjacent building (that was reinforced by grout injections and steel-mesh reinforced concrete coating). The thicknesses of the new URM block masonry are 45 and 30 cm, for the ground floor and the higher levels, respectively. The horizontal diaphragms (likely timber-beam floor) were also demolished in 1986 and replaced with 1-way steel-reinforced concrete joists, tile hollow blocks and a RC slab. An indicative configuration of the new floor is shown in Figure 4. During the earthquake in 2016, the building was seriously damaged. A long horizontal crack, passing through the wall thickness, opened near the first level floor (Figure 6a,b). Other horizontal cracks were noted near the floor at ground level. It is worth noting that the typical diagonal cracks, induced by in-plane lateral loading, or the also-common out-of-plane mechanisms, were not observed at all.

Figure 6. Crack pattern: (a,b) Building No. 2; (c) Building No. 3.

A 2-story building is the last case-study. This building, has a rectangular floor plan of 6.8 m × 9.7 m and was reconstructed in 1989 using new URM load-bearing block masonry. The horizontal diaphragms were made of traditional 1-way steel-reinforced concrete joists, tile hollow blocks and a RC slab. Ring RC beams were also used to connect the floor to the walls to prevent an out-of-plane collapse mechanism during an earthquake (as represented in Figure 4). The 2016 post-earthquake report of the state of the building (“Aedes” report [34]) highlights a medium level of damage. However, the building was evacuated and its use was not authorized. Figure 6c shows the damage: a horizontal crack opened in the external walls at the level of the first floor. This crack passed through the wall thickness. A horizontal sliding of 2 cm of the upper part of the building was measured by the technicians after the earthquake.

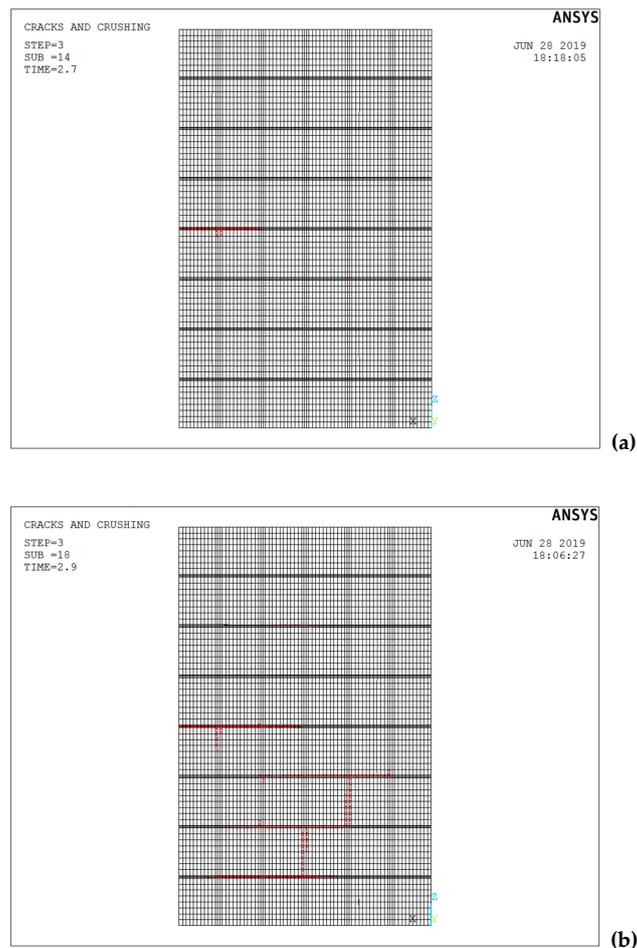
A numerical analysis was thus performed, in which the FE model was firstly subjected to both self-weight and a distributed pressure load, followed by a ramped 10 kN horizontal load. Figure 8 shows the failure progression sequence observed during the FE analysis on the block masonry panel. Cracking is not present on the whole specimen, but mainly on its lower half. In detail, following the opening of a predominant horizontal crack at the panel mid-height (Figure 8a), stepped diagonal cracks developed (through bed and head joints) along the compressed diagonals (Figure 8b), when the interface bond strength was attained.

Figure 8. FEM crack pattern: (a) opening of the horizontal crack; (b) stepped diagonal cracks.

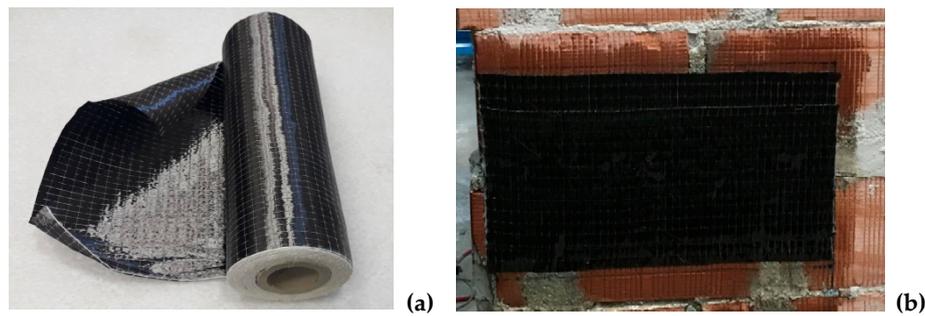
Figure 11. (a) Uni-directional CFRP sheet, used for local repair, (b) detail of a repaired wall panel.

To repair the wall panels, only one type of CFRP composite was used: this was made from carbon fibers embedded in an epoxy resin matrix to form a unidirectional CFRP sheet, as shown in Figure 11. The 0.165 mm thick CFRP sheet had a tensile strength of 3,324 MPa with a tensile modulus of 312.2 GPa (Table 2). The rupture strain was 1.07%. The same epoxy resin employed to cure the carbon fibers was also used to apply the fibers to the wall's surface. The epoxy resin is produced by Kimia, under the brand name Kimitech-ep-in: this is a low-viscosity, transparent, bi-component product. The manufacturer declares in the data sheet a compressive strength of 65 MPa, and a tensile strength of 30.4 MPa. The weight density of the epoxy resin is 1.08 g/cm³. The surface of the wall panels was not treated to improve the bond performance: the CFRP was directly glued to the tile blocks.

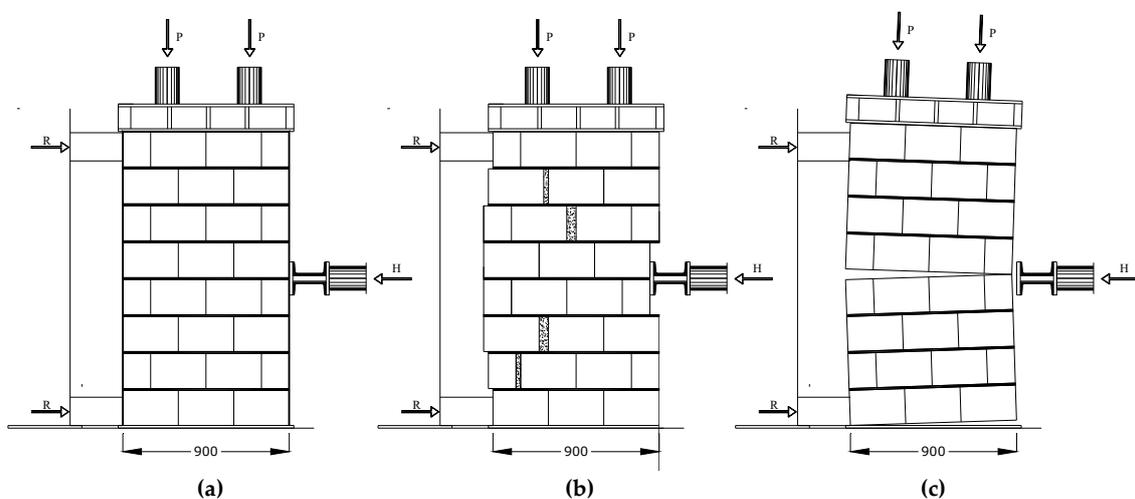
Figure 16. (a) Un-deformed wall panel, (b) shear failure (diagonal cracking), (c) bending failure (horizontal cracking) (units in mm).

The failure mode of the defective panels entailed a different mechanism, compared to the non-defective ones (Figures 16c and 18c). Two limit states were noted for defective wall panels: a horizontal crack progressively opened between the two overhanging semi-panels (along the wall's horizontal line of symmetry). The mechanism consisted in a relative rotation around the point of application of the horizontal load of the two halves. This had a maximum thickness of 8–12 mm at the maximum horizontal load. The vertical confinement of the panel prevented further separation and rotation of the two halves. By comparing the maximum lateral load, it can be noted that the defective panels exhibited a reduced shear-load capacity: this was 40.8% smaller compared to non-defective panels. Following the formation of the horizontal crack, shear cracks also developed for a lateral load of 152.89 kN (P3-ND-20) and 182.98 kN (P4-DE-30) (second limit state), associated with a compressive stress of 0.2 and 0.3 MPa, respectively. These values are consistent with the failure loads recorded for non-defective wall panels (158.68 and >150.55 kN). The mean shear strength was 0.173 MPa.

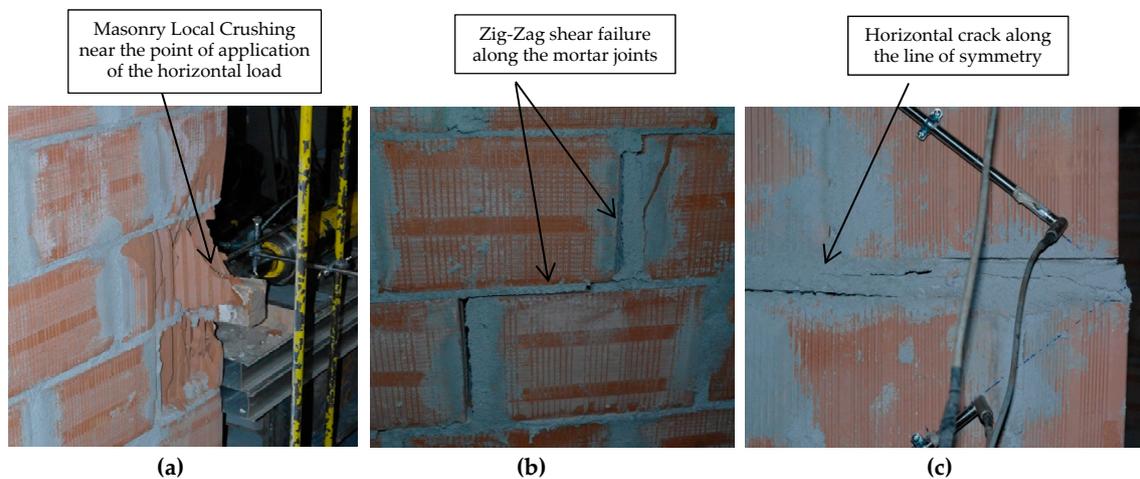
The results demonstrated that non-defective panels exhibited a very high shear strength: the average value was 0.156 MPa. This included the result of the P1-ND-30 sample, where local crushing was recorded (Figure 18a). If this result is excluded, the shear strength of non-defective panels was 0.175 MPa. The reader should be alerted about the limited number of available test results. Few standards provide information about mechanical properties of different masonry typologies to be used for design and calculations. The recent Italian Guidelines [42] provide such data. The guidelines suggests the range value of 0.08–0.17 MPa for hollow tile block masonry with cement mortar. It is interesting to note that our results demonstrate that the tested block masonry exhibited a much higher shear strength. Obviously, the Code provides characteristic values, including safety factors, but it could be suggested that the Code underestimates the mechanical properties of block masonry.

Figure 18. Failure modes: (a) un-defective control panel: local crushing; (b) un-defective control panel: diagonal cracking (zig-zag pattern), (c) defective control panel: horizontal crack along the panel's horizontal line of symmetry.

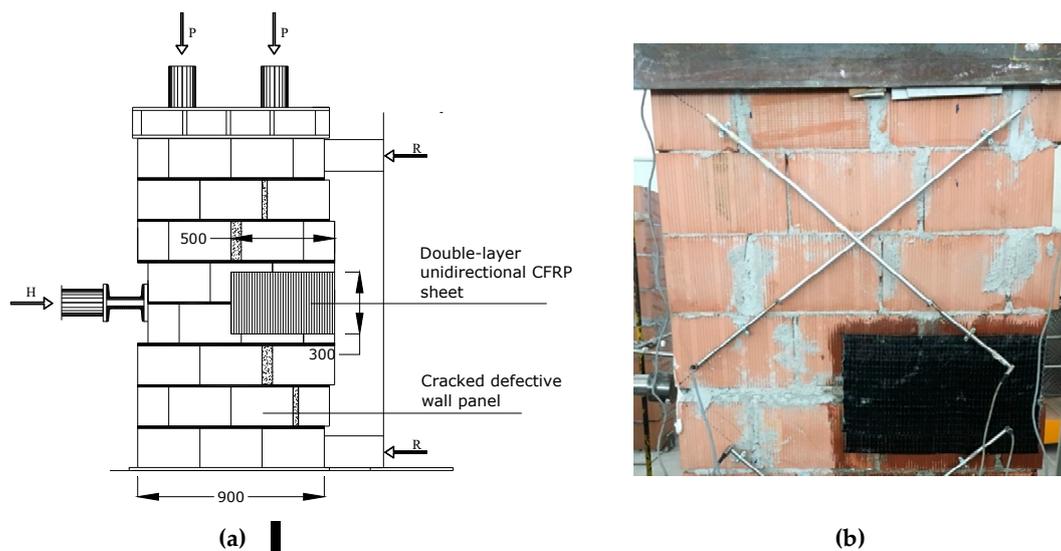
By increasing the in-plane lateral load (H), the wall panel started to exhibit increasing shear strains, reaching failure due to diagonal cracking (Figure 19), in one or both of the semi-panels. The failure mode was similar to that observed for non-defective control wall panels: cracks alternately opened in the vertical joints and in the horizontal mortar beds following a “zig-zag” pattern, leaving the tile blocks for the most part un-damaged. Apart from the initial bending deformation (due to the partial re-opening of the horizontal crack), the CFRP repair reversed the effect of the construction defect. Figure 20a shows the development of the angular strains of the two semi-panels during shear loading (Test No. P6-RE-30): the different values of the strains demonstrate that an equal distribution of the shear load between the two semi-panels is likely too simplistic.

Figure 19. (a) CFRP repair, (b) typical failure mode of repaired wall panels (detail of upper half panel) (units in mm).

All defective panels initially failed due to the formation of a horizontal crack in the bed joint between the two semi-panels. The defect was not critical, and it did not cause a high reduction of the lateral load capacity compared to the control panels: for some panels it was possible to continue to test up to the shear failure. In order to prevent the bending failure mode (horizontal cracking), a double layer of unidirectional CFRP sheets was applied on both sides of the panel. The CFRP repair was made using two 300 mm × 500 mm overlapping sheets, applied on both sides, with the fibers perpendicular to the horizontal crack. After the CFRP repair, defective panels were re-tested in shear, according to the same procedure used to test control panels.
