Citation: Sarwar, Mohammed, Haider, Julfikar, Persson, Martin and Hellbergh, Hakan (2008) Evaluating the performance of TiN coating on a PM HSS milling cutter used in manufacturing of bandsaws. In: 3rd International Conference on Surface Coatings and Nanostructured Materials (NanoSMat 2008), 21-24 October 2008, Barcelona, Spain.

**EVALUATING THE PERFORMANCE OF TiN COATING ON PM MILLING
CUTTERS USED IN THE MANUFACTURING OF BANDSAWS**

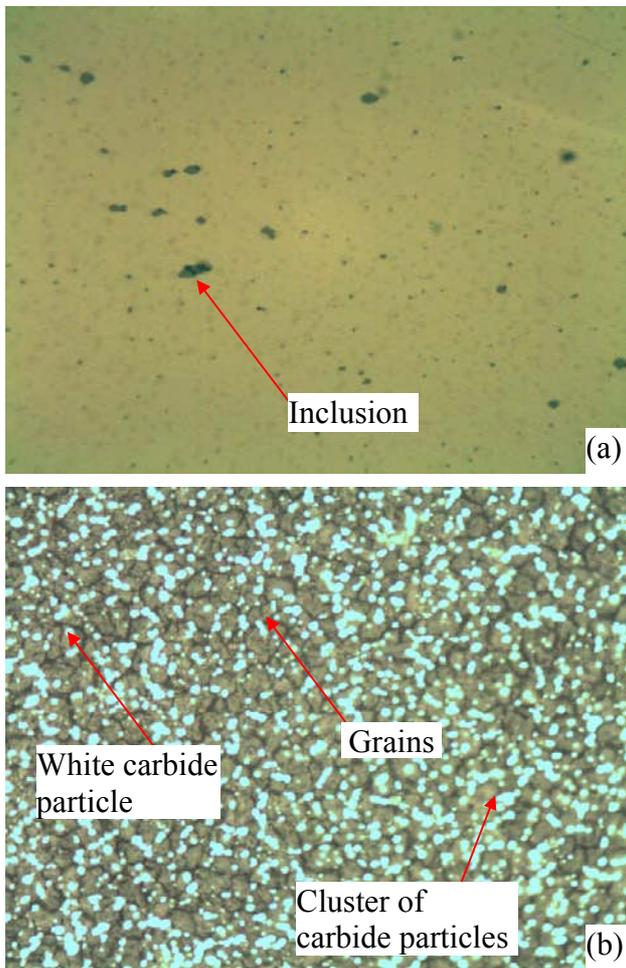
Figure Number: 3

The hardness of cutter substrate (PM REX 54 HSS) varied from 840-860 HV_{1.0} (equivalent to 65.5 - 66 Rc), which was in the given specification. The surface morphology before etching under the light optical microscope showed non-metallic inclusions dispersed in the material (Fig. 3a). These inclusions were believed to be small sulphide particles, which could result in machinability and grindability benefits with no adverse effect on toughness. In the etched sample, optical microscope revealed smaller grains (25 grains across 0.127 mm diameter circle) with uniformly distributed round carbide particles (Fig. 3b), which will provide required strength at the cutting edges of the cutter.

Fig. 3. Surface morphology of the PM Rex 54 HSS material (a) without etching and (b) after etching (Mag. 1000×)

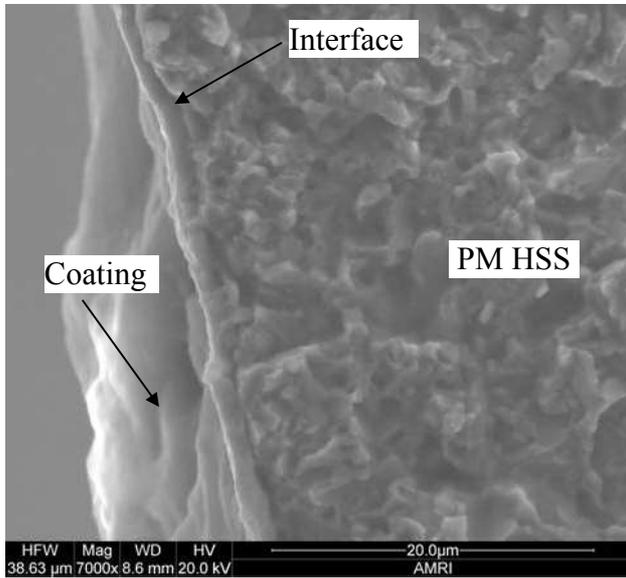
Figure Number: 4

Under SEM, the coating fracture morphology appeared very densely packed with no distinguishable feature, which indicated good quality of coating (Fig. 4). After examining the interface between the coating and the substrate, it appeared that the coating was also well adhered. However, the thickness of the coating varied between 2 µm - 4 µm around cutting edges of milling cutter.

Fig. 4. SEM image of TiN coating fractured morphology on a milling cutter tooth

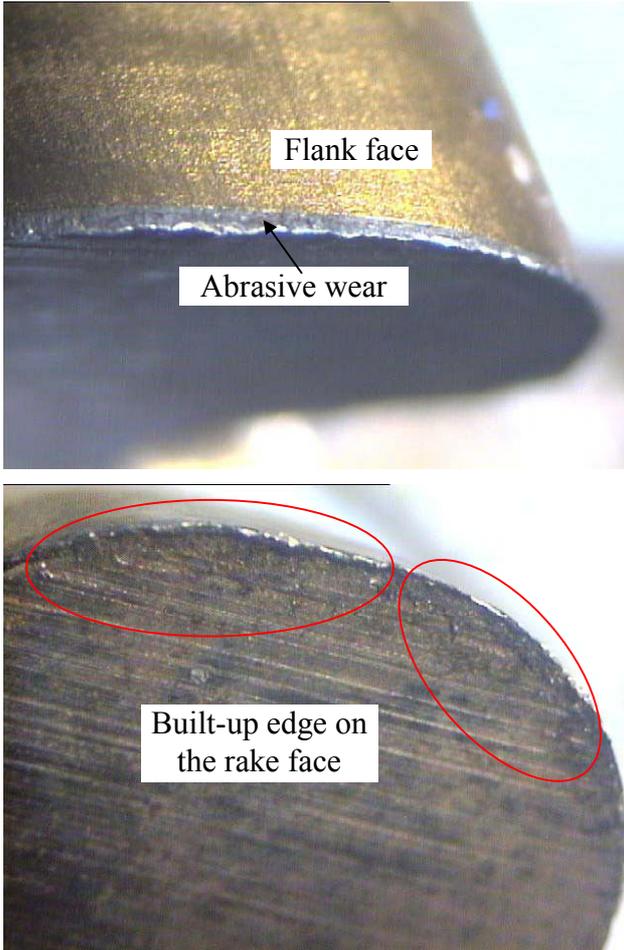
Figure Number: 5

Edge radius of an uncoated cutter at new condition was very small (~ 7 µm -9 µm), which was typical of grinding process. On the other hand, edge radius of a coated cutter at new condition was slightly higher (9 µm - 12 µm) than that of uncoated cutter due to the coating on the cutting edges. At new condition both the coated and uncoated edges were sharp with no burr. After examining many cutters, flank wear and notch wear were identified as the principal mode of wear in both coated and uncoated cutters. The abrasive wear and adhesive wear with the detachment of built-up edges were the governing mechanisms of the flank wear as shown in Fig. 5. No macro flaking of the TiN coating from the flank face was observed. The built-up

Fig. 5. Wear characteristics in a coated milling cutter tooth under optical microscope

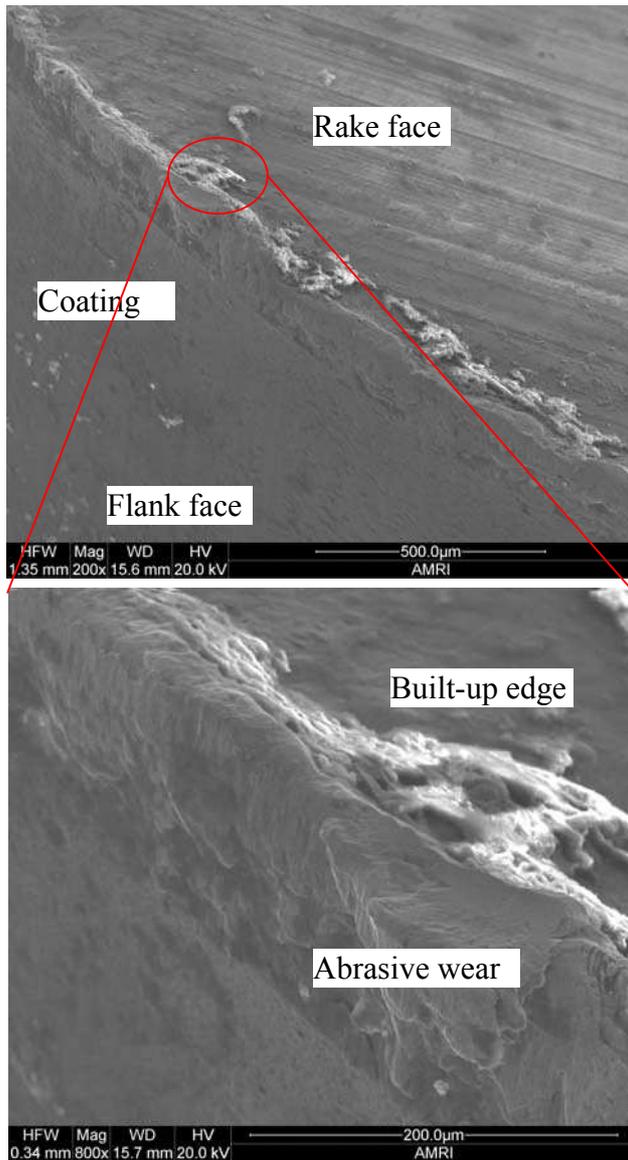
Figure Number: 6

edge and abrasive wear were more clearly revealed under SEM (Fig. 6). Similar abrasive and adhesive wear were also observed in the uncoated cutters. Notch wear at the crossover point on the flank face was quite common in small tooth form cutters. Notch wear was not observed in big tooth form cutters and full form cutters (roughing flute followed by finishing flute). In many coated cutters notch wear was significantly lower. It was established that notch wear at the crossover point on the flank face was related to the tooth tip burr in the bandsaw. In the uncoated and small tooth form cutters, strong burrs are left in the flank face after regrinding due to material flow from the grinding action. In the coated and big tooth form cutters, cutting edges are sharp with no burrs left in the flank face after regrinding. The coating could provide hard surface to prevent any material flow as burr after regrinding. Furthermore, TiN coating on milling cutter also offered more confidence in operating at higher feeds and speeds. The premature failure of the cutter generally occurred due to the rubbing with the band, hard join-up welding in the band or thinner flute width at the end of the cutter life.

Fig. 6. Wear characteristics in a coated milling cutter tooth under SEM

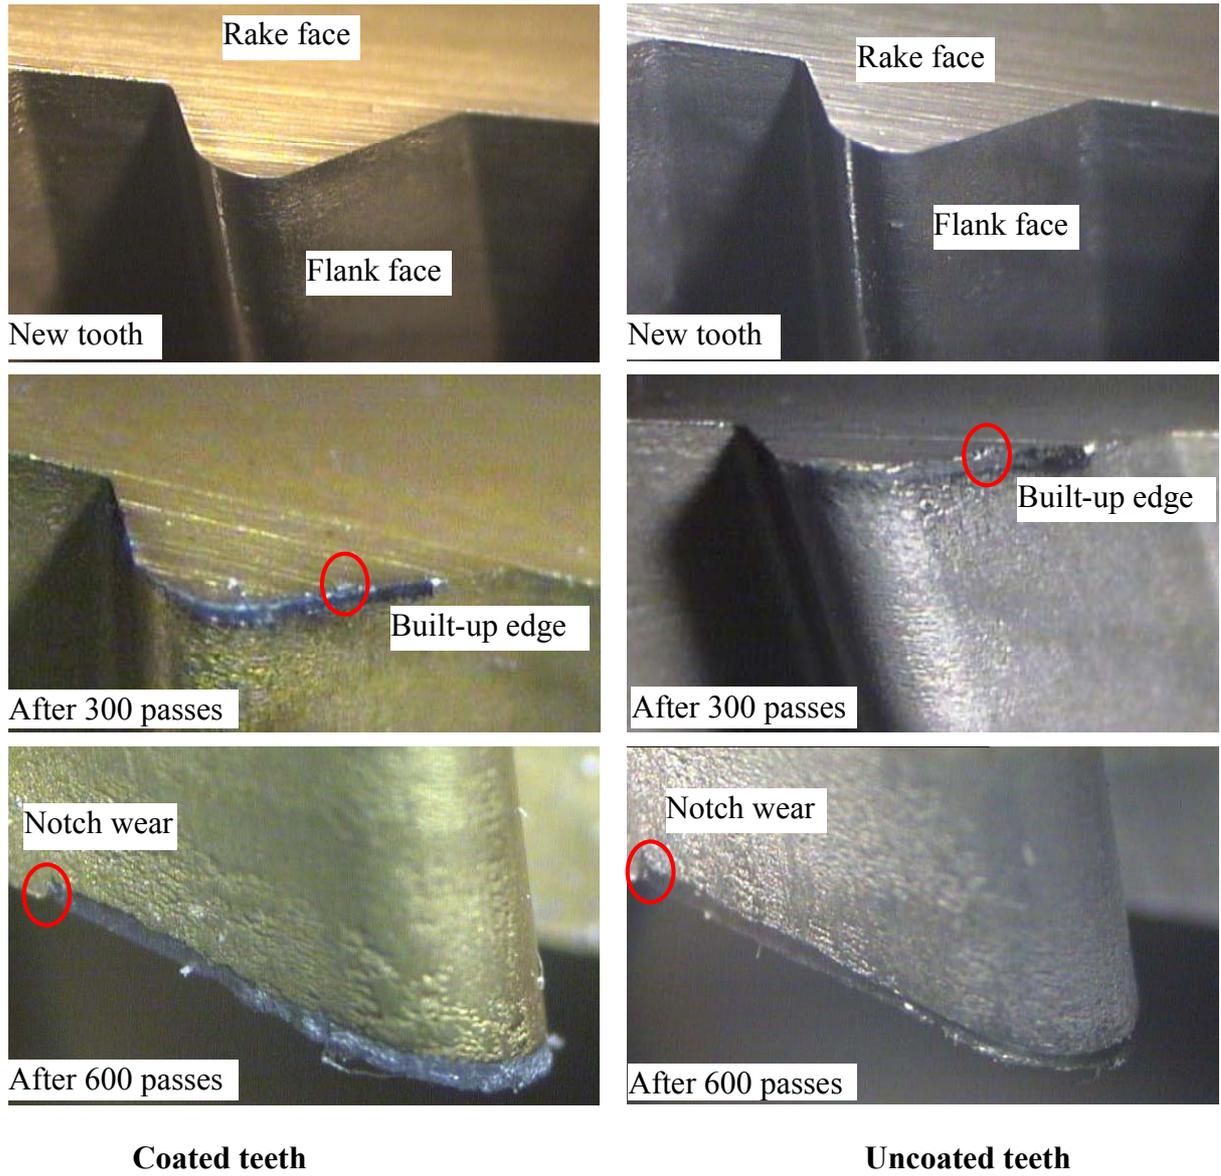
Figure Number: 7

Cutting edges of the new coated and uncoated teeth of the half-length coated cutter were sharp with no burr. After 300 milling passes coating started to break off from the flank face and adhesive wear with built-up edge developed in both coated and uncoated teeth. Flank wear and adhesive wear with the built-up edge also increased after 600 passes. In some flutes the built-up edges broke off along with the cutter material both in coated and uncoated teeth. Notch wear at the crossover point on the flank face of the cutter were also visible in both coated and uncoated teeth. **Fig. 7** shows the coated and uncoated teeth at new condition, after 300 milling passes and after 600 milling passes. Flank wear in the coated teeth after 600 passes was in the range of 0.10 mm to 0.22 mm whereas, the flank wear in the uncoated teeth was in the range of 0.13 mm to 0.35 mm when measured using image analysis software. The measurement was also verified in few selected teeth by profiling them across the flank face. Flank wear in the coated and uncoated teeth of the half-length coated cutter was in the range of 0.17 mm to 0.20 mm and 0.25 mm to 0.34 mm respectively when measured by the Contacer profilometer.

Fig. 7. Coated and uncoated teeth of the half-length coated milling cutter at new condition, after 300 passes and after 600 passes.

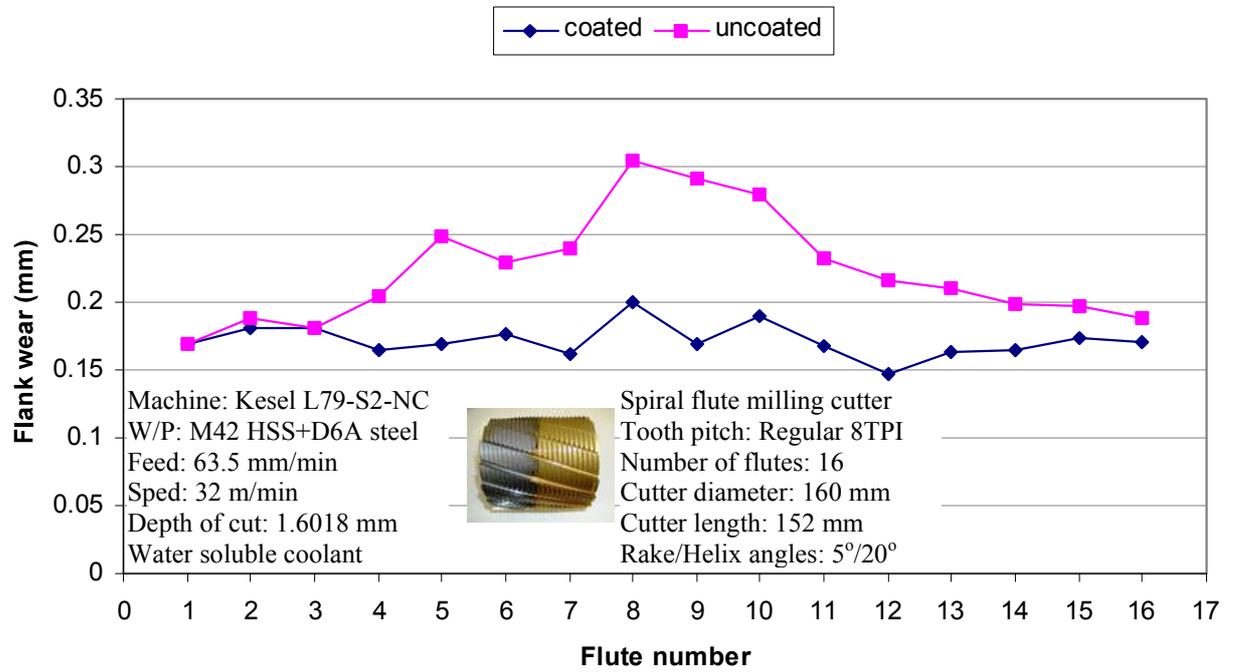
Figure Number: 8

Flank wear in a selected coated tooth and uncoated tooth of all 16 gashes were measured on three different positions on the flank face. **Fig. 8** shows the amount of flank wear at one position near the crossover point and the percentage of reduction of flank wear by TiN coating. The coating reduced the flank wear up to 40% compared to the uncoated teeth. However, the flank wear in the coated teeth was not always consistent. In some flutes flank wear in the coated teeth were equal to the wear in the uncoated teeth. Complex cutting action by the multipoint milling cutters compared to single point cutting tools, lack of manufacturing

accuracy of the cutter teeth and variation in the quality of the coating on complex geometry of every tooth could be responsible for this kind of variation. It should be noted for multi-point tools, such as milling cutters, the overall performance is determined by the combination of cutting edge, rake face and gullet characteristics. Furthermore, it is important that all teeth are manufactured to the same specification in order to maximise the tool performance and life, as a multi-point tool is only as good as its weakest tooth [5]. A total systems approach combining tool materials, tool design, manufacturing quality, surface preparation and appropriate coating characteristics is necessary to achieve beneficial performance from the coated multipoint cutting tools.

Fig. 8. Flank wear plot of the coated and uncoated teeth in all 16 flutes of the half-length coated milling cutter

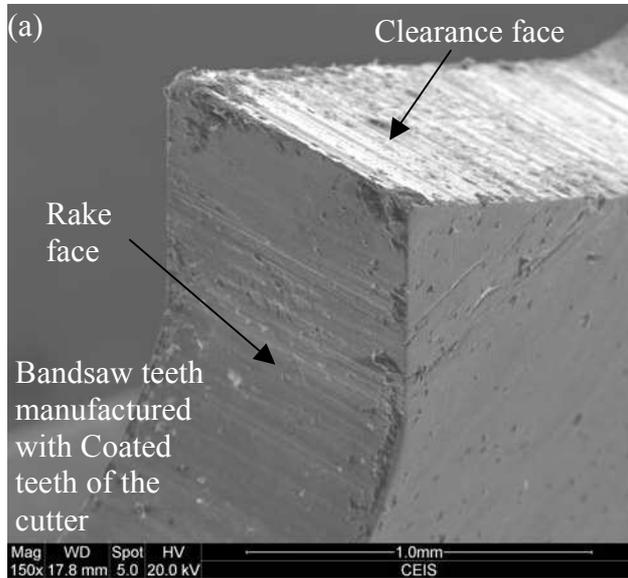
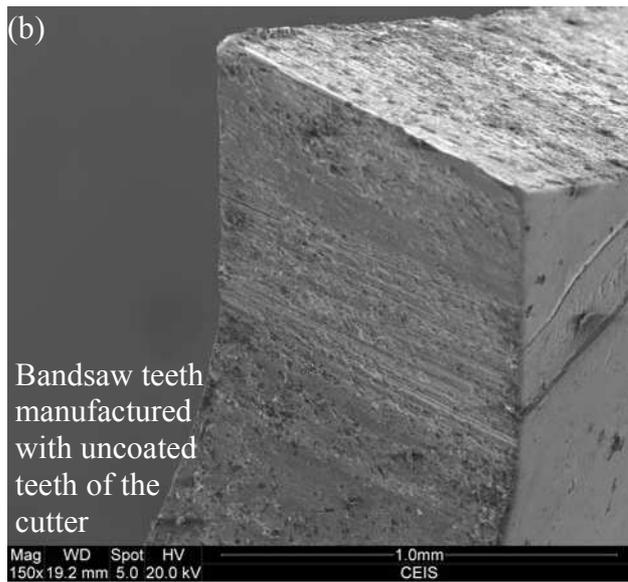
Figure Number: 9

Fig. 9 shows that under SEM a better surface characteristics can be observed in the bandsaw teeth manufactured by coated teeth of the milling cutter. This fact was further evidenced by the surface roughness of the bandsaw teeth manufactured by the coated and uncoated teeth of the milling cutter (Fig. 10). The surface roughness of both the rake and clearances faces was reduced. Less friction between the cutter teeth and workpiece can be attributed for the better surface finish in the bandsaw teeth manufactured by the coated teeth of the milling cutter.

Fig. 9. Bandsaw cutting edges formed by the (a) TiN coated and (b) uncoated teeth of the half-length coated milling cutter

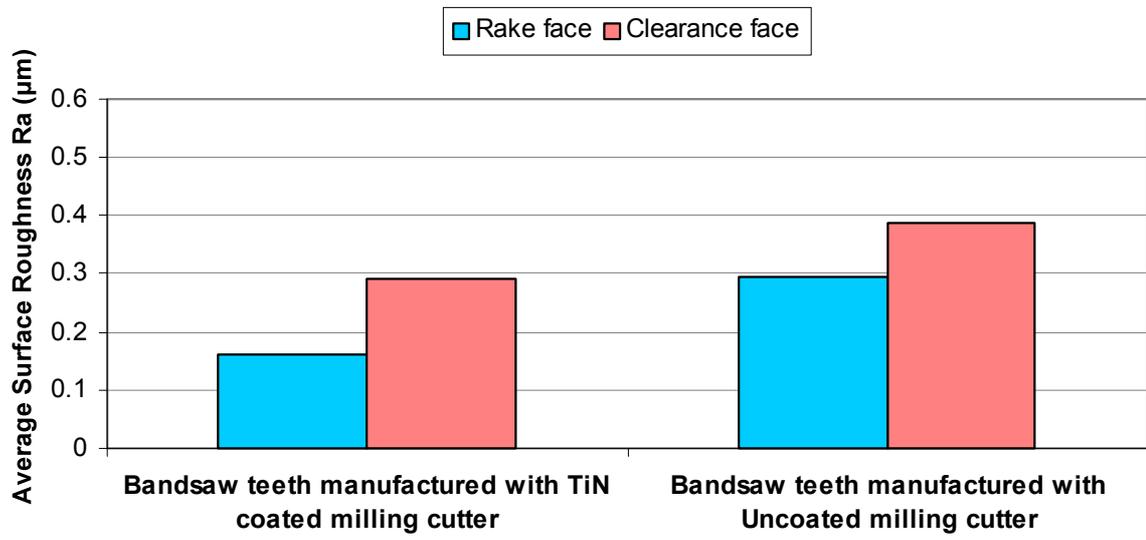
Figure Number: 10

Fig. 10. Average surface roughness of bandsaw cutting edges formed by the TiN coated and uncoated teeth of the half-length coated milling cutter
