# **Experimental evaluation of shear and compression strength of masonry wall before and after reinforcement: deep repointing**

**Keywords:** masonry, shear strength, reinforcement, deep repointing

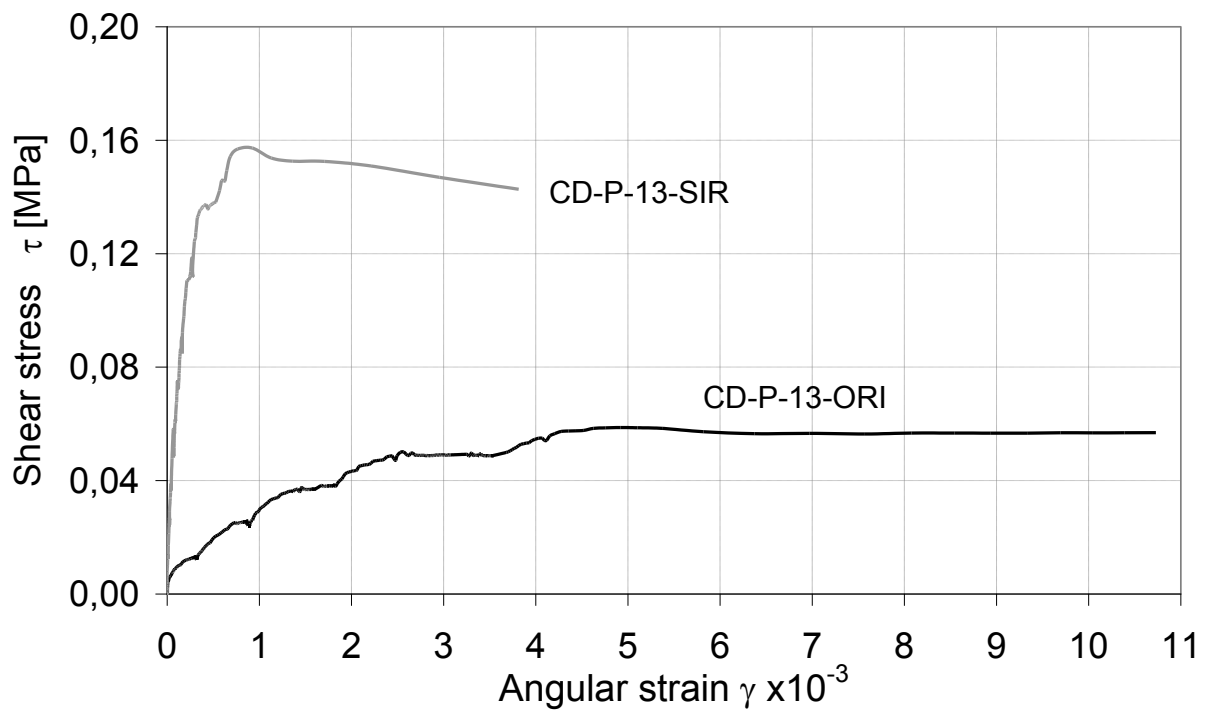
Finally the last two diagonal tests were carried out on the Trevi building (CD-26-T-ORI, CD-26-T-RIR). The panel with a thickness of 670 mm was only repaired by deep repointing in order to check the influence of the technique when used alone. The results are also reported in Table 4. In this case the shear strength change from the un-repaired panel to the panel after repair, is from 0.045 N/mm<sup>2</sup> to 0.054 N/mm<sup>2</sup>, which is only a very small increase in value. On the contrary, the shear stiffness changed from 79.60 N/mm<sup>2</sup> to 231.56 N/mm<sup>2</sup>. Figs. 12 and 13 show the comparison of the stress-strain curves of the panels in Trevi and Ponte.

From these results, a clear tendency is shown: the deep repointing alone can increase the shear stiffness of the masonry, while a significant increase in shear strength can be obtained by the synergic effect of repointing and grout injection. It is nevertheless important before using the grout injection technique to accurately examine its applicability. In fact when the technique was applied by the authors always a study of masonry injectability was carried out [4]. A certain percentage of voids must be present in the masonry and no loose material or clay must be found inside the masonry section, in order to have a successful injection. The results obtained for the diagonal compression tests carried out on panels repaired by means of injection and deeprepointing showed significant high increases both in terms of shear strength and stiffness. However, it must be pointed out that the presence of cracks (these cracks were caused by the initially tests on the same un-strengthened panels) facilitated the distribution of the injected grout within the panels.

Figure 12 Angular strain vs shear stress for the Trevi panel before and after reinforcement.
