Citation: Candela, Michele, Borri, Antonio, Corradi, Marco and Righetti, Luca (2016) Effect of transversal steel connectors on the behaviour of rubble stone-masonry walls: two case studies in Italy. In: 16th International Brick and Block Masonry Conference, 26th - 30th June 2016, Padua.

Effect of transversal steel connectors on the behaviour of rubble stone-masonry walls: two case studies in Italy

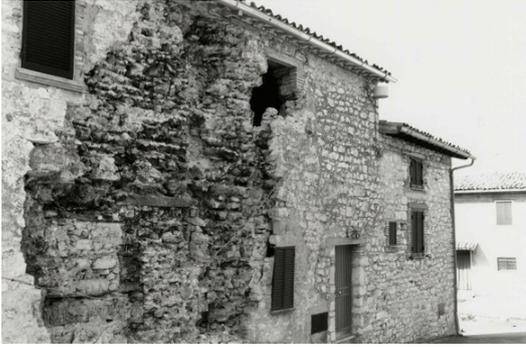
Figure 1. Example of separation between two leaves of masonry due to seismic action.

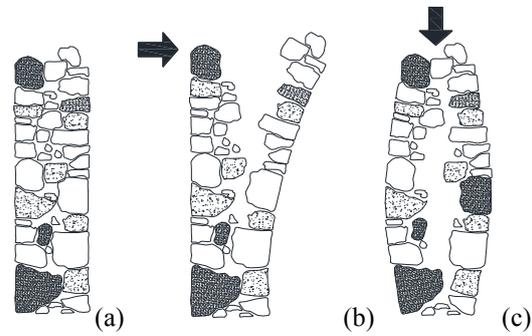
Double-or triple-leaf walls (Fig. 2a) are usually subjected to two different failure mechanisms. Figure 2b presents the out-of-plane mechanism of a double-leaf masonry wall subjected to a horizontal seismic action.

Figure 2. Leaf masonry wall failure mechanism: (a) un-loaded panel; (b) panel subjected to a horizontal load; (c) panel subjected to a compression vertical load.

Consequently, the capacity of the wall to resist horizontal loads is smaller when compared with the one of a well-connected masonry wall. Multi-leaf masonry walls exhibit disadvantages also when subjected to high compression loads; this could again produce the detachment of the two leaves and the failure of the wall (Fig 2c).

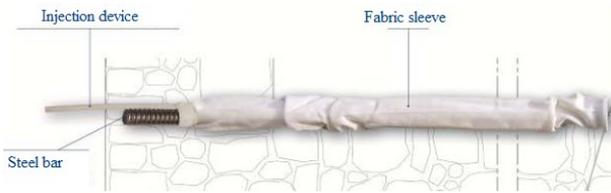
The strengthening system (Fig. 3) consists in a steel bar inserted in a mesh fabric sleeve (bag-case). This is injected at high-pressure (3-5 atm, depending on the quality of the masonry material) using a high-strength cement-based grout. The fabric sleeve avoids unexpected and often damaging scattering and wastefulness of the grout between the masonry leaves and increases the level of connection of the injected material to the masonry surface throughout its entire length.

Figure 3. Anchor with fabric bag-case.

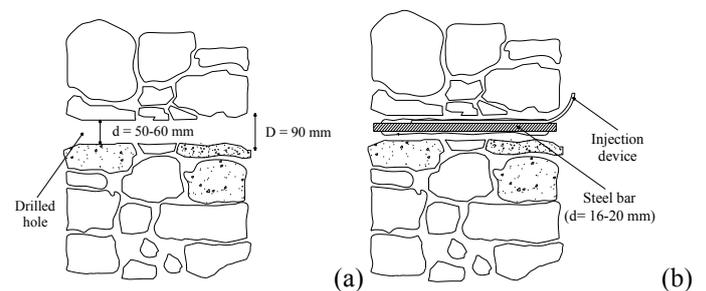
- drilling the masonry panel using a machine equipped with diamond bits (Fig. 5a), which work only with rotation movements in order to avoid percussion and vibration effects on the masonry. Hole's diameter is evaluated according to the anchors size: it is usually about three times the steel bar diameter. It is important to use the correct borehole diameter in order to guarantee an easy insertion of the anchor equipped with fabric bag-case; moreover the adherence surface is strictly influenced by the drilling diameter;

Figure 5. Reinforcement procedures: (a) drilling the masonry; (b) application of the anchor in the drilled hole.

- the reinforcement, made of the steel bar, supplied with the special fabric bag-case, is assembled on-site, and then applied inside the holes (Fig. 5b). The connection between the different parts is obtained with full strength couplers and special turnbuckles in case of tendons designed to contain the drift of pushing elements such arch and vaults;

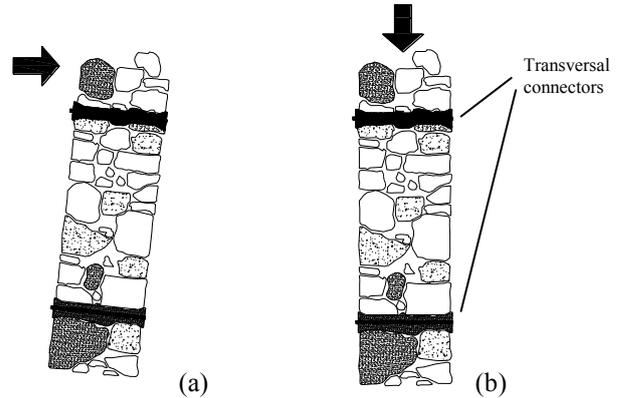
Figure 8. Leaf masonry wall behaviour expected after the reinforcement: (a) panel subjected to a horizontal load; (b) panel subjected to a compression vertical load.

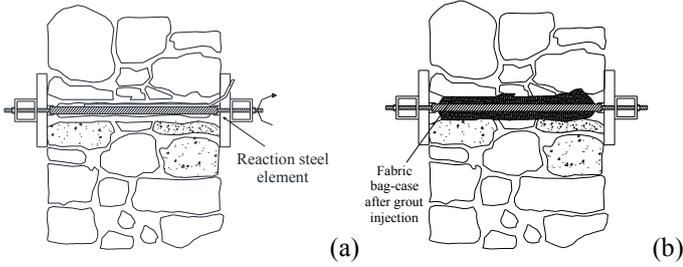
Figure 6. Reinforcement procedures: (a) pre-stress of the steel bar using a torque wrench which applied load on reaction steel element; (b) grout injection.

- the steel bar, installed inside the hole, can be pre-loaded using a torque wrench (Fig. 6a); a reaction steel frame is used to keep applied the pre-load.

- grout is then injected through the plastic injection device at high-pressure values between 3 and 5 bars (Fig. 6b). The value of the grouting pressure depends on the quality of the masonry and on the vertical compression stress acting on it at the level of the application of the connector. For good quality masonry walls subjected to high compression stresses, it is possible to use a high pressure value. The effective anchor's length is another aspect to consider: this depends on the thickness of the wall. The injection should be done gradually until the anchor is fully injected;

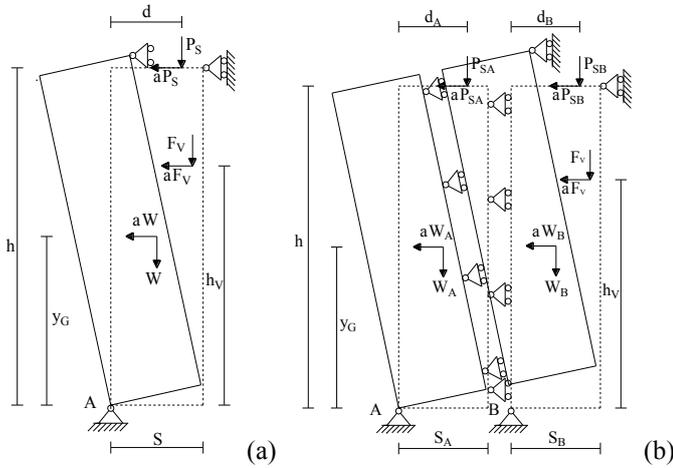
In Figure 9a, W is the weight of the masonry wall panel and y_G is the distance of the panel's centroid from hinge in A and s is the wall thickness. F_V is the vertical load due to the presence of a floor or roof and h_V and d_V are the vertical and horizontal distances from the point of application of load to the point A. P_S is the vertical load due to the weight of the floor above the masonry wall and h and d are the vertical and horizontal distances from the load to the point A. Combining equations (1) and (2), the collapse – load factor is equal to:

Figure 9. Overturning mechanism: (a) monolithic masonry wall. (b) double-leaves masonry wall.

Figure 9b shows the overturning mechanism for a double-leaf masonry panel. The collapse – load factor is given here by:

The reinforcement has been designed considering the overturning mechanism of the monolithic masonry wall and using a theoretical approach to evaluate the collapse - load factor (α). The overturning moment ($M_{R(A)}$) causing the rotation of the wall about the hinge A is:

$$\alpha = \frac{W \cdot \frac{s}{2} + F_V \cdot d_V + P_S \cdot d}{W \cdot y_G + F_V \cdot h_V + P_S \cdot h} \quad (3)$$

$$\alpha = \frac{W_A \cdot s_A + W_B \cdot s_B}{2[(W_A + W_B)y_G + F_V \cdot h_V + (P_{SA} + P_{SB})h]} + \frac{P_{SA} \cdot d_A + P_{SB} \cdot d_B + F_V \cdot d_V}{(W_A + W_B)y_G + (P_{SA} + P_{SB})h} \quad (4)$$

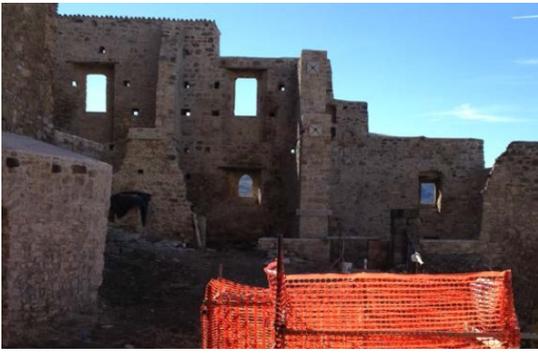
Figure 11. Main entrance of the castle where the connectors have been applied.

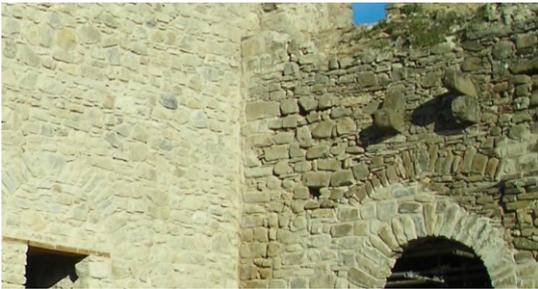
The existing walls are made of barely cut stone-masonry bonded with a weak (pulverulent) lime-based mortar, often damaged from excessive water action. The walls are made of 3 adjacent masonry leaves (triple-leaf walls) with a total thickness varying between 100 and 169 cm. The strengthening intervention has interested these massive walls, which are located near the main entrance of the castle (Fig. 11). The masonry arrangement is shown in Figure 12. Stones with larger dimension of approx. 35 cm were used together with smaller pinning stones, needed to increase the stability of larger stones. The three masonry leaves are weakly connected to each other. In order to increase the transversal connection of the different layers the technique described in the previous paragraphs has been choice by the authors. Twenty eight connectors GBOS 20-60 P characterized by steel bar with nominal diameter of 20 mm have been placed in a hole with diameter of 60 mm while the both sides of the hole were characterized by a diameter of 90 mm (Fig. 13a) to allow the pre-stress of the bar.

Figure 12. Masonry arrangement of the Laurenzana castle.

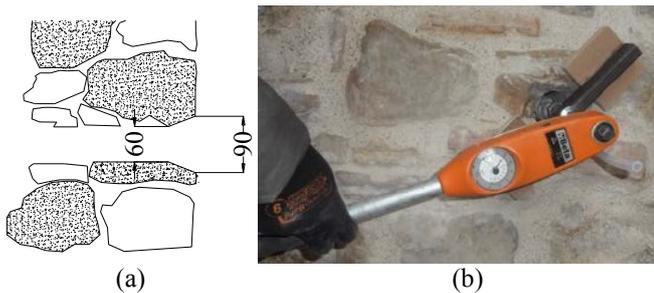
Figure 13. (a) Geometry of the hole drilled in the masonry (dimension in mm). (b) pre-stressing of connectors.

order to avoid vibration and percussion effects on the masonry panels. The anchors, supplied with the special sock, are installed inside the holes and pre-stressed with 3.92 kN using a torque wrench which applied load on reaction steel elements (Fig. 13b) and the grout has been injected inside the sock with a pressure between 3.0 and 3.5 bar.

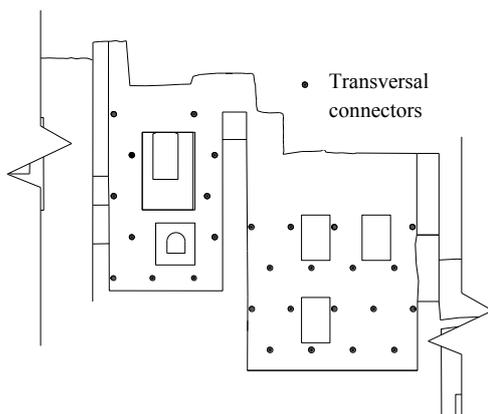
Figure 14. Arrangement of the position of the connectors.

The length of the bars varied between 960 and 1650 mm and the mutual distance in the horizontal and vertical direction between the connectors was around 1500 mm and they have been placed in according with the geometry in Figure 14. The holes have been drilled with drilling machines with diamond bits that work only with rotation movement in

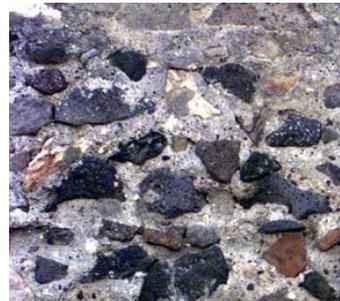
Figure 16. Tuff masonry arrangement of the goat house of the Royal Palace of Capodimonte.

The goat house is a two storey building made of tuffstone masonry walls and vaults (Fig. 16). Tuff was the typical stone of the area coming from local quarries. Double-leaf wall panels were used when a thicknesses between 46 and 55 cm was required. For larger thicknesses (between 57 and 103 cm) completely disconnected triple-leaf masonry have been

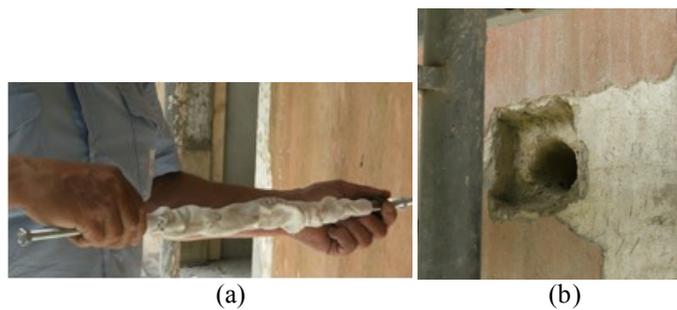
16mm-diameter steel-connectors (type GBOS 16-50 P) have been used (Fig.17a) to bond the masonry leaves together. A total of 78 50mm-diameter holes were drilled on the building perimeter walls. To allow the application of a tensile pre-load on the steel bar, holes were enlarged near the wall surface to a diameter of 90 mm (Fig. 17b). The length of the bars varied between 420 and 990 mm depending on the thickness of the wall panels and the centre-to-centre distance in the horizontal and vertical direction between the connectors was approx. 2000 mm. Figure 18 shows the arrangement in the north-east façade. A professional non-percussion rotary hammer drill with an active vibration control system and a 90 mm-diameter diamond core drill bits hole cutter were used to drill the holes (Fig. 19).

Figure 17. (a) 16 mm-diameter steel connector before insertion; (b) hole countersinking.

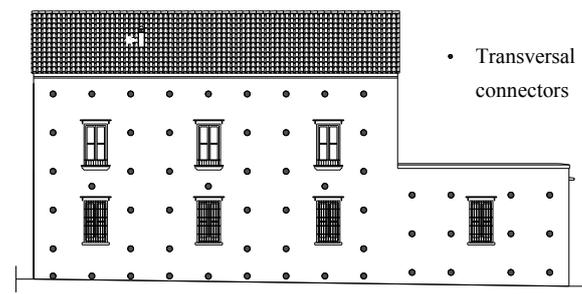
Figure 18. Arrangement of the connectors.

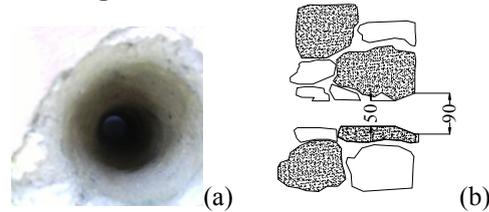
Figure 19. (a) View of a hole realized on the goat house building; (b) Geometry of the hole drilled in the masonry (dimensions in mm).

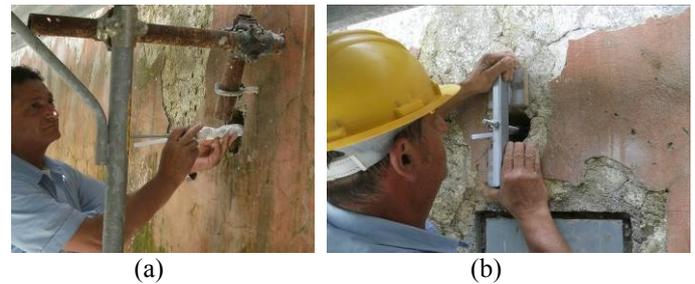
The steel bars, supplied with the special fabric bag-case, are then installed inside the holes (Fig. 20a). A tensile pre-load of 7.84 kN was also applied using a standard torque wrench. It was possible to keep the steel bars under loading using a reaction steel element (Fig. 20b). Finally the cement-based grout has been injected inside the fabric bag-case at pressure of 2.5 bar (Fig. 21a). The grout was cured for 28 days (Fig. 21b). At the end of this period, the reac-

Figure 20. (a) Insertion of the steel bar; (b) pre-load application.

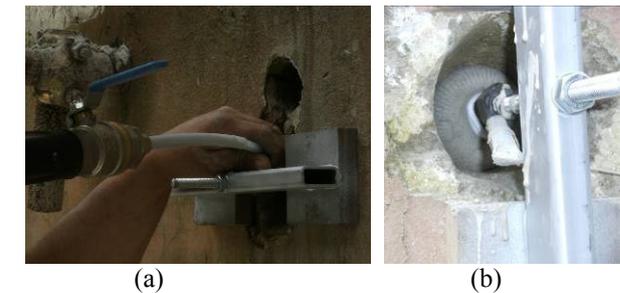
Figure 21. (a) Grouting operation; (b) the reinforcement during curing time.
