1 An experimental study on the influence of composite materials used to
2 reinforce masonry ring beams

30 ABSTRACT: For historic masonry constructions the out-of-plane wall behavior is critical to
31 seismic performance. Because the main cause of out-of-plane collapses is the wall-to-wall
32 level of connection, the application of a Reinforced Concrete (RC) ring beam at the eaves lev-
33 el of historic masonry buildings is an effective method to prevent an out-of-plane mechanism
34 of a wall panel. However this effective reinforcing method presents some drawbacks. In order
35 to address this, this paper describes the problems associated with this “traditional” reinforcing
36 method and introduces a new retrofitting technique for historic masonry buildings by realizing
37 a new type of ring beam made of recycled old stones or bricks reinforced at the bed joints with
38 glass-fibre sheets, GFRP (Glass Fiber Reinforced Polymer) grids or/and PBO (polybenzoxa-
39 zole: poly-p-phenylene benzobisoxazole) cords. An experimental investigation has been car-

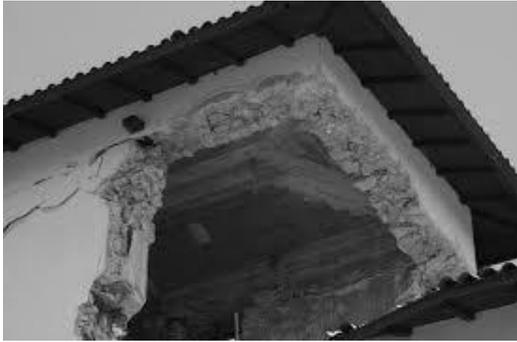
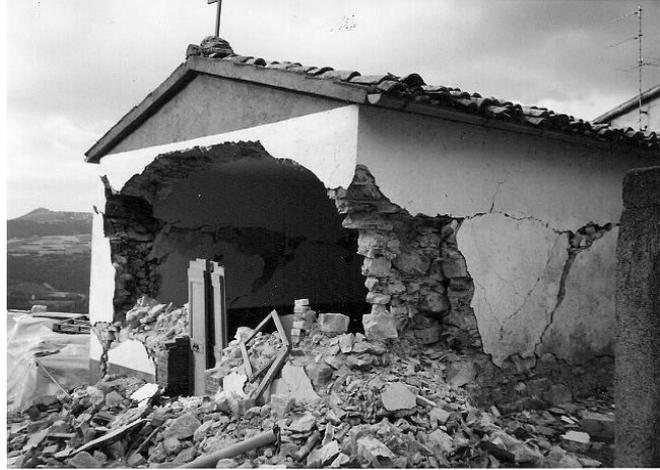
499 Figure 2. Examples of an out-of-plane collapse due to poor connection between the RC ring beam and
500 the underlying masonry.

74 mechanisms, the action of vertical static loads may contribute to stabilize wall panels, but the
75 application of stiff RC ring beam may cause the re-distribution of vertical compressive stress-
76 es and some portions of masonry could results unloaded and, during earthquakes, be prone to
77 become unstable (Fig. 2) [6-8].

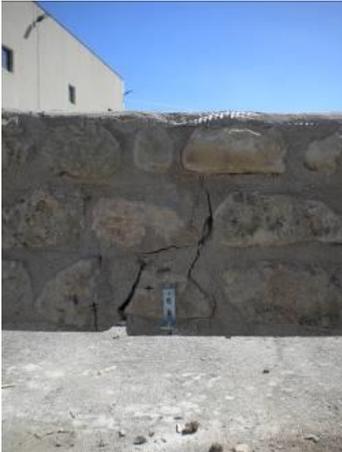
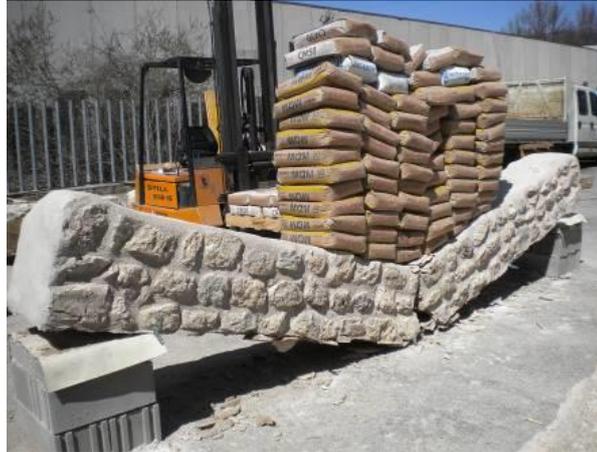
Figure 15. a) Crack pattern produced by self-weight; b) Ring-beam No. P3-U-V after testing.

247 whereas the PBO cords were not damaged (Fig. 15a). The variation in bending stiffness indi-
248 cated a shift from an elastic behavior (in which all the materials act as one) to a plastic one (in
249 which only the PBO cords provide the needed tensile strength to the beam). By increasing the
250 bending load, the deflection of the beams increased considerably until failure; it is noteworthy
251 to mention that the tensile failure of PBO cords was never reached (Fig. 15b). Debonding of
252 the composite reinforcement (glass-fiber sheet and PBO cords) and mortar cracking were the
253 main cause of the ring-beam's collapse.

471 Figure 15. (a) Crack pattern produced by gravity self-weight load. (b) Ring-beam No. P3-U-V after
472 testing.

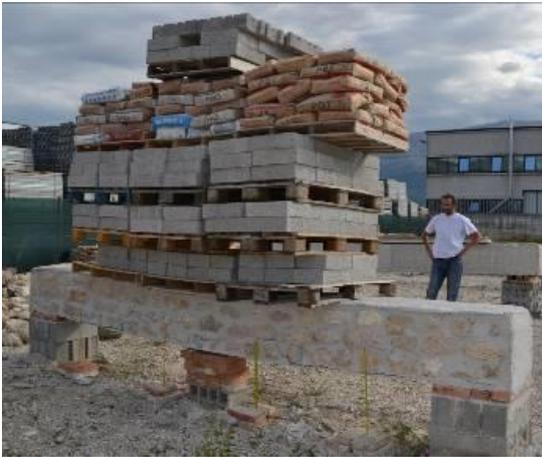
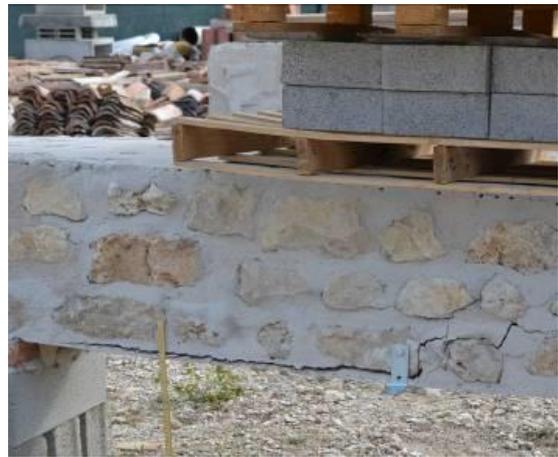
Figure 16. Ring beam No. P5-G33-V: a) under loading, b) detail of the cracks.

261 With regard to the specimens reinforced using GFRP grids (P5, P6, P7, P8, P9 and P10), the
262 overall capacity of the ring-beams was significantly higher compare the one measured for
263 specimens reinforced with PBO cords and fiberglass sheets. The maximum mid-span bending
264 moment increased to 48.35 kNm from 21.44 kNm measured for beams previously tested. The
265 6 simply-supported specimens that had failure initiating at mid-span had similar longitudinal
266 and transverse strain gradients prior to failure. For a load of 21 kN, specimen P5-G33-V ex-
267 hibited vertical cracks on both the lateral vertical surfaces. By increasing the load magnitude,
268 the ring beam underwent a progressive degradation: the number of vertical cracks amplified
269 and horizontal crack at the bed joints opened near the beam's ends (Fig. 16). At beam's mid-
270 span, diagonal cracks also opened and composite partially separated from the mortar. The ca-

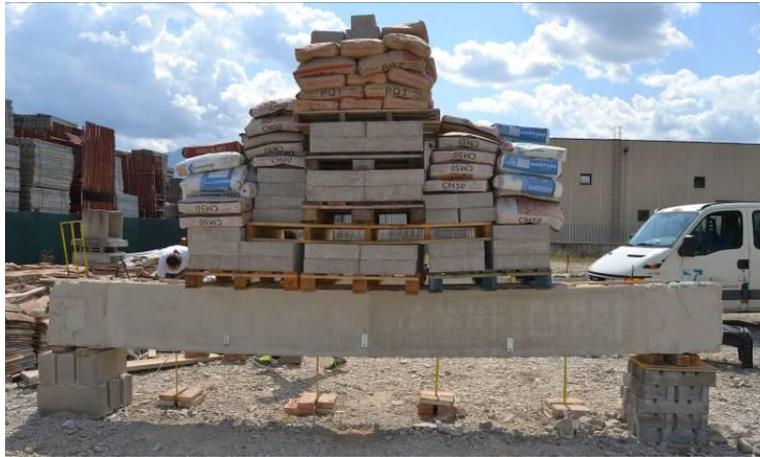
Figure 17. Test No. P8-G66-H.

272 Test P8-G66-H exhibits vertical cracks at mid-span for a load of 10.5 kN. The maximum load
273 applied on this ring-beam was 43.1 kN. For this load level many vertical cracks opened at
274 beam intrados (Fig. 17). However it was not possible to take the specimen to failure for the
275 difficulty in the application of the external load.
