Citation: Richardson, Alan, Coventry, Kathryn and Pasley, Jack (2016) Bacterial crack sealing and surface finish application to concrete. In: Sustainable Construction Materials and Technologies (SCMT4), 7th - 11th August 2016, Las Vegas.

SCMT4  
Las Vegas, USA, August 7-11, 2016

## Bacterial Crack Sealing and Surface Finish Application to Concrete

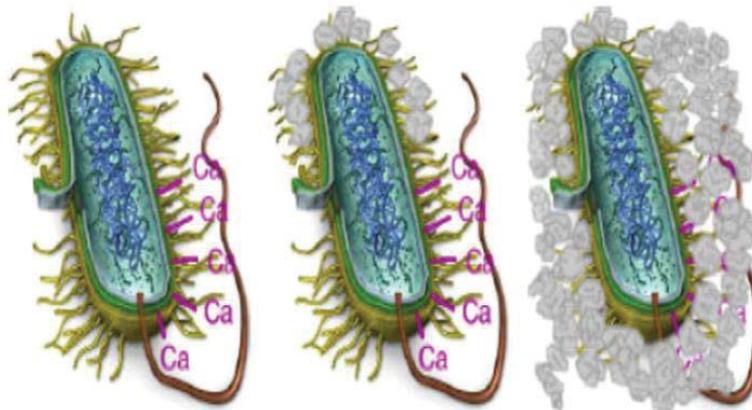
**Bioremediation.** A bacterial cell surface can provide a nucleation site to non-specifically induce mineral deposition due to its variety of ions (Siddique and Chahal, 2011). Bacteria have the largest surface area to volume ratio of any life form (Fortin et al., 1996). Therefore they are able to harbour calcium carbonate formation as shown in Figure 1.

**Figure 1. Simplified Ureolysis Calcite Precipitation (De Muynck, De Belie, et al., 2010)**

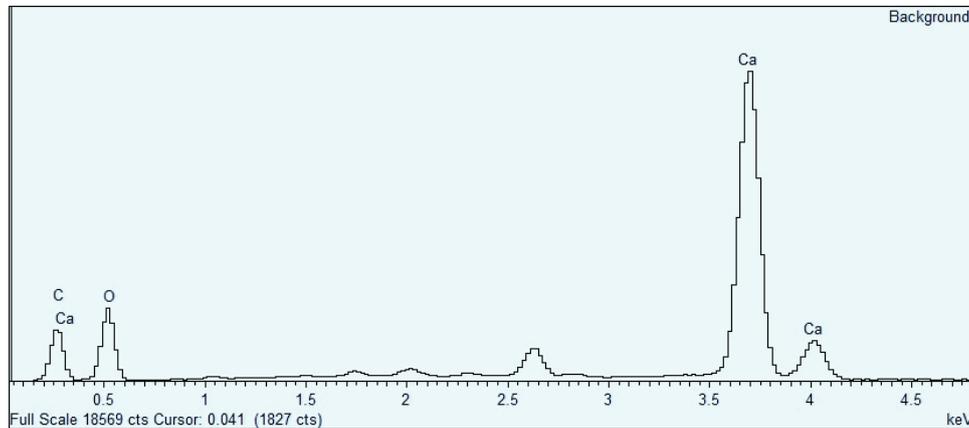
The bacterial residue was examined at the surface (foreground) and at the intersection between the calcite and the concrete (background), using an Energy Dispersive Spectroscopy (EDS) image analysis technique and the chemical component parts are displayed in Table 3 and Figure 2.

**Figure 2. Energy Dispersive Spectroscopy (EDS) image**

The Energy Dispersive Spectroscopy (EDS) results were tested alongside a MOH's hardness test and hydrochloric acid test which showed the calcite formation was within normal hardness associated with the formation of calcite and the acid test showed the material to be of an alkaline nature. Following the treatment, an average oven dry weight increase of 3.6g was recorded. The WCR ratio of the cubes did not effect the average weight gain for the respective samples.

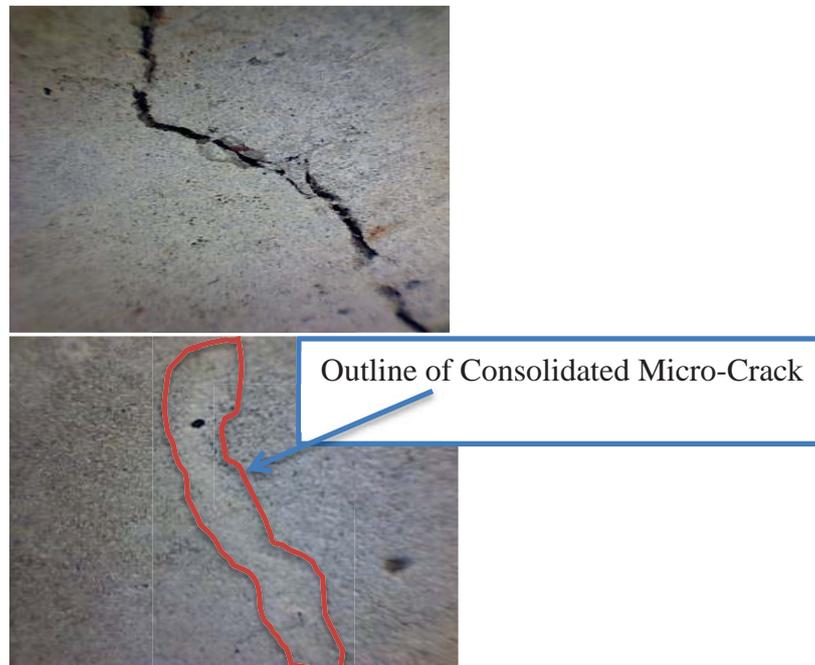
The effectiveness of the MICP crack healing properties are displayed in Figures 3 and 4.

**Figure 3. Above cracked fibre beam and below MICP sealing the crack**

The results, with regard to depth of calcite penetration, demonstrated the near 100% consolidation of the micro cracks to a depth of approximately 20mm. The use of the treatment in such a way could be plausible on a commercial scale as the cracks house the NBU, in turn pooling the solution and leading to MICP. This reduces the reliance on surface pooling which was needed with the cube samples.

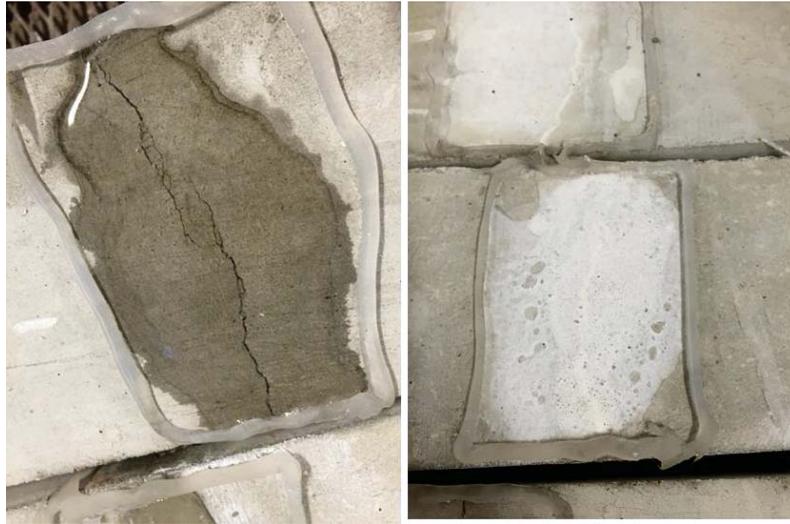
**Figure 4. Cracked concrete beam on left and healed concrete beams to the right.**

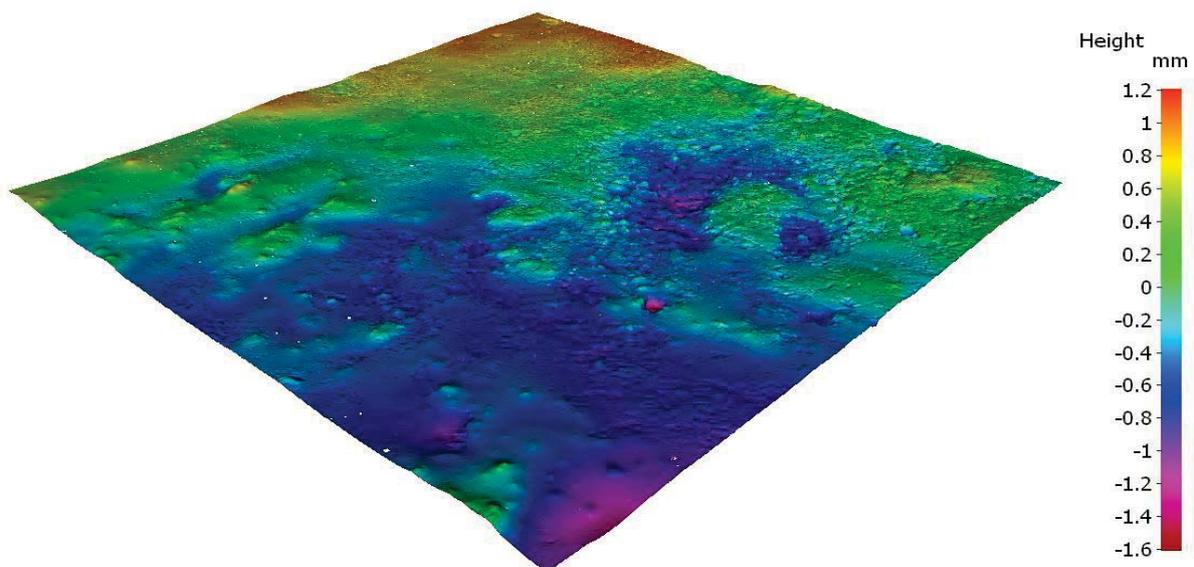
Figures 5 and 6 display how the surface height of each of the sample cubes has been altered following the MICP surface treatment. In each of the three sample cubes the mean surface height deviation has visibly reduced as the  $\text{CaCO}_3$  increased the lowest depth references. The 'Height' legend shows less surface abnormality following application.

**Figure 5. Cube 1: Height Deviation Scan Prior to Treatment**

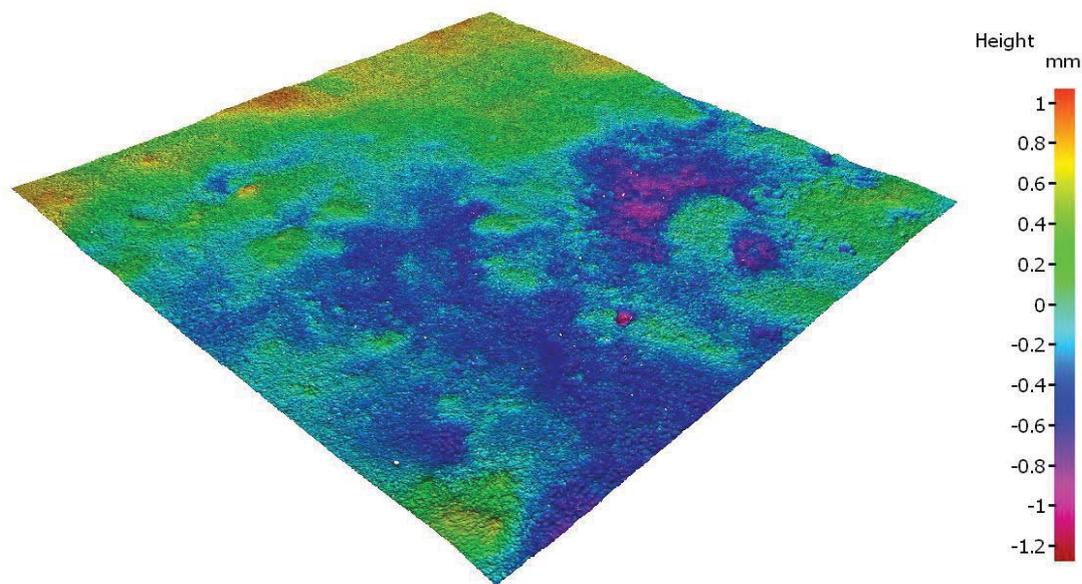
**Figure 6. Cube 1: Height Deviation Scan Post Treatment**

A bonding of the uneven and loose surface was observed after a surface application of bacterial broth.

Uneven concrete surfaces can also be smoothed using this treatment; the Alicona scanner showed a reduction in differential surface topography. This has scope to aesthetically improve concrete surfaces although the colour of calcite (white) may not be deemed aesthetically pleasing and therefore require suitable pigmentation additives.
