# The use of transverse connectors as reinforcement of multi-leaf walls

Marco Corradi · Antonio Borri · Elena Poverello · Giulio Castori

Received: 27 April 2016 / Accepted: 30 November 2016  
© The Author(s) 2016. This article is published with open access at Springerlink.com

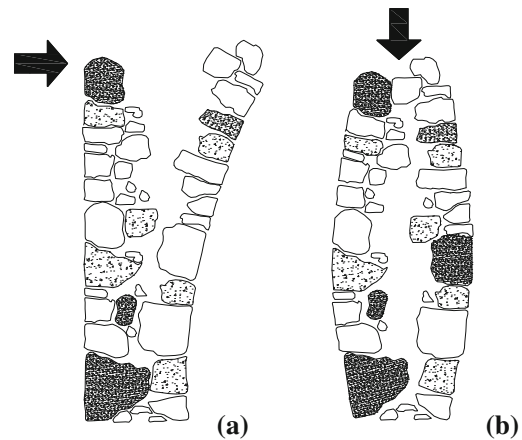
**Fig. 1** **a** Failure mechanism of a double-leaf wall panel subjected to a *horizontal load*. **b** Failure mechanism of a panel subjected to a *compression vertical load*

Since the out-of-plane behavior of masonry structures is mainly governed by simple boundary conditions and rotational equilibrium equations, previous research on the analysis of the mechanical properties of the masonry material supplemented by numerical models and laboratory studies, has limited relevance: masonry mechanical parameters (shear and compressive strengths, elastic moduli) do not govern the overall out-of-plane behavior of a slender masonry wall panel. For example the application of a vertical compressive load may have a positive effect on the out-of-plane behavior since it stabilizes the wall. For a multi-leaf wall, the out-of-plane mechanism often involves the external (outdoor) unconfined masonry leaf being vulnerable to horizontal actions (Fig. 1).

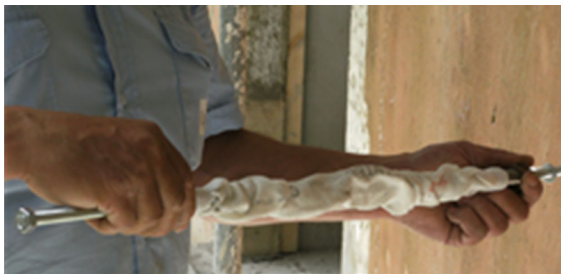
**Fig. 2** The steel rod connector with fabric sleeve before grout injection

The strengthening system consisted in a SAE 304 (or AISI 304) stainless steel rod inserted in a fabric sleeve (Fig. 2). Wall panels were drilled from one side only with full-thickness holes. A diamond core drill bit was used to remove a cylinder of existing masonry material. Connectors were made of a solid stainless steel rod, with a diameter of 12, 16 or 20 mm, encased in a fabric sleeve injected with a cement-based grout. The choice of rod diameter depended on many factors like the magnitudes of the acting loads, the wall's thickness and on the quality of the masonry material.

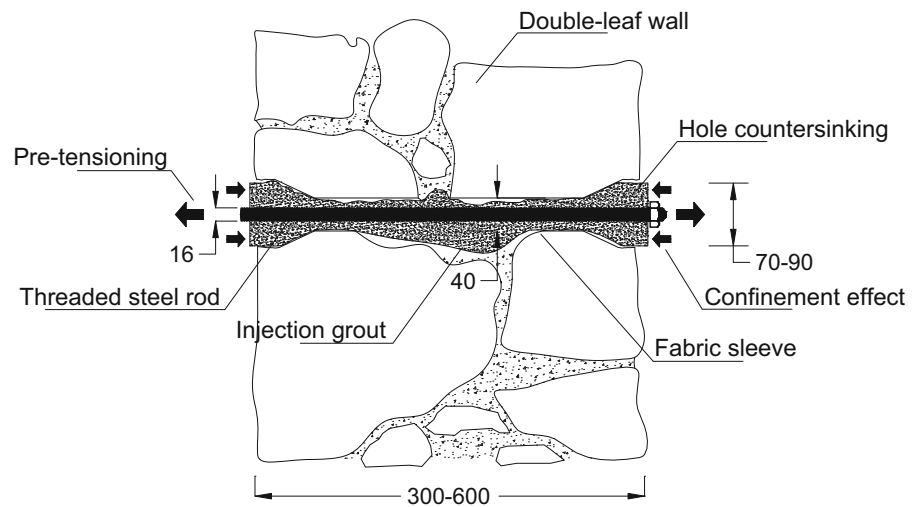
**Fig. 3** Detail of the 16 mm-diameter connector (dimensions in mm)

In order to activate a mechanical interlocking between the new connector and the masonry substrate, the hole was countersunk at both ends up to a diameter

90% greater than the diameter of the hole. Installation of the rod into the core-drilled hole (Fig. 3) was also followed by a pre-tensioning operation up to 10–20% of the rod yielding strength. Finally, the fabric sleeve was injected in pressure (2.5–5 atm, depending on the quality of the masonry material) using a high-strength ready-to-use cement-based grout. The effect of pre-tensioning and countersinking produced a confinement of the masonry material and increased the level of connection between wall leaves (Fig. 3). The fabric sleeve avoided unexpected scattering and wastefulness of the grout between the masonry. Thanks to its flexibility, it could expand, moulding itself into the shape and voids within the walls, providing mechanical bond. Although the use of cement is generally detrimental in heritage structures due to its scarce compatibility with historic masonry, the cement-based grout provided by the producer was still used here for the tests. In fact, the fabric sleeve encasing the anchor did not allow the cement-based grout to spread freely within the masonry, thus largely limiting the used quantity. The grout's mechanical and thixotropic properties and its low porosity also guaranteed the needed characteristics for the transmission of the loads between the masonry leaves.

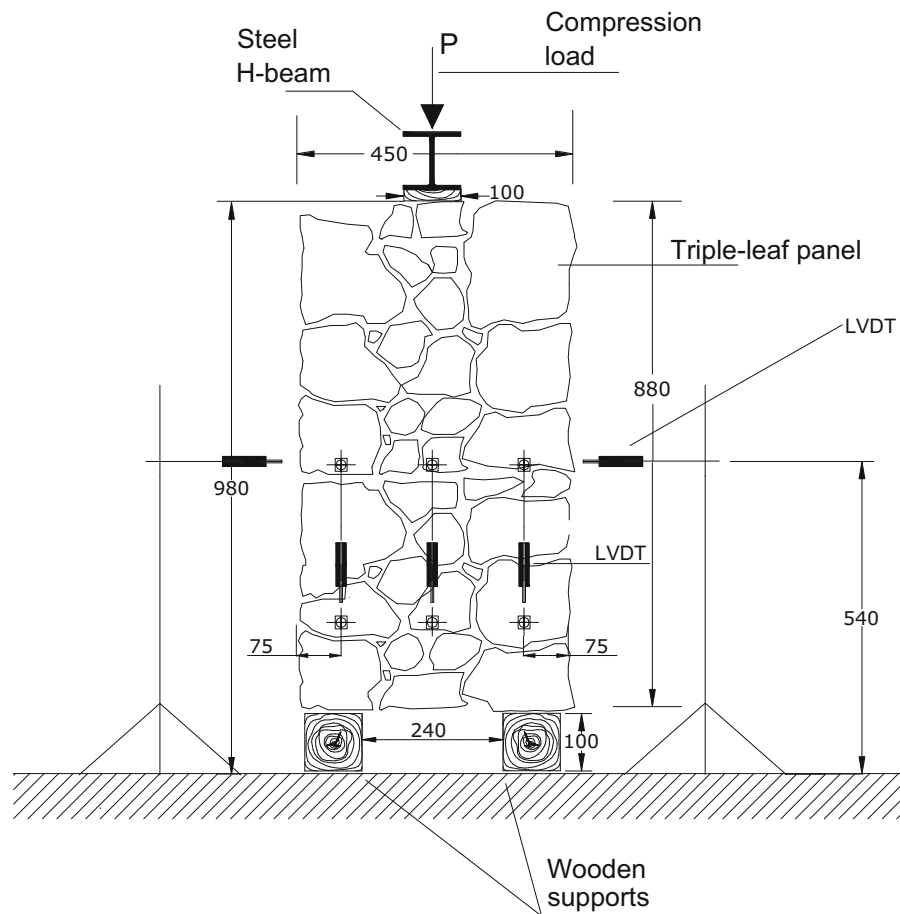
**Fig. 4** Shear test arrangement (dimension in mm)

external masonry leaves rested on timber prisms and the inner rubble core was loaded by the application of a compression force on the top of the panel. A drawing of the test setup is shown in Fig. 4. A 50-tons hydraulic jack was applied centrally to generate the vertical compression load on the inner rubble core. A steel H-shaped beam (flange's width = 100 mm) was inserted between the jack and the panel to achieve a uniform distribution of the vertical load along the panel's width. The width of both the panel and the steel beam was 0.88 m. The two wall panels were loaded at a rate of approximately 4 kN/min up to failure. The deflection of the inner core—critical to structural assessment—was obtained with contact instrumentation. Six LVDTs were used to measure the deformations of the three masonry leaves. Two more LVDTs were placed horizontally near the leaf's centroid to monitor the out-of-plane movements. All deflection measurements were logged continuously by LVDTs and readings included panel load and 8 LVDT over the duration of the test. Figure 5a shows the position of the transverse connectors used for shear testing.

Two full-scale masonry wall panels were built in the laboratory for shear tests. Each panel was made of a triple-leaf wall and the inner core was loaded in compression in order to study the shear response of the adjacent masonry leaves (Fig. 4).

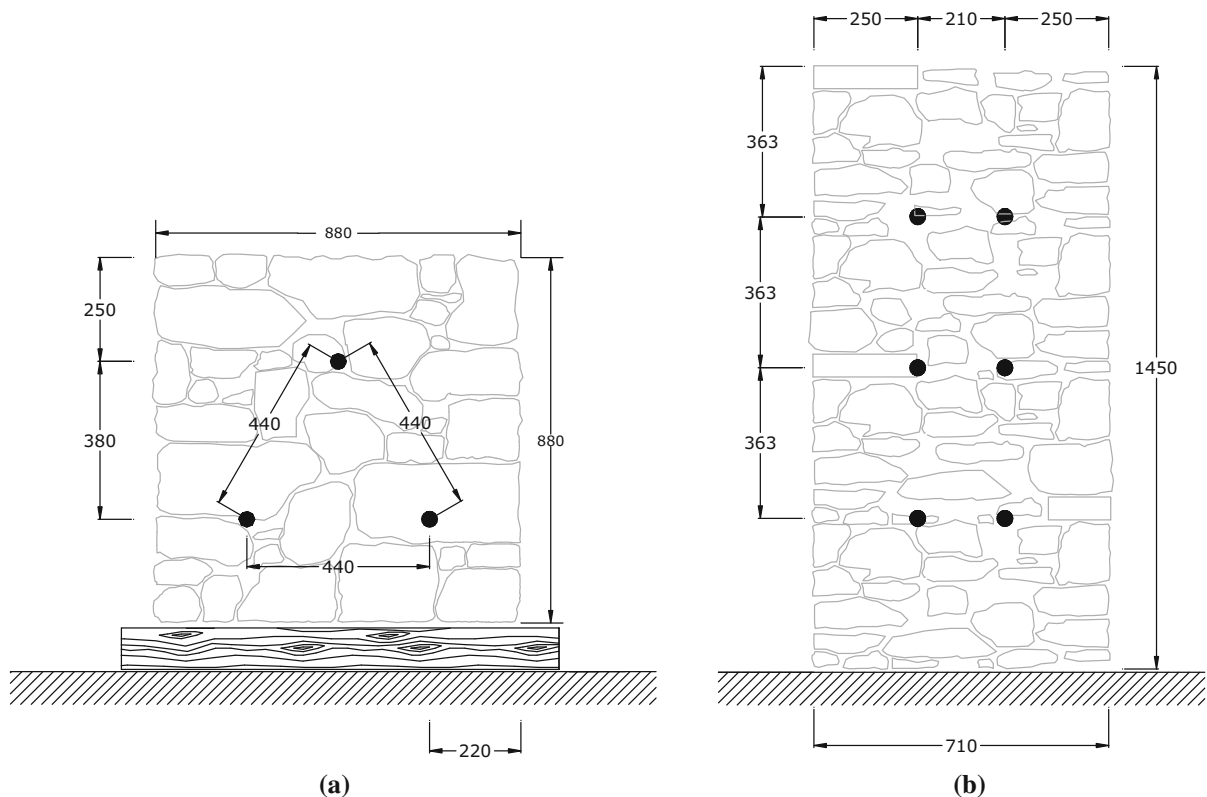
**Fig. 5** Arrangement of connectors: **a** shear test. **b** Compression test (dimensions in mm)

reinforced according to the same arrangement used to repair Panel No. 3 (Fig. 5b).

The application of three transverse connectors (Fig. 5a) produced an interesting effect both in terms of load and deformation capacity: Panel 2Rf has been tested after being retrofitted and a compressive maximum load  $P_{\max}$  of 109.43 kN was recorded (Table 3). This is an increment of 3.21 compared to the load capacity of the unreinforced panel (Panel 1Un). The leaf response in terms of vertical and horizontal deflections was more symmetric and the difference between leaf deflections at failure was approx. only 15%.

Panel 3 was also repaired by the application of 6 traverse connectors and tested again (Panel 3Rp) (Fig. 5b). The capacity of the panel increased to 91.1 kN and a compression stress of 0.583 MPa was

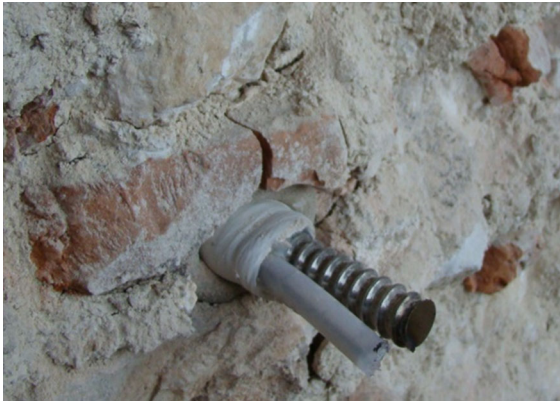
**Fig. 6** Typical masonry failure mode during pull-out tests

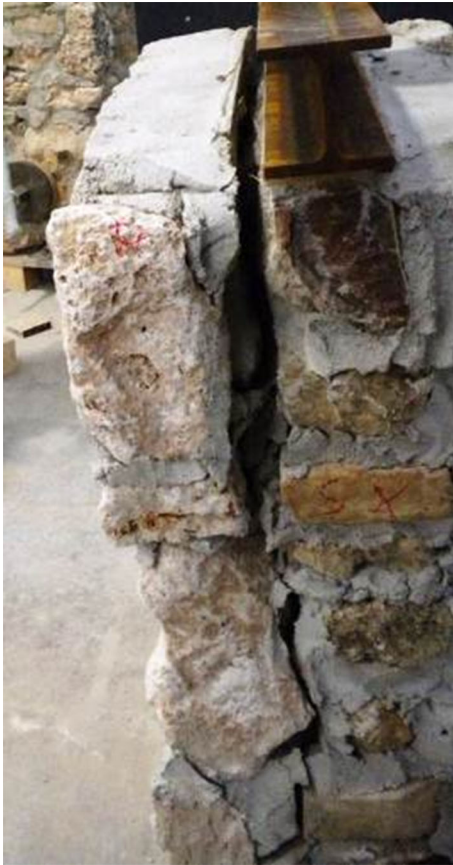
**Fig. 7** Failure mode (unreinforced panel)

Results of unreinforced Panel 1Un clearly demonstrated that the vertical planes between masonry leaves were critical for the overall behavior of a triple-leaf wall. Mechanical interlocking was not able to prevent the separation between masonry leaves. A maximum compression load  $P_{\max}$  of 34.11 kN was recorded (Table 3). Failure was by splitting of the inner rubble core from one of the two external wall leaves. The failure occurred progressively in a non-brittle manner: a vertical crack opened near the point of application of the load and propagated toward the wall base (Fig. 7).

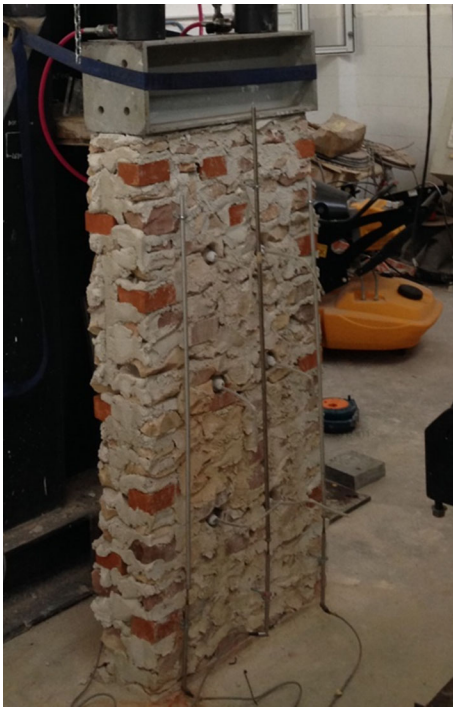
**Fig. 8** Compression tests on reinforced panel 4Rf

Positive indications of the effectiveness of the transversal connectors to bond double-leaf walls (Fig. 8) were obtained from the results of three compression tests. The first test, carried out on an unreinforced panel (Panel 3Un), failed for a compression load of 48.8 kN. The analysis of the vertical deformations (recorded using 4 LVDTs) clearly indicated that the two masonry leaves deformed differently: for panel's side B a maximum vertical strain of 0.0011 was recorded, while, for side A, this was only 0.0006 (Fig. 9). The ratio between the two strain values was 1.83. The compression test showed that the two adjacent masonry leaves behaved differently and the difference in behavior tended to get bigger when the compression load increased as a consequence of the progressive detachment of the two masonry leaves. The opening of vertical cracks was the typical failure mode of a masonry member in compression. However no vertical cracks could be noted on the leaf's surface: this could be due to a buckling failure mode of the masonry leaves that anticipated the compressive one.

A third compression test was carried out on an undamaged panel (Panel 4Rf). This panel was identical to Panel 3 for dimensions, mortar type and masonry arrangement. The application of the connectors was an effective method to bond the masonry leaves and a compression load of 101.5 kN (0.65 MPa

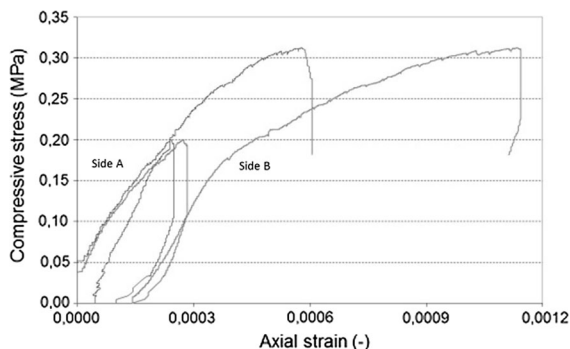
**Fig. 9** Stress versus axial strain of masonry leaves for unreinforced panel 3Un

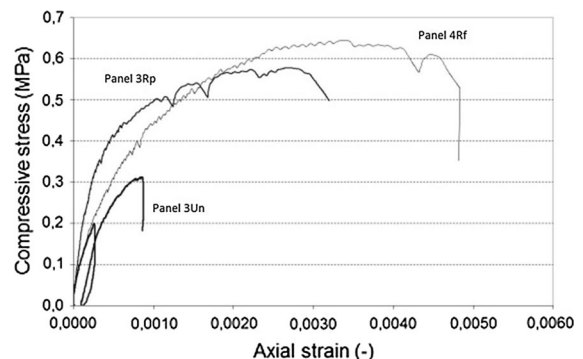
**Fig. 10** Stress versus axial strain: comparison between the three compression tests

calculated (Fig. 10). For this second test, vertical cracks mainly appeared on the leaf's surface highlighting a more-likely compressive failure. Scattering of vertical strains between wall leaves highly reduced indicating a monolithic behavior of the wall.

in terms of compressive stress) was reached (Fig. 10). This was more than 108% greater compared to the control unreinforced wall panel. Again the failure occurred for the formation of vertical cracks on the leaf's surface. The analysis of the vertical deformations clearly showed the similar behavior between the two masonry leaves. For test on Panel 3Rp the magnitudes of the vertical strain at maximum load were 0.0030 and 0.0023, for side A and B, respectively (with a ratio between the strain values of 1.3). For test on Panel 4Rf this ratio was only 1.03.

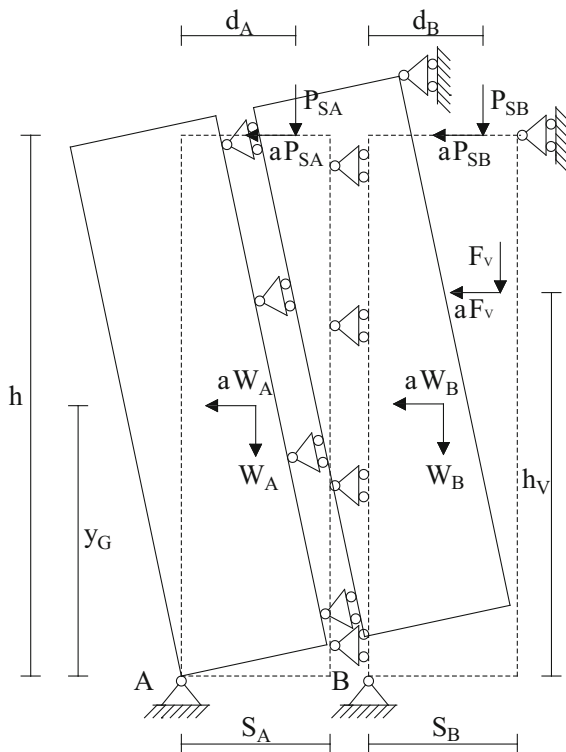
**Fig. 11** Behavior of an unreinforced double-leaf wall
