Citation: Borri, Antonio and Corradi, Marco (2019) Architectural Heritage: A Discussion on Conservation and Safety. *Heritage*, 2 (1). pp. 631-647. ISSN 2571-9408

Architectural Heritage: A Discussion on Conservation and Safety

Abstract: This paper presents a study carried out in the Italian region of Umbria, after the 2016 Central Italy earthquake. The aim is to address the problem of the conservation and protection of architectural heritage in Italy. The application of retrofitting strategies, while improving the seismic performance of historic—and frequently listed by conservation bodies—buildings, will not significantly alter their appearance, will be reversible, and fall within the principle of minimum intervention (minimal (least) intervention (or conservative repair)). These issues were evaluated in the paper by considering the different points of view of structural engineers and conservators. Heavy structural-oriented interventions as well as the underestimation of the importance of the structural safety for masonry monuments has produced, in the past, irreversible damage to important buildings and monuments, and loss of architectural heritage in Italy. The requirement of

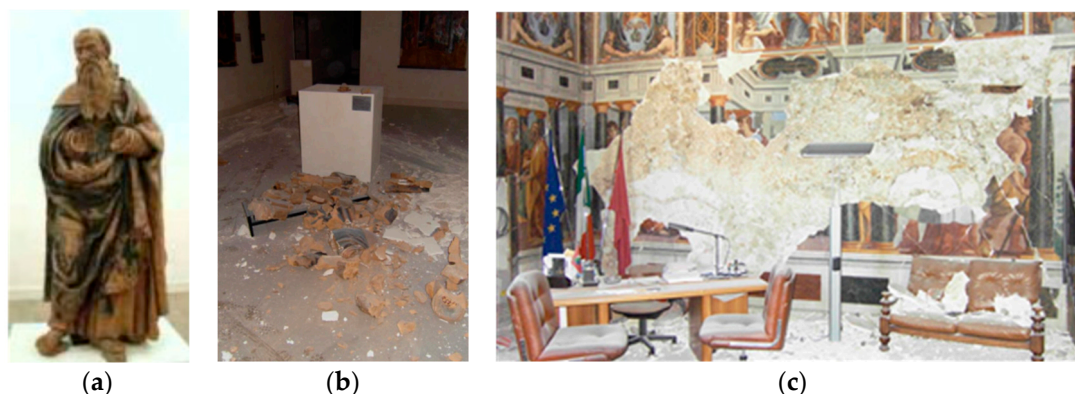
Figure 1. Irreparable damage to the cultural heritage due to the missing implementation of effective and preventive interventions: Example of the overturning and associated destruction of an antique statue in L’Aquila museum ((a) before the earthquake and (b) after); (c) serious damage/destruction of 16th-century frescos in Palazzo Branconio-Farinosi in L’Aquila after the 2009 Abruzzo earthquake.

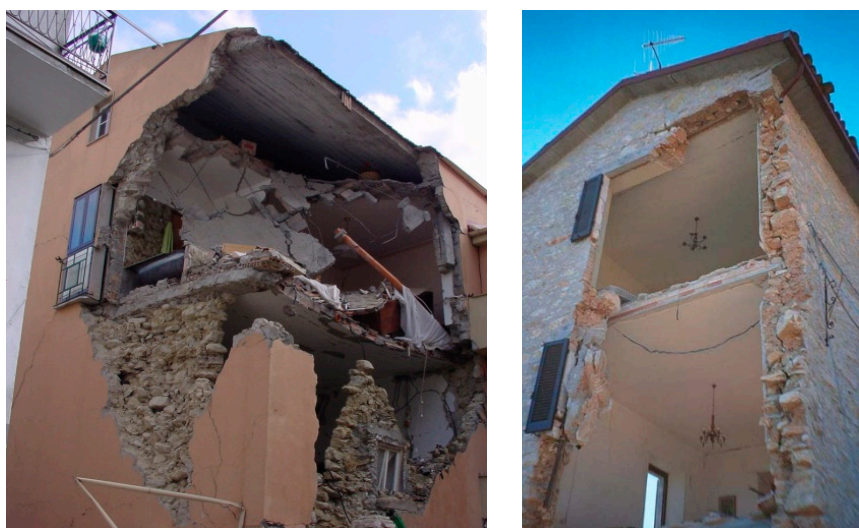
Figure 2. Examples of the effects of a typical intervention carried out in the 1980s in Italy: The intervention consisted of the removal of the timber-beam floor and roof, insertion of reinforced concrete (RC) ring beams, concrete-rib and hollow-block floor, RC slab roof.

This is the case of the frequent removal of light timber beam floors and their replacement with solid or hollow-core concrete. This was sadly required by the only need to use the POR calculation method [28] and the software based on this method, commonly employed by structural engineers and explicitly imposed by the Building Codes in terms of rigid horizontal diaphragms. These Codes also suggested the generalized use of RC ring-beams, to be applied at eave level or near the horizontal diaphragms of the floors. Dovetail RC joints were often added to increase the wall-to-wall level of connection. Evidence after recent earthquakes demonstrated the limited effectiveness of these interventions (Figure 2). Replacement of pre-existing timber–joist or timber–beam floors or roofs with new concrete-rib and hollow-block diaphragms was also common in the 1980s: This intervention highly increased the bending capacity of the floors, but the increment in mass and stiffness had deleterious effects on the seismic behavior of the building. The demolition of timber–beam floor causes vertical stresses to migrate to the external wall-leaf, and the subsequent reconstruction of the new concrete-rib and hollow-block floor produces high compressive stresses in the walls (Figure 3). However, this is typically limited to the indoor wall leaf. The consequence of this is the punching shear action of the floor and the overturning mechanism of the external wall leaf during an earthquake.

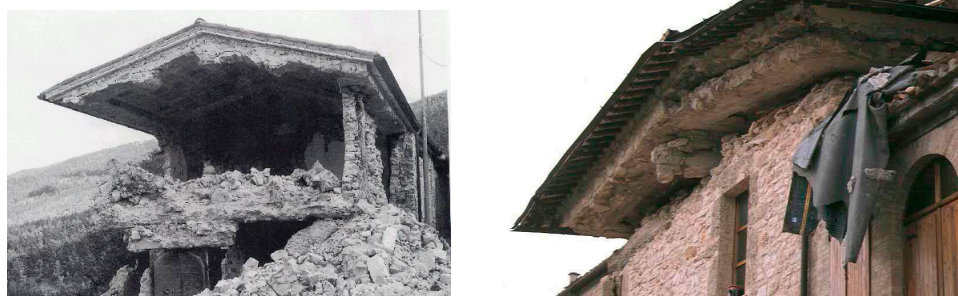
Figure 4. Examples of buildings where replacement of timber beam floor/roof was made (Umbria-Marche 1997 quake).

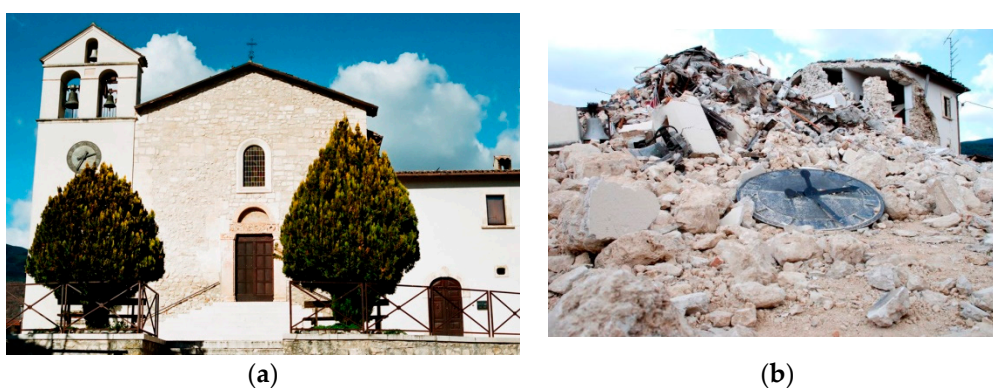
Figure 5. Parish Church of Tempera, near L’Aquila, before (a) and after (b) the 2009 quake: Replacement of timber-beam roof and grout injections were used to reinforce this historic construction in 1984.

In Figure 5, the destructive effect of the 2009 L’Aquila earthquake on the parish church of Tempera can be noted: This building was retrofitted in the 1980s with grout injections by the demolition of the pre-existing timber floor, replaced with a new concrete-rib and hollow-block one.

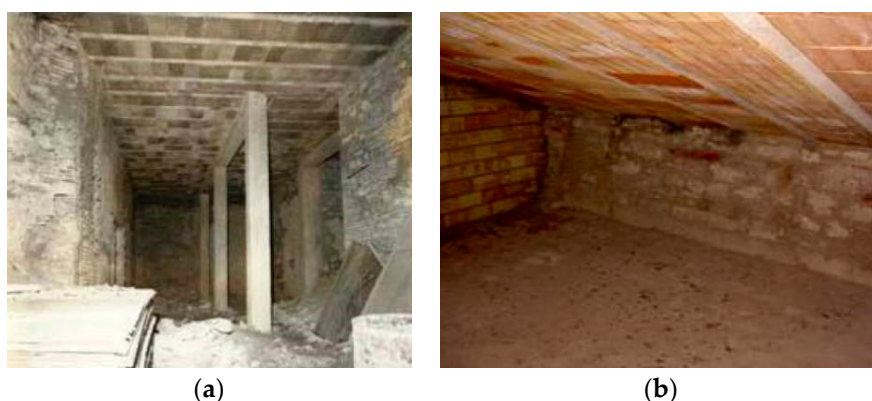
Figure 6. Example of an intervention carried out on a 14th-century building in Gubbio, Italy in the 1980s: (a) New RC frame, (b) replacement of timber-beam floor with a hollow-core concrete one.

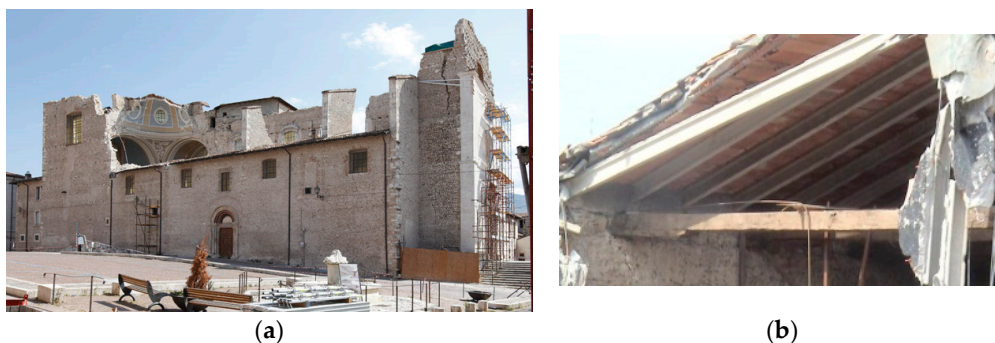
Figure 8. (a) St. Mary of Paganica (*S. Maria di Paganica* in Italian) in L’Aquila after the 2009Abruzzo earthquake; (b) detail of the roof structure.

It is worth citing what has happened in Abruzzo in the 1960s and 1970s. An excess of delegation to structural engineers caused the implementation of inappropriate and incorrect retrofitting interventions on listed stone masonry buildings. The application of heavy RC ring beams and the replacement of timber beam floors with RC ones was frequently carried out, and this produced significant damage to historic buildings during earthquakes. Figure 8 shows the effect of the 2009 L’Aquila earthquake on the masonry building of St. Mary of Paganica church: The roof, after the demolition of the timber structure in the 1970s, was made of a heavy RC slab, hollow blocks, and RC ribs.

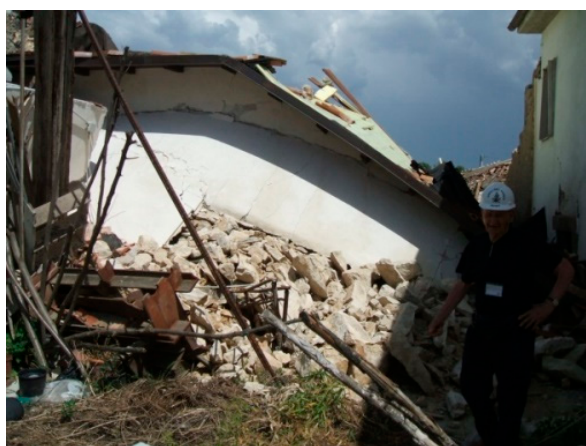
Figure 10. Example of ruined historic building with a portion of the façade wall left unreinforced (fair-faced aspect), without the application of RC jacketing.

Leaving a small part of a stone work wall unreinforced is another example of recognizability. Figure 10 shows a historic stone building where RC jacketing was applied to reinforce the walls. However, a portion of the masonry was left unreinforced and visible (fair-faced aspect) to facilitate recognizability: This highly increased the seismic vulnerability of the building, facilitating its collapse during the 2009 L’Aquila earthquake.

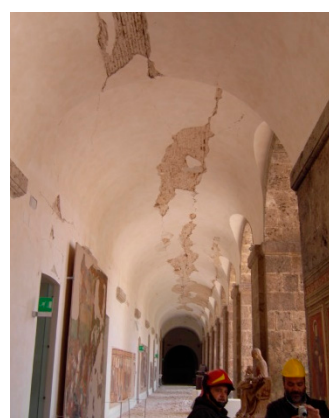
Figure 11. Fortezza Spagnola, L'Aquila, Italy: (a) The bolted endplates of the steel ties are clearly visible on the façade of the building. (b) However, the steel ties are missing inside the corresponding vaulted zone. These were likely removed in a previous restoration.

Finally, the removal of seismic interventions and reinforcements, although applied in the past, is another error not difficult to detect in historic constructions. Figure 11a shows the bolted endplates of the steel ties applied in the 19th century on the masonry vaults of the Fortezza Spagnola in L'Aquila. A thorough inspection of the vaults from inside, using the available photographic evidence before and after the 2009 quake (Figure 11b), demonstrates that steel ties had been removed. The consequence of this was a serious damage of the untied vaults during the 2009 earthquake (hinge-mechanism in the vaults and overturning of the side walls).

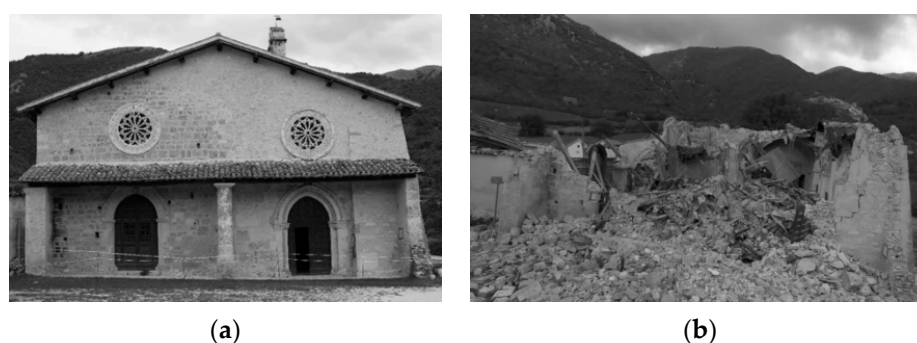
Figure 12. St. Savior's, near Norcia, Italy: Before (a) and after (b) the quake.

We analyzed several churches located near Norcia, Italy and, in most cases, we noted a macroscopic underestimation of the structural problems [38,39]. Figures 12–14 show different religious buildings, before and after the 2016 Central Italy quake. These churches often underwent restoration works in the last 10–30 years, but little was done to improve their structural behavior. Some of these problems could be solved using simple, cost-effective, and non-invasive retrofitting measures. Nevertheless, it is difficult to state with any certainty that the churches could have been preserved if these interventions had been carried out. However, with these structural interventions, their seismic vulnerability would have surely decreased.

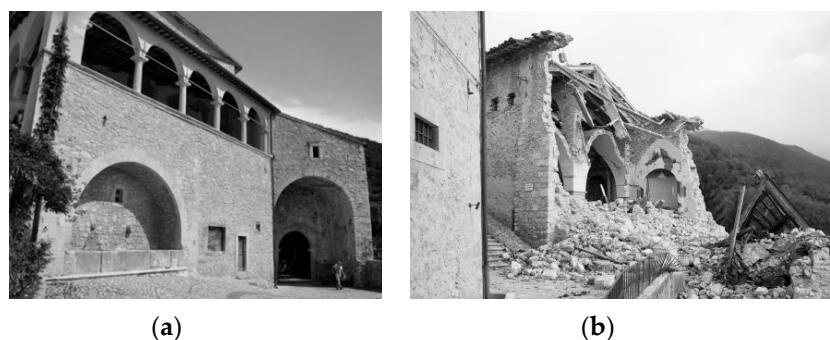
Figure 13. St. Andrew's in Campi, Norcia, Italy: Before (a) and after the quake (b).
