Citation: Giaccone, Domenico, Santamaria, Ulderico and Corradi, Marco (2020) An Experimental Study on the Effect of Water on Historic Brickwork Masonry. *Heritage*, 3 (1). pp. 29-46. ISSN 2571-9408

# An Experimental Study on the Effect of Water on Historic Brickwork Masonry

**Abstract:** Architectural heritage is deeply threatened by extreme weather events due to ongoing climatic change. Since these phenomena are becoming more and more serious, their effects cannot be neglected when a reliable assessment of a historic masonry structure is required. In this paper, the phenomenon of rising damp was studied, focusing on the influence of water on the unit weight of masonry walls made from fired clay bricks and lime mortar. This study consists of a basic experimental research on the variations in the unit weight of masonry undergoing an ageing treatment, which was simulated through some cycles of capillary water absorption and temperature changes. The experimental study proves that penetrating damp causes an increase in masonry unit weight of more than 20%. This basic result is significant in the structural assessment of historic masonry buildings. Subsequent papers will analyze the i

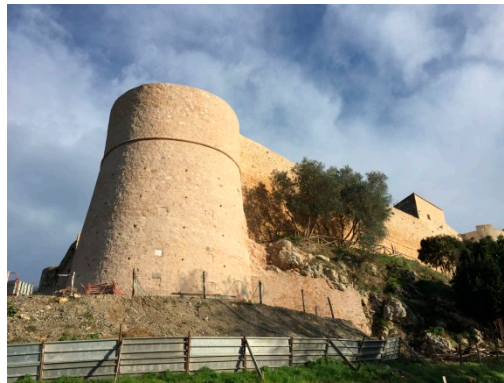
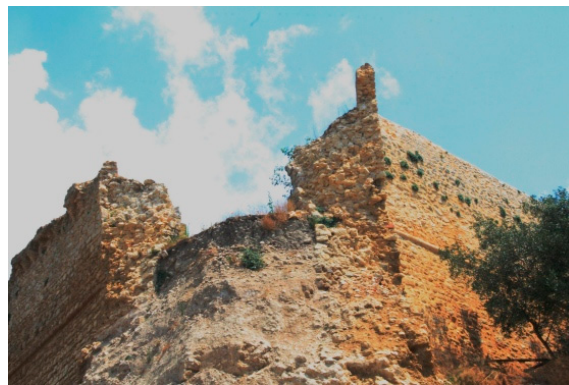
**Figure 1.** Example of the effect of heavy and extended rainfalls: the city wall of the fortress of Magliano, Italy, suddenly collapsed in 2012: (a) before the collapse; (b) after.

Water is one of the most serious causes of damage to masonry architectural heritage [4–6]. It is the main actor in hazards, which lead both to sudden and slow disasters, such as floods on the one hand, and precipitations and water intrusion on the other [7]. With an increased strain on resources for conservation and protection, these natural events represent a major threat to architectural heritage. Heavy rain falls and flooding recently struck many parts of Europe, causing heavy damages and the collapse of important heritage structures. The city walls of Amelia [8], Italy, Cockermonth Castle, UK [9,10], and the fortress of Magliano (Figure 1) [11], also in Italy, are examples of heritage masonry structures recently collapsed or damaged due to water-related issues.

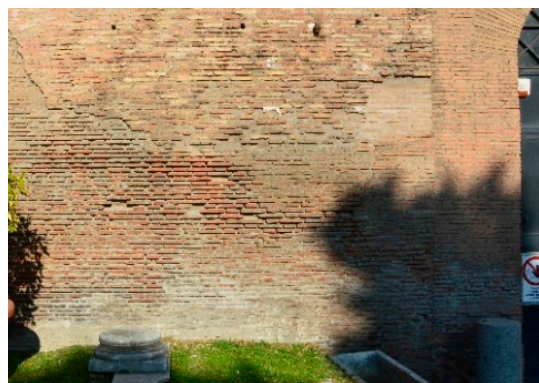
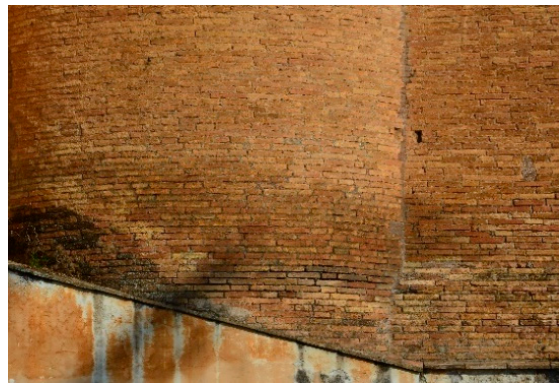
**Figure 2.** (a) Diocletian Bath, Rome; (b) *San Pietro in Vincoli* church, Rome, Italy.

If water penetrates from the ground, the rising damp phenomenon occurs. It can affect any building element which is close to the ground, such as the wall structures. Figure 2 shows two representative examples in Rome. The first relates to one of the *aulae* of the former Bath of Diocletian, now a National Museum, while the second relates to one of the lateral chapels of the *San Pietro in Vincoli* church.

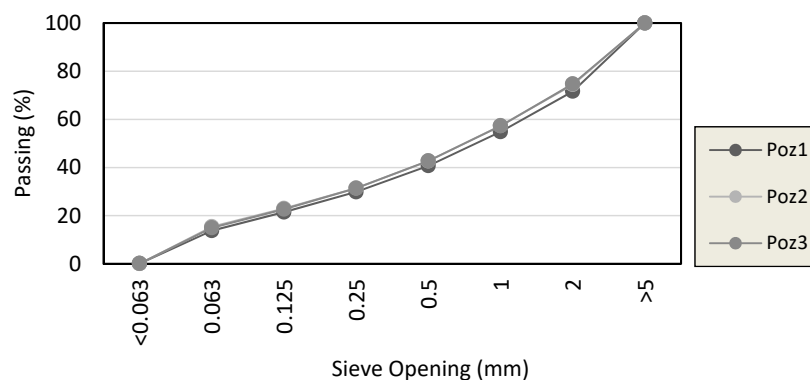
**Figure 4.** Grain-size distribution of the *pozzolana*.

A pozzolanic mortar was used for construction. This was prepared by mixing three parts of aggregate and one of binder, according to a traditional method that already known by the Romans [27] and widely reproduced in the following centuries [28]. The mix was prepared in the laboratory where the environmental temperature was  $24 \text{ }^\circ\text{C}$  and the relative humidity was 70%. Elements were mixed through a trowel, until an adequate blend and consistency was obtained. The water/binding ratio by volume was 1/4. The binder was a commercially available lime-putty, and its physical characteristics are summarized in Table 1. They were determined according to the EN 459-1 standard [29] and provided by the manufacturer. The aggregate consisted in a *pozzolana* came from a local quarry. It was characterized through a sieving test, performed in accordance with the EN 933-1 [30] standard. Test results are shown in Figure 4 and in Table 2.

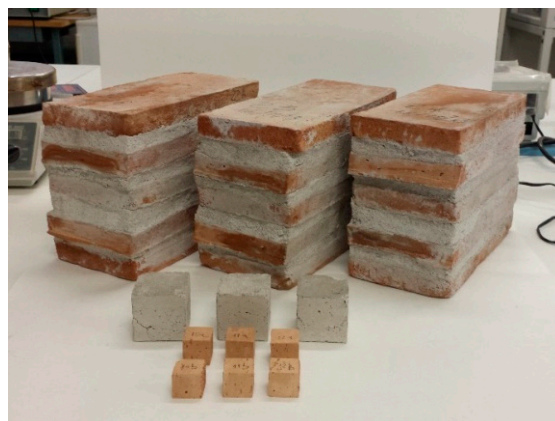
**Figure 7.** Different typologies of tested specimens (letter designation: Br = Brick, Mo= Mortar, Ma = Masonry).

In addition to masonry specimens, six brick specimens, measuring  $20 \times 20 \times 20$  mm, were cut out from one brick, and three mortar specimens,  $40 \times 40 \times 40$  mm in dimensions, were made by pouring the same mixture used for the construction of the masonry specimens into polymethylmethacrylate (PMMA) molds. The complete set of the specimens is shown in Figure 7. The specimens are designated by an alphanumeric code: two letters specified the type of material (Br = Brick, Mo = Mortar, Ma = Masonry) while a number was used to identify each tested specimen.

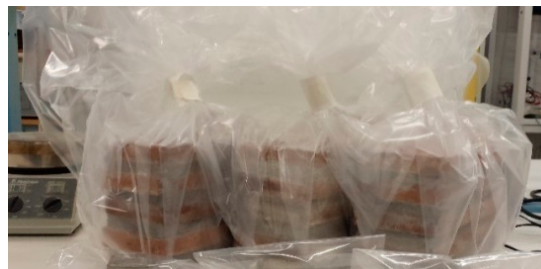
**Figure 9.** Masonry specimens inside the polyethylene (PE) bags.

Subsequently, each specimen was inserted into a polyethylene (PE) bag in order to protect it (Figure 9), and was buried in a refrigerating mixture made by adding 23 g of sodium chloride per kg of ice (Figure 10). Specimens were left curing for 8 h. During this period, the environmental temperature gradually reduced to  $-18\text{ }^{\circ}\text{C}$ , and then increased again. As a consequence of this, the surface temperature of the specimens was also varied in order to reach the thermal equilibrium. Finally, the specimens were removed from the PE bags and placed into the oven at  $60\text{ }^{\circ}\text{C}$  for 16 h (Figure 11).

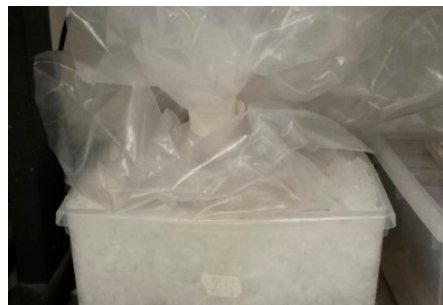
**Figure 10.** Masonry specimens buried in the refrigerating mixture.

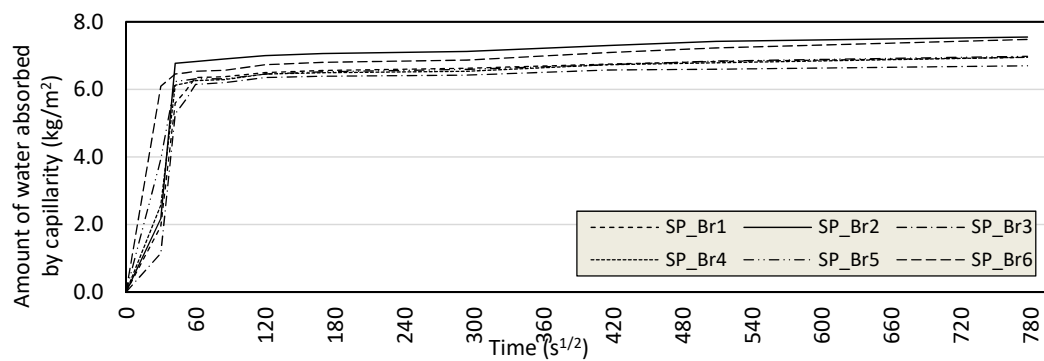
**Figure 13.** Water absorbed by capillary action (brick specimens).

With regards to absorption by capillary action, the test results are summarized in Table 5, while Figures 13–15 show the amount of water absorbed by the three different types of specimens as a function of the square root of the time. Bricks and mortar absorbed a high amount of the water in the first hour of the test, while the absorption rate was almost constant for masonry specimens. It can be noted that the flow velocity was higher in the mortar than in the brick and masonry specimens.

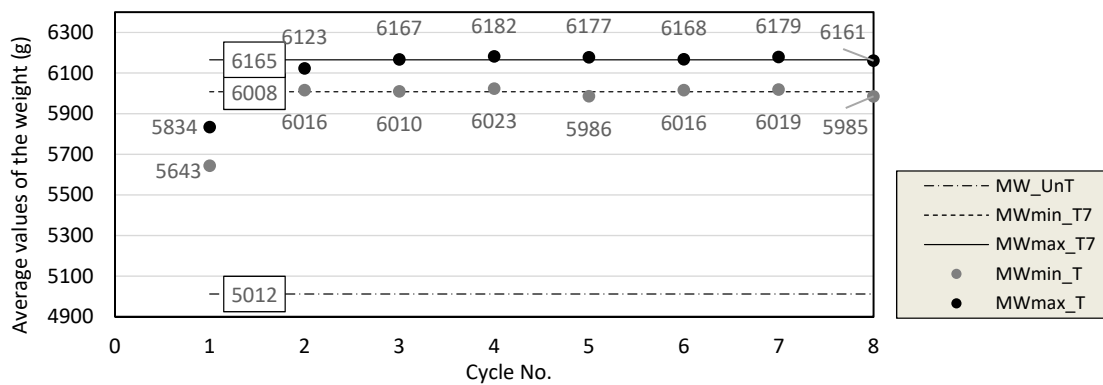
Figure 21. Average values of the weight over each cycle (masonry specimens). MW\_UnT = mean weight of the untreated specimens, MWmin\_T = minimum mean weight of the treated specimens, MWmax\_T = maximum mean weight of the treated specimens, MWmin\_T7 = minimum mean weight of the treated specimens over the last seven cycles, MWmax\_T7 = maximum mean weight of the treated specimens over the last seven cycles.

They are averaged over the three specimens and related to the respective mean values over the last seven cycles (dashed line and continuous line), and to the mean value before the start of the ageing treatment (dashed-dot line).
