Citation: Borri, Antonio, Corradi, Marco and De Maria, Alessandro (2020) The Failure of Masonry Walls by Disaggregation and the Masonry Quality Index. *Heritage*, 3 (4). pp. 1162-1198. ISSN 2571-9408

The Failure of Masonry Walls by Disaggregation and the Masonry Quality Index

Abstract: The visual method for assessment of the structural behaviour of historic masonry walls, known by the acronym MQI (Masonry Quality Index) was introduced in 2002 by a team of researchers from the University of Perugia, Italy. This is based on a visual survey of the faces and the cross section of a wall panel, and it aims at verifying if a wall complies with the “rules of the art”. Based on this analysis, it is possible to calculate a numerical index: numerous tests, carried out on site by the authors to validate the method, have demonstrated that the index is able to provide useful information about the mechanical characteristics and structural response, in general, of the analysed wall panel. The failure mode of a wall panel under the action of an earthquake is a critical aspect. In general, the failure modes can be categorized in two classes: masonry disaggregation and the development of a local or

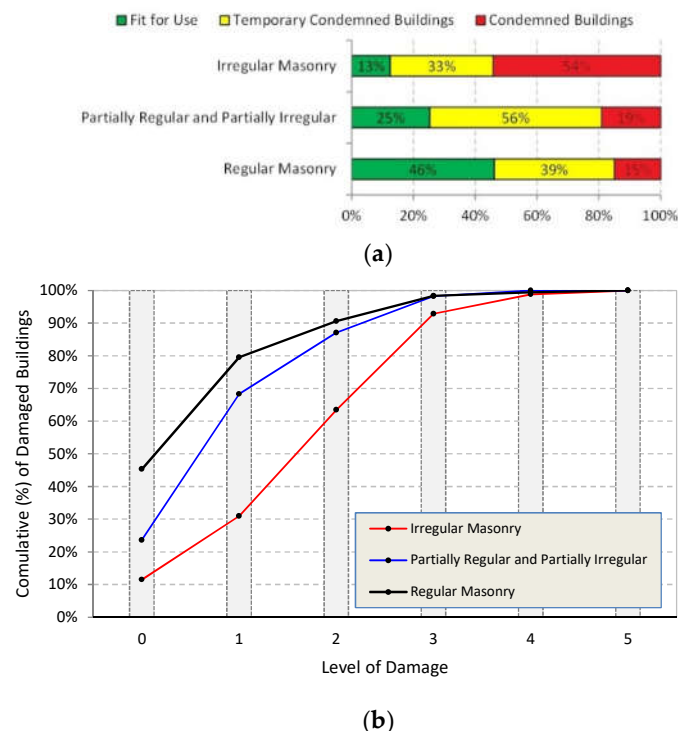
Figure 1. Results of the post-earthquake assessment of the existing building stock of Norcia, Italy (city centre): (a) classification in terms of masonry typology and (b) cumulative percentage of damaged/collapsed buildings in terms of level of damage (0 = no damage; 5 = building collapse).

Unfortunately, the situation we face is more complex: it is difficult to be placed inside well-defined relationships and we cannot say that the only reason for these collapses was the masonry low quality. For example, in addition to the low masonry quality, ineffective wall-to-wall connections, presence of horizontal out-of-plane static forces (for example, due to arched or vaulted structures), and other seismic vulnerabilities were often noted in collapsed buildings. However, a statistical analysis based on a large number of buildings and using the reports of the damage suffered by masonry buildings after the 2016 central Italy earthquake clearly demonstrated that the influence of the masonry quality is critical (Figure 1).

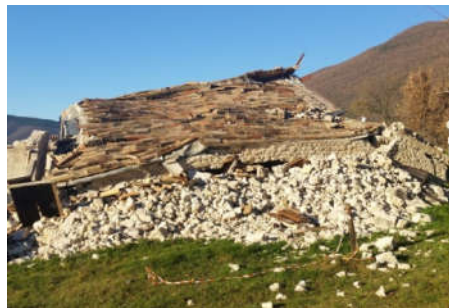
Figure 2. (a) Example of masonry disaggregation of a low-quality masonry in Campi Basso (Perugia, Italy), Italy, after the 2016 Central Italy earthquake and (b) an out-of-plane mechanism of a wall panel of a building in Norcia (Perugia, Italy), Italy (2016 Central Italy Earthquake).

the building and the presence of weakening elements, like openings in the walls, sections where the walls are narrow, and cracks caused by previous earthquakes. In particular, collapse mechanisms may develop from weak areas in the masonry (openings, preexisting cracks, recesses of walls, grafts of floors, etc.) (Figure 2b).

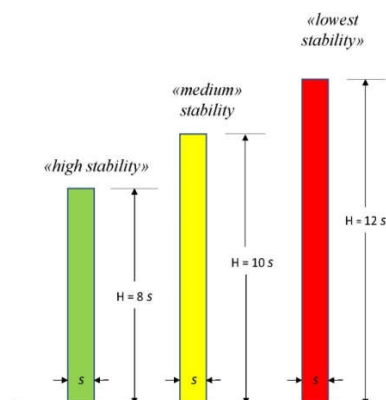
Figure 3. Stability of wall panels, according to Rondelet [27].

This collapse mechanism is mainly governed by the horizontal component of seismic acceleration. However, the vulnerability of the wall will considerably worsen if the earthquake is characterized by high vertical seismic acceleration [9,10]. This mechanism is well-known in the scientific community. This was studied by Giuffrè [22], Lagomarsino and Podestà [23], Lourenço et al. [24], and Borri et al. [25,26]. It is worth to cite here the conclusion drawn by Rondelet [27]: “overall stability is more important than acting forces for the analysis of the integrity of the buildings”. Rondelet states that the equilibrium of the wall panels of “all types of buildings” depends on their slenderness: “a wall panel will be highly stable if its thickness s is $1/8$ of its height”, “the wall will exhibit a medium stability if its thickness is $1/10$ of the height”, and “it will be almost unstable (lowest stability) if the wall thickness is $1/12$ of its height” (Figure 3).

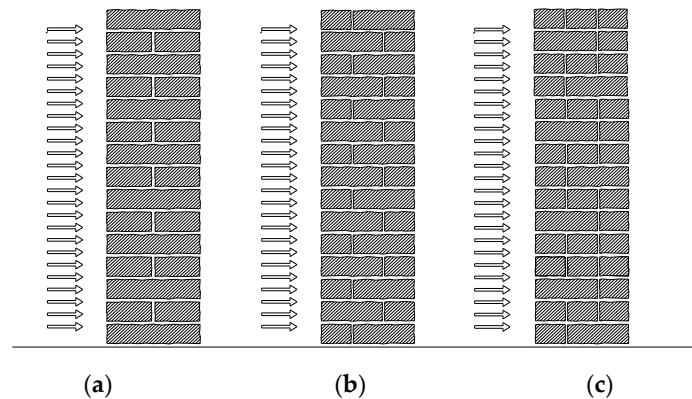
Figure 4. Rocking of a wall panel: the out-of-plane capacity of the wall depends on the arrangement of the blocks. The horizontal load-capacity of wall in (a) is higher than in (b), that, in turn, is higher than the wall in (c), [22].

Giuffrè adapts Rondelet’s conclusions to buildings in seismic prone areas by adding the concept of “masonry quality”. We believe that this is the path to follow to use the MQI method for disaggregating masonry under the action of an earthquake. The main conclusion drawn by Giuffrè is that the failure of a wall panel under the effect of horizontal (i.e., seismic) action is the consequence of its loss of monolithicity and integrity, resulting in a loss of equilibrium. The masonry arrangement and the noncompliance with the “rules of the art” of wall construction methods play a crucial role in this regard. Giuffrè studied the rocking (i.e., out-of-plane) collapse mechanism of three wall panels with identical dimensions (thickness and height), type of applied loads, and constituent materials (Figure 4). The three walls only differed in the arrangement of the blocks: Figure 4a shows a wall where the “rules of the art” are fulfilled (particularly a good connection between adjacent wall leaves), while these are progressively removed for the two walls in Figure 4b,c. The magnitude of the uniformly distributed load needed to activate the wall’s out-of-plane rocking (Figure 5) is significantly smaller for the wall in Figure 4c compared to the one in Figure 4a.

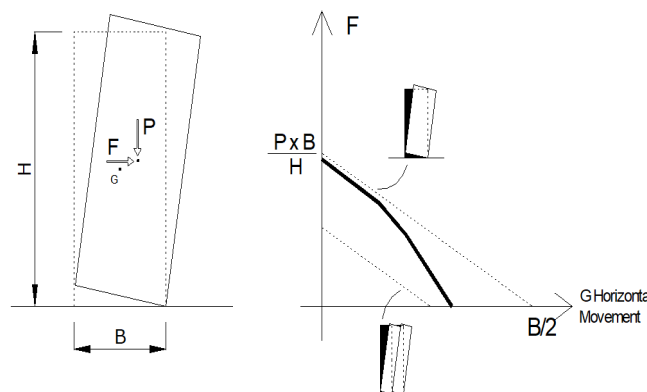
Figure 5. The rocking behaviour of a wall panel: the bold curve in the graph represents the horizontal load F vs. horizontal movement relationship for a wall panel not fulfilling the “rules of the art”. The two dashed lines are the corresponding relationships for a “rigid” single-leaf and a double-leaf wall panel with unconnected wall leaves, [22].

When the rules of the art are not fulfilled, Figure 5 also shows that the displacement capacity (in terms of horizontal movement at the top) of the wall reduces. The way Giuffrè describes this is illuminating: “when the effectiveness of the headers reduces (to note that the length of the headers is smaller in Figure 4b compared to the thickness of the wall) or their number decreases (to note a smaller number of headers for the wall in Figure 4c), this causes a reduction of the horizontal load producing the rocking mechanism. This load reduction becomes greater as the masonry arrangement differ from the one in Figure 4a. The wall panel will disaggregate due to a loss of equilibrium in a part of it, before the acting load can reach the magnitude corresponding to the rigid and monolithic rocking of the entire wall panel. With this regard, headers will guarantee the monolithic behaviour of the wall under the action of the horizontal load only if they are positioned according to the rules of the art. A decrement (in their number or dimensions) will result in a reduced load-capacity.”

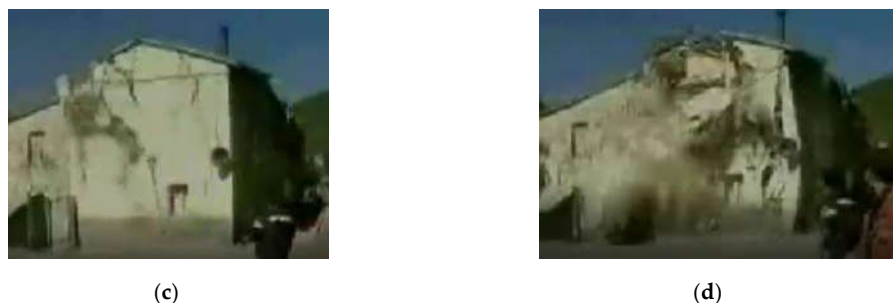
Figure 6. Photographs of the collapse mechanism of a building located in Foligno, Italy during the 1997 earthquake: (a) masonry starts cracking; (b) wall macro-elements develops; (c) rocking (out-of-plane) mechanism of wall façade (on the left); (d) masonry disaggregation

As an example, Figure 6 shows 4 slides of a video of the collapse of a masonry building located near Foligno, Italy, during the 1997 earthquake. Initially, it can be noted (Figure 6a) that the façade cracked and several wall macroelements formed. This is typically a collapse mechanism according to the theory of kinematic chains (Figure 6b). The rotation of the wall (on the left) appears to suggest a rocking (out-of-plane) mechanism of this wall (Figure 6c). However, the very low quality of the masonry does not allow this mechanism to develop further, and several masonry portions of the building become unstable and collapse. It is the façade wall of the first floor on the front that fails first. Subsequently, the wall on the left and the entire building collapse (Figure 6d).

It is evident that the structural response of the building under the action of the earthquake highly differs from the theory of macroelements with well-defined collapse mechanisms. These mechanisms cannot further develop because of disaggregation of the masonry.

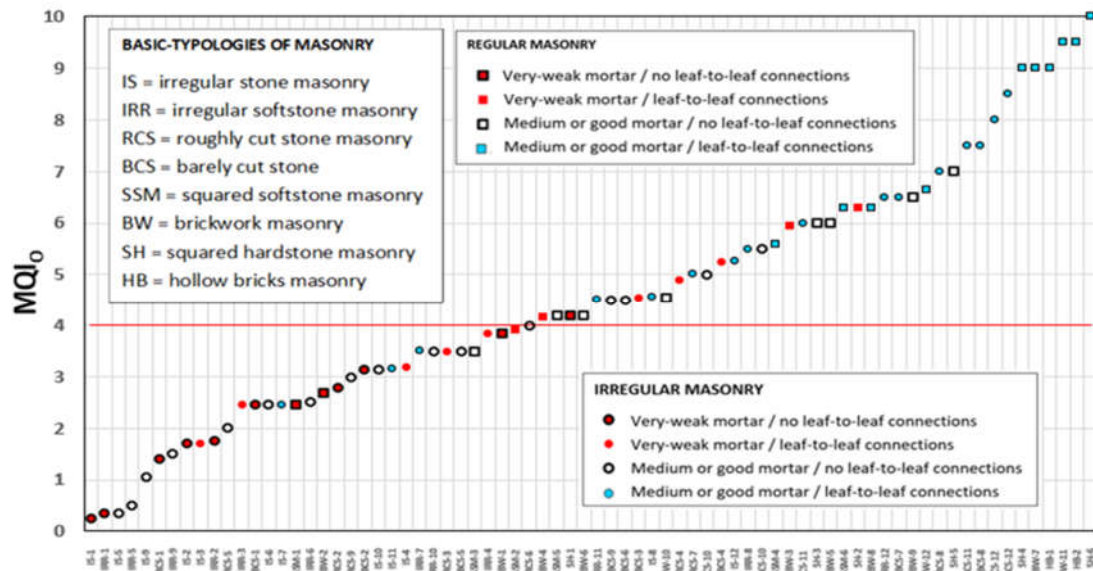
Figure 7. MQIo values for the masonry typologies suggested by the Italian Seismic Code: each masonry typology is identified by an abbreviation and by a number that corresponds to the description reported in Tables 4–10.

Figure 7 shows the MQIo values of the masonry typologies considered in the Italian Seismic Code. In addition to the MQIo, the figure specifies the quality of the mortar, the masonry arrangement (regular or irregular), and the level of connection between the wall leaves (for multi-leaf walls). A red line for a value of 4 of the MQIo divides the graph in two regions. It can be noted that the masonry typologies characterized by a very weak mortar, unconnected wall leaves, and an irregular arrangement are usually below this line. For these masonry typologies, we believe that it is likely to fail by disaggregation under the action of an earthquake. Oppositely, the MQIo values of masonry typologies, both regular and irregular, and characterized by a non-weak mortar and connected wall leaves is typically higher than 4 (Figure 7).

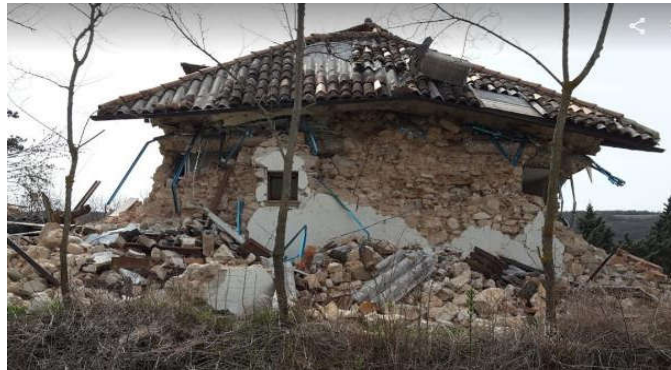
Figure 8. A collapsed building in Campi Basso, Norcia, Italy: The masonry (combination No. 1 of Table 4) of this building disaggregated during the earthquake.

This is the basic masonry typology where disaggregation is more frequent. Based on our database, it is rare that entire buildings or wall members made of this basic masonry typology can crack when subjected to the seismic action without disaggregating. This happened only when the quality of the mortar was not too weak and there were horizontal mortar bed joints and headers (combination No. 8 in Table 4) or when the mortar was good and there were some headers (combination No. 11 and 12 in Table 4). Table 4 shows the combination of 3 different critical parameters (quality of the mortar (possible outcomes: very weak, medium, and good), horizontality of the bed joints (yes or no), and level of connection between wall leaves (yes or no)), resulting in 12 masonry types. Figures 8 and 9 show two different masonry typologies where masonry disaggregation was noted (Figure 8) and did not occur (Figure 9) during recent seismic events in Italy.

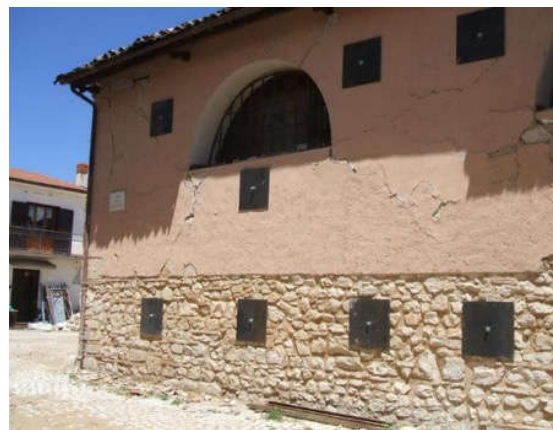
Figure 9. Stonework building in Onna, near L'Aquila in Italy: the arrangement of the stonework is uniform, and the masonry texture is well-organized (homogeneity of the stones and random presence of bricks to improve the overall wall's stability) (combination No. 12, Table 4). It can be noted that this wall was consolidated using a deep repointing the mortar joints. The medium dimensions of some stones suggest a good connection between wall leaves. The masonry material of this building did not disaggregate during the 2009 Aquila earthquake. It should be also highlighted here that most historic masonry buildings of Onna, typically made of a masonry of lower quality, disaggregated during the 2009 earthquake [28].

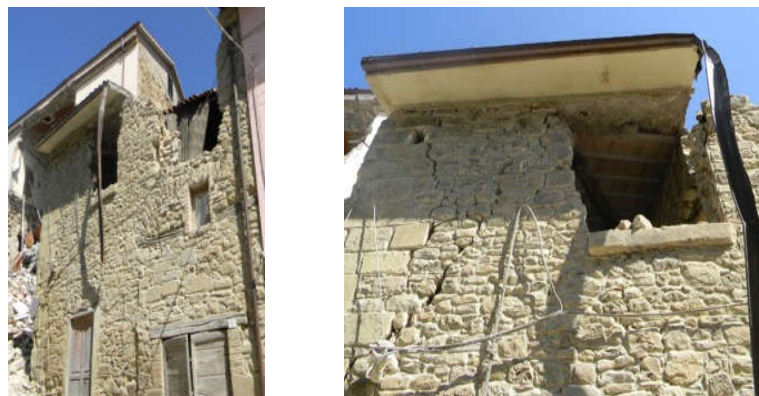
Figure 10. A building in Accumoli, near Rieti, in Italy: a large number of large cut stones was used here. This highly increased the level of connection between the wall leaves (combination No. 7, Table 5: cut stone masonry, medium-quality mortar, and effective connection between wall's leaves). For the upper part of this building, the quality of the masonry is lower and the wall leaves seem unconnected (combination No. 5, Table 5: cut stone masonry, medium-quality mortar, and non-effective connection between wall's leaves). The masonry of the upper part of this building disaggregated during the 2016 Central Italy earthquake.

This basic masonry typology (made of roughly cut stones, *conci sbazzati* in Italian) is very common in Italy, and a large number of slightly different types of masonry can be categorized here (Figure 10). Under the action of an earthquake, the failure modes can be both by disaggregation or in-plane cracking. The most important parameter, governing the failure mode, is the quality of the mortar. Masonry made with very-low quality mortar typically failed by disaggregation, with the only exception of walls with horizontal bed joints and headers (Table 5).

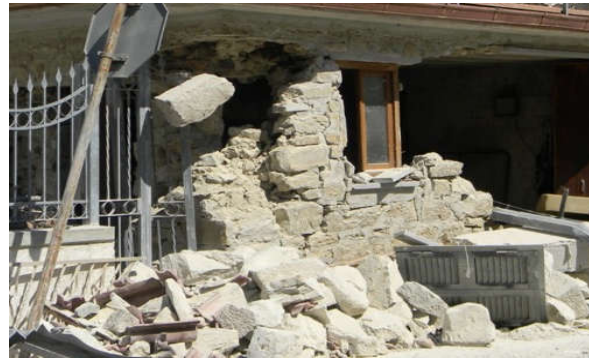
Figure 11. Pescara del Tronto, near Ascoli Piceno, in Italy. This is an example of cut-stone masonry, very weak mortar, unconnected wall's leaves (Combination No.2, Table 6). The building failed due to masonry disaggregation.

It is worth noting that “barely cut stones” (*pietre a spacco* in Italian) are mechanically worked stones (Figure 11). These stone blocks are more regular than roughly cut stones (described in Section 6.1.2). Walls made with barely cut stones exhibited a satisfactory structural response when struck by seismic action. Only when the used mortar was very weak and there were no headers in the walls was masonry disaggregation noted (Table 6).

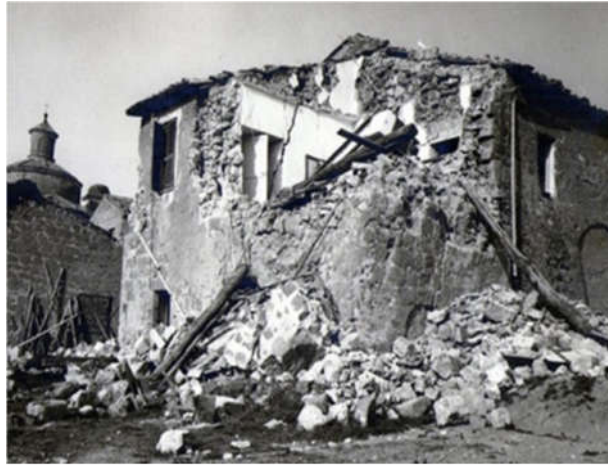
Figure 12. Tuff stone building in Tuscany, Italy, after the 1971 earthquake: the masonry typology can be classified in combination No. 1 of Table 7: irregular stones, non-horizontal bed joints, unconnected wall leaves, and very weak mortar. The failure mode is by disaggregation.

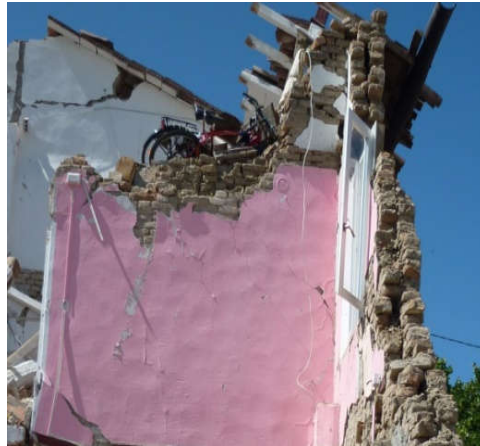
Figure 15. Brickwork building damaged by the 2012 Emilia earthquake: load-bearing walls were made of two unconnected leaves and a very-weak mortar (combination No.2, Table 10). The disaggregation of masonry is evident.

This basic typology is common in a large number of buildings struck by the 2012 Emilia earthquake (Figure 15). Solid brickwork masonry is also easy to find in Central Italy (Umbria, Marche, and Abruzzi), and several buildings were damaged in recent earthquakes. The mortar used here must be made of lime and sand. This type of masonry does not typically fail by disaggregation, with the exception of some particular situations where brickwork masonry was used to build double-leaf walls using a very-weak lime mortar. This has been noted in several buildings damaged by the 2012 Emilia earthquake. Table 10 shows the MQIo values for the masonry resulting from the combination of three parameters (quality of the mortar, thickness of bed joints, and level of connection between leaves in multi-leaf walls). The Italian Seismic Code defines a “thick joint” if its thickness is larger than 13 mm.

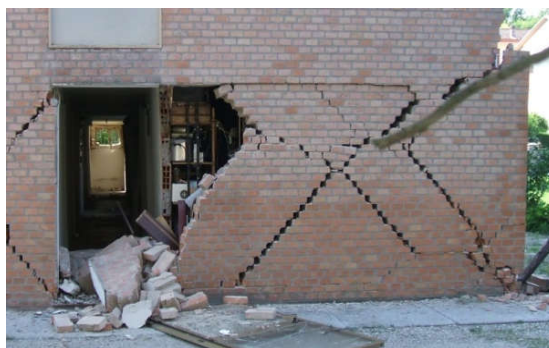
Figure 17. Failure mode of a building made of bricks and cement mortar (San Possidonio, Italy).

Another interesting case study is shown in Figure 17. Again, the masonry typology cannot be assigned to one of the types suggested by the Italian Seismic Code. This is a brickwork building located in San Possidonio, in Emilia Romagna. The mortar is made of cement, and the type of bond is heading bonding pattern. The 2012 earthquake caused in-plane shear cracking without masonry disaggregation phenomena. The MQIo is 8.5.

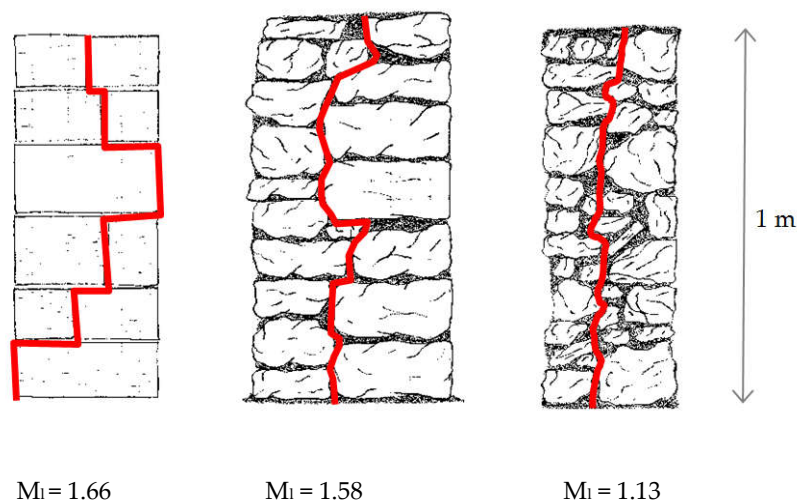
Figure A1. Calculation method of M_l .

All criteria are based on a qualitative analysis [29]. However, for WC, a quantitative criterion, based on the length of some broken lines that can be drawn on a wall section, has been proposed. If the wall section is accessible and visible (quantitative analysis), the “minimum length” M_l between two points can be used. This nondimensional value is the ratio between the minimum distance passing through two points (red line in Figure A1) only through mortar joints and the straight distance between the two points. The straight distance is usually assumed to be equal to 1 m, but smaller values up to 50 cm can be used. M_l values smaller than 1.40 indicate a weak connection between masonry leaves (NF outcome). When this value is bigger than 1.6, the assumed outcome is F (Table A3).

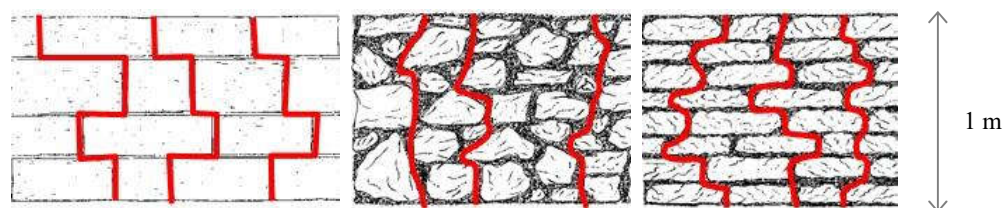
**Figure A2.** Calculation method of M_l .**Table A7.** Criteria for analysis of stagger properties of vertical (head) joints (VJ) (quantitative analysis).

For the assessment of stagger properties of head joints (VJ), the authors also proposed a quantitative analysis [26], based on the calculation of “minimum length” M_l between two points. This can be calculated using a wall panel with dimensions of 1 m² (Table A7, Figure A2).

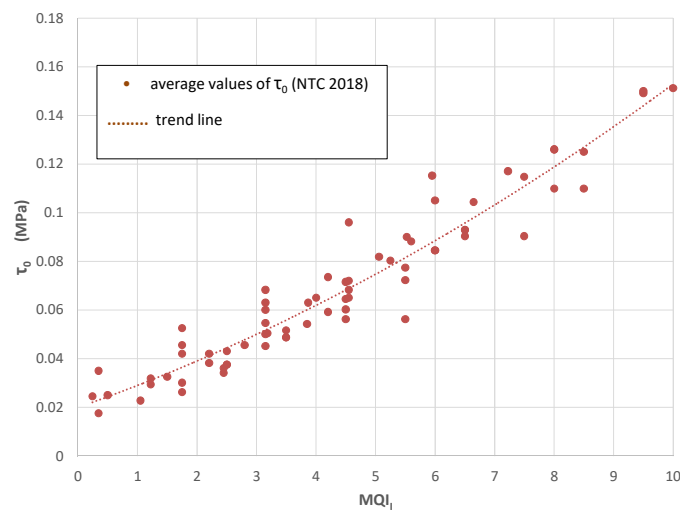
Figure A3. Masonry shear strength τ_0 vs. MQI_i (NTC 2018, Italian Seismic Code, 2018).

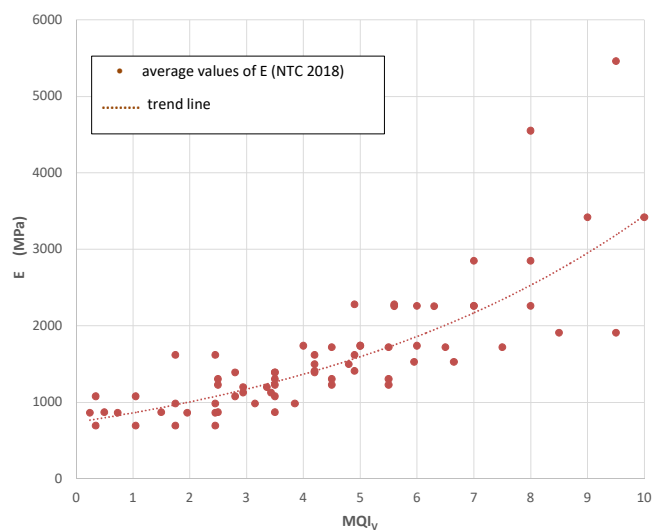
Figure A4. Masonry Young's modulus E vs. MQI_v .

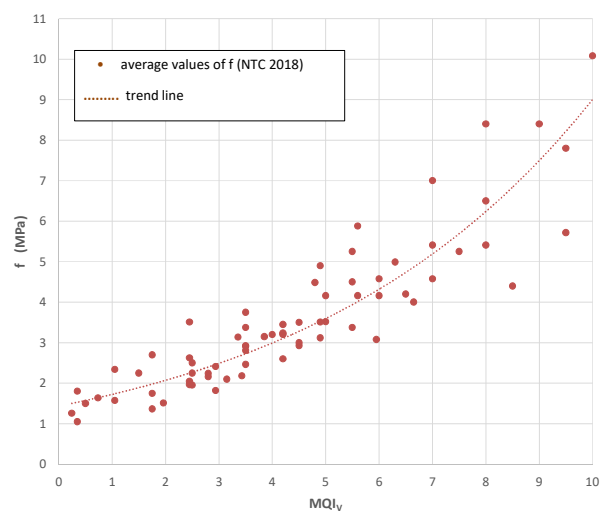
Figure A5. Masonry compressive strength f vs. MQI_v .

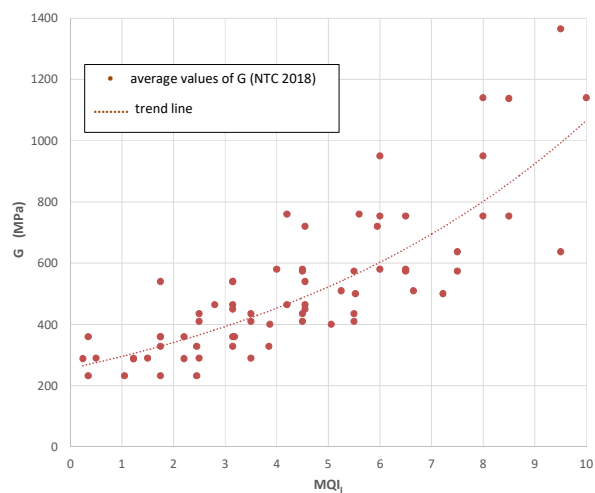
Figure A6. Masonry shear modulus G vs. MQI_i .

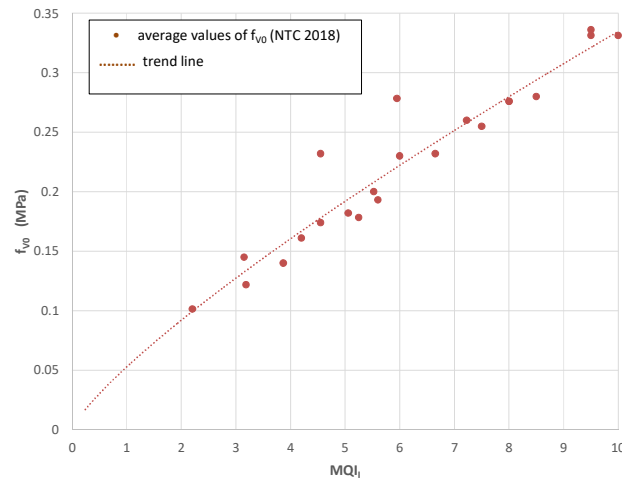
Figure A7. Masonry shear strength f_{v0} vs. MQI_I .

$$f_{v0 \text{ mean}} = 0.0475 MQI_i^{0.854} \quad R^2 = 0.928$$

$$f_{v0 \max} = 0.0654 MQI_i^{0.822} \quad R^2 = 0.918$$

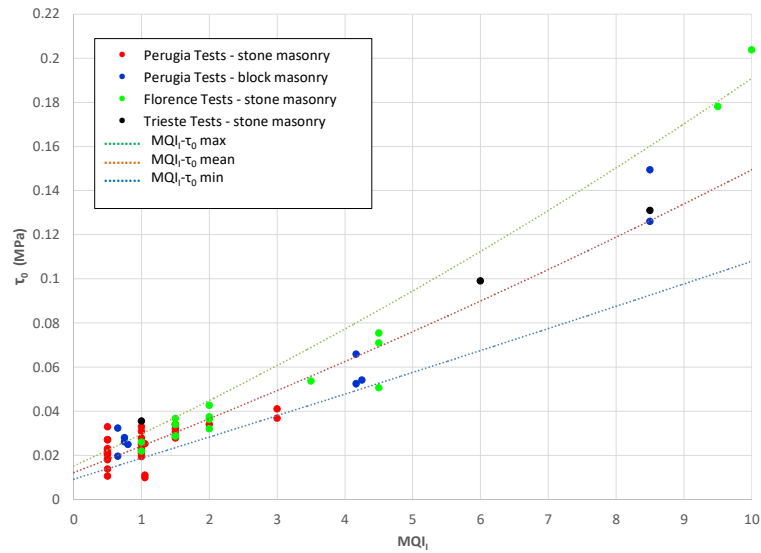
Figure A8. MQI_i vs. shear strength τ_0 : experimental results are compared with suggested relationships.

Sixty experimental results of diagonal tension tests have been used for calibration purposes. These tests (55 conducted on-site and 5 in the laboratory) have been carried out on full-scale wall panels (1.2×1.2 m). Tests used for calibration were carried out at the University of Perugia, Florence and Trieste. On-site testing was performed in buildings located in Italy (Umbria, Abruzzi, Emilia Romagna, and Tuscany regions). In Figure A8, shear strength values τ_0 from on-site testing [31,32] are correlated with MQI_I values. It can be noted that the MQI method is able to provide an adequate estimation of the masonry shear strength: most experimental results fall in between the two upper and lower bound curves of the suggested τ_0 vs. MQI_I relationship.

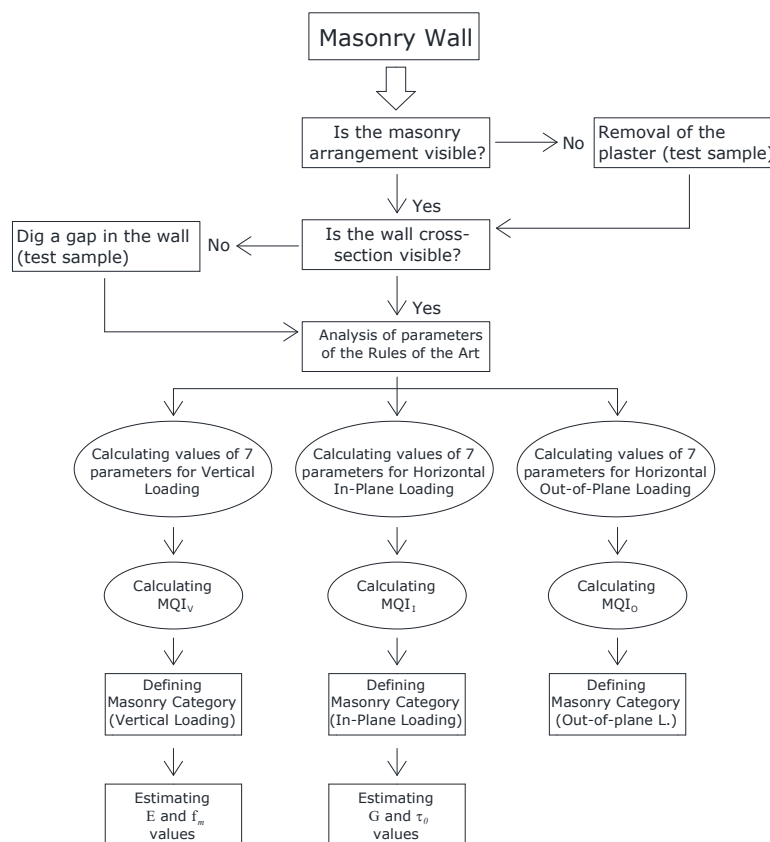
Figure A9. Scheme of the MQI methodology.

Finally, to improve reading comprehension and the methodological approach, Figure A9 shows a flow chart of the MQI method for the three different loading conditions (vertical, in-plane, and out-of-plane loading). The analysis begins with the visual analysis of a wall panel and ends with the identification of masonry categories (A, B, or C, Table A12) and the corresponding estimation of the mechanical properties.
