Citation: Righetti, Luca, Edmondson, Vikki, Corradi, Marco and Borri, Antonio (2016) Behaviour of small masonry assemblages reinforced with a steel cord reinforced joint repointing. In: 16th International Conference on Structural Faults and Repair, 17-19 May 2016, Edinburgh.

BEHAVIOUR OF SMALL MASONRY ASSEMBLAGES REINFORCED WITH A STEEL CORD REINFORCED JOINT REPOINTING

KEYWORDS: Brick masonry; Bed joint reinforcement; Repointing; Steel cords.

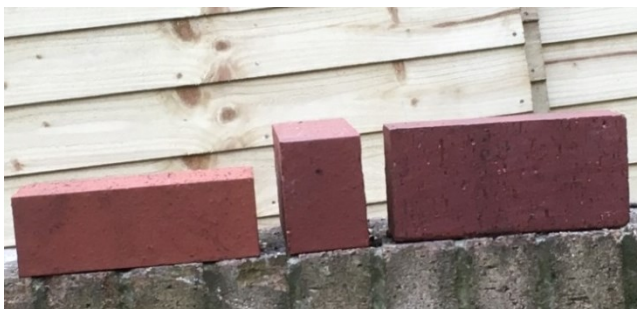
Fig. 5: Bricks used for construction of specimens.

Solid clay units, with nominal dimensions 215 x 102 x 65 mm, have been used for the construction of the masonry specimens (Fig. 5). The compressive strength of the masonry units has been evaluated in accordance with EN 772-1:2011 standard. Uniaxial compression tests have been carried out on six specimens. Test results showed a mean compressive strength of 121.01 N/mm² (Standard deviation (SD) = 9.36 N/mm²).

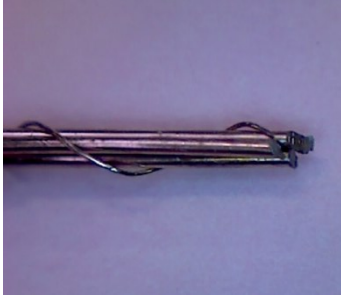
Fig. 7: Detail of the steel cord.

High strength cords are manufactured with four steel filaments each covered with a layer of brass to increase bonding with the mortar and avoid oxidation. Three filaments are wound together by a single external filament characterized by a small diameter compared with the others (Fig. 7). Seven specimens have been tested in tension and the mechanical and geometrical characteristics are described in Table 2.

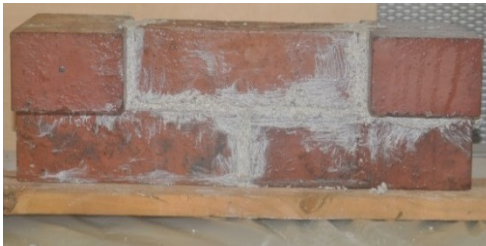
Fig. 8: Unreinforced specimens.

Twenty small masonry specimens (Fig. 8) have been constructed using 5 clay bricks to be tested in three-point bending. They were 440 mm wide and 140 mm high. The minimum width of the masonry assemblages was 102 mm (Fig. 9). Ten specimens have been prepared for each type of mortar. For each batch, five rectangular prisms have been subjected to manual excavation along the horizontal mortar joint, realizing a notch 10-15 mm deep (Fig. 10) where the steel cords have been allocated. After a curing period of 28 days at room temperature notches have been air-cleaned in order to remove powder and possible residual elements, finally two steel cords have been applied for each specimen.

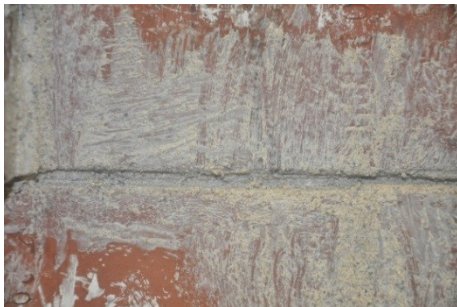
Fig. 10: Excavation manually realized in the horizontal mortar joint.

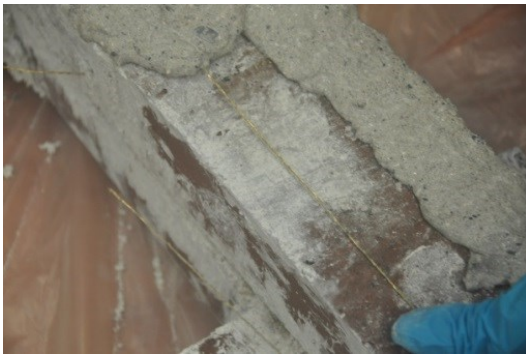
Fig. 16: Application of the steel cord in the horizontal mortar joint.

In order to evaluate the effectiveness of the technique described above, ten reinforced specimens (five from the RA and five of the RB series) have been tested in bending (Fig. 16). Test results are reported in Table 5. The average failure load increased to 3.142 kN (SD. 0.195 kN) and 1.718 kN (SD 0.075 kN) for the specimens built with mortar type A and B, respectively. Fig. 16 shows the load – displacement curves for all reinforced specimens: after an initial linear phase, reinforced specimens exhibited a plastic phase in which the load increased less compared with the elastic phase. The linear phase ended when the mortar started cracking and the resulting detachment between the lower bricks. However the value of the load at the end of the elastic phase increased by 34% and 43% for mortar type A and B, respectively. It is evident that the application of the steel cords on the bottom side of the masonry element provided the needed tensile strength. After the mortar cracked, bending loads kept increasing due to the presence of the steel cords until the failure of reinforcement occurred (Fig. 17). Figure 18 shows the load – displacement curves for reinforced specimens (RA and RB). It can be seen that after an initial linear behavior, all samples exhibited a plastic phase in which the bending load increases with large deformations.

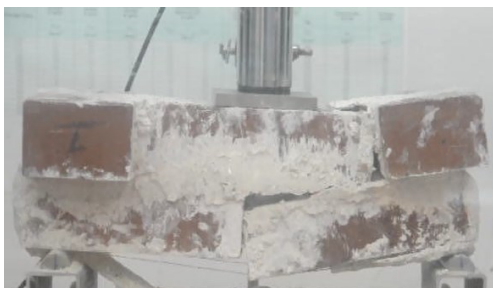
Fig. 17: Failure mode of an unreinforced specimen
