Experimental analysis of masonry ring beams reinforced with composite materials

ABSTRACT: It is known that the application of a ring beam is an effective method to prevent an out-of-plane collapse mechanism of perimeter wall panels. However this effective reinforcing method presents some problems. In order to address this, this paper describes the problems associated with this reinforcing method and studies a new technique for reinforcing historic masonry buildings by realizing a new type of ring beam made of recycled old stones or bricks reinforced at the bed joints with glass-fibre sheets, GFRP (Glass Fiber Reinforced Polymer) grids or/and PBO (polybenzoxazole: poly-p-phenylene benzobisoxazole) cords. An experimental investigation has been carried out on 8 full-scale rubble-stone or brickwork masonry ring beams tested in bending. The testing included the use of composite materials inserted into the mortar joints during the fabrication phase of the beams and pinned end conditions (four-point bending configuration). Beams were reinforced with different reinforcement layout.

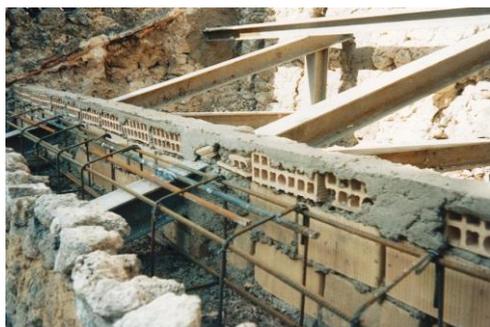
Figure 1. Example of a RC ring-beam.

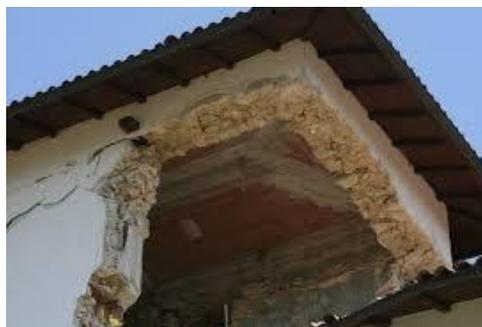
Figure 2. Example of an out-of-plane collapse due to poor connection between the RC ring beam and the underlying masonry.

It has been recognized by now that the greater stiffness of the RC ring beam compared to the stiffness of the masonry, produces a different response in these two materials during earthquakes and causes the load to be unevenly spread. In order to prevent out-of-plane collapse mechanisms, the action of vertical static loads may contribute to stabilize wall panels, but the application of stiff RC ring beam may cause the re-distribution of vertical compressive stresses and some portions of masonry could result unloaded and, during earthquakes, be prone to become unstable (Fig. 2) (Binda et al. 1999, Furukawa 2009, Magenes et al. 2014).

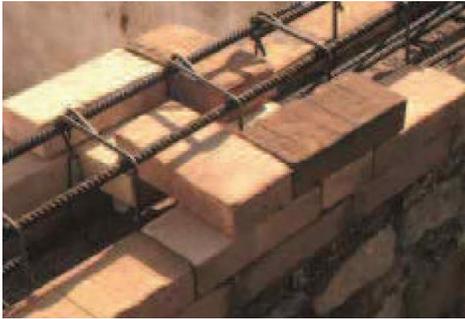
Figure 3. Example of a brickwork steel-reinforced ring-beam.

Nowadays, it's usual to apply steel-profiles or masonry ring beams (Figs. 3-4). However, when a building is faced with stone, the ring beams are made thinner than the wall so that they are screened

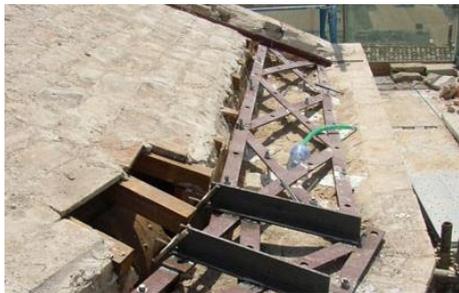
Figure 4. Example of a steel-profile ring-beam.

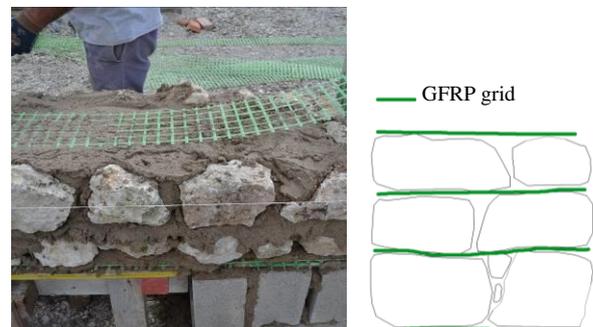
Figure 10. Construction of stone ring-beam strengthened with GFRP grids.

Four stone beams were built inserting a GFRP grid, made of AR (Alkali-Resistant) glass fiber with zirconium content equal to or over 16%, and of thermosetting epoxy vinyl ester resin. A rigid square meshes sized 33x33 mm were used in samples P5 and P6, whereas dimensions of 66x66 mm were employed in the P7 and P8 samples (Fig. 10).

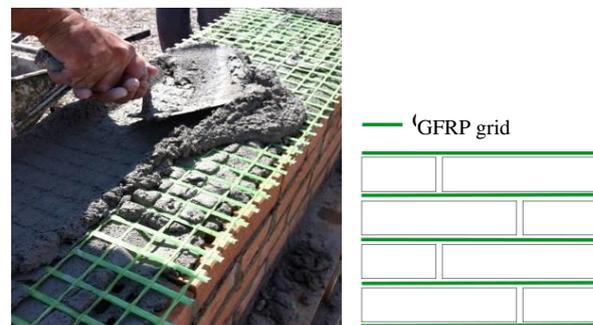
Figure 11. Construction of brickwork ring-beam using a GFRP grid.

The remaining two samples were made of brickwork masonry. Their length were the same as the other specimens (5 m) whereas the cross-section was 0.4 x 0.33 m and they were formed by 4 courses of bricks and mortar and 5 layers of reinforcement (Fig. 11). The mortar used in their construction was a ready-to-use cement-based mortar (denomination: M15).

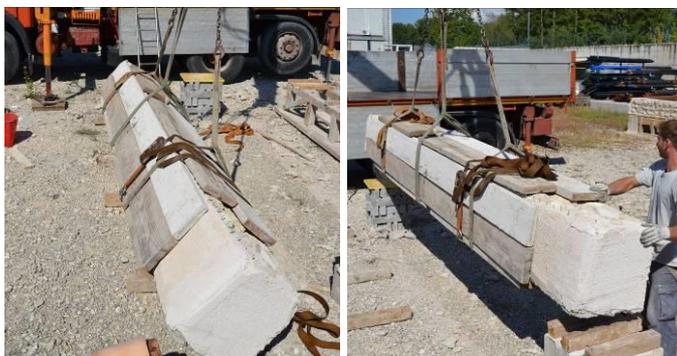
Figure 13. Rotation of a beam which were tested in horizontal plane.

In order to bend the beams in their horizontal plane and simulate the seismic action, some specimens were confined with wooden planks and web-bings clamped with ratchets and then were rotated 90° (Fig. 13). After this rotation the load was spread on the upper surface.

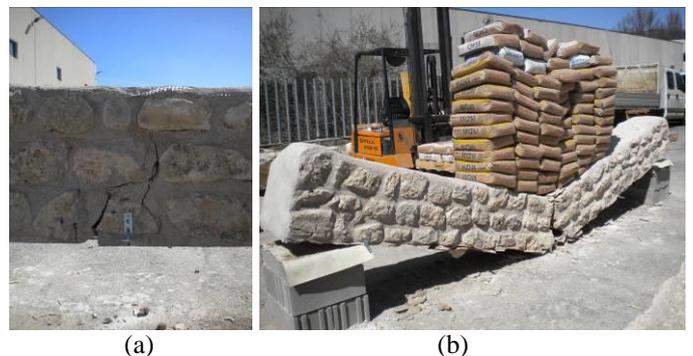
Figure 14. (a) Crack pattern produced by gravity self-weight load. (b) Ring-beam No. P3-U-V after testing.

In P2-T-H, P3-U-V and P4-UH specimens, one or two cracks appeared in the middle part of the ring-beams as result of self-weight loads when the wooden scaffoldings were dismantled. Looking into the cracks, it could be observed the breaking of the glass fiber sheet, whereas the PBO cords were not damaged (Fig. 14a). The cracking also indicate the transition from an elastic behavior (in which all the reinforcing materials collaborate) to a plastic one (in which just the PBO cords provided the tensile strength). After the failure of the glass-fibre sheet, the load was applied in order to analyze the beam's plastic behavior. In all the three cases the deflection of the beam increased considerably until it leaned on

ground; however the failure of PBO cords was never reached (Fig. 14b).
