Citation: Corradi, Marco, Osofero, Adelaja Israel and Borri, Antonio (2019) Repair and Reinforcement of Historic Timber Structures with Stainless Steel—A Review. *Metals*, 9 (1). p. 106. ISSN 2075-4701

Repair and Reinforcement of Historic Timber Structures with Stainless Steel—A Review

Abstract: Recent trends in the use of stainless steel profiles for repair and reinforcement of historic timber structures, after degradation due to biotic and non-biotic attacks, are discussed in this paper. These structural challenges can vary from inadequate load carrying capacity to complexities involved with choice of repair materials and techniques. Given the recurring requirements of conservation authorities in terms of reversibility of interventions and compatibility between historic and new materials, an increase in the use of non-invasive reinforcement materials and reversible techniques was observed. Subsequently, engineers and researchers have increasingly employed stainless steel alloys in retrofitting historic timber structures. This paper therefore presents the state of the art in the use of stainless steel profiles in retrofitting timber structural elements within historic structures

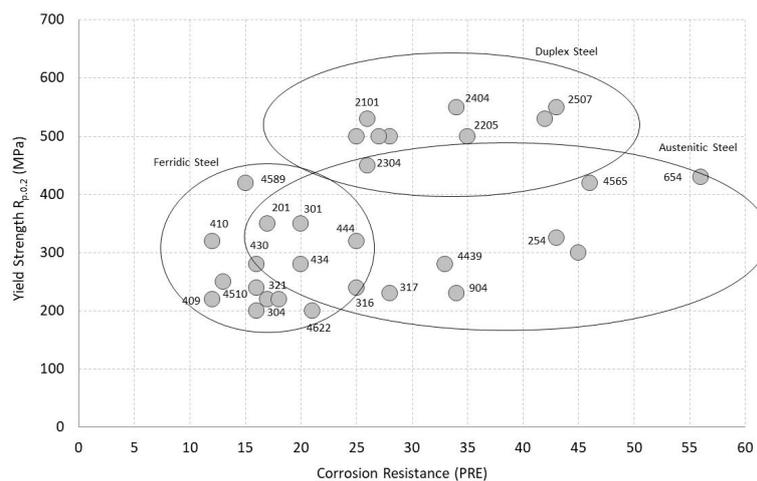
Figure 1. Corrosion resistance (PRE) vs. stainless yield strength (indicative) for different stainless steel grades. Reproduced from [29], with permission from Elsevier, 2018.

Stainless steels applications require optimum mechanical properties and corrosion resistance (PRE), both of which strongly depend on the steel microstructure (Figures 1 and 2). The corrosion resistance of stainless steels increases with an increase in the PRE value. For example, for a stainless steel to be considered sea water resistant, it is suggested to have RPE that is greater than 32. Corrosion resistance is also critical for outdoor/unprotected applications. For example, when stainless steel profiles are used to reinforce deficient external masonry structures.

Yield stress, strain at yield and corrosion resistance all strongly depend on the type of stainless steel: low with ferritic steels and typically high with duplex steels. For example, with a reference value of 275 MPa yield strength (typical of the standard JR275 grade [30]), an elongation at failure of 40% is expected for ferritic stainless steels while about 60% extension is estimated in the case of austenitic steels. Ductility requirement for stainless steel applications varies, i.e., moderate ductility and high modulus are generally required for interventions related to confinement of timber columns or compressed members, while higher ductility is required for bending reinforcement of beams. To avoid stress concentrations, ductility is also a desirable requirement when stainless steels are used to repair rotting wood and for reinforcement interventions [31].

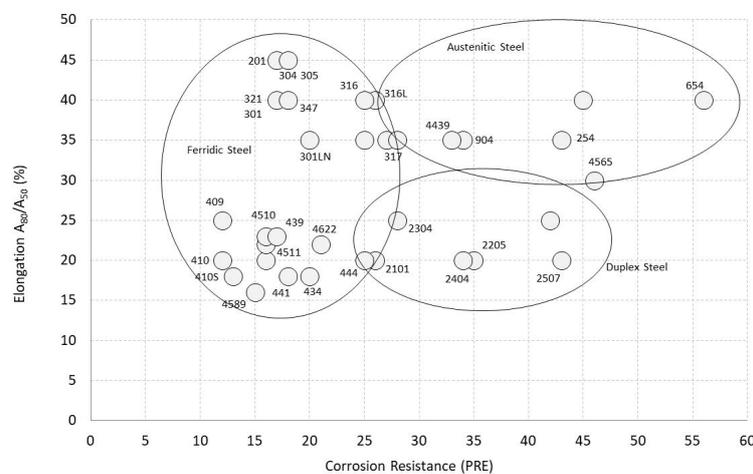
Figure 2. Corrosion resistance (PRE) vs. elongation characteristics (indicative). Reproduced from [29], with permission from Elsevier, 2018.

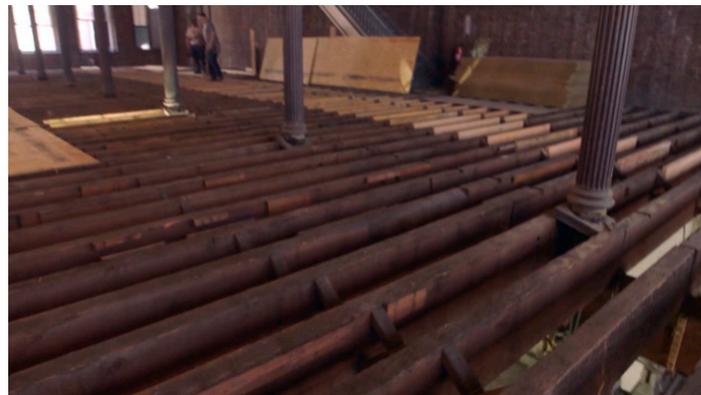
Figure 3. Historic joist floor.

Figure 3 shows a typical joist floor. This one-way beam-floor is common in the UK, where it is still in use for new construction. To repair the joist ends from rotting at the point where the joists rest in brick or stone walls, pairs of stainless or galvanized steel plates, pre-drilled, are typically used with standard coach screws, which are secured at the end of degraded timber joists (Figure 11). The plates rest in or on the wall and allow for the rotted end to be cut off. To give additional stiffness, for use in rows of continuous end repairs, with no sound joist ends between. A bolted connection through the plates into the parent joist can be adopted [42–44].

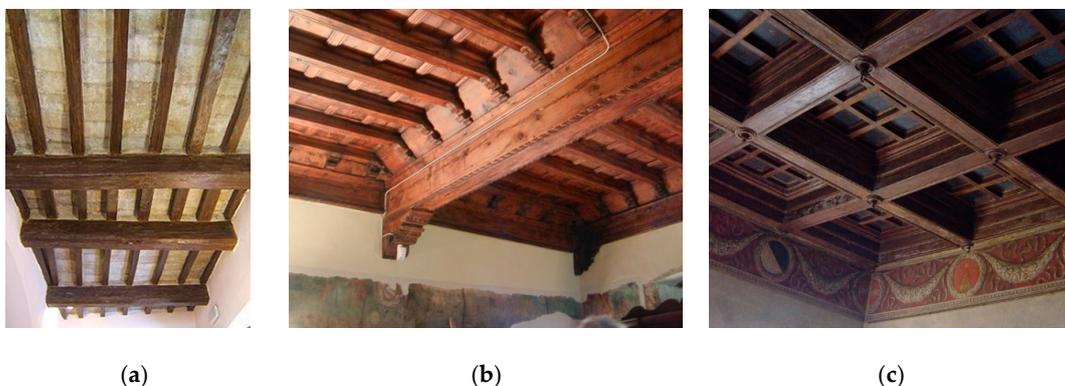
Figure 4. Different types of horizontal diaphragms (floors): (a) common timber-beam floor (solid beams and rafters, tiles); (b) decorated and carved timber timber-beam floor; (c) bi-directional timber-beam floor.

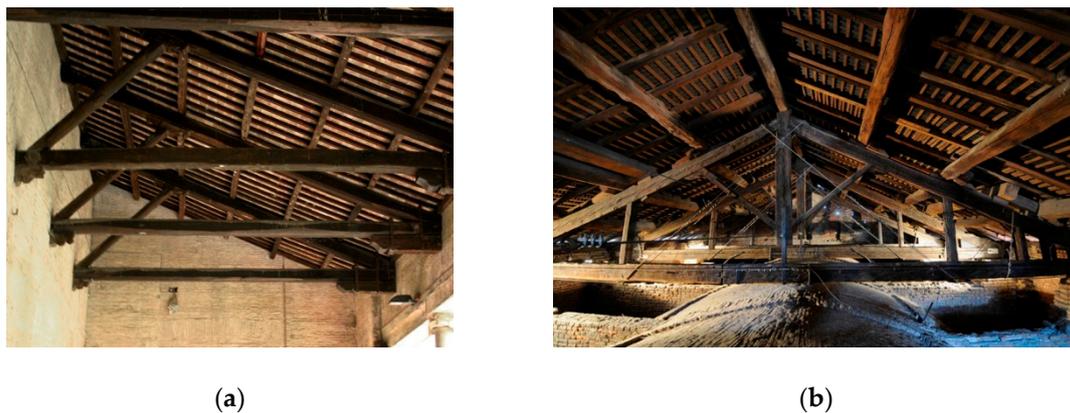
Figure 5. Different types of roof timber historic structures: (a) timber frame for a shed (skillion) roof; (b) traditional timber frame for a gable roof.

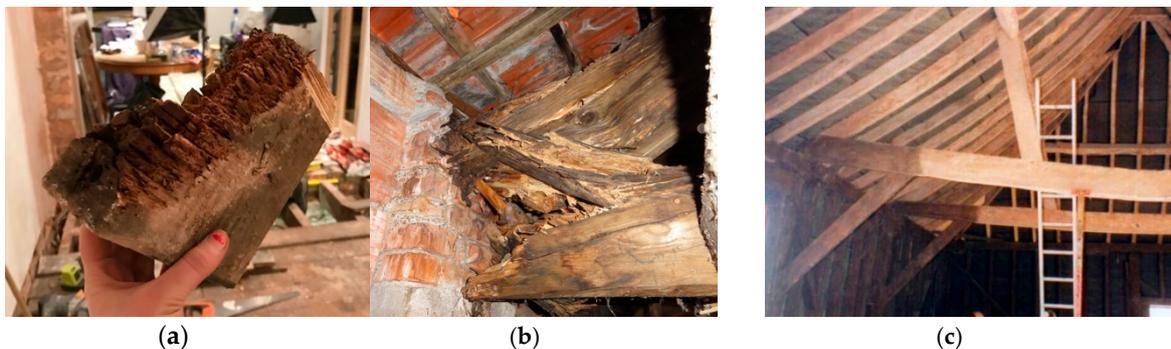
Figure 6. Examples of damage in timber structures: (a) and (b) Rotting wood at the beam-ends, and at the joists in timber roof truss; (c) Deformed timber tie in a frame of a roof structure because of over-loading.

Rotting timber is the main cause for repair (local) interventions on historic timber structures. Figure 6a,b show two critical points where repair is typically needed: the end (timber-to-masonry connection) of timber beam-floors and the joint between principal rafter and tie-beam for the traditional king post roof truss. As damp and moisture facilitate the attach of biotic agents (*fungi*, insects, *larvae*, etc.), unprotected areas are at high risk.

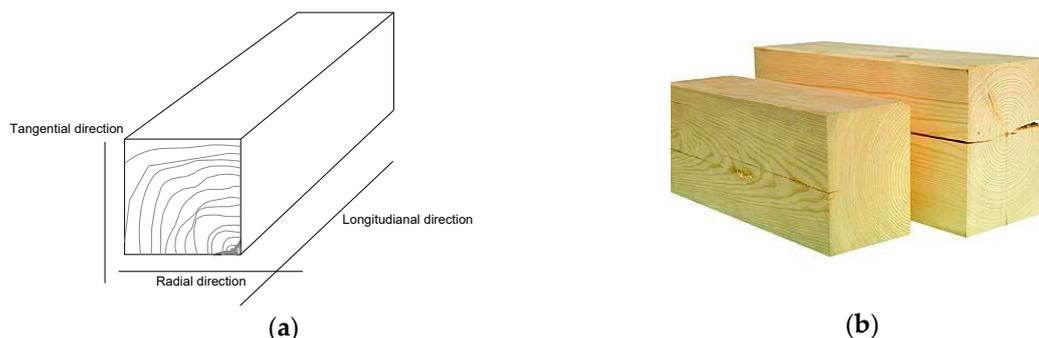
Figure 7. (a) Timber is an orthotropic material: the three principal directions (tangential, radial and longitudinal) depend on the grain orientation; (b) differential shrinkage can produce significant damage. Shrinkage is typically very high along the tangential direction.

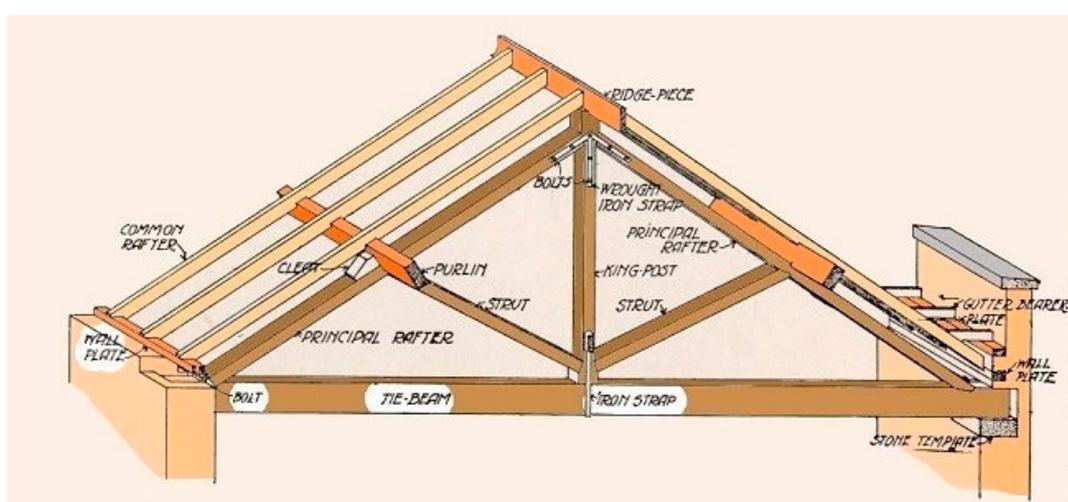
Figure 8. Symbols and terminology used for structural members of the traditional king post roof truss [36].

Creep and shrinkage of timber may cause damages (mechanical), leading to excessive deflection, reduction of structural stiffness and strength. Time-dependent deformation under a certain applied dead-load (creep) generally occurs at high temperature, but in timber it can also happen at room conditions. Figure 6c shows a deformed beam due to over-loading. Such deformation is typically produced by bending loads. Differential shrinkage along the three principal directions in timber (radial, tangential and longitudinal) (Figure 7) can cause high reductions of the second moment of inertia of a beam section and also facilitate the attack of biotic agents (insects, fungi, etc.). For mechanical-based damages, interventions with repair or reinforcement are usually required. For the traditional king post roof truss, the relevant terminology and used symbols are reported in Figure 8 [36].

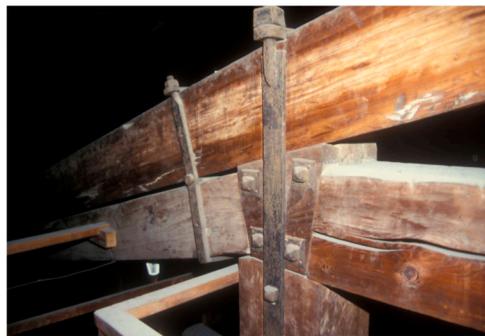
Figure 9. Salone dei Cinquecento, Palazzo Vecchio, Florence, Italy: Detail of timber roof structure and iron fasteners (the iron reinforcement is part of the original structure from 17th century).

The use of metal fasteners to reinforce local timber beams and trusses is a traditional technique (Figure 9). This was very common in the 19th and 20th centuries and it is still applied today [40,41]. The method simply consists in the application of one or more metal fasteners, made of metal strips, to prevent the slippage between two timber elements and increase the resisting section in critical areas. It is typically applied at the beam-to-template connection points and in the timber-to-timber joints of the traditional king post roof trusses (Figure 10).

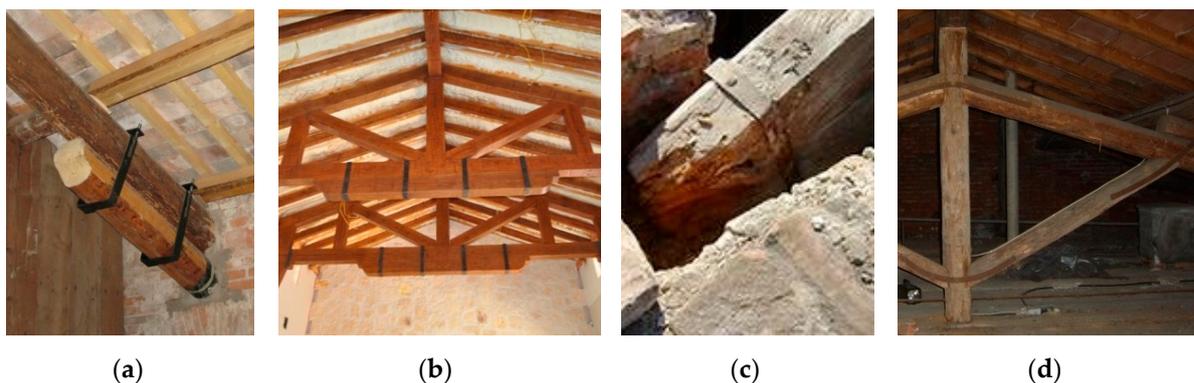
Figure 10. The traditional use of metal fasteners in critical sections of the timber beam floor and the king post roof truss: (a) timber template-beam (beam-floor); (b) joint king post-tie beam (truss); (c) joint strut-king post and principal rafter-king post (truss); (d) joint principal rafter-tie beam (truss).

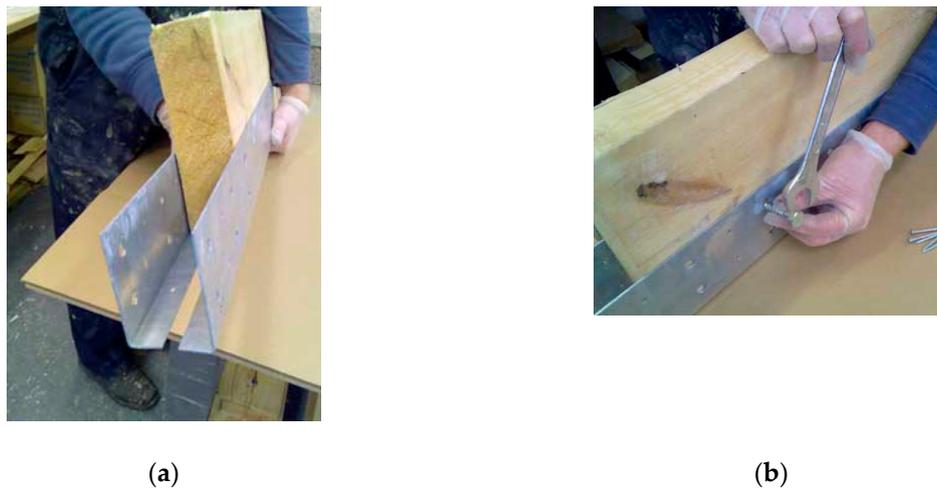
Figure 11. Re-construction of joist ends with stainless steel L-shaped profiles (press-bended stainless steel sheets) [43].

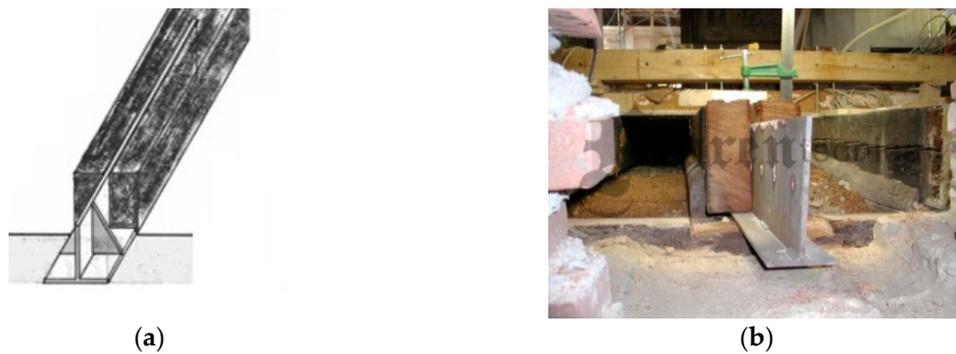
Figure 12. A stainless steel fitch plate inserted into a timber beam and bolted side-to-side: detail of the steel profile used at the beam ends [44,45].

To reinforce the decayed timber beam ends, stainless steel flitch plates can be inserted along the beam length (Figure 12). This method involves cutting a slot into the timber and making the beam a composite of stainless steel and timber. The plate may also take a T-shape either the right way up (top of the beam) or upside down (underside of the beam). The steel flitch plate is best used at the underside of the beam and fixed upside down, so the wide part of the T is positioned to carry the highest tensile stresses. However, the functionality of the composite beam depends on the type of connection between steel and timber members. When reinforcement is carried out at the ends of simply-supported beams, connection should be able to transfer only the shearing forces (zero bending moment at the supports). In this situation, bolts in the stainless steel web are sufficient. From a practical viewpoint, these are difficult repairs to carry out on site, requiring overhead cutting of the slot by multiple drillings or chain-morticer/chain-saw cutting.

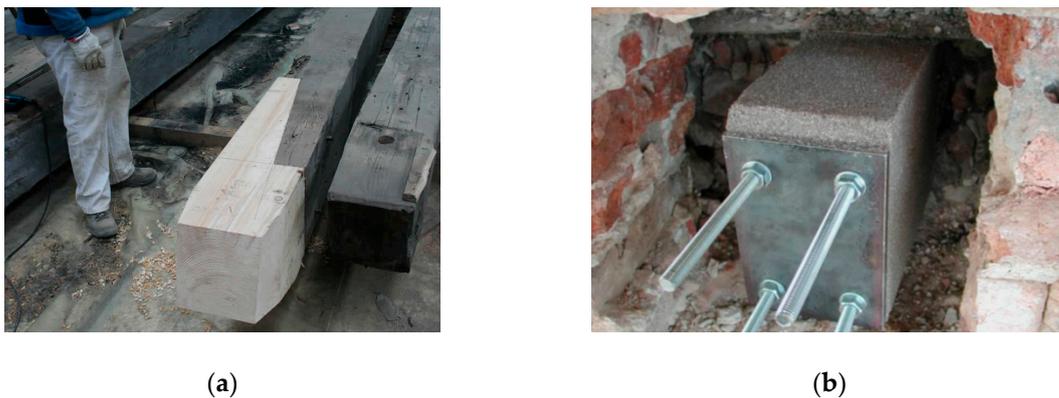
Figure 13. Re-construction of the beam ends: (a) stainless steel reinforced wooden prosthesis; (b) detail of the stainless steel reinforced epoxy prosthesis [48].

For repairing old solid timber beams, lintels or rafters, it is also common to use timber prostheses to connect with the damaged beam using smooth or ribbed stainless steel rods, connectors or bars. Holes are drilled, or a groove cut, in the undamaged pre-existing timber to accommodate the rod reinforcement. The prosthesis is usually made of a new, laminated structural timber (Figure 13), made in kiln dried wood or epoxy paste (using construction shutters). The rods are typically made of fiberglass, carbon FRP or stainless steel (Figures 14 and 15). Pouring or injection resins are used to fix the rods into the prostheses and the pre-existing beam [45–48].

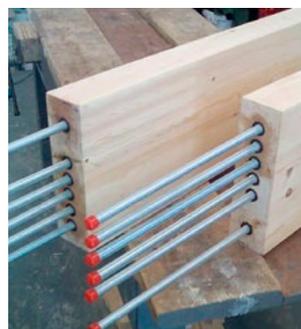
Figure 14. Re-construction of joist or beam ends with stainless steel rods [43].

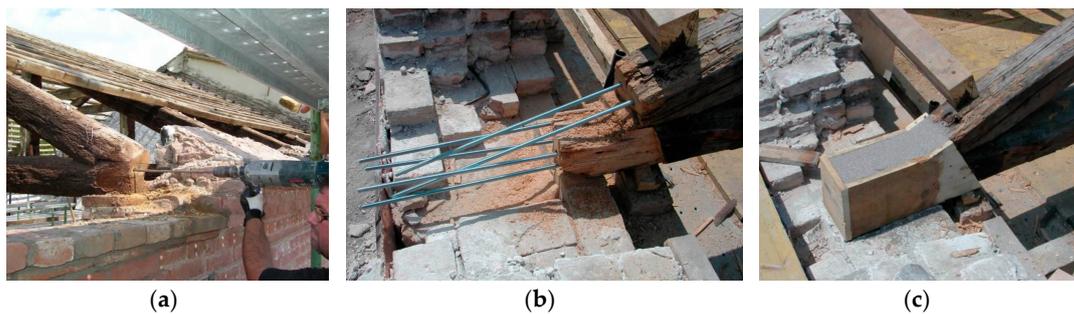
Figure 15. Re-construction of tie or rafter ends with stainless steel rods [45]: (a) drilling the holes for rod installation; (b) insertion of the stainless steel rods; (c) resin casting.

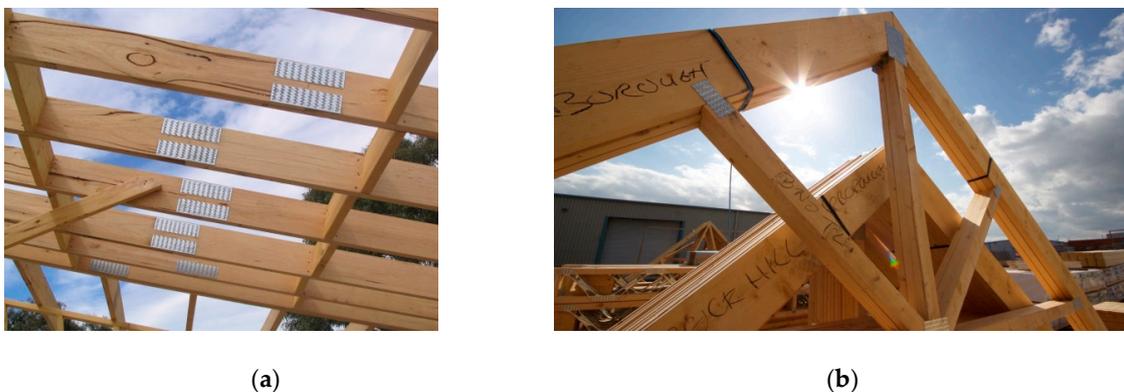
Figure 16. Examples of connections made with nail-plates [51,52].

Although the use of nail plates can be considered a versatile and cost-effective method to improve the connection between wood elements (Figure 16), their use for historic or listed timber structures is rare and not often authorized by conservation bodies. This is mainly due to the fact that a nail-plate connecting system can cause damage to the timber structure, and facilitate biotic attack by saprophytic insects and fungi. For historic structures, it is always preferable to repair/restore the pre-existing historic connecting devices (post-and-beam, tie-and-rafter and other construction techniques). Furthermore, nail-plate connections are rarely able to transfer to maximum allowable internal force from one element to another [49,50].

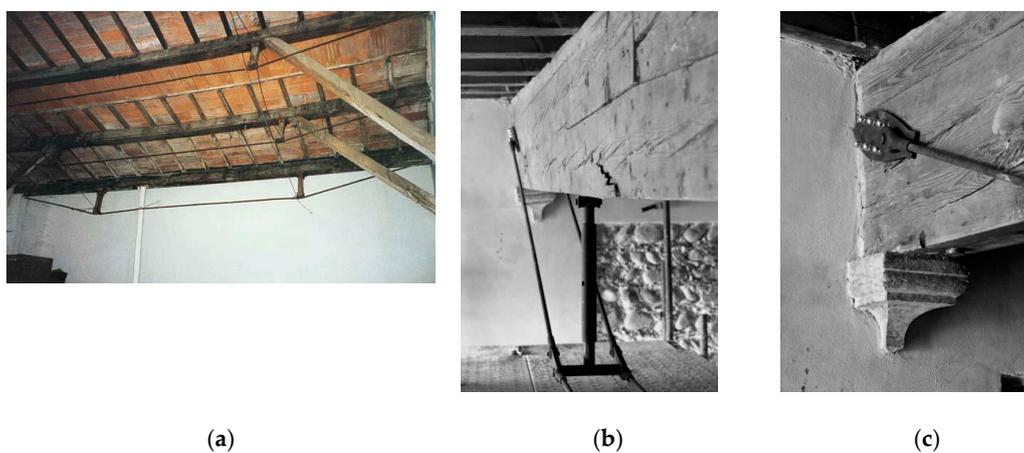
Figure 17. Examples of bending reinforcement by conversion of a timber-beam floor into a trussed girder by adding steel struts and tension rods underneath ([53] for (b) and (c)).

The conversion of a beam-floor into a trussed system is a traditional method, introduced in the 19th century to reinforce deficient timber-beam floors [53–58]. Figure 17a shows a retrofitting intervention carried out in the 1920s on a timber-beam floor in Italy. A more recent application is shown in Figure 17b,c. Nowadays, it is possible to use stainless steel bars, thus highly reducing corrosion problems. A critical aspect of this intervention is the creep deformation of both the timber and the stainless steel materials. Mechanical devices (turnbuckles) are often needed for the stainless ties and low-creep, high-modulus stainless steel alloys should be preferred.

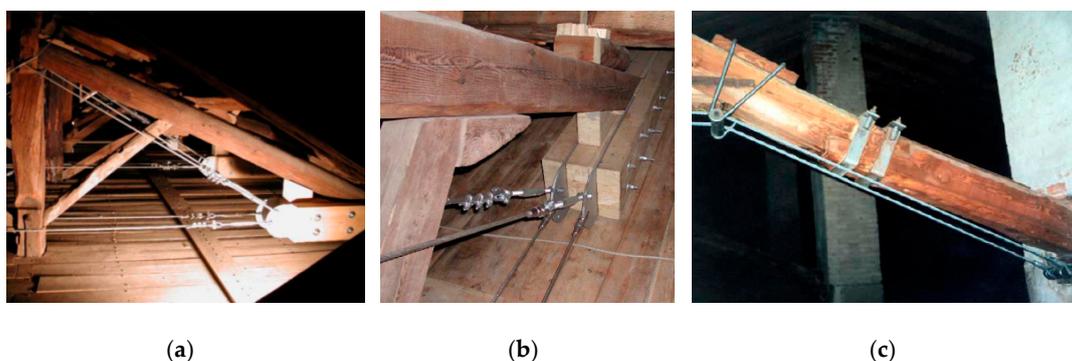
Figure 18. Reinforcement interventions using stainless steel wire ropes (design, Prof. L. Jurina): (a) and (b) Residence Masciadri in Arcene, Italy; (c) Residence Masciadri in Arcene, Italy [55].

Figure 18 shows different retrofitting interventions, designed by professor L. Jurina [54]. The use of stainless steel wire ropes may represent an interesting solution when the reinforcement is exposed and unprotected. The installation of the ropes is relatively easy, the intervention is reversible, and the damage to the timber structure is very limited. However, particular attention should be given to stress concentration problems at the rope-timber joints and it is recommended to take periodic measurements of the creep deformation of the stainless steel ropes. The joint between the wire rope (tie) and the timber rafter is made using two steel plates (Figure 18b). These are inserted into a glulam element connected to the diagonal timber rafter with a bolted connection. The wall-to-wire connection can be effectively realized using anchor bolts (Figure 18c).

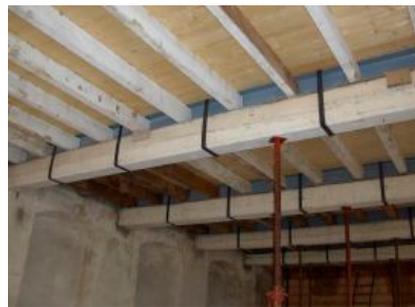
Figure 19. Reinforcement of a timber beam using a stainless steel H-shaped beam applied on the compressed area.

When conservation bodies or local authorities do not authorize retrofitting interventions, on listed buildings, at beam intrados (under the timber beams), for example, for the presence of decorations, it is possible to effectively reinforce timber-beam floors by operating on the beam extrados (over the beams) [58] (Figures 19 and 20). In fact, to increase both the bending capacity and stiffness characteristics of existing wood beams, the use of stainless steel profiles placed in the compression side is an interesting solution. Stainless steel elements do not function as a substitute for the timber beams but rather effect an increase in their capacity and flexural stiffness through the creation of a mixed timber–stainless steel structure [59]. The application of stainless steel profiles can be done using epoxy resins, fasteners and/or metal screws or bolts. The use of mechanically attached connectors (screws or bolts) is usually preferred, given the high stress level, under loading, at interface between the timber beam and stainless steel beam. Stainless steel profiles can be also notched to better accommodate the floor joists, without highly affecting the effectiveness of the steel reinforcement. Furthermore, it should be noted that the reinforcement can be completely invisible behind the timber beams, it does not cause significant damage to the timber beams, and it can be easily removed, if needed, providing the method with reversibility characteristics. The reinforcement with H-type elements is characterized by this property and by high machinability of stainless steel elements to be carried out on-site. The reinforcement of timber beams using stainless steel beams is capable of resulting in a significant increase in strength, stiffness, and ductility and the application of the reinforcement is extremely fast and effective.

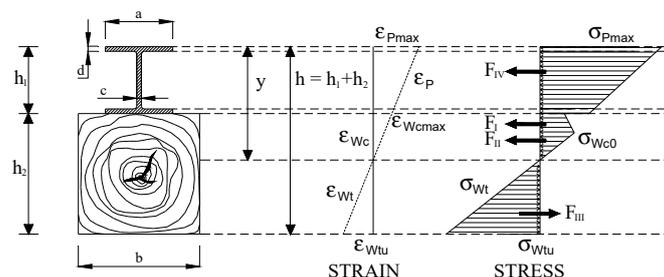
Figure 20. Reinforced timber beam cross section: stress and strain distribution, after timber yielding in compression. Reproduced from [58], with permission from Elsevier, 2007.

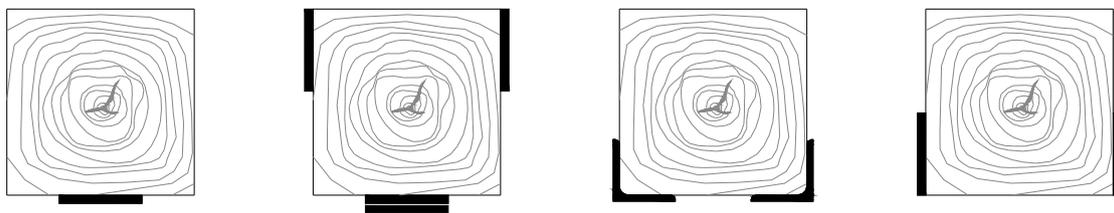
Figure 21. Examples of flexural reinforcement using externally-bonded or screwed stainless steel plates, strips or profiles.

Reinforcement of deficient timber beams using epoxy-bonded or screwed stainless steel plates or profiles is not a new technique. Several methods have been developed since the 1960s, which are particularly focused on reinforcing timber beams with steel elements, applied to the beam tension side and bonded by epoxy adhesives [60,61] (Figure 21). More recently, mechanically attached (bolted) stainless steel plates have been proposed with the aim of facilitating the removal of the reinforcement, when needed (the so-called requirement for “reversibility”) [62,63]. These reinforcement methods use wide steel plates, steel cords [64–66], I- or L-shaped profiles which cover a large part of the lateral or intrados (bottom) surfaces of the timber beam (Figure 22): this represents a limitation for the application of this reinforcement method, especially when the beams are painted, decorated or carved. Because wood is hygroscopic, its cellulose molecules attract water and, when stainless steel plates are used for reinforcement, areas under the plates could remain more humid and this could facilitate biotic attacks to the timber material.

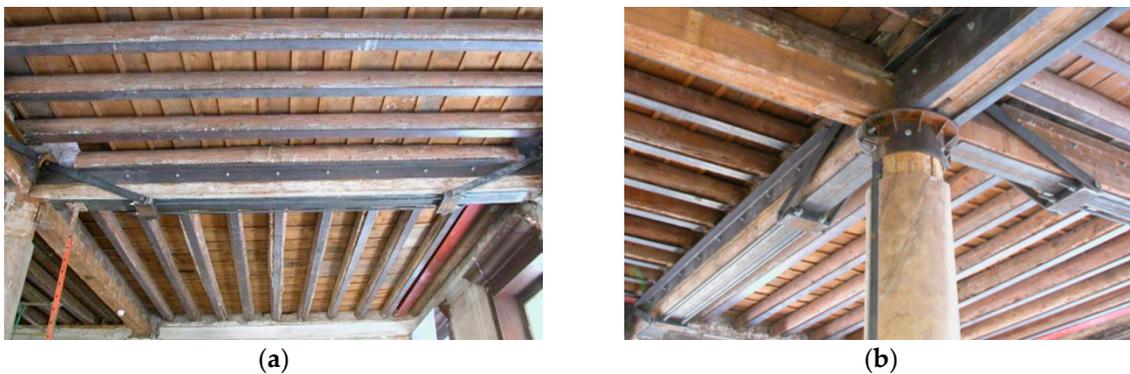
Figure 22. Steel plates and profiles as flexural reinforcement of timber beams [64].

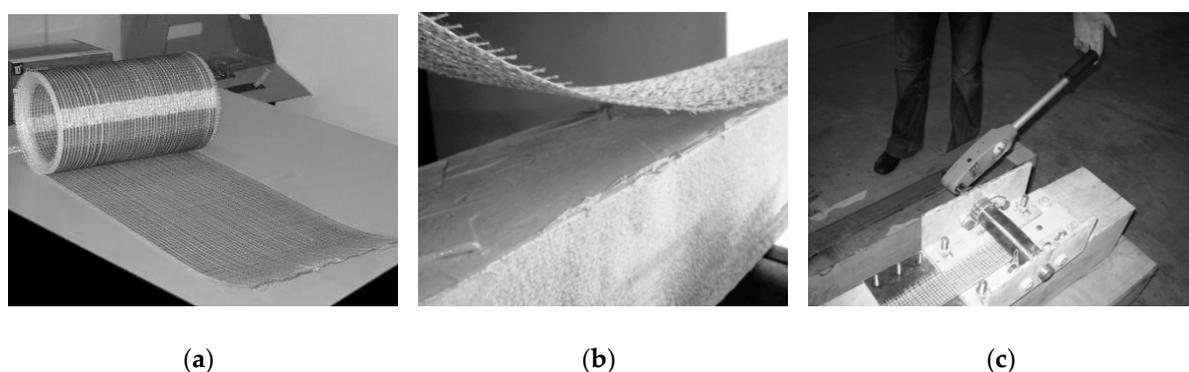
Figure 23. Use of steel cords: (a) steel-fiber coil, (b) application of the cords using an epoxy paste, (c) pre-stressing device. Reproduced from [66], with permission from Elsevier, 2011.

Figure 23a shows the application of stainless steel cords. The application of the cords at the beam bottom is a relatively simple operation: an epoxy paste is needed to glue and protect the fibers on the beam surface (Figure 23b). The negligible bending stiffness of the stainless steel fibers also allows for pre-stressing them: a mechanical device, consisting of a metal cylinder, positioned at one beam end, can be used for this purpose. Fibers are wound around the metal cylinder (Figure 23c) using a clamp and fastened to the other end, until the design target-value of the clamping couple is reached. At the end of curing time of the epoxy paste (typically 48–72 h), the mechanical pre-stressing device can be removed. The final result is a timber beam strengthened, at the tension side, with pre-tensioned stainless steel cords.

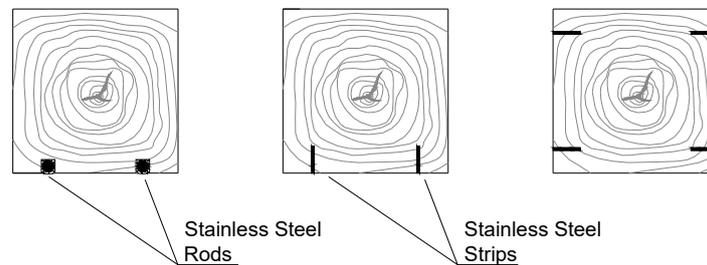
Figure 24. Examples of flexural reinforcement using bonded-in stainless steel rods or strips.

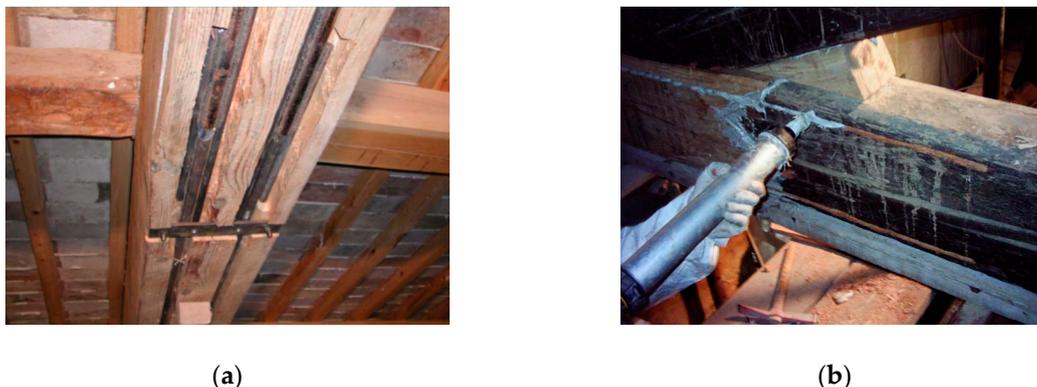
Figure 25. Bonded-in steel bar reinforcement: (a) detail of the reinforcement before resin application; (b) filling of the grooves with epoxy paste.

Bonded-in stainless steel reinforcements has some drawbacks (Figure 25): timber beams are usually damaged due to the use of a groove cutter for the installation of the rods/strips, and the use of adhesives is not recommended, given their unsatisfactory long-term behavior. However, several positive characteristics can also be highlighted: because the reinforcement is confined in the groove and it is completely embedded in the resin, the risk of the delamination of the steel reinforcement is very low. Reinforcement delamination is typically induced both by bending loads (and resulting shear stresses at interface) and by the swelling and shrinkage of the wood. Furthermore, unlike the externally-applied reinforcements, glued to the beam's sides or to the bottom surface, the choice of bonded-in methods allows the epoxy adhesive layer to be partially protected in case of fire by applying a longitudinal wooden board, which covers the groove.

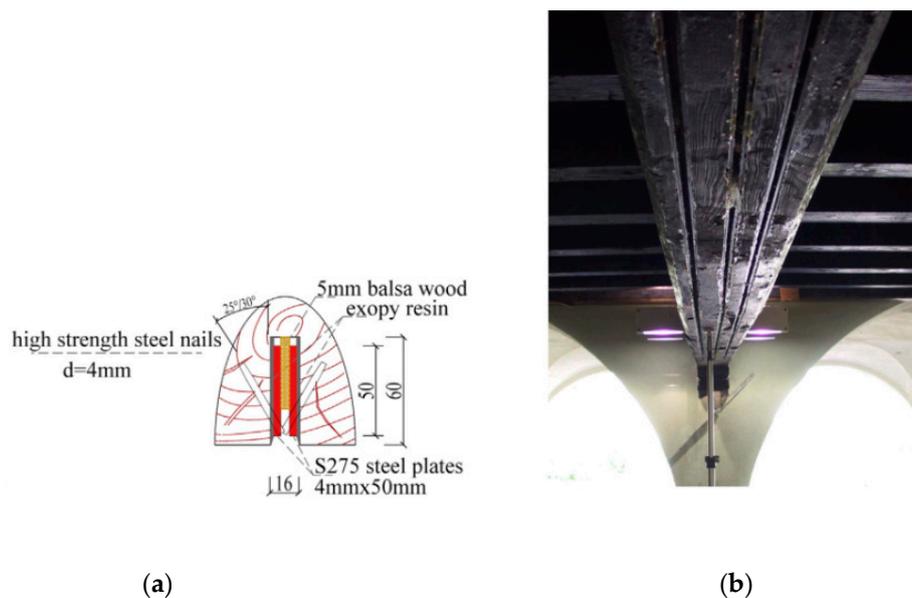
Figure 26. Bonded-in steel strip reinforcement: (a) detail of the groove; (b) layout of the reinforced beam. Reproduced from [71], with permission from Elsevier, 2016.

When metal strips are used, it is recommended to apply them vertically. Figure 26 shows an on-site experimental investigation [71]: the 15th-century timber beams of an historic building in Brescia, Italy. The width of the grooves was 16 mm and the depth varied from 60 mm at the mid-span to 0 mm at the groove ends in order to minimize wood removal. Strips were 50 mm × 4 mm × 4200 mm in dimensions. They were applied vertically using both an epoxy resin and diagonal high strength steel nails.

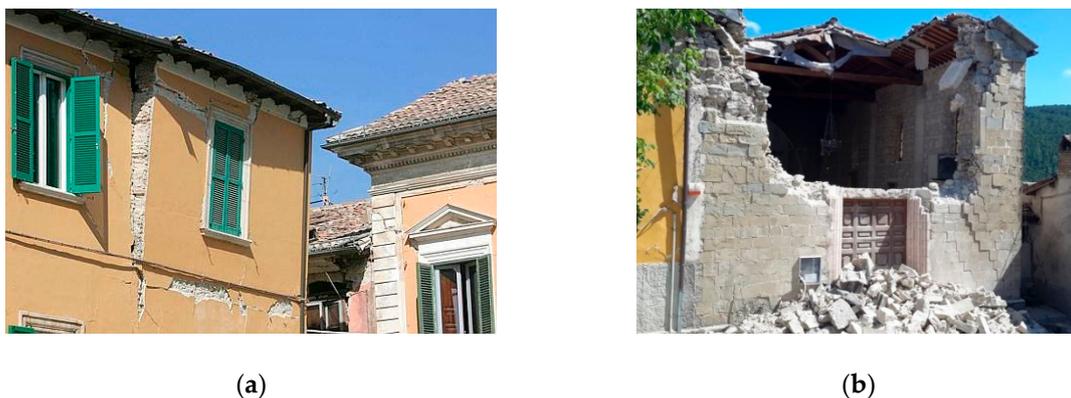
Figure 27. In seismic prone areas, wooden floors may prevent the out-of-plane mechanism of external walls (overturning). To facilitate this function, the wooden floors should be stiff enough (in-plane stiffness) and effectively connected to the walls to transfer the seismic load to the walls parallel to the seismic direction.

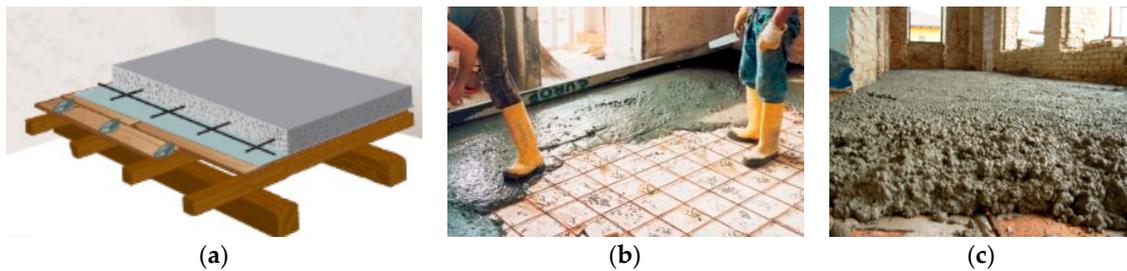
Figure 28. Traditional reinforcement of one-way wooden floor. A steel mesh reinforced concrete slab is applied over the wooden floors (there are no connections between the slab and the timber beams or rafters): (a) schematic arrangement; (b) RC slab application; (c) use of autoclaved aerated concrete; to reduce the RC slab weight (dead loads).

In respect of the traditional reinforcement of one-way wooden floors with a steel mesh reinforced concrete (RC) slab (Figure 28), it is important to document research efforts on the use of stainless steel studs. These are typically used to connect the new RC slab with the pre-existing underlying timber structure [81–83]. The advantages of this method are numerous: the bending stiffness and capacity of the floor are highly enhanced (given the increment of the second moment of inertia of the cross section); the in-plane response of the floor is also improved as the steel-mesh reinforcement is able to provide the needed tensile strength to the RC slab. If the floor or the RC slab is properly connected to the load-bearing walls, the seismic response of the building can be significantly enhanced.

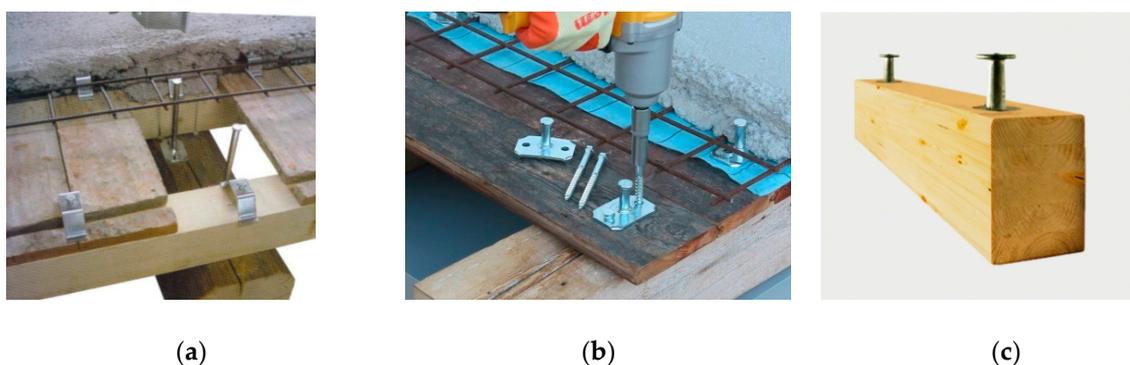
Figure 29. Examples of metal and shear stainless steel studs [82,83].

The damage produced to the timber beams/rafter due to the application of the stainless steel studs is negligible. However, it should be remarked that the application of RC slab can also increase the magnitude of the dead load (Figure 28b). A mitigation measure of this problem is the use of autoclaved aerated concrete (Figure 28c), but this should be applied with caution given the reduced mechanical properties of this type of concrete. However, the use of autoclaved aerated concrete can produce savings in terms of energy consumption, given its highly thermally insulating properties. Different types of connectors are available in the construction market. Examples are shown in Figure 29.

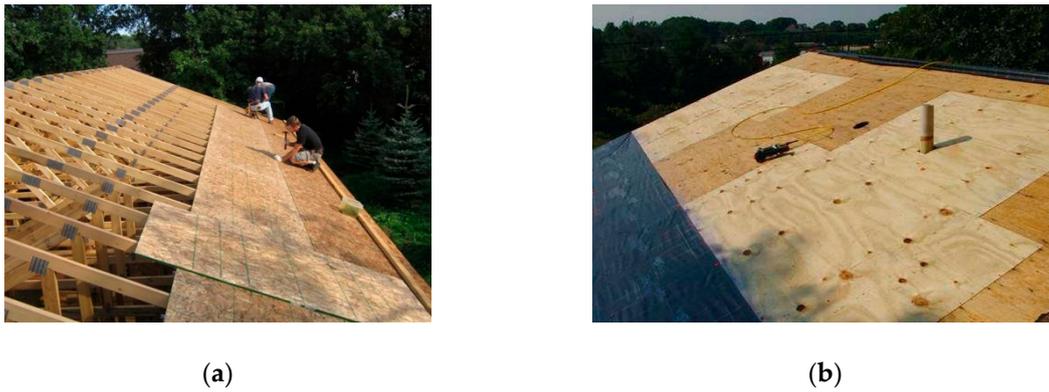
Figure 30. Examples of use of wooden boards.

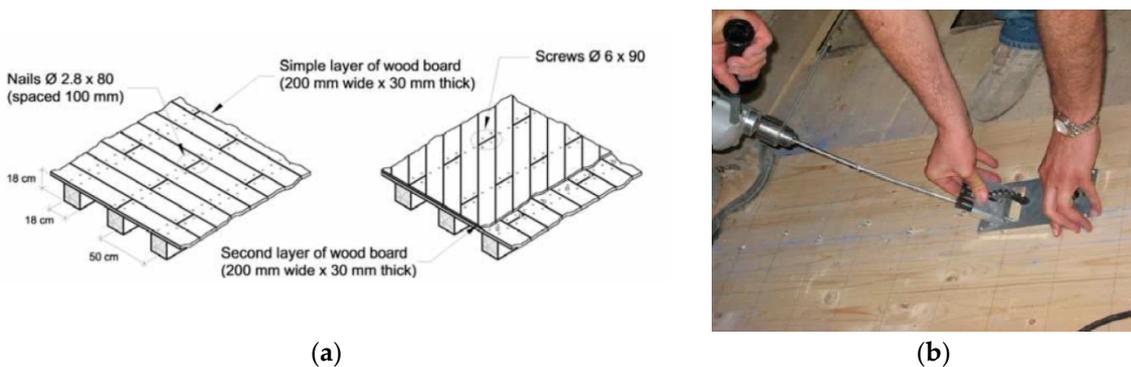
Figure 31. Reinforcement of timber floor: two layers of wood boards can be added over a pre-existing timber beam floor. The use of stainless inclined steel screws to connect the boards to the beams may highly increase both flexural and in-plane stiffnesses. Reproduced from [80], with permission from Elsevier, 2015.

Figure 31 shows a schematic layout of the reinforcement of wooden floor by adding a new layer of wood boards. These can be effectively connected to the underneath wooden floor boards and timber beams by using inclined high-strength stainless screws. A variation of the reinforcement method in Figure 31 consists of the application of diagonal stainless steel strips [80] (Figure 32), screwed to the pre-existing underlying wood boards and beams/joists.

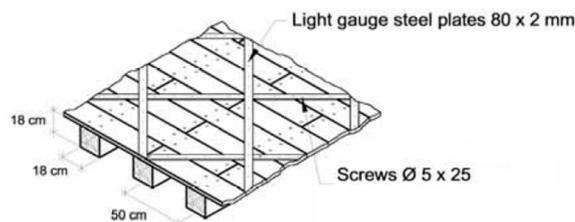
Figure 32. A possible alternative solution to the use of a double layer of timber boards—application of stainless steel strips over the new or pre-existing wooden floor boards. Reproduced from [80], with permission from Elsevier, 2015.
