**CONSERVATION OF FUNCTIONAL
HERITAGE RAILWAY BUILDINGS
AS AN ARCHETYPE FOR THE
CONSERVATION OF FUNCTIONAL
HERITAGE BUILDINGS**

CHRISTOPHER DIETMAR REEVES

A thesis submitted in partial fulfilment
of the requirements of the University
of Northumbria at Newcastle for the
degree of Doctor of Philosophy

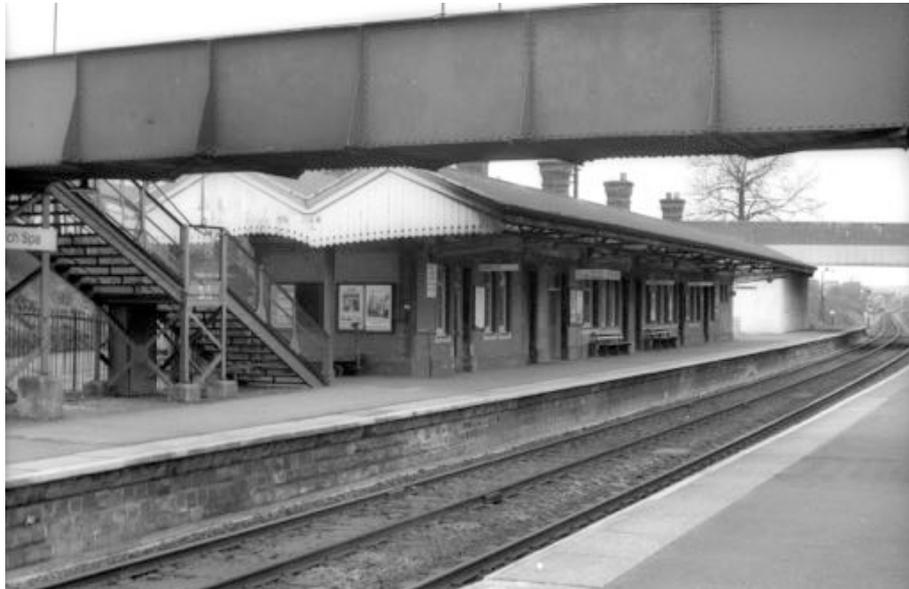
Figure 3.1: GWR station building, Droitwich Spa. (Author, 1981)

buildings, and the reality of increasingly difficult to maintain buildings was the motivation for designing the previously described 'Rat-Trad: Rational-Traditional' modular buildings that, starting in the early 1980s, replaced many smaller stations (compare figures 3.1 and 3.2).

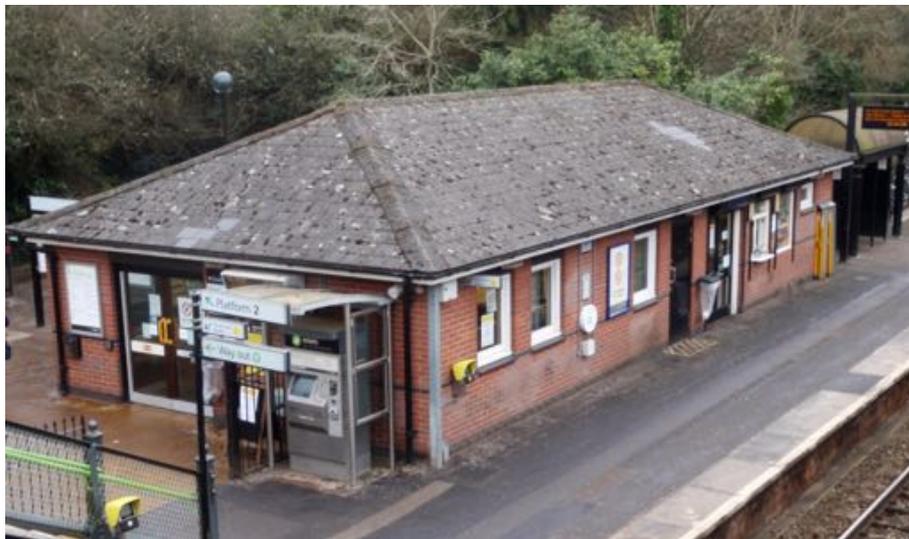
Figure 3.2: Replacement station building at Droitwich Spa to a standardised modern design. (Author, 2016)

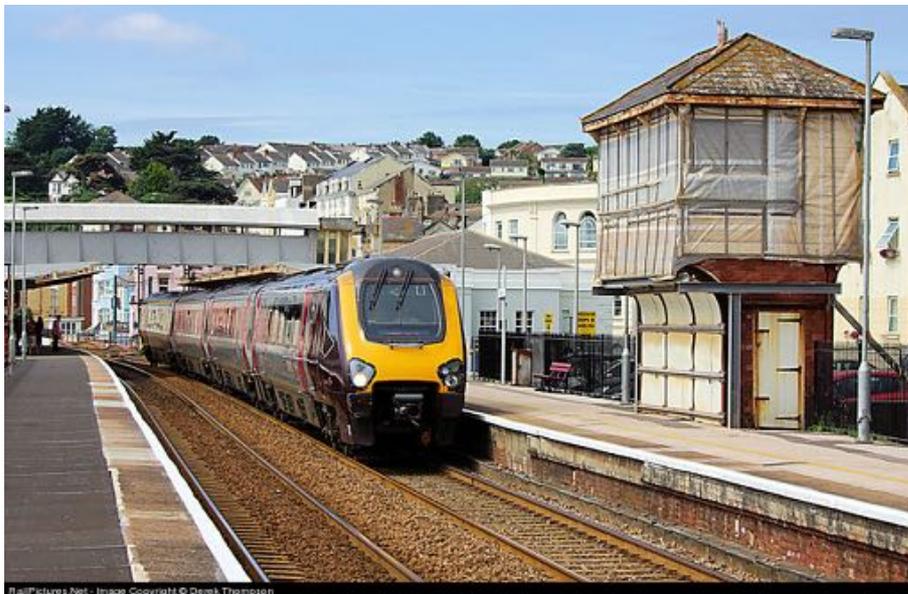
Figure 3.6: Dawlish Signal Box, tentatively conserved against the coastal environment, seen shortly before demolition. (Thompson, D. 2013, used with permission)

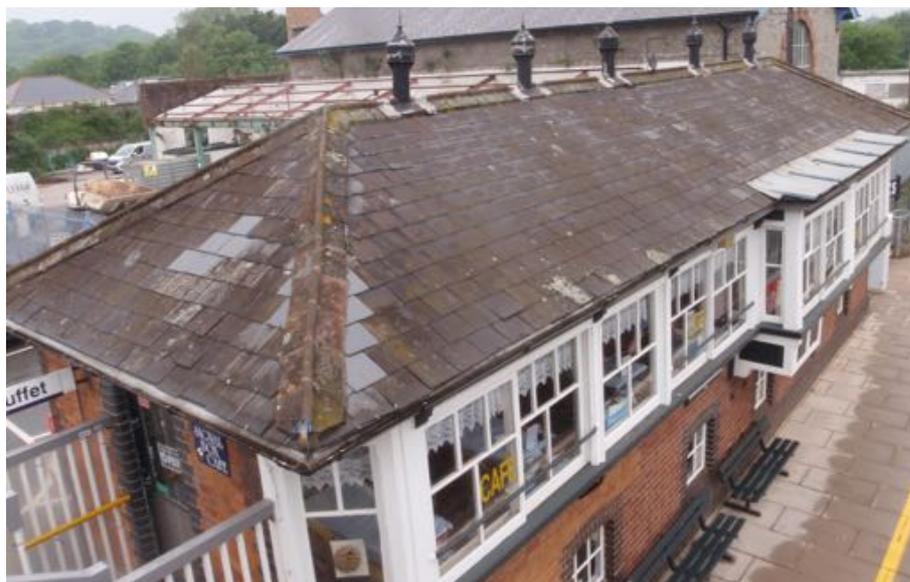
Figure 4.2: Totnes Signal Box repurposed as a café. (Author, 2018)

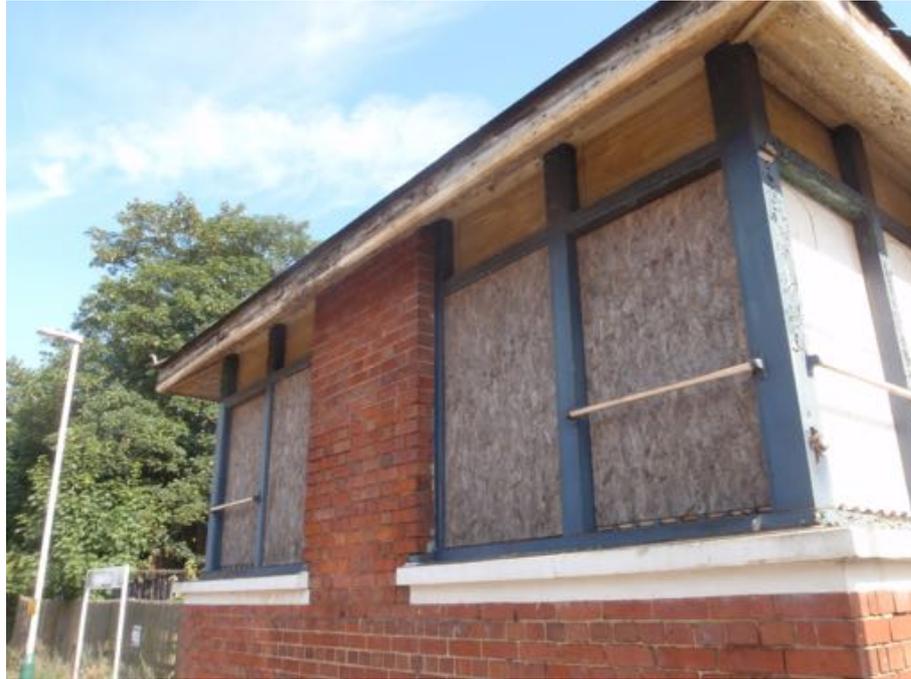
Figure 4.3: Applied protection to windows and doors, Woolston Signal Box. (Author 2018)

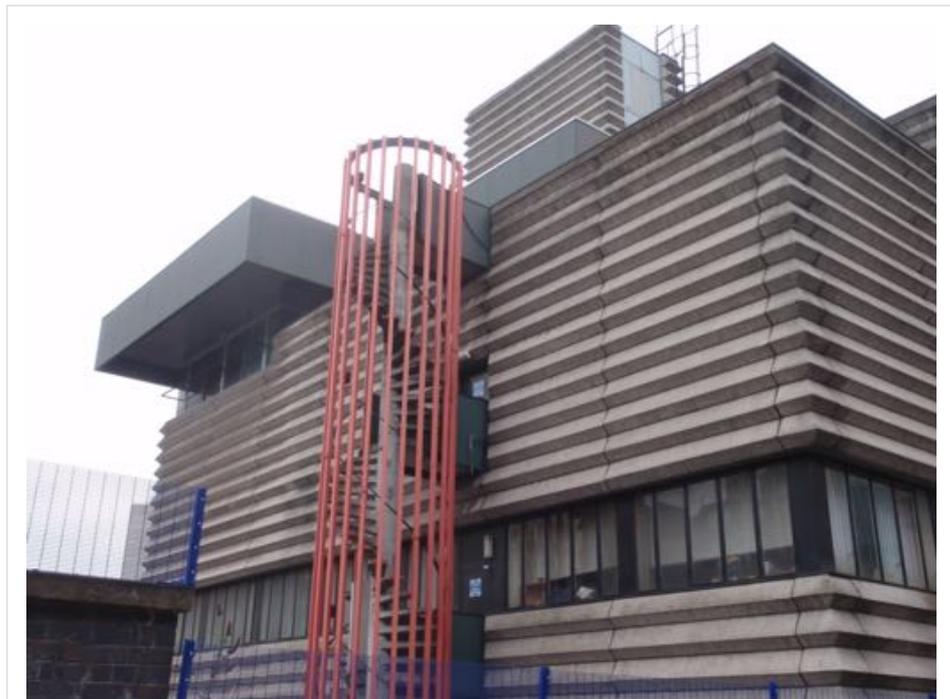
Redolent of the Brutalist genre, despite the architect claiming to be strictly Modernist (section 3.4) and the list entry describing it a one-off sculptural form (Historic England 1995), the building takes a place with other Brutalist buildings of the era, and thereby a building conservation expert will judge it according to the purity of design. The details are significant (figure 6.2), with the triangular form cladding finish, deep fascia for the operating level and a strongly contrasting red external fire escape, all contributing to a building that is atypical of the elegiac associated with traditional signal boxes and makes the building narrative that of a specific era in architecture.

Figure 6.2: Details of cladding, deep fascia and fire escape, Birmingham New Street PSB. (Author 2016)

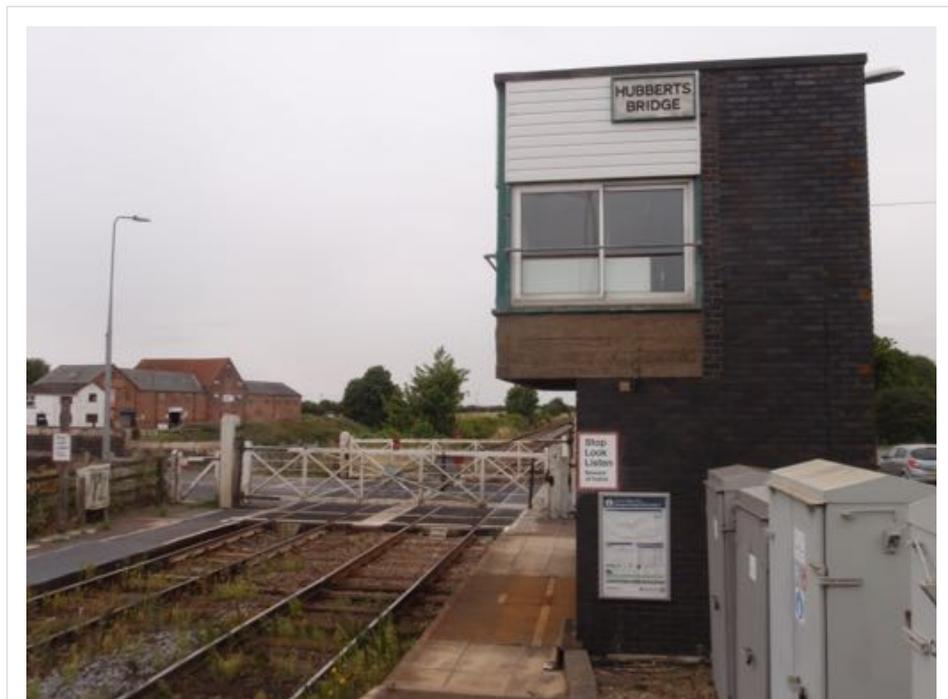
Figure 6.4: Hubberts Bridge Signal Box, with main road to right and commercial property the other side of South Forty Foot Drain bridged left of the level crossing. (Author 2016)

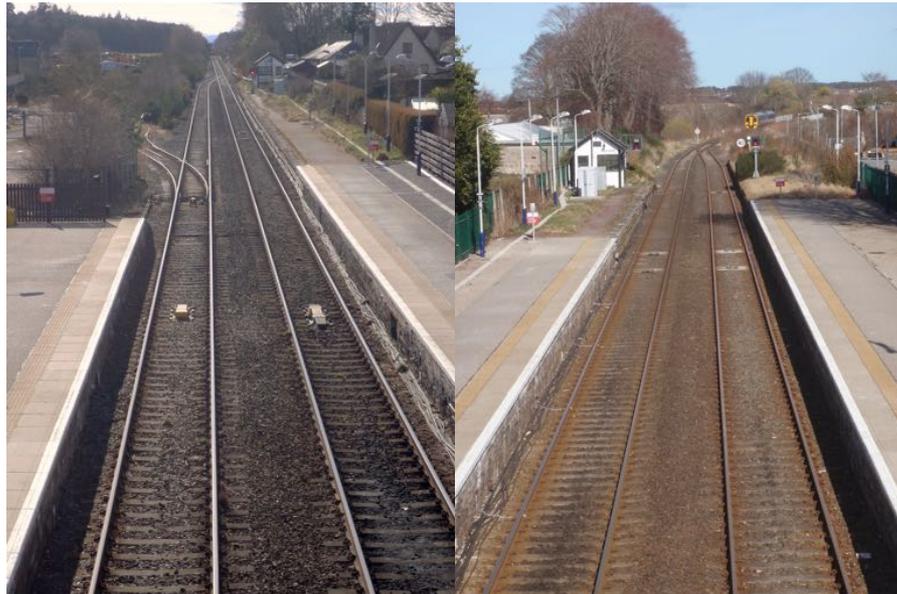
Both buildings are small timber huts at platform ends, so for the custodian represent modest maintenance requirements to support an ongoing narrative.

Figure 6.5: See from the station footbridge, platform end Nairn West (left, far end right hand platform) and Nairn East (right, far end left hand platform). (Author 2018)

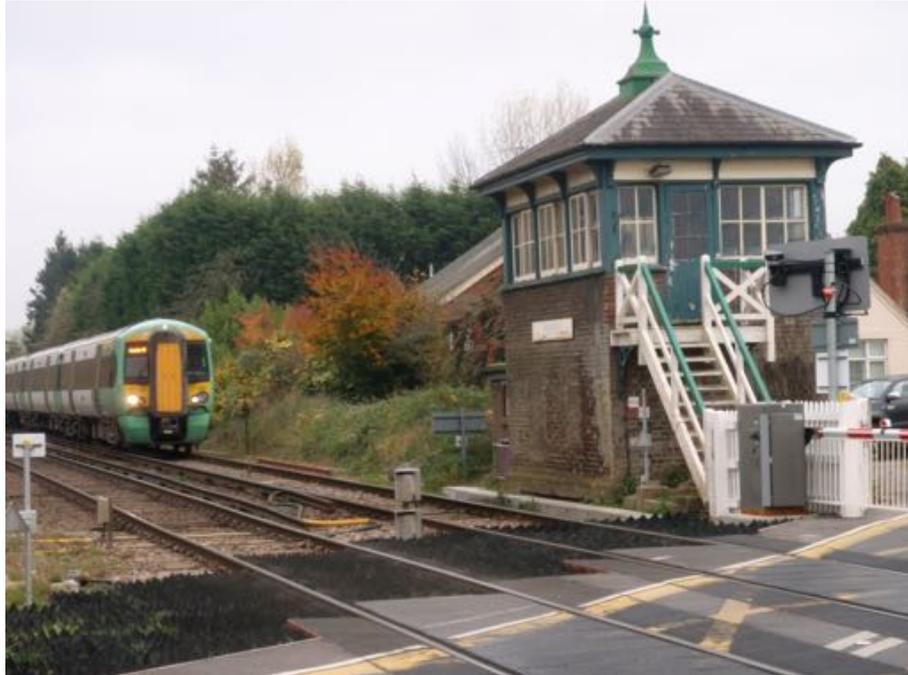
Following replacement of signaller operated level crossing by a modern automatic system, the listed Plumpton Signal Box serves no further purpose for the custodian. The ongoing narrative is therefore a mothballed maintenance liability.

Figure 6.5: Plumpton Signal Box, showing some of the controversial replacement level crossing equipment and trackside control equipment. (Author 2016)

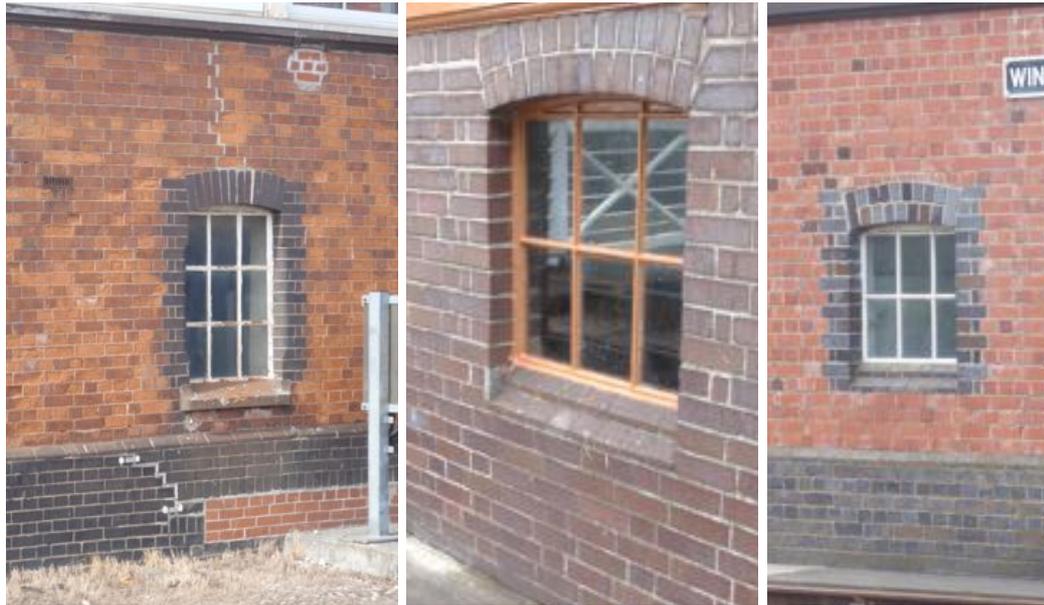
Figure 7.2: Left to right comparison of original brickwork at Truro East to replica brickwork for relocated Radstock North and reconstructed brickwork for relocated Winchcombe. (Author 2016-8)

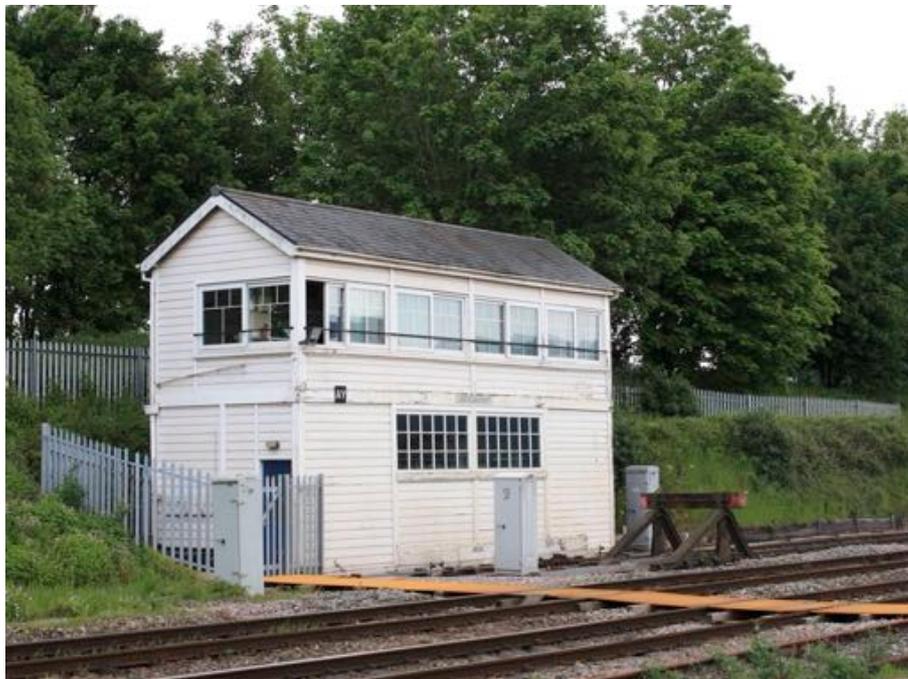
Figure A.2: Abergavenny Signal Box. (Fraser, M., 2016)

Administrative location: Monmouthshire, Wales. Constraints: Reasonable. Design: GWR 28b. Built: 1934. Listing: n/a. Status: Use ML. Future/use: Short term. Heritage value: Modified (replacement uPVC windows). Overall condition: Fair. Reuse potential: Poor. Relocatable: Yes. Risk: Normal. Comment: Conversation.

Slightly remote from public circulation and with modified heritage value diminishes the heritage value of Abergavenny Signal Box. One interesting feature concerning the replacement uPVC framed windows

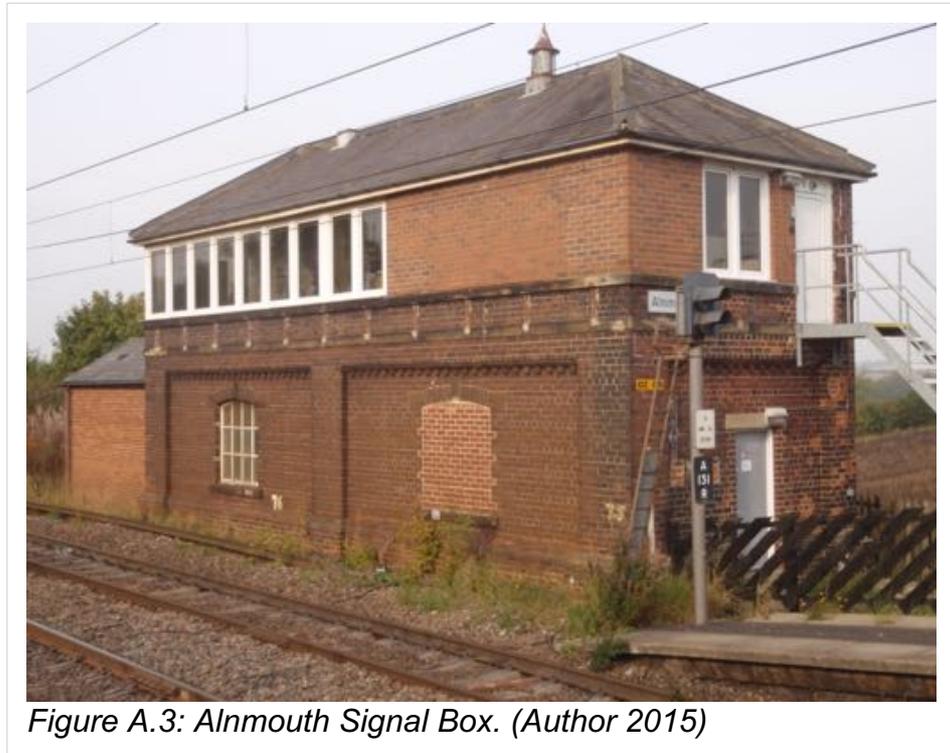
A.2.3 Alnmouth Signal Box

Administrative location: Northumberland, England. Constraints: Reasonable. Design: NER N3. Built: 1907. Listing: n/a. Status: Use ML. Future use: Medium term. Heritage value: Modified (replacement uPVC windows, replacement steel staircase, removal of balcony), communal. Overall condition: Fair. Reuse potential: Accessible. Relocatable: No. Risk: Weather.

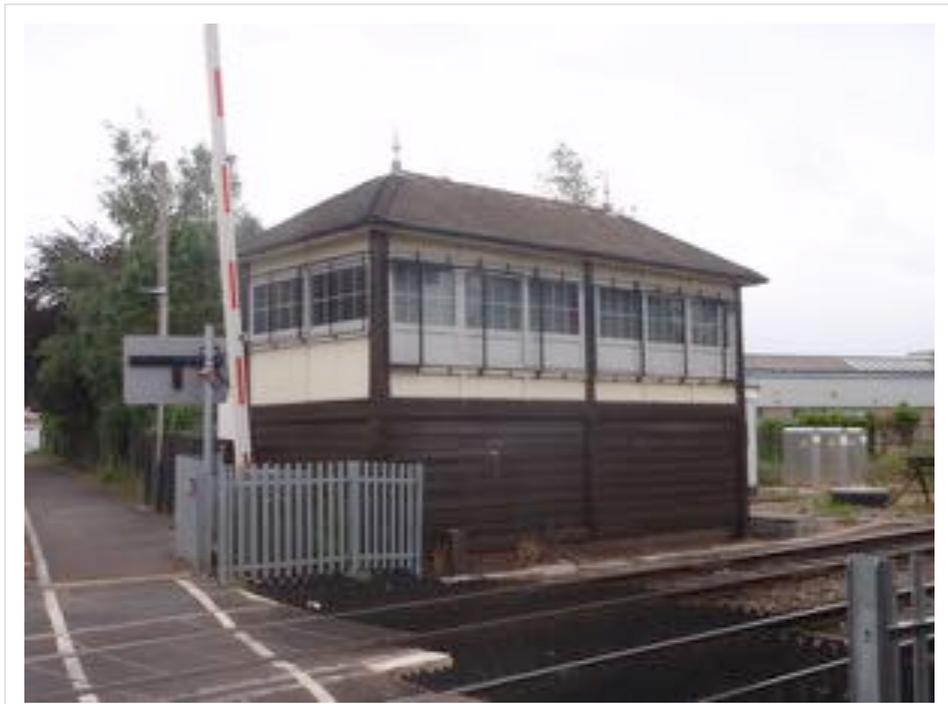
Figure A.4: Alstone Crossing Signal Box. (Author 2018)

Administrative location: Gloucestershire, England. Constraints: Close. Design: Midland 2a. Built: 1891. Listing: n/a. Status: Use ML. Future/use: Short term. Heritage value: Modified (replacement uPVC windows, replacement steel and timber staircase), communal (level crossing). Overall condition: Good. Reuse potential: Accessible. Relocatable: Yes. Risk: Deliberate.

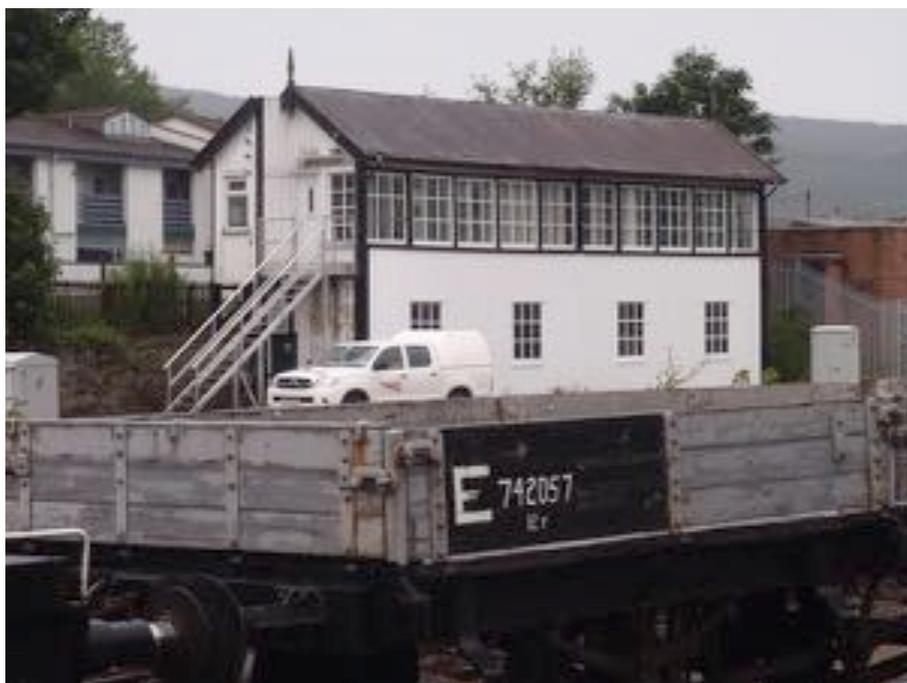
Figure A.6: Aviemore Signal Box. (Author 2016)

Administrative location: Highland, Scotland. Constraints: Reasonable. Design: McK&H 3 [Highland]. Built: 1898. Listing: B. Status: Use ML. Future/use: Short term. Heritage value: Modified (uPVC windows, replacement staircase). Overall condition: Fair. Reuse potential: Accessible. Relocatable: Yes. Risk: Weather.

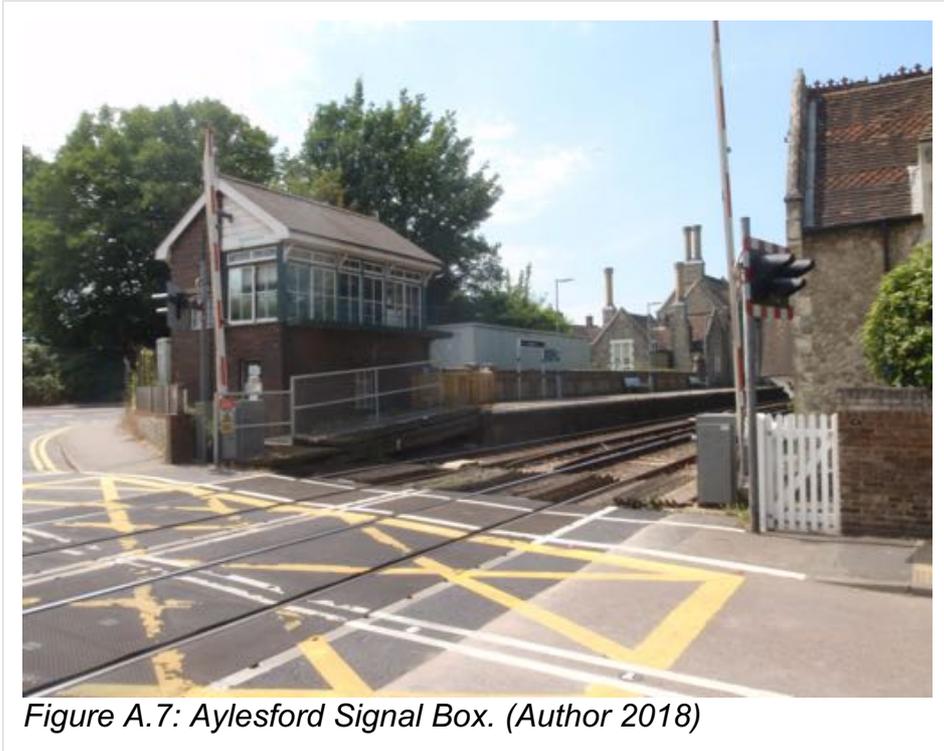
Figure A.7: Aylesford Signal Box. (Author 2018)

Administrative location: Kent, England. Constraints: Close. Design: SECR/SR 11a. Built: 1921. Listing: II. Status: Use ML. Future/use: Long term. Heritage value: Modified (replacement galvanised steel staircase), communal (level crossing). Overall condition: Fair. Reuse potential: Accessible. Relocatable: None. Risk: Normal.

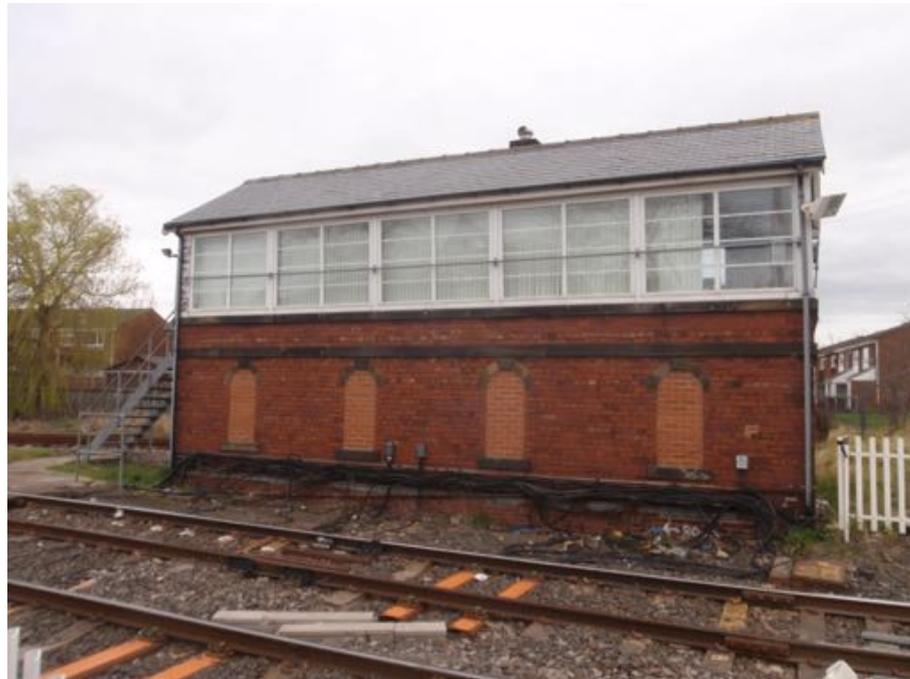
Administrative location: Northumberland, England. Constraints: Reasonable. Design: NER N4+. Built: 1912. Listing: n/a. Status: Use ML. Future/use: Short term. Heritage value: Modified (replacement uPVC windows, replacement galvanised steel staircase), communal (level crossing). Overall condition: Fair. Reuse potential: Accessible. Relocatable: No. Risk: High.

Figure A.8: Bedlington North Signal Box. (Author 2019)

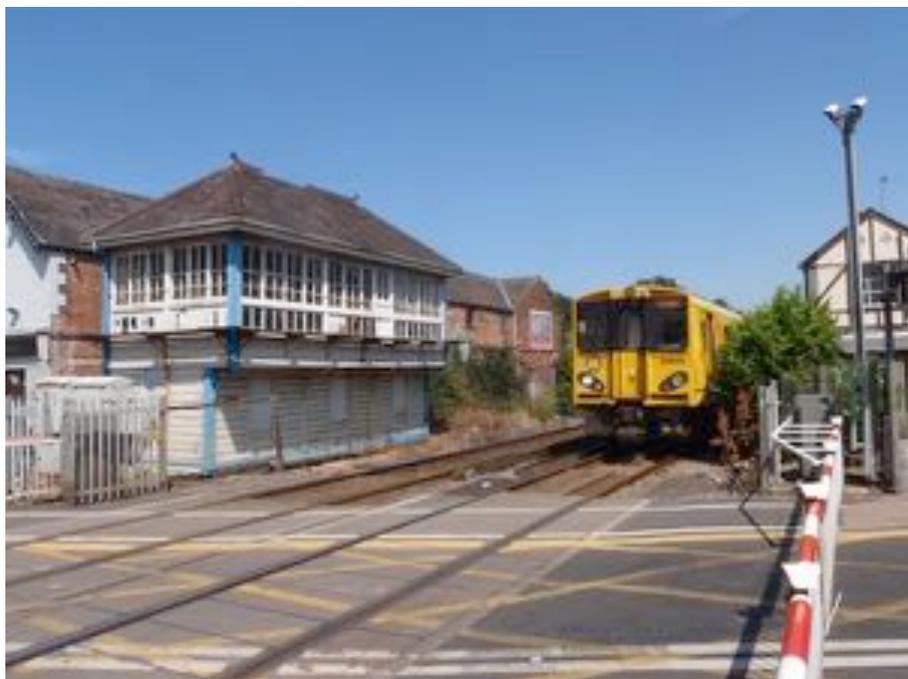
Figure A.10: Birkdale Signal Box. (Author 2018)

Future/use: Mothballed. Heritage value: Modified (balcony partially missing, staircase either internal or external no longer extant), communal (level crossing). Overall condition: Fair. Reuse potential: Accessible. Relocatable: Yes. Risk: Deliberate.

Prominently located within a pleasant streetscape and next to a level crossing strengthens public awareness attributable to Birkdale Signal Box. However, the problems of mothballing a timber structure are evident.

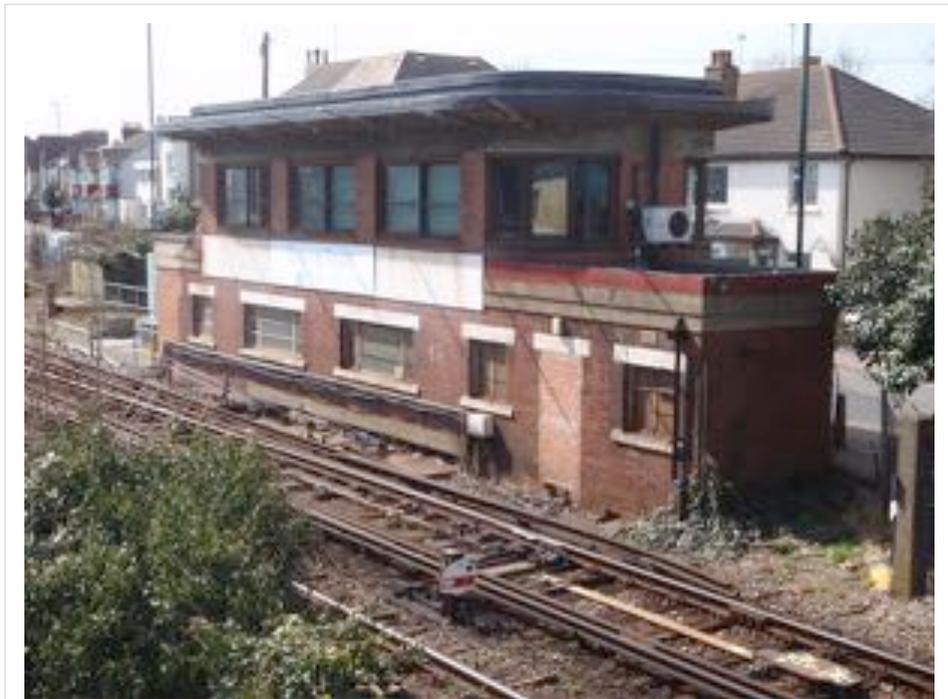
Figure A.14: Bognor Regis Signal Box. (Author 2016)

Administrative location: West Sussex, England. Constraints: Close. Design: SR 13. Built: 1938. Listing: n/a. Status: Use ML. Future/use: Long term. Heritage value: Original (other than rebuilding of brickwork to south following accident), communal (public location). Overall condition: Deficient, roof oversail structurally unsound and propped. Reuse potential: None. Relocatable: None. Risk: High.

Although nominally identified as having a long-term use, this building displays evidence of maintenance issues. Most obvious is scaffold propping to the oversail. Additionally, the survey noted rebuilding to the

south end ground floor, apparently after collision damage in November 1995 from an unattended train rolling away and into the building.

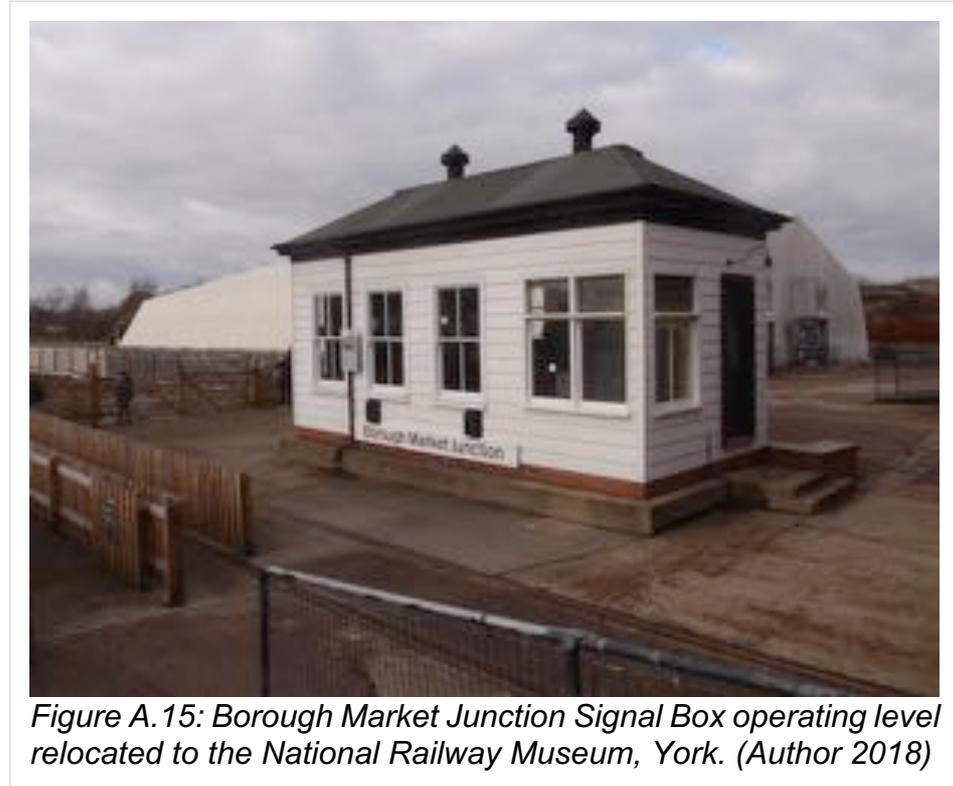
A.2.15 Borough Market Junction Signal Box

Administrative location: York, England. Constraints: Close. Design: SER. Built: unknown/unknown. Listing: NH83. Status: OOU HR. Future/use: Museum. Heritage value: Modified (grounded operating floor, missing staircase), communal. Overall condition: Good. Reuse potential: None. Relocatable: None, previously relocated. Risk: Normal.

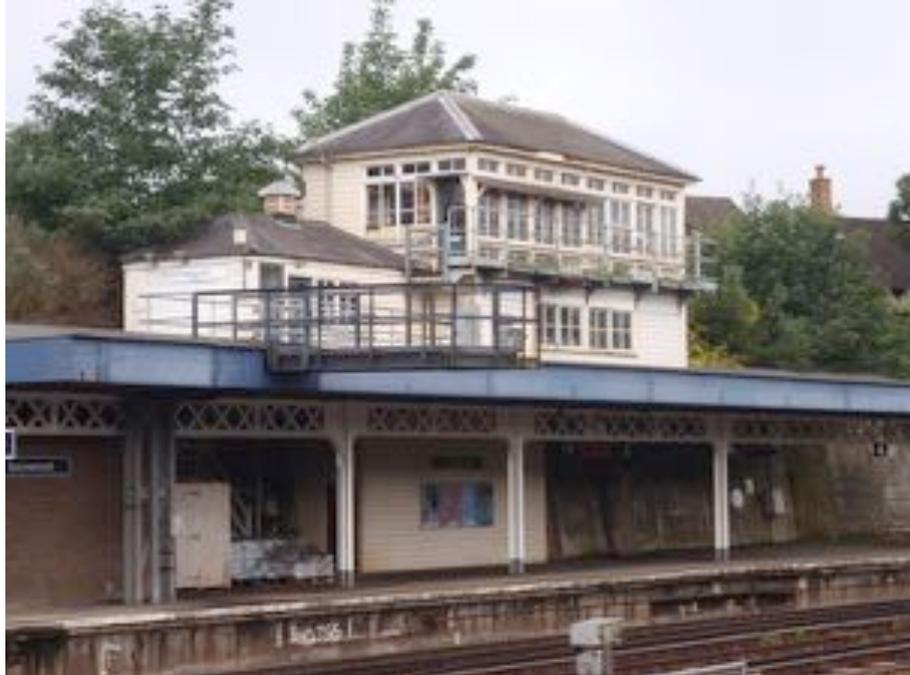
Status: OOU ML. Future/use: Mothballed. Heritage value: Original, listing as integral with listed station. Overall condition: Deficient. Reuse potential: Accessible. Relocatable: No. Risk: Weather.

Figure A.16: Bournemouth Central Signal Box. (Author 2016)

While not specifically mentioned in the listing, Bournemouth Central Signal Box comes within the curtilage of the grade II listed station. The through canopy arrangement is unusual. As an indicator of potential for public perception of a building, no public access to the platform section under the signal box limits reuse potential, although the signal box is visible from the station car park that replaced a steam locomotive shed.

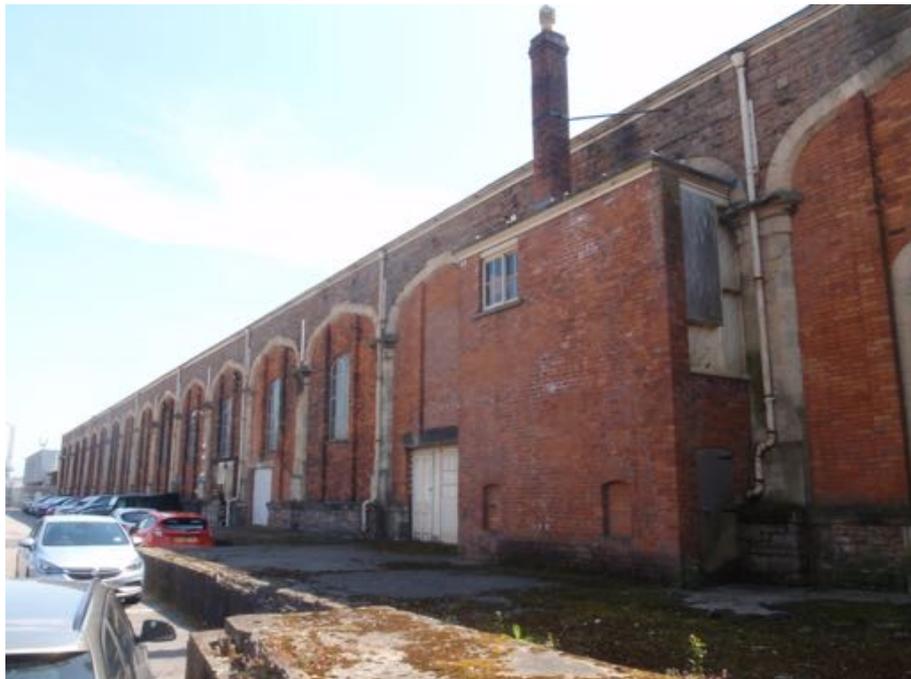
Figure A.17b: Rear of Bristol Old Station Signal Box, showing the awkward insertion into the station building. (Author 2018)

Slightly awkwardly inserted into Brunel's trainshed at Bristol Temple Meads, Bristol Old Station Signal Box is England's only grade I listed signal box though being an integral part of the station structure. Closed on 6 September 1965, with the old station itself now in use as car park,

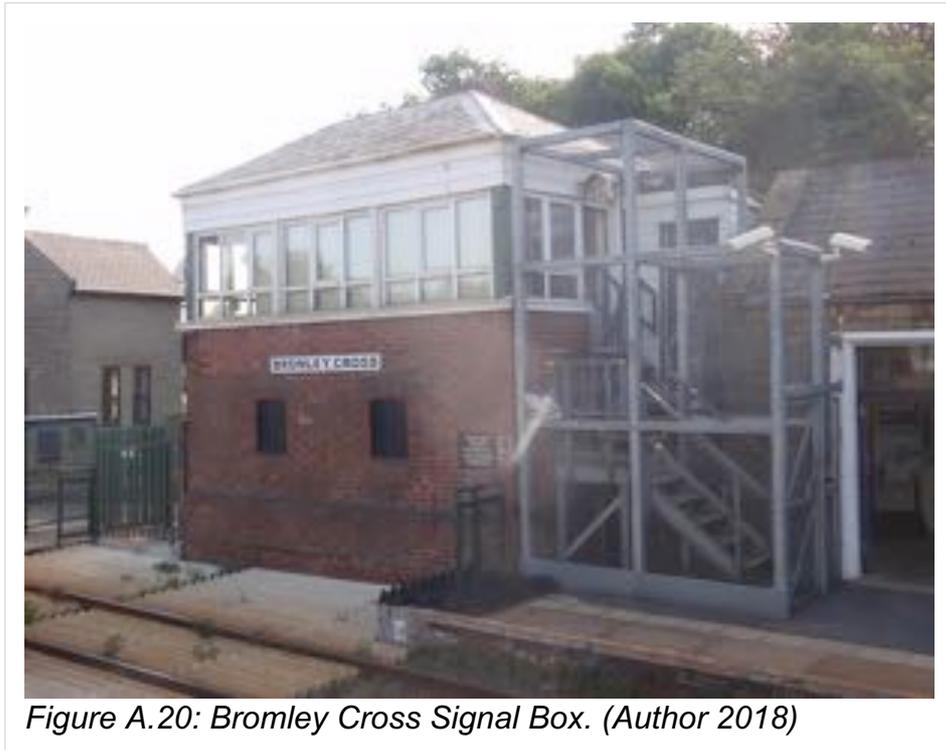
Figure A.20: Bromley Cross Signal Box. (Author 2018)

Administrative location: Bolton, England. Constraints: Close. Design: Yardley 1. Built: 1875. Listing: II [G]. Status: Use ML. Future/use: Short term. Heritage value: Degraded (replacement uPVC windows, replacement steel staircase, security cage). Communal (level crossing). Overall condition: Fair. Reuse potential: Accessible. Relocatable: Partially. Risk: Deliberate.

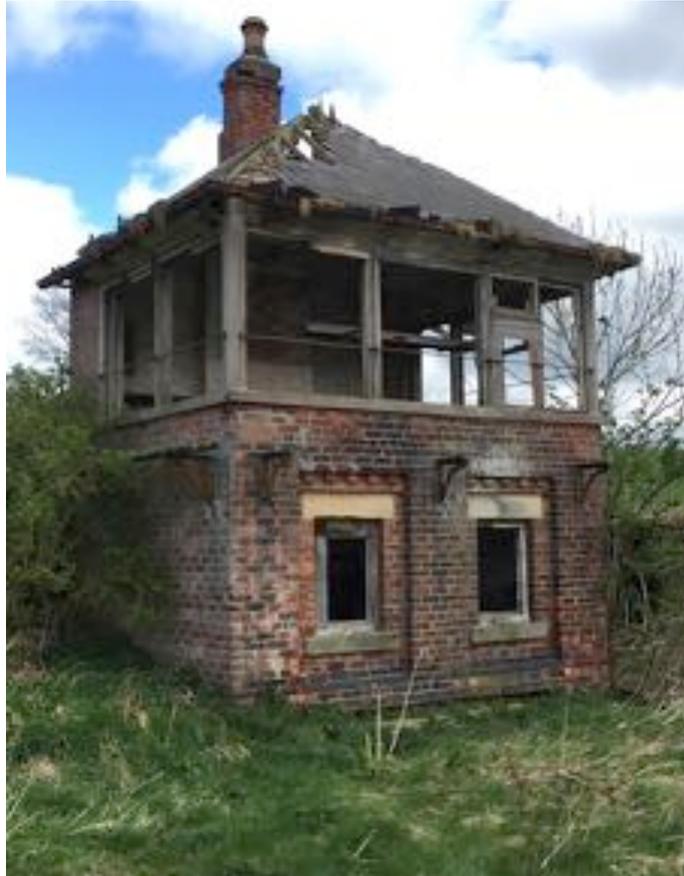
Administrative location: County Durham, England. Constraints: Close. Design: NER C2a. Built: 1897. Listing: n/a. Status: OOU IS. Future/use: Abandoned. Heritage value: Degraded (staircase missing, windows/doors missing, structurally deficient), evidential (well-preserved despite abandoned since 1965). Overall condition: Derelict. Reuse potential: Poor. Relocatable: Difficult. Risk: Weather.

Out of use and derelict for as long as it was in use, Broomielaw Signal Box is a remarkable survivor. The original quality of construction is clear in the minimal deterioration of joinery, yet to view this building takes preplanning and without the benefit of statutory protection it is vulnerable to demolition without notice.

Figure A.21: Broomielaw Signal Box. (Author 2017)

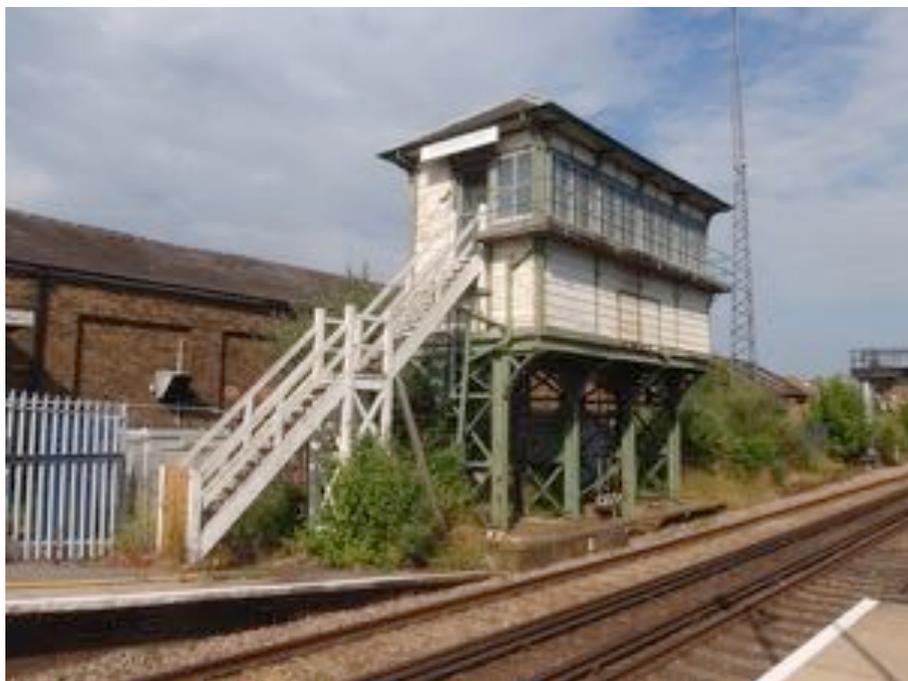
Figure A.24: Canterbury East Signal Box. (Author 2018)

Administrative location: Kent, England. Constraints: Reasonable. Design: SECR. Built: 1911. Listing: II. Status: OOU ML. Future/use: Mothballed. Heritage value: Modified (replacement timber staircase), communal (station location). Overall condition: Deficient. Reuse potential: Accessible. Relocatable: Difficult. Risk: Weather. Comments: Rare steel/wrought iron structure

does seem to present problems with conservation of this mothballed building.

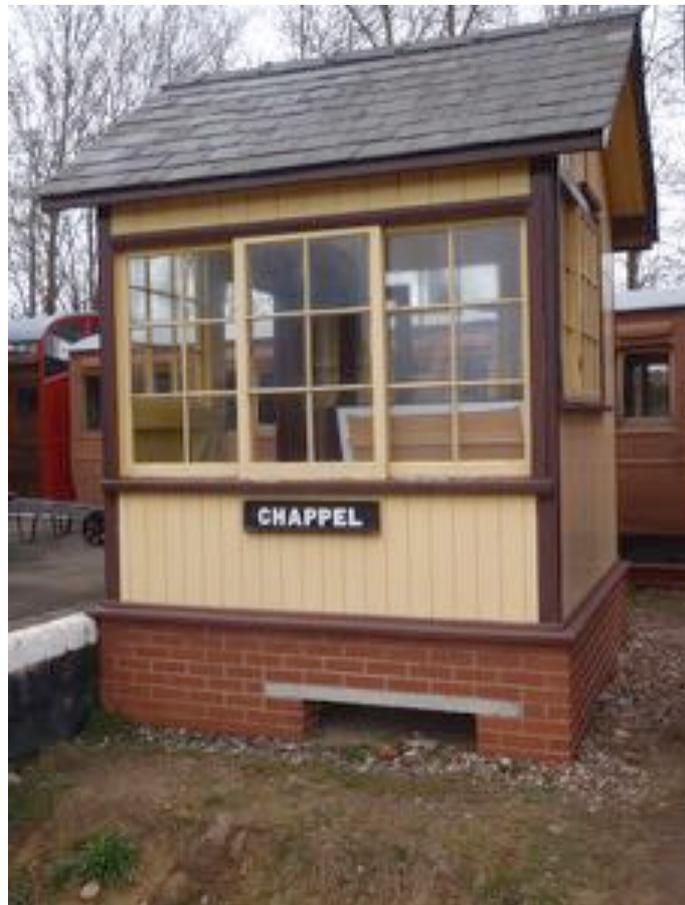
Figure A.29: Chappel South (Fotherby) Signal Box. (Author 2018)

Administrative location: Essex, England. Constraints: Close. Design: GNR Hut. Built: 1886/1986. Listing: n/a. Status: OOU HR. Future/use: Museum. Heritage value: Modified (rebuilt plinth to match original), communal (museum location). Overall condition: Good. Reuse

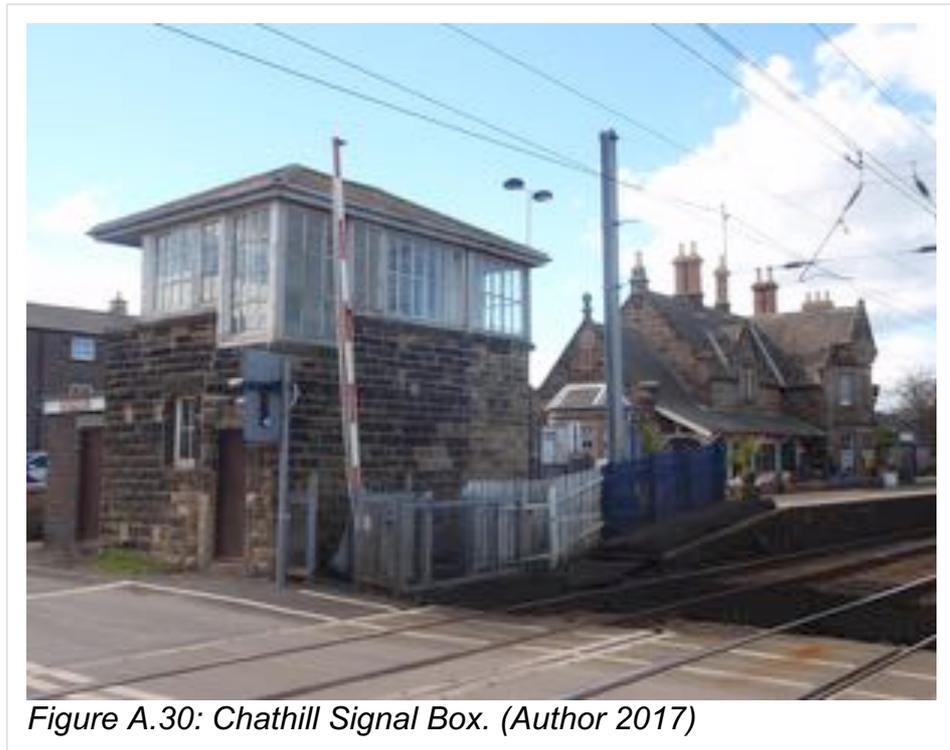
A.2.30 Chathill Signal Box

Administrative location: Northumberland, England. Constraints: Close. Design: NER N1. Built: c1873. Listing: II. Status: OOU ML. Future/use: Switchroom. Heritage value: Modified (balcony removed, replacement steel staircase), communal (level crossing). Overall condition: Good. Reuse potential: None. Relocatable: None. Risk: Normal. Comments: Unusual drop sill design variant.

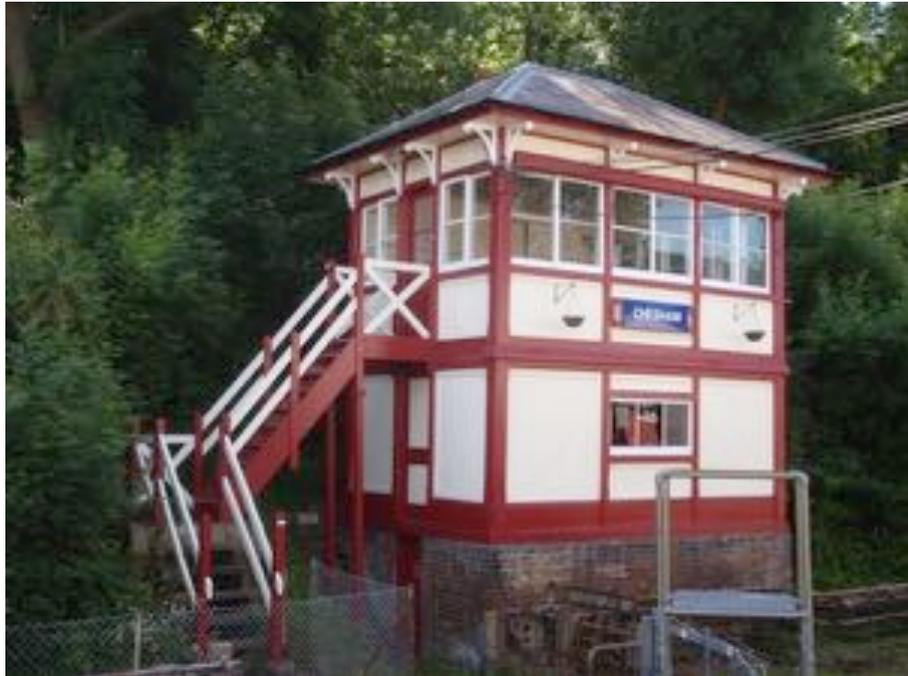
Figure A.31: Chesham Signal Box. (Author 2018)

Administrative location: Buckinghamshire, England. Constraints: Reasonable. Design: Metropolitan 1. Built: 1889. Listing: II [G]. Status: OOU LR. Future/use: Mothballed. Heritage value: Modified (probably replacement timber staircase), communal (station location). Overall condition: Good. Reuse potential: Poor. Relocatable: Partially. Risk: Normal. Comment: Conversation.

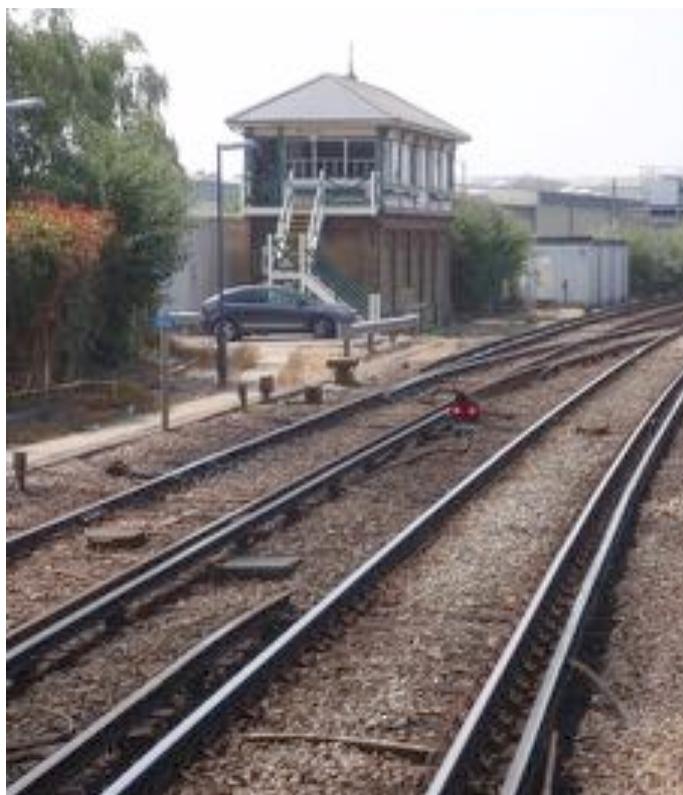
Figure A.32: Chichester Signal Box. (Author 2018)

Administrative location: West Sussex, England. Constraints: Distant. Design: S&F 5 [LBSCR]. Built: 1882. Listing: II. Status: Use ML. Future/use: Short term. Heritage value: Original. Overall condition: Good. Reuse potential: Poor. Relocatable: Partially. Risk: Normal.

An attractive and well-maintained example of the design type. The taxonomy survey notes a doubt about the staircase. As the listing (Historic England 2013a) describes the staircase without comment, if it is a replacement, then it is sensitive to the original design.

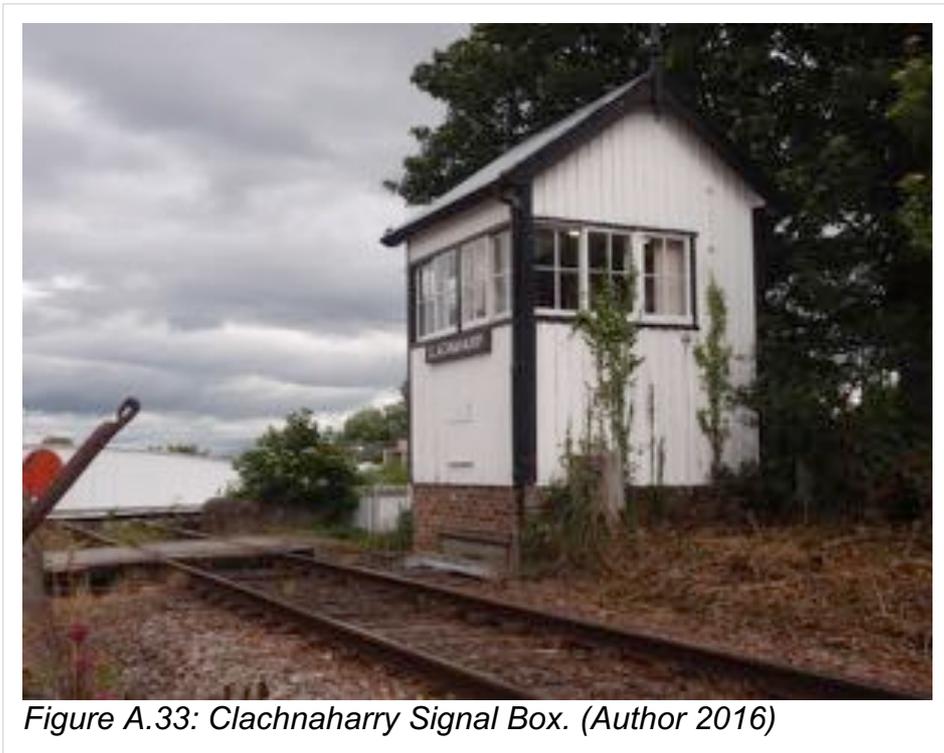
While some signal boxes survive solely to control a level crossing, Clachnaharry Signal Box unusually survives to control a swing bridge over the Caledonian Canal, with the list entry covering the swing bridge and signal box. Having only four levels to control (Kay 2010, p17) and a limited train service, the signaller will have plenty of time to enjoy the superb view over Beaully Firth. Users of the foot crossing and minor road alongside the railway provide the only public awareness of the signal box, which has a supporting tourist potential to the swing bridge.

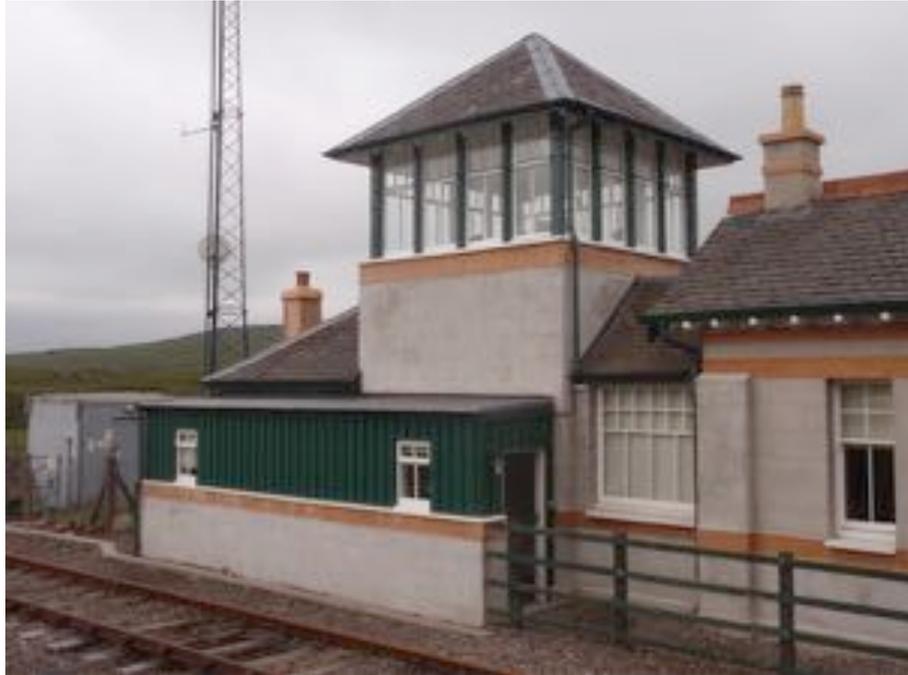
Administrative location: Highland, Scotland. Constraints: Close. Design: NBR 6a. Built: 1894. Listing: C [G]. Status: OOU PR. Future/use: Hotel. Heritage value: Modified (rendered board overcladding, possible replacement timber windows), communal (station location). Overall condition: Good. Reuse potential: None. Relocatable: None. Risk: Weather.

Figure A.34: Corroul Signal Box. (Author 2018)
