**CONSERVATION OF FUNCTIONAL
HERITAGE RAILWAY BUILDINGS
AS AN ARCHETYPE FOR THE
CONSERVATION OF FUNCTIONAL
HERITAGE BUILDINGS**

CHRISTOPHER DIETMAR REEVES

A thesis submitted in partial fulfilment
of the requirements of the University
of Northumbria at Newcastle for the
degree of Doctor of Philosophy

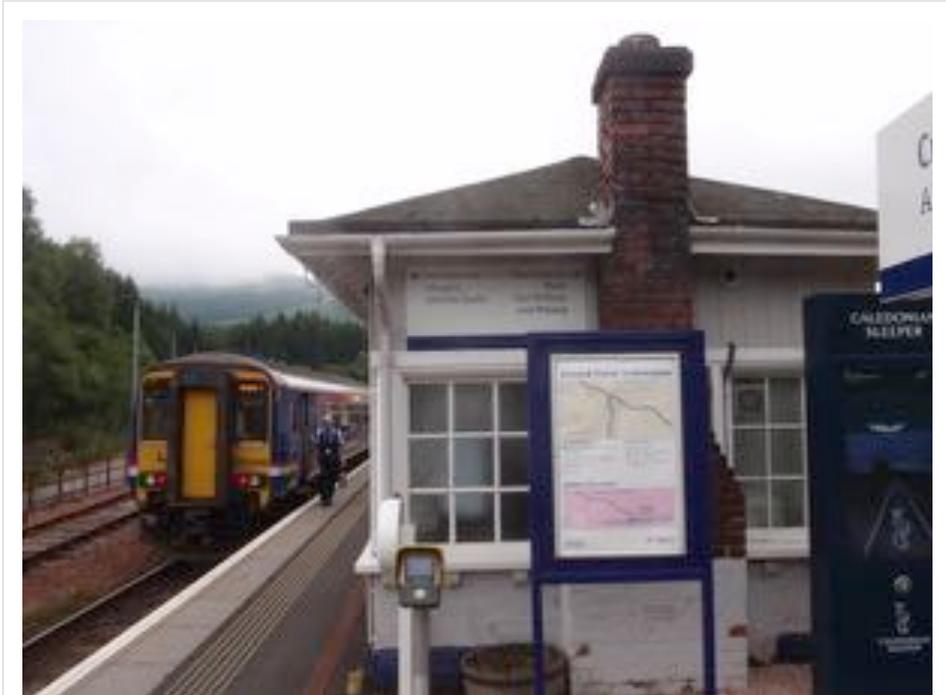
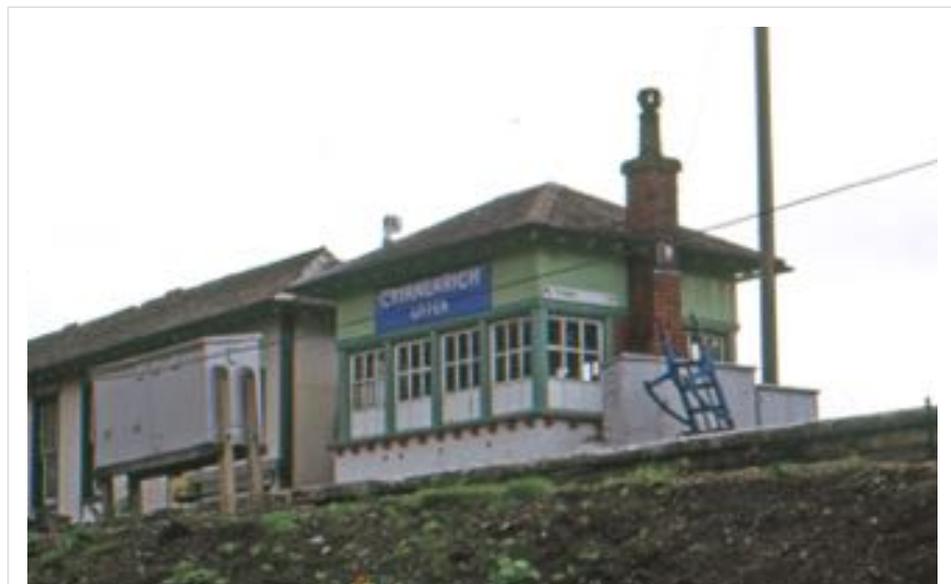
Administrative location: Stirling, Scotland. Constraints: Close. Design: NBR 6. Built: 1894. Listing: n/a. Status: OOU ML. Future/use: Office. Heritage value: Original, communal (station location). Overall condition: Good. Reuse potential: None. Relocatable: None. Risk: Normal.

Figure A.35a: Crainlarich Signal Box. (Author 2018)

Figure A.35b: Crainlarich Signal Box. Seen here in operational use and demonstrating the signal box as surveyed unchanged in external appearance other than a few cosmetic details. (Harrop, J., 1980)

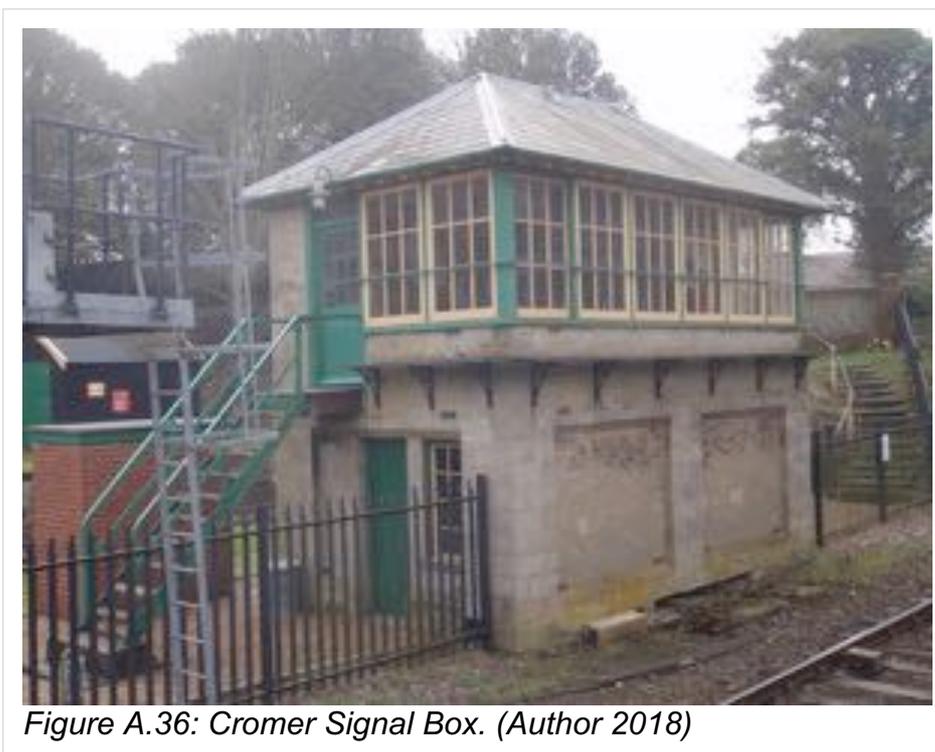
A.2.36 Cromer Signal Box

Administrative location: Norfolk, England. Constraints: Reasonable. Design: MGNR bespoke. Built: c1920. Listing: II. Status: OOU HR. Future/use: Museum. Heritage value: Modified (replacement steel staircase), aesthetic (rare use of concrete blockwork), communal (museum). Overall condition: Good. Reuse potential: None. Relocatable: None. Risk: Normal. Comment: Conversation.

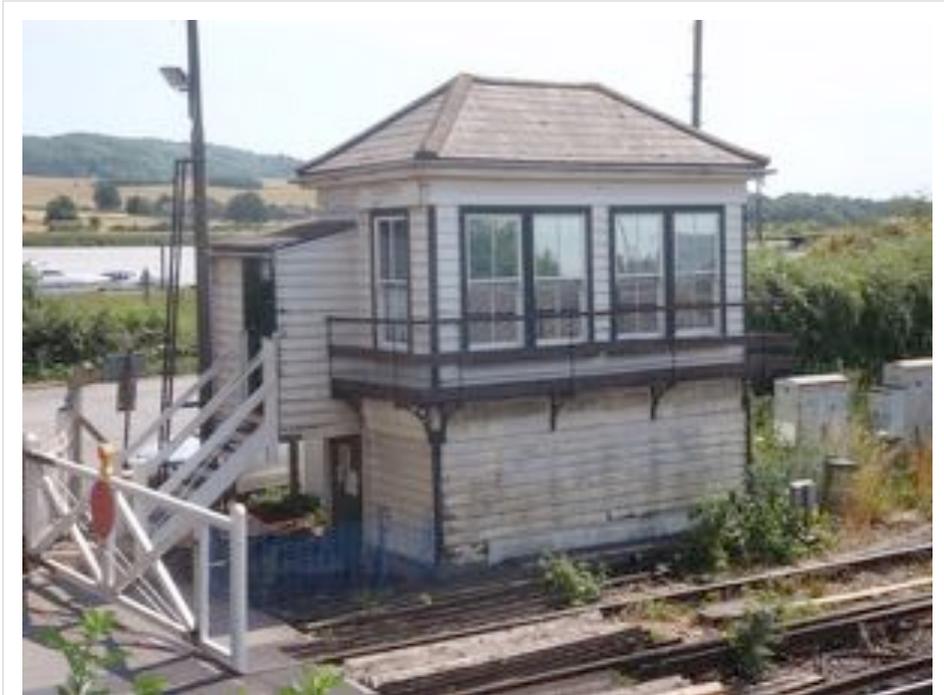
Figure A.37: Cuxton Signal Box. (Author 2018)

crossing). Overall condition: Deficient, leaning structure from a bomb near miss during the Second World War. Reuse potential: Accessible. Relocatable: Yes. Risk: High. Comment: Conversation.

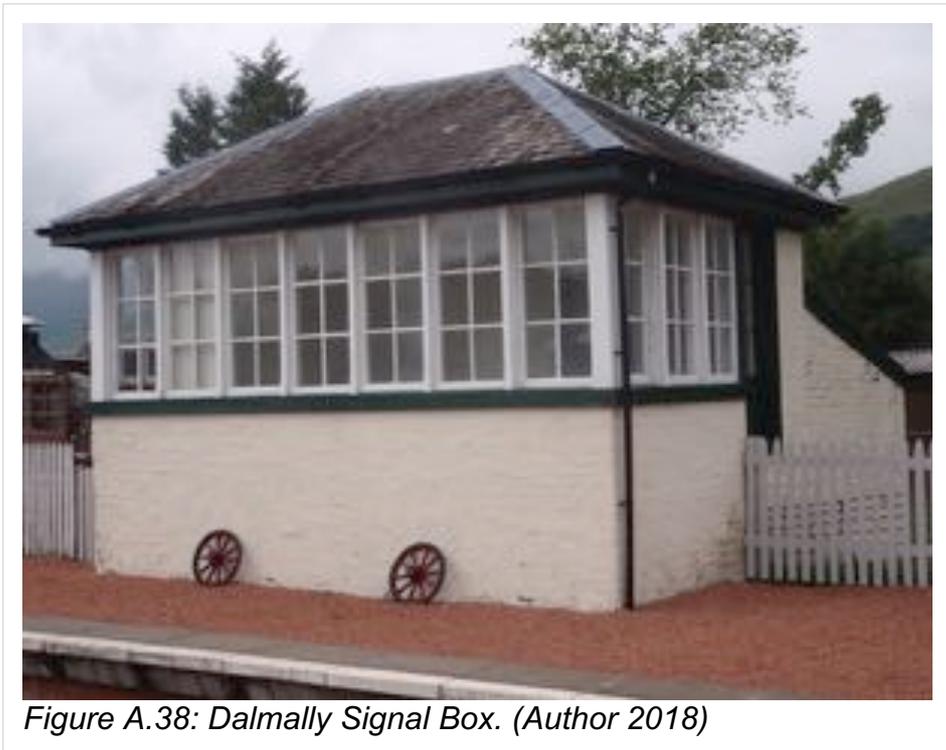
Administrative location: Argyll & Bute, Scotland. Constraints: Close. Design: Caledonian N2. Built: 1896. Listing: C [G]. Status: OOU ML. Future/use: Mothballed. Heritage value: Modified (staircase removed),

communal (platform location). Overall condition: Good. Reuse potential: Accessible. Relocatable: No. Risk: Weather.

The platform location will provide a modicum of public awareness in an area that has tourist potential. Dalmally Signal Box is backing onto a garden and there is reason to assume that it is informally functioning as a garden shed. The wheels positioned in front of the building are an idiosyncratic decoration.

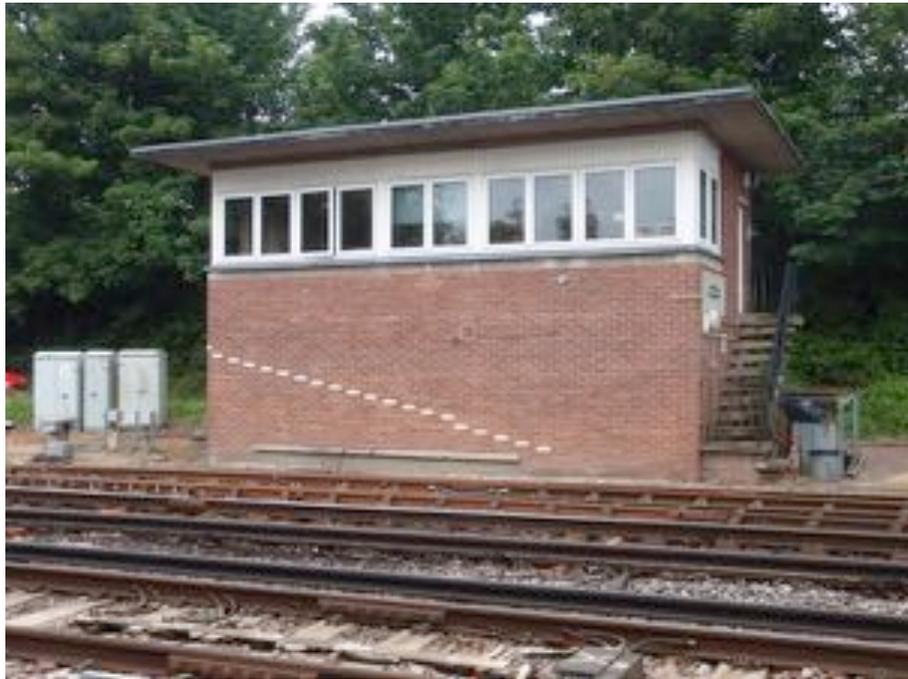
Administrative location: Dorset, England. Constraints: Reasonable. Design: BR(SR) 16. Built: 1959. Listing: n/a. Status: Use ML. Future/use: Short term. Heritage value: Modified (replacement uPVC windows), evidential enhanced as represents last BR(SR) design. Overall condition: Fair. Reuse potential: Poor. Relocatable: No. Risk: Normal.

strong evidential value. One immediately obvious feature that remains impossible to explain is the stepped, apparently paintwork, pattern on the brickwork. Comparison with original design drawings for the BR(SR) Type 16 design held by the National Railway Museum reveals no reason for this pattern.

Figure A.39: Dorchester South Signal Box. (Author 2016)

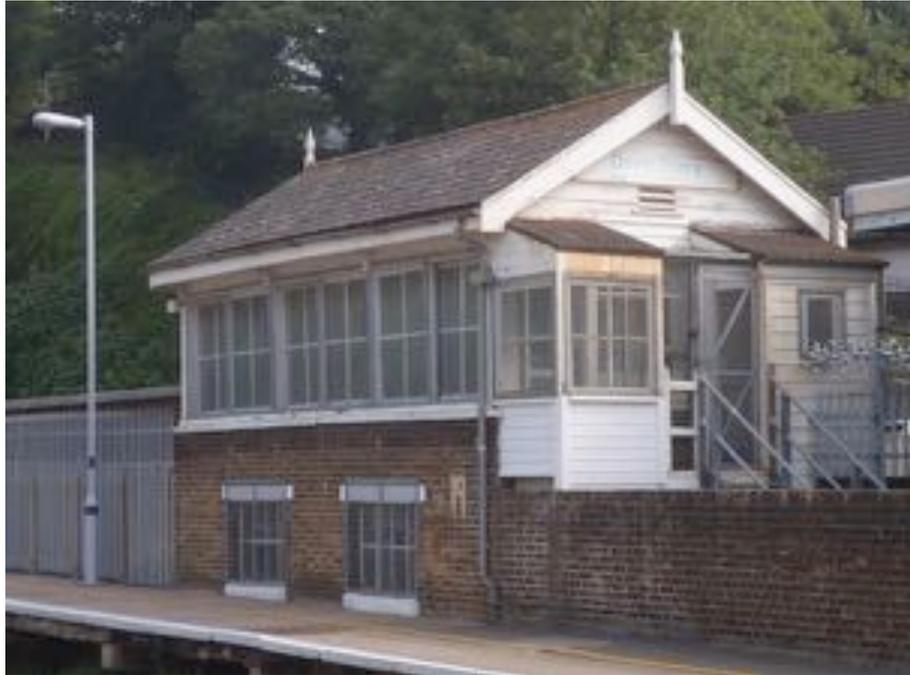
Administrative location: Kent, England. Constraints: Close. Design: SR 12. Built: 1930. Listing: n/a. Status: OOU ML. Future/use: Mothballed. Heritage value: Modified (replacement steel staircase), communal (station location). Overall condition: Fair. Reuse potential: Accessible. Relocatable: No. Risk: Weather.

Figure A.40: Dover Priory Signal Box. (Author 2018)

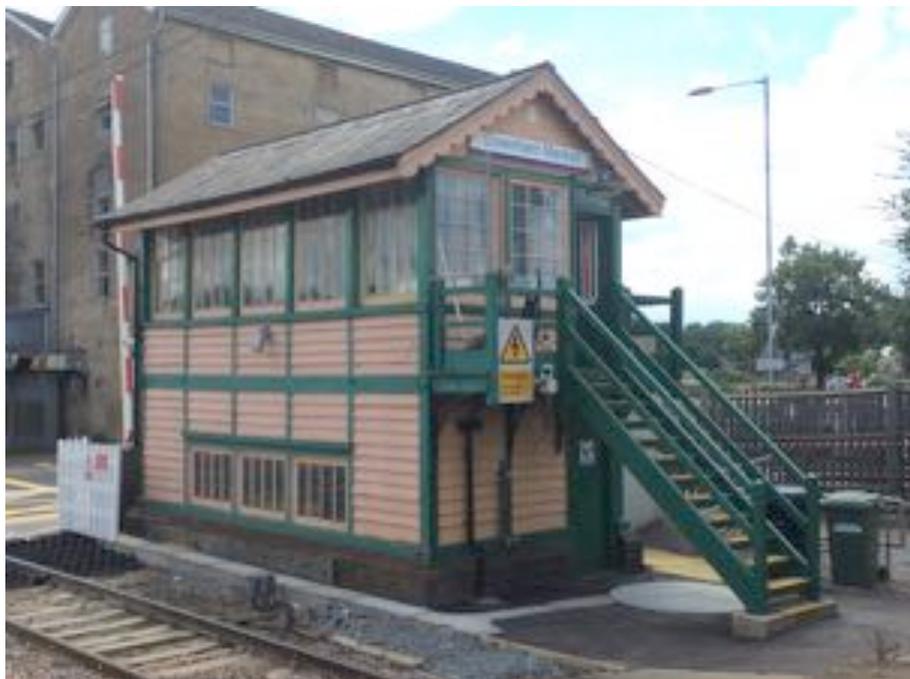
Figure A.41: Downham Market Signal Box. (Author 2016)

Administrative location: Norfolk, England. Constraints: Close. Design: GER 2. Built: 1881. Listing: II. Status: Use ML. Future/use: Short term. Heritage value: Modified (replacement timber staircase), communal (by

level crossing). Overall condition: Fair. Reuse potential: Accessible. Relocatable: Yes. Risk: Deliberate. Comment: Conversation.

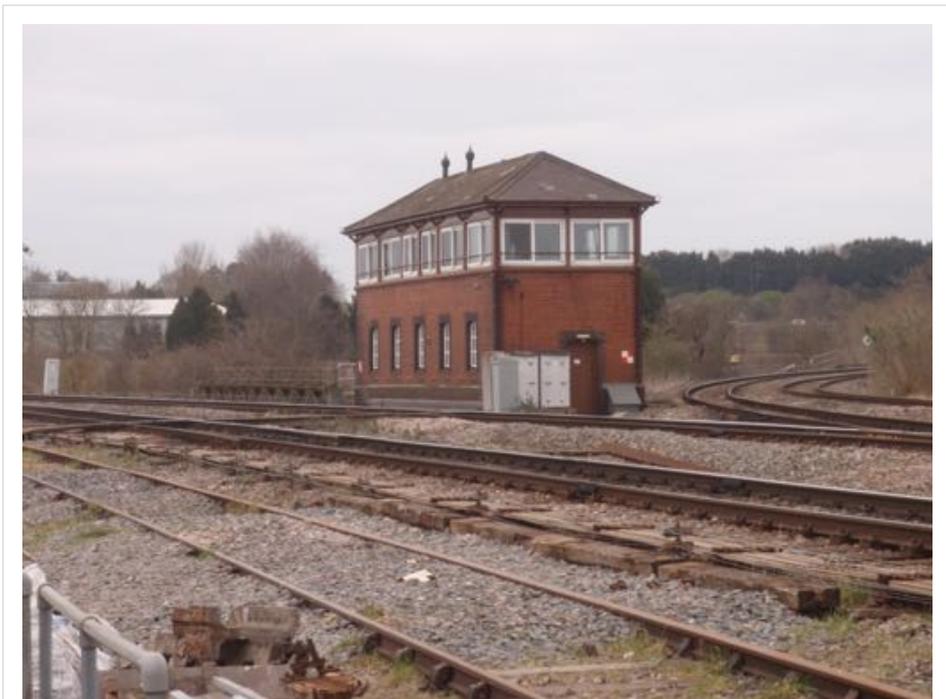
Figure A.42: Droitwich Spa Signal Box. (Author 2016)

Administrative location: Worcestershire, England. Constraints: Distant. Design: GWR 7d. Built: 1907. Listing: n/a. Status: Use ML. Future/use: Long term. Heritage value: Modified (replacement uPVC windows, replacement steel staircase). Overall condition: Deficient, apparent structural movement. Reuse potential: Poor. Relocatable: None. Risk: Normal.

Remote from public areas, displaying a modified external condition, the structure displaying evidence of a dip towards the canal cutting at the

north end and the GWR 7d being a common surviving design, in terms of heritage values it is difficult to make an effective conservation case.

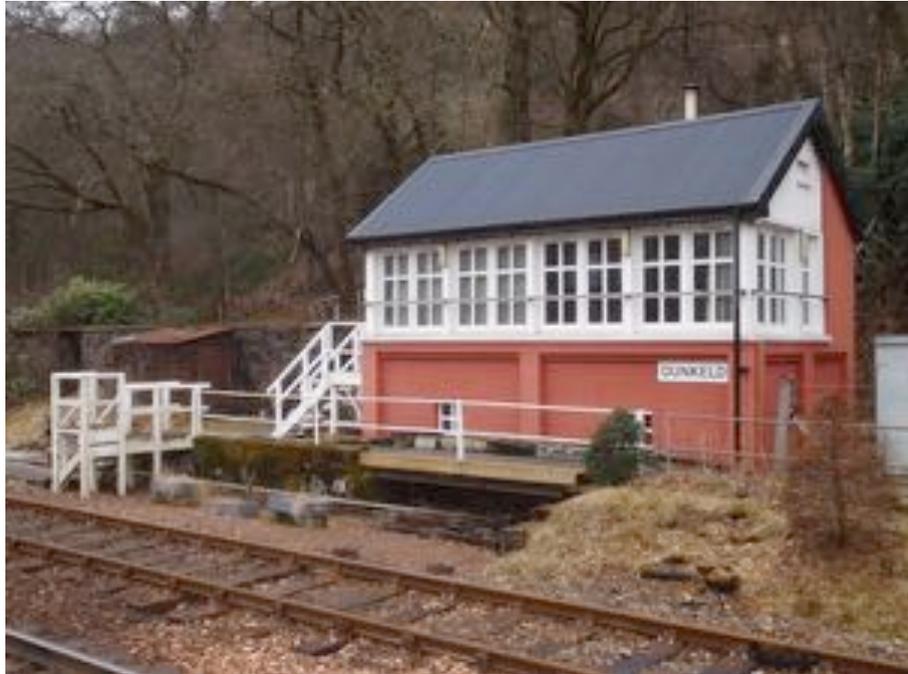
Figure A.43: Dunkeld & Birnam Signal Box. (Author 2018)

Administrative location: Perth & Kinross, Scotland. Constraints: Close. Design: Highland. Built: 1919. Listing: B. Status: Use ML. Future/use: Short term. Heritage value: Modified (replacement uPVC windows, replacement timber staircase), communal (visible public location). Overall condition: Good. Reuse potential: Accessible. Relocatable: No. Risk: Weather.

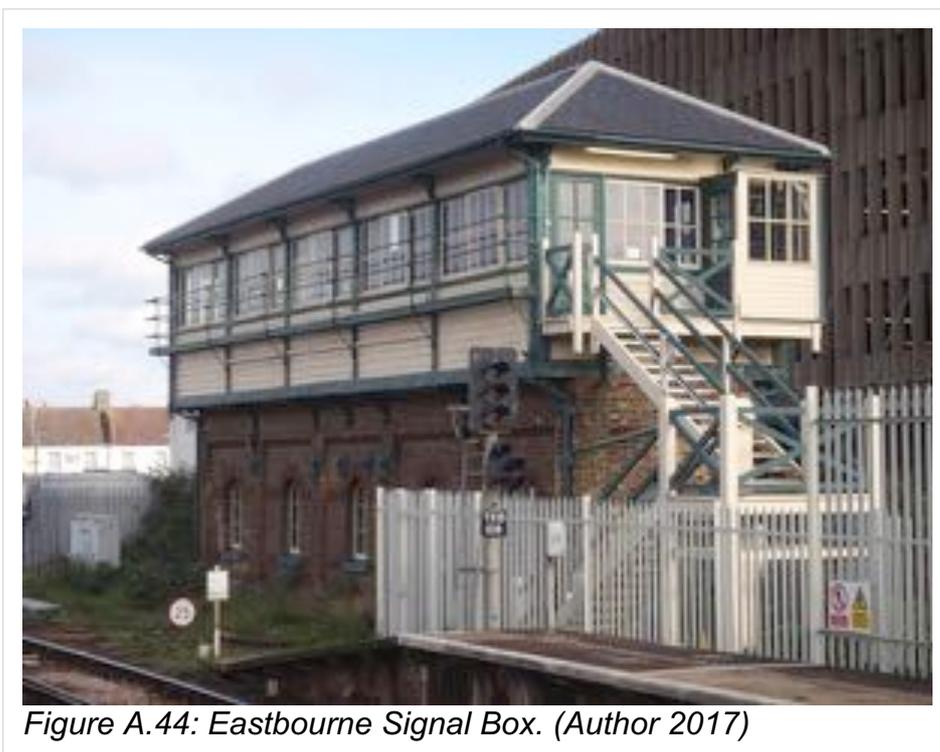
A.2.44 Eastbourne Signal Box

Administrative location: East Sussex, England. Constraints: Close. Design: S&F 5 [LBSCR]. Built: 1882. Listing: II. Status: OOU ML. Future/use: Mothballed. Heritage value: Modified (timber staircase possibly a replacement), communal (station location, listing through local community support). Overall condition: Good. Reuse potential: Accessible. Relocatable: No. Risk: Weather.

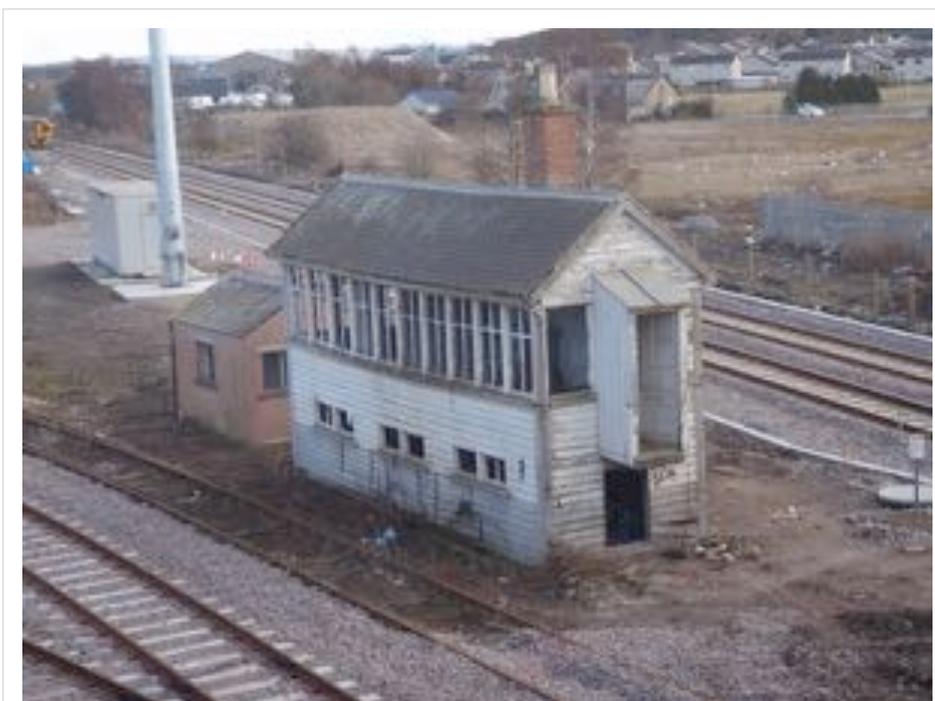
Figure A.45: Elgin Centre Signal Box. (Author 2018)

Administrative location: Moray, Scotland. Constraints: Reasonable. Design: GNSR 2a. Built: 1888. Listing: C. Status: OOU ML. Future/use: Abandoned. Heritage value: Modified (staircase missing). Overall condition: Derelict. Reuse potential: Poor. Relocatable: Yes. Risk: Normal.

Despite nominal protection provided by the listing, the condition of Elgin Centre Signal Box provides cause for concern. With limited public awareness, with the only public view being from a road bridge there is, other than a legal obligation, little apparent incentive to maintain this building and the structure may already be too fragile to allow for relocation.

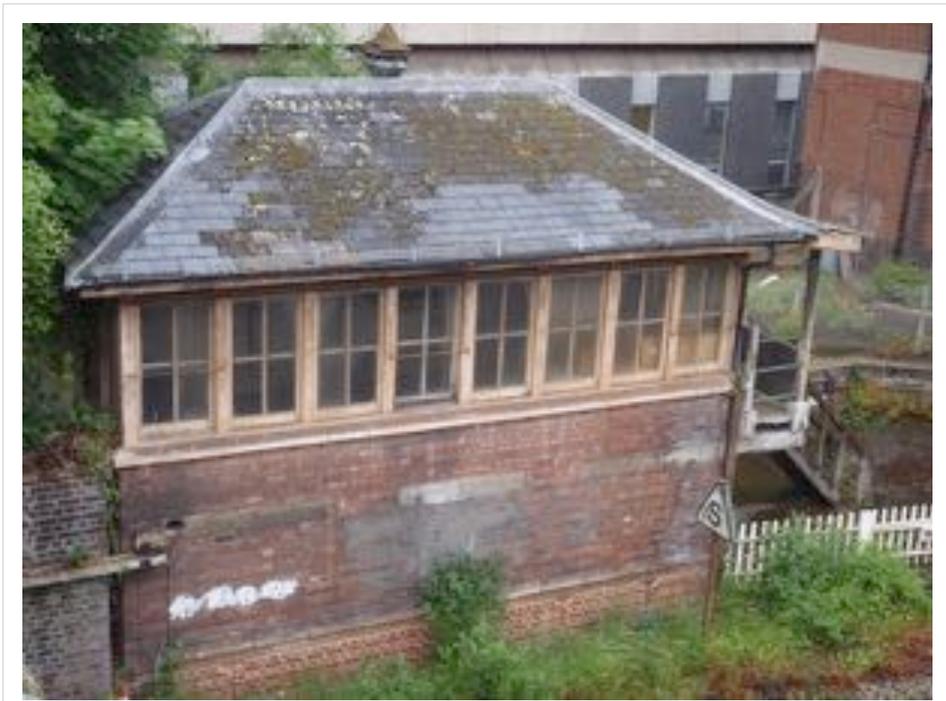
Figure A.46: Exeter Central Signal Box. (Author 2018)

Fair. Reuse potential: None, in use as a store. Relocatable: No. Risk: Normal. Comments: Unusual concrete staircase.

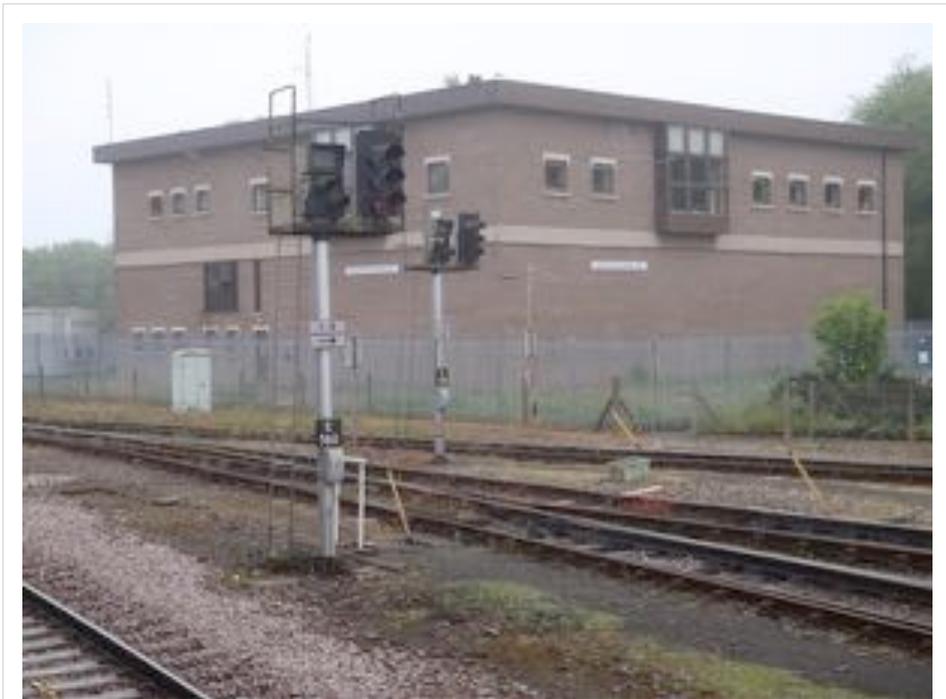
Administrative location: Devon, England. Constraints: Reasonable. Design: BR(WR) PB. Built: 1985. Listing: n/a. Status: Use ML. Future/use: Medium term. Heritage value: Original. Overall condition: Good. Reuse potential: Poor. Relocatable: No. Risk: Normal.

Figure A.47: Exeter PSB. (Author 2018)

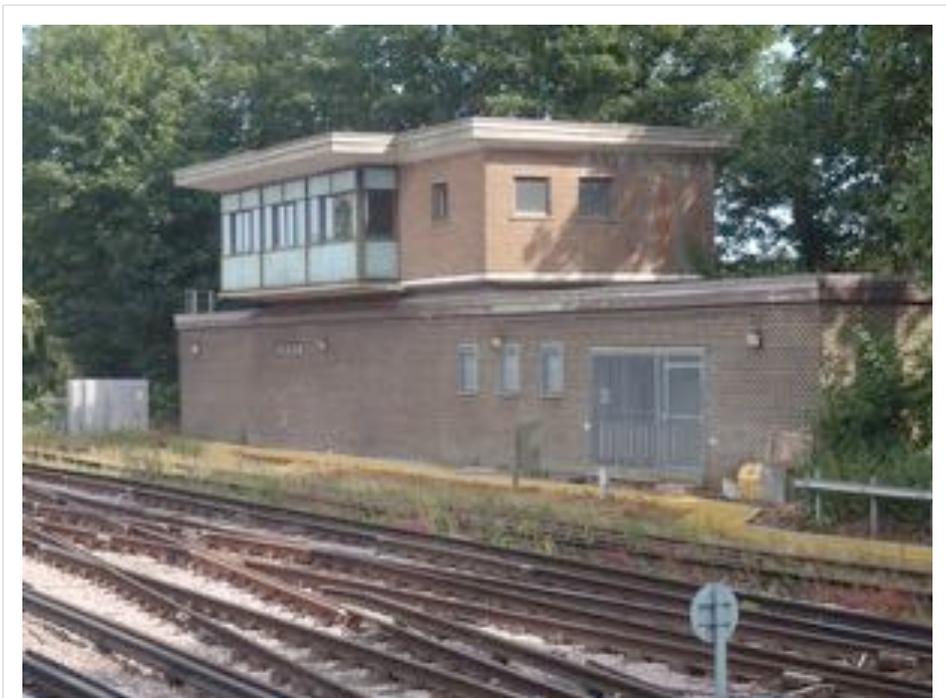
Figure A.48: Faversham PSB. (Author 2018)

Administrative location: Kent, England. Constraints: Distant. Design: BR(SR) 17. Built: 1959. Listing: n/a. Status: OOU ML. Future/use: Mothballed. Heritage value: Original, evidential (example of design from period). Overall condition: Fair. Reuse potential: Poor. Relocatable: No. Risk: Normal.

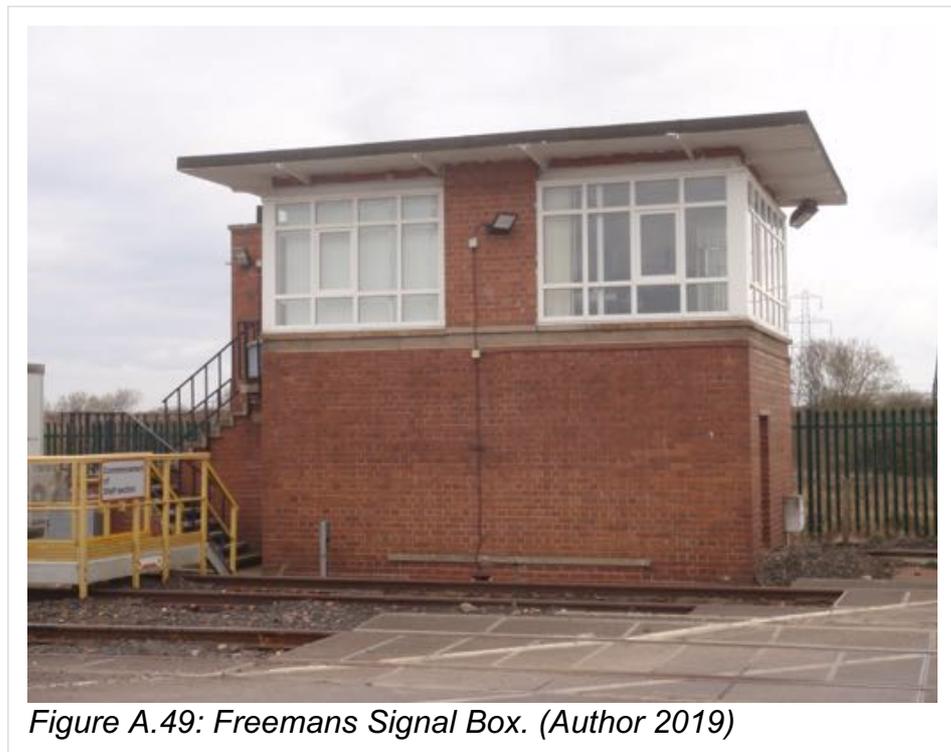
A.2.49 Freemans Signal Box

Administrative location: Northumberland, England. Constraints: Reasonable. Design: BR(NER) 16b. Built: 1956. Listing: n/a. Status: Use ML. Future/use: Short term. Heritage value: Modified (replacement uPVC windows seemingly matching original glazing pattern), communal (level crossing). Overall condition: Good. Reuse potential: Accessible. Relocatable: Difficult. Risk: High.

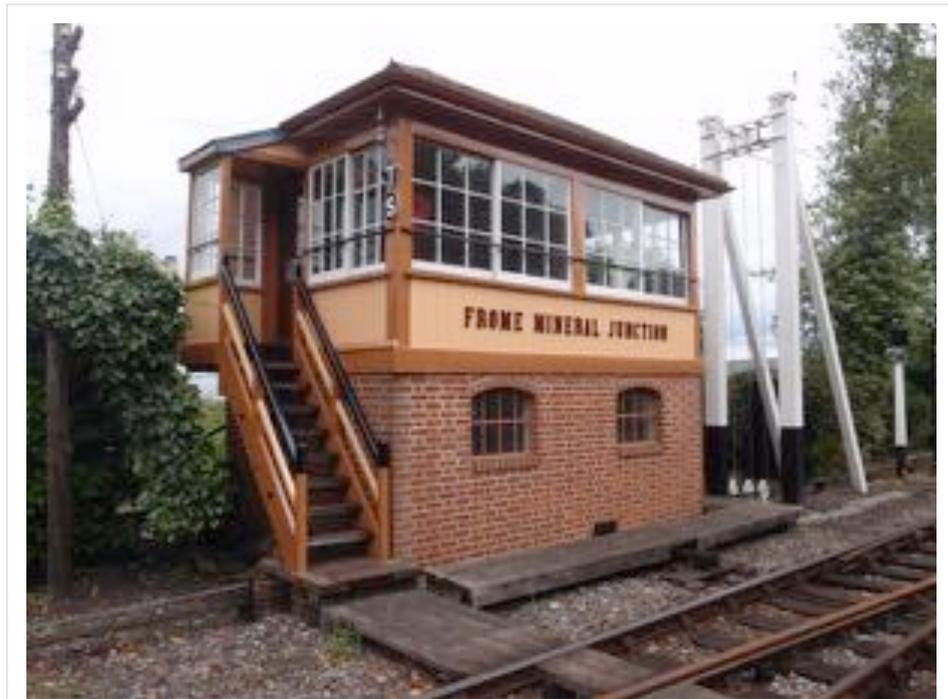
Figure A.50: Frome Mineral Junction Signal Box as relocated to the Great Western Society at Didcot. (Author 2016)

Administrative location: Oxfordshire, England. Constraints: Close. Design: GWR 2. Built: 1875/1990s. Listing: n/a. Status: Use HR. Future/use: Museum and heritage operational. Heritage value: Modified (modern brickwork plinth, replacement timber staircase), communal (museum location). Overall condition: Good. Reuse potential: None. Relocatable: None, relocated 1990s. Risk: Normal.

One of the two relocated heritage signal boxes at this heritage railway centre, this displays the signal box in a late 19th Century condition, albeit with what is obvious modern brickwork for the reconstructed locking room plinth under the relocated operating room superstructure.

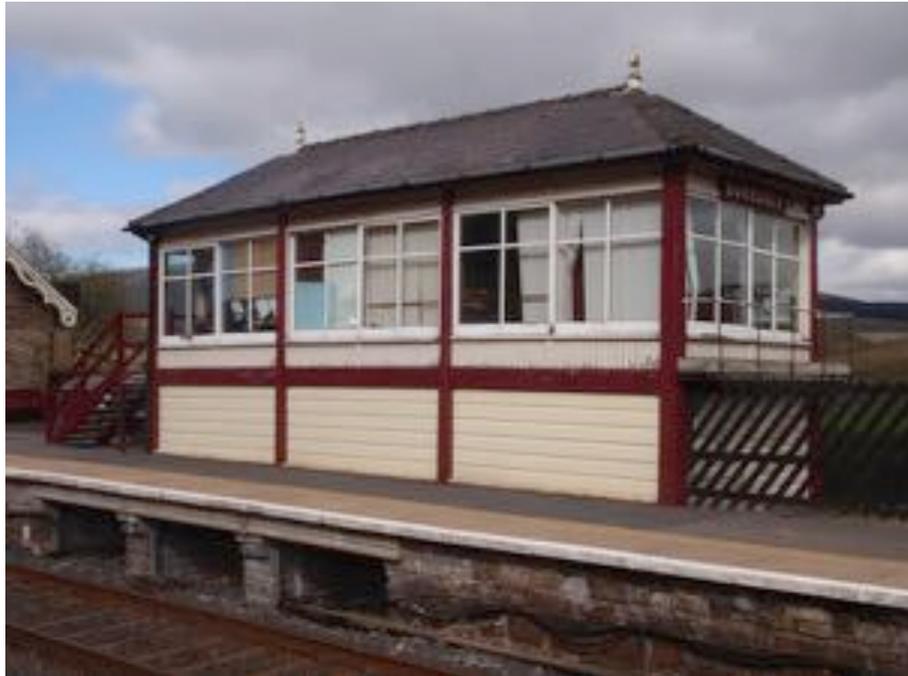
Figure A.51a: Garsdale Signal Box. (Author 2016)

Administrative location: Cumbria, England. Constraints: Close. Design: Midland 4c. Built: 1910. Listing: II. Status: Use ML. Future/use: Medium term. Heritage value: Modified (replacement timber staircase), historical (Ais Gill Disaster 1910). Overall condition: Deficient, significant movement controlled by piles to rear. Reuse potential: Accessible. Relocatable: Yes. Risk: Weather.

Section 4.4 outlines the almost Gothic melodrama, occurring on the dark and stormy night of Christmas Eve 1910, that defines the historical heritage value of Garsdale Signal Box. This timber structure contrasts with the dour solidity of the stone station buildings, a surprisingly attractive contrast even if the signal box feels fragile in such an exposed location. Noted is the significant lean backwards of the structure, a quite common defect attributable to the weight of the frame. The platform

Figure A.51b: Piles and beams to prevent further structural movement of Garsdale Signal Box. (Author 2016)

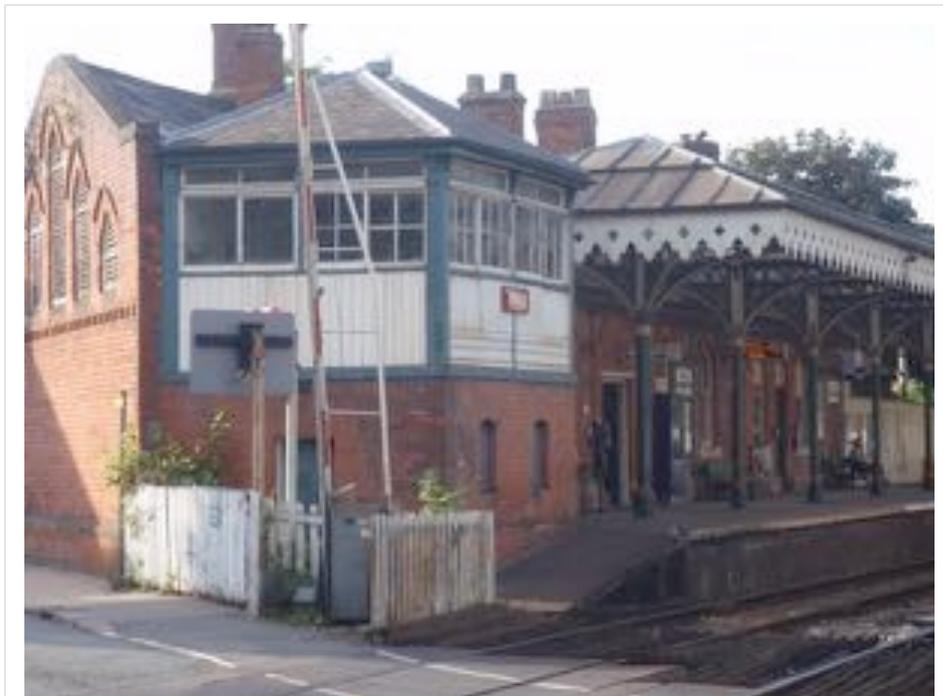
Figure A.52: Hale Signal Box. (Author 2018)

Administrative location: Trafford, England. Constraints: Close. Design: S&F [CLC]. Built: c1875. Listing: II [G]. Status: OOU ML. Future/use: Mothballed. Heritage value: Original, communal (level crossing). Overall condition: Fair. Reuse potential: Accessible. Relocatable: No. Risk: Deliberate.

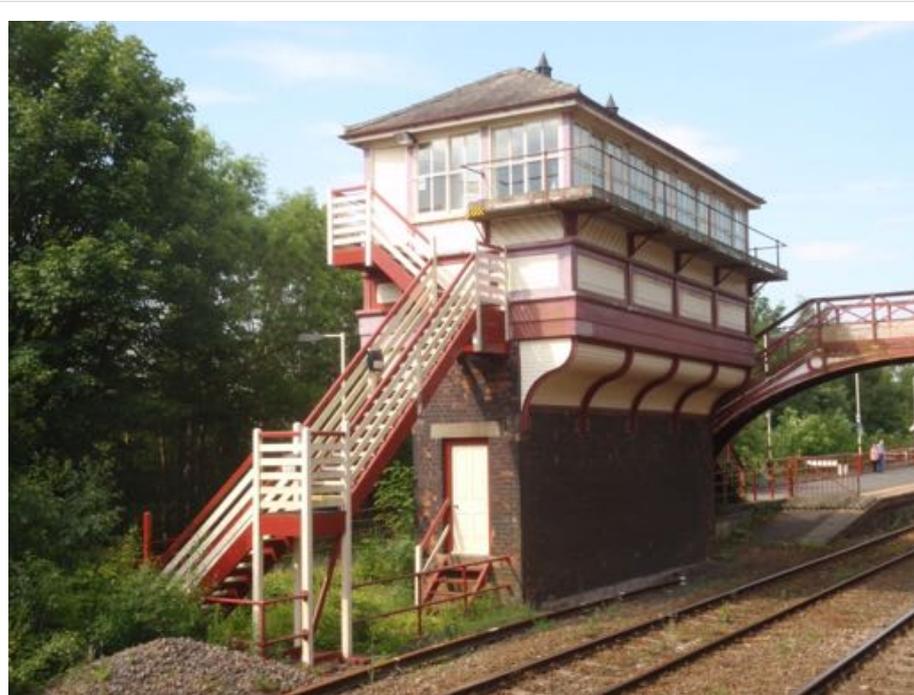
Figure A.53: Haltwhistle (NER) Signal Box. (Author 2015)

Administrative location: Northumberland, England. Constraints: Close. Design: NER bespoke. Built: Late 19th C. Listing: II. Status: OOU ML. Future use: Mothballed. Heritage value: Modified (replacement timber staircase), aesthetic, communal (station location). Overall condition: Good. Reuse potential: Poor. Relocatable: No. Risk: Normal.

erstwhile branch line to Alston, with the height enabling a view of trains approaching from three directions. Closure of the branch line allowed modification of the staircase to better align with modern building regulations, the change in direction near ground level being impossible until removal of the branch line.

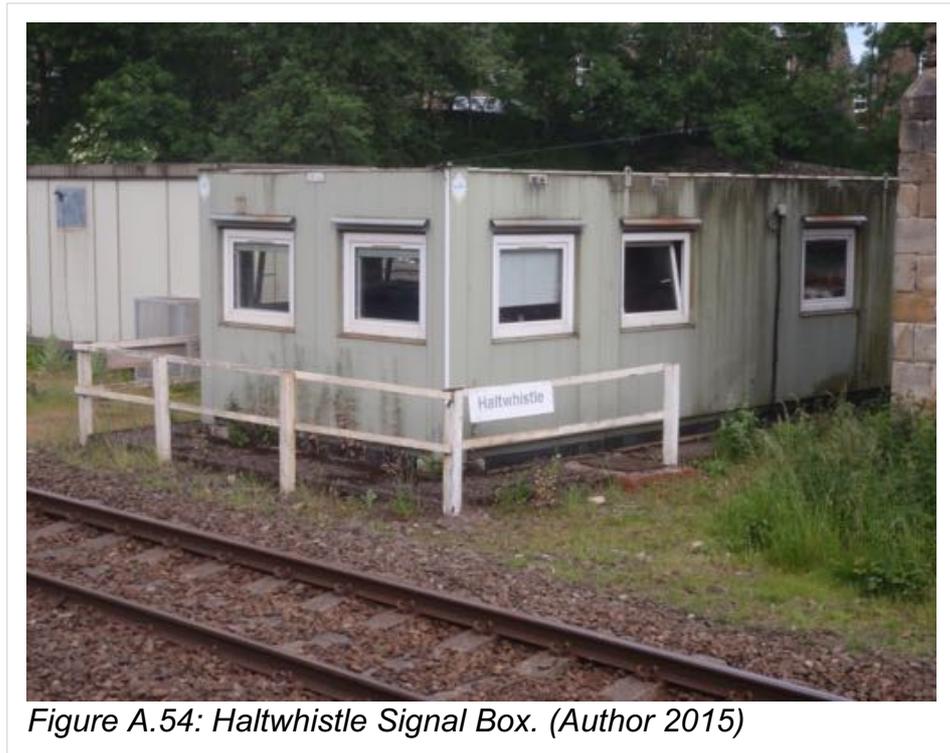
Figure A.54: Haltwhistle Signal Box. (Author 2015)

Administrative location: Northumberland, England. Constraints: Reasonable. Design: Portable building. Built: 2009. Listing: n/a. Status: Use ML. Future/use: Short term. Heritage value: Original. Overall condition: Deficient. Reuse potential: Accessible. Relocatable: Yes. Risk: Normal.

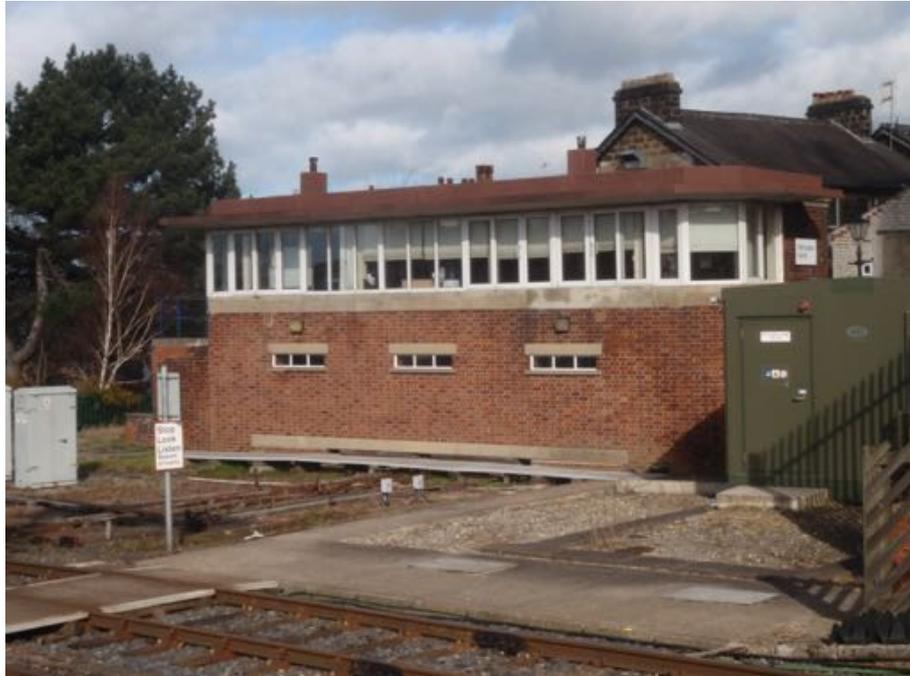
Figure A.55: Harrogate Signal Box. (Author 2019)

Administrative location: North Yorkshire, England. Constraints: Reasonable. Design: LNER 15+. Built: 1947. Listing: n/a. Status: Use ML. Future/use: Short term. Heritage value: Modified (replacement uPVC windows). Overall condition: Good. Reuse potential: Accessible. Relocatable: No. Risk: Normal.

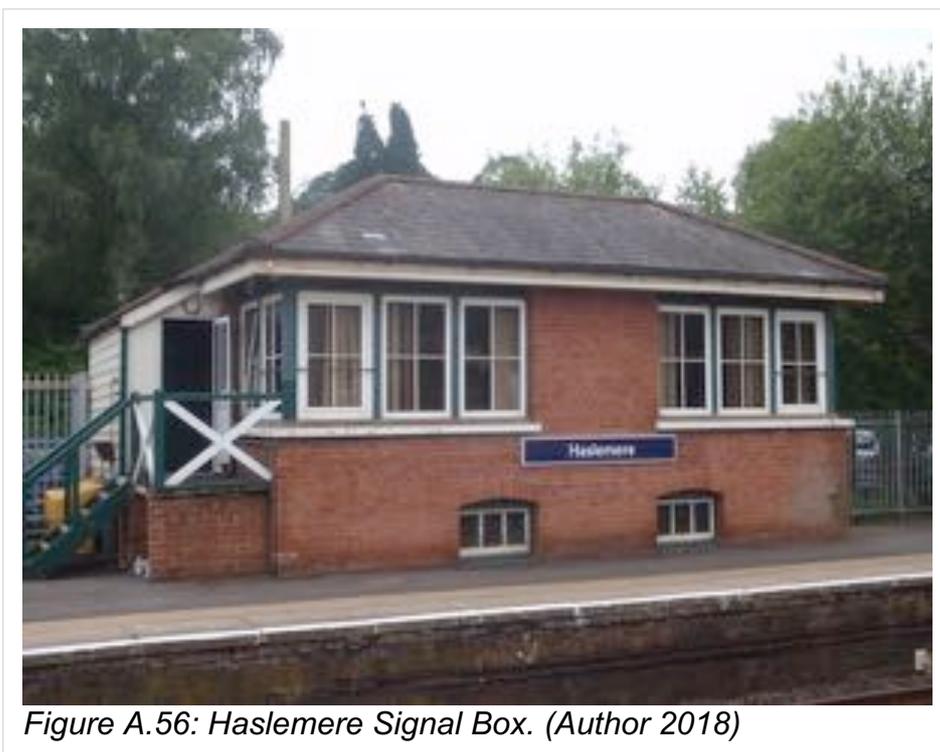
A.2.56 Haslemere Signal Box

Administrative location: Surrey, England. Constraints: Close. Design: LSWR 4. Built: 1895. Listing: II [GV]. Status: Use ML. Future/use: Long term. Heritage value: Modified (replacement uPVC windows, replacement timber staircase), communal (station location). Overall condition: Good. Reuse potential: Accessible. Relocatable: None. Risk: Normal.

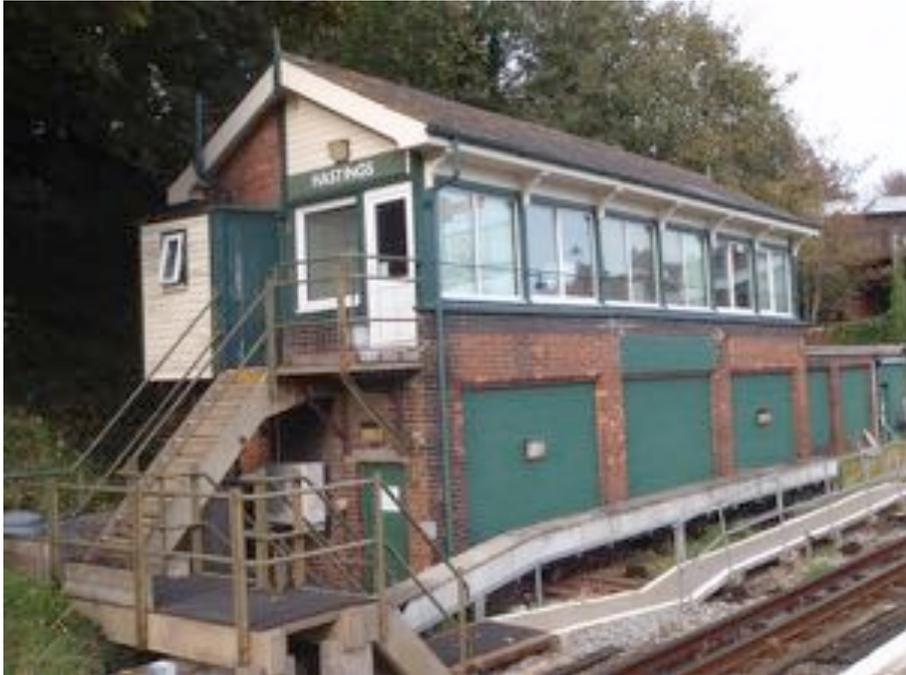
Administrative location: East Sussex, England. Constraints: Close. Design: SR 12. Built: 1930. Listing: n/a. Status: Use ML. Future/use: Long term. Heritage value: Degraded (replacement uPVC windows, replacement staircase toilet extension), communal (station location). Overall condition: Fair. Reuse potential: Poor. Relocatable: None. Risk: Weather.

Figure A.57: Hastings Signal Box. (Author 2017)

Visible from the platforms will provide a modicum of public awareness for Hastings Signal Box. However, the obvious degraded heritage value and overall condition will do little to endear this building to observers.

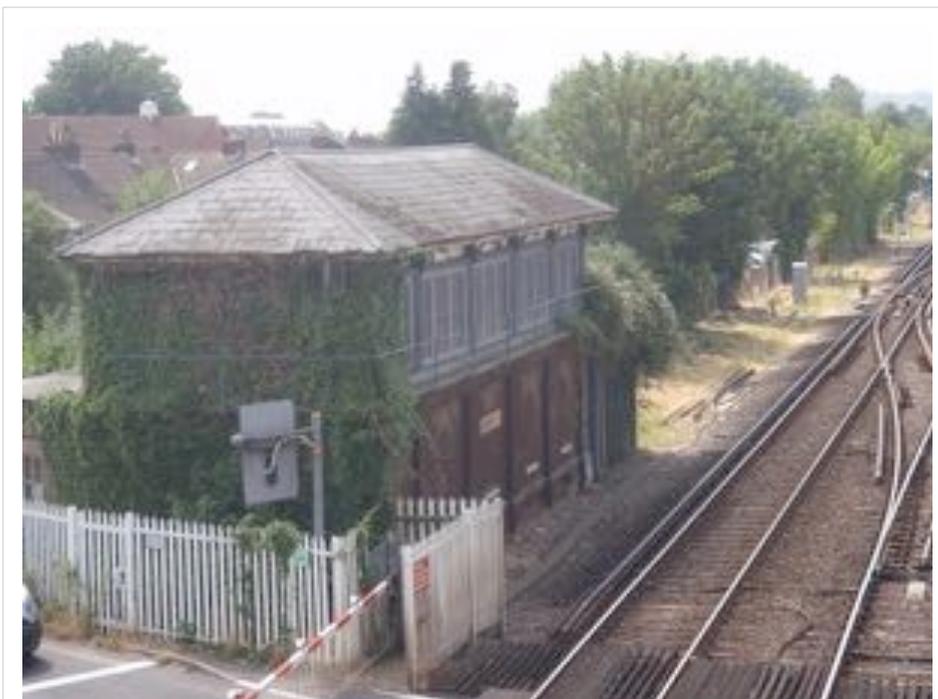
Figure A.58: Havant Junction East Signal Box. (Author 2018)

Administrative location: Hampshire, England. Constraints: Close. Design: S&F 5 [LBSCR]. Built: 1876. Listing: II. Status: OOU ML. Future/use: Mothballed. Heritage value: Original as extended (possibly with internal staircase) to original design upon rebuilding of Havant station 1937-8 (Reeve and Hawkins 1980, p66), communal (level crossing). Overall condition: Fair. Reuse potential: Accessible. Relocatable: No. Risk: Deliberate.

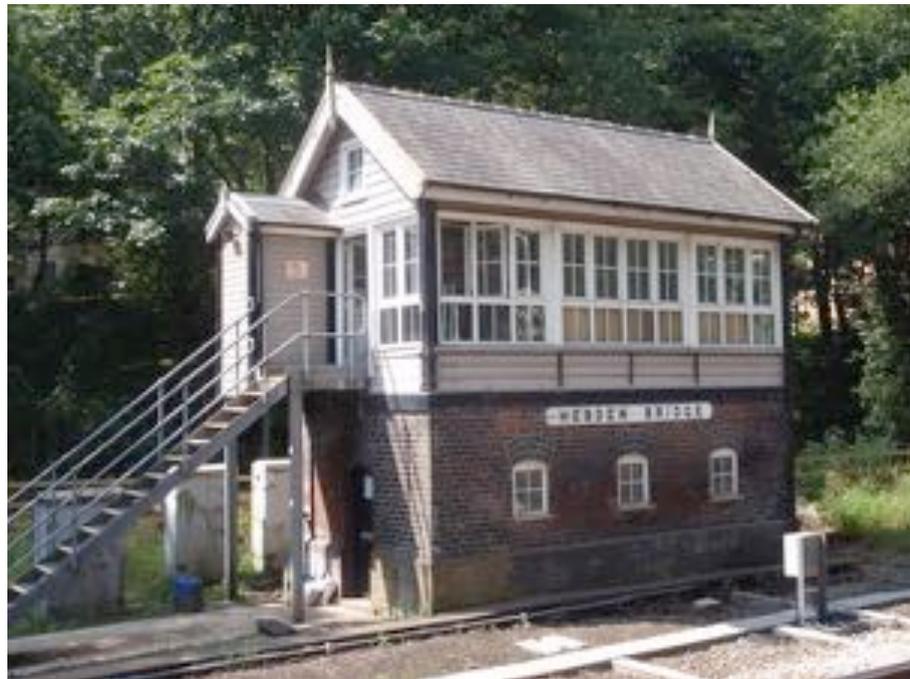
Figure A.59: Hebden Bridge Signal Box. (Author 2018)

Administrative location: West Yorkshire, England. Constraints: Close. Design: LYR. Built: 1891. Listing: II [GV]. Status: Use ML. Future/use: Short term. Since closed (2018). Heritage value: Modified (replacement

uPVC windows, replacement steel staircase), communal (station location, community involvement). Overall condition: Fair. Reuse potential: Accessible. Relocatable: Partially. Risk: Normal.

Visible from an opposite platform and next to a lane behind will provide a modicum of public awareness, along with local public interest in conserving the now closed Hebden Bridge Signal Box. This is another example where an attractive design, despite modified heritage value, in a picturesque station setting creates a pleasing synergy.

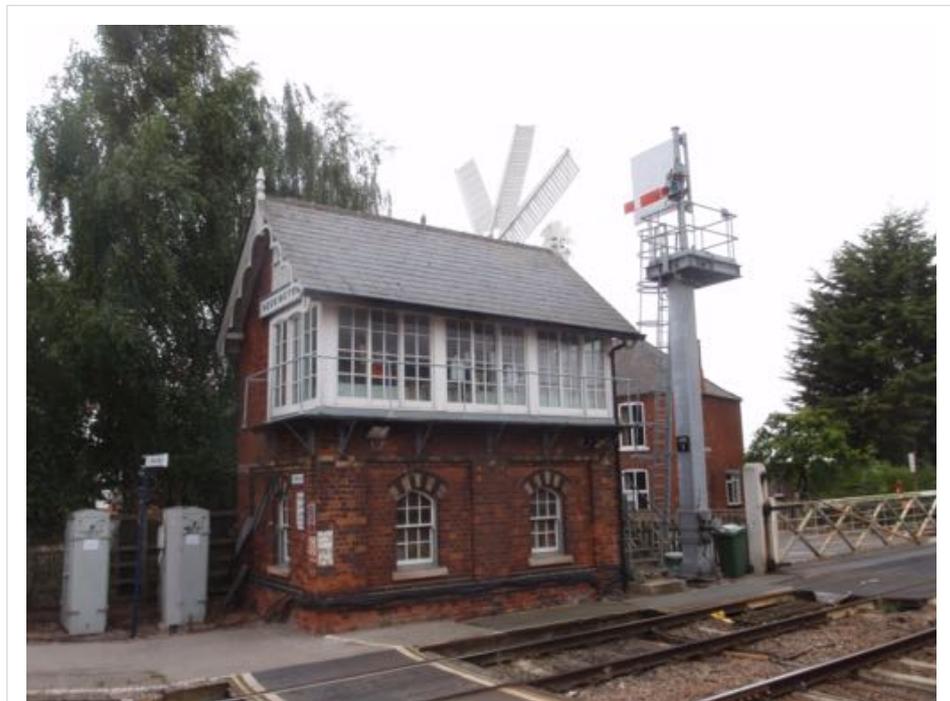
Figure A.60: Heckington Signal Box. (Author 2015)

Administrative location: Lincolnshire, England. Constraints: Close. Design: GNR 1. Built: 187A. Listing: II. Status: Use ML. Future/use: Short term. Heritage value: Modified (replacement steel staircase), communal (level crossing, proximity to grade I listed building). Overall condition: Good. Reuse potential: Accessible. Relocatable: Partially. Risk: Normal.

That this grade II listed building is next to a grade I listed windmill in station environment retaining much of the original character within an attractive village location potentially makes this an idealised version of conservation. Users of the station and passing public will be aware of the signal box. The modifications are discrete, although the replacement signal post is uncompromisingly modern.

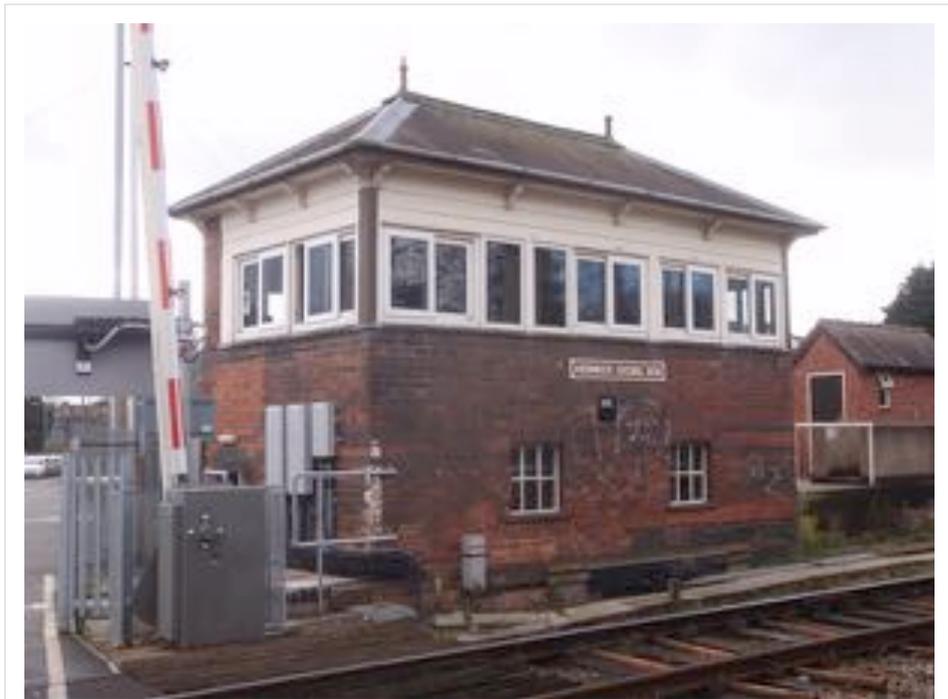
Figure A.61: Henwick Signal Box. (Author 2017)

Administrative location: Worcestershire, England. Constraints: Close. Design: McK&H 1 [GWR]. Built: c1875. Listing: n/a. Status: Use ML. Future/use: Long term. Heritage value: Modified (replacement uPVC windows), communal (level crossing). Overall condition: Good. Reuse potential: Accessible. Relocatable: None. Risk: Deliberate.

Next to a level crossing will strengthen public awareness of Henwick Signal Box, although the overall location will make this communal appeal marginal. Furthermore, even though there is little detracting from the heritage value and the building is in a good condition, the context leaves a marginal impression.
