**CONSERVATION OF FUNCTIONAL
HERITAGE RAILWAY BUILDINGS
AS AN ARCHETYPE FOR THE
CONSERVATION OF FUNCTIONAL
HERITAGE BUILDINGS**

CHRISTOPHER DIETMAR REEVES

A thesis submitted in partial fulfilment
of the requirements of the University
of Northumbria at Newcastle for the
degree of Doctor of Philosophy

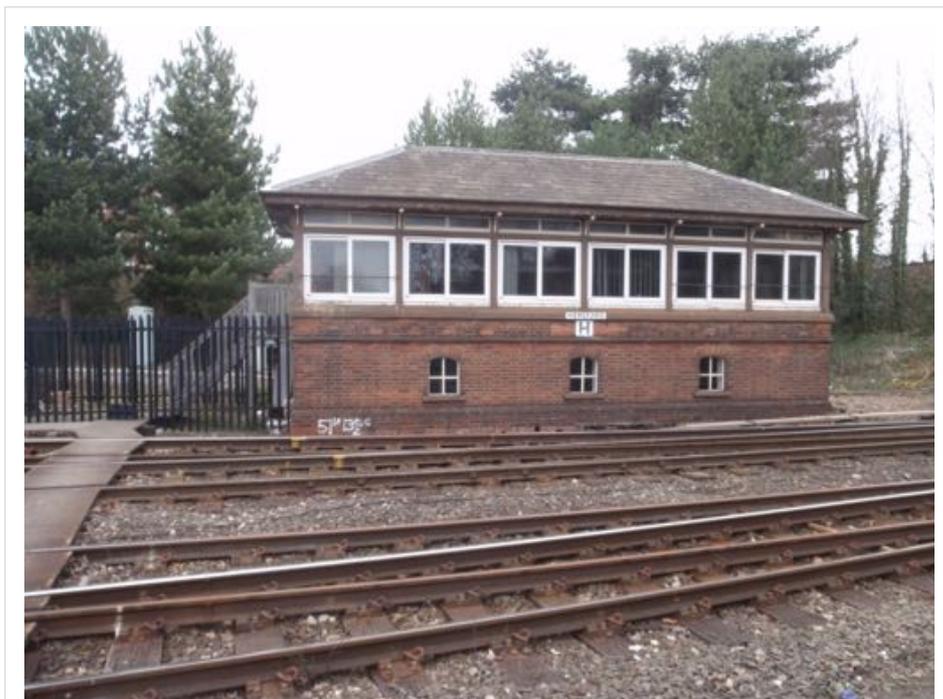
Figure A.62: Hereford Signal Box. (Author 2016)

Administrative location: Herefordshire, England. Constraints: Close. Design: LNWR/GWR Joint 2. Built: 1884. Listing: n/a. Status: Use ML. Future/use: Partial, short/long term. Heritage value: Modified (replacement uPVC windows, replacement steel staircase), communal (public location). Overall condition: Fair, structural movement. Reuse potential: Accessible. Relocatable: No. Risk: Normal. Comment: Conversation.

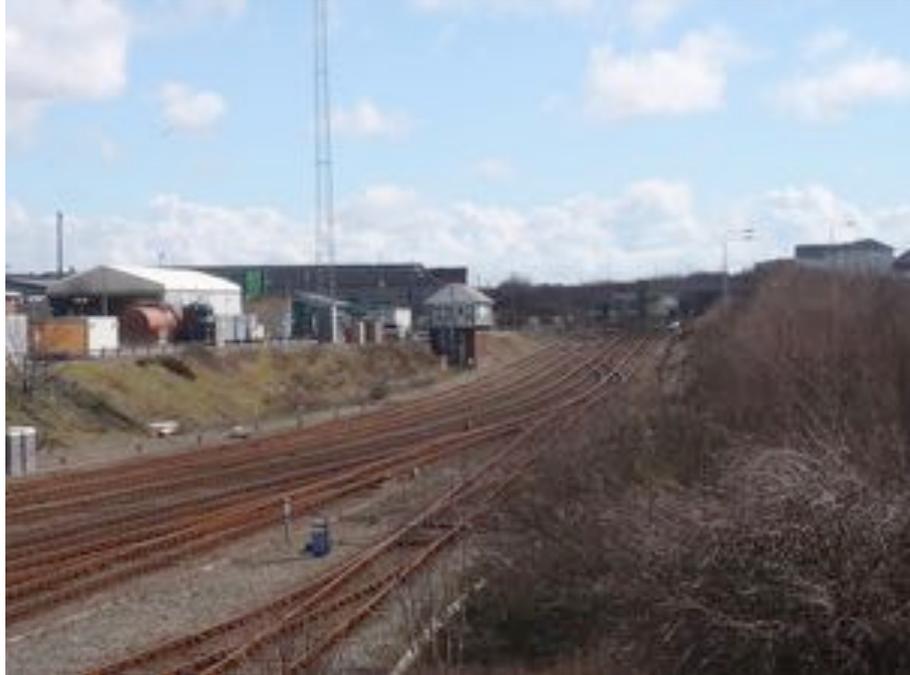
Figure A.63: Holyhead Signal Box. (Author 2016)

Administrative location: Isle of Anglesey, Wales. Constraints: Distant. Design: LMS 11c. Built: 1937. Listing: n/a. Status: Use ML. Future/use: Short term. Heritage value: Degraded (replacement uPVC cladding to

superstructure, replacement uPVC windows, replacement steel staircase). Overall condition: Good. Reuse potential: Poor. Relocatable: No. Risk: Weather.

Remote from public areas and displaying a degraded external condition in terms of heritage values, it is difficult to make an effective conservation case for Holyhead Signal Box.

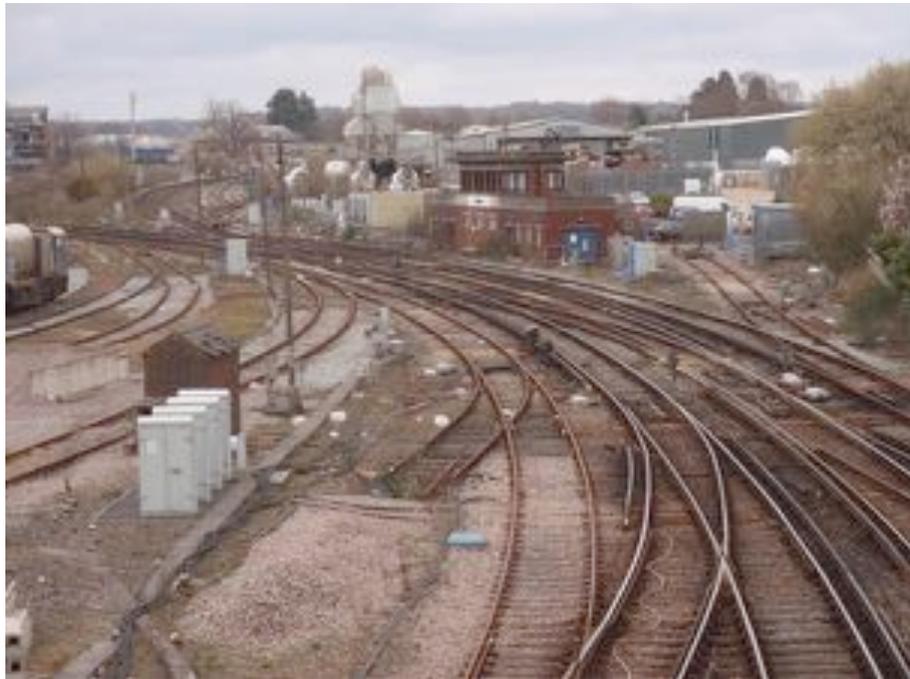
Figure A.64: Horsham Signal Box. (Author 2016)

Administrative location: West Sussex, England. Constraints: Close. Design: SR 13. Built: 1938. Listing: II. Status: OOU ML. Future/use: Offices. Heritage value: Original, communal (relatively unmodified railway environment). Overall condition: Fair. Reuse potential: Accessible. Relocatable: No. Risk: Normal.

Not a conventionally understood communal environment, yet the railway environment for Horsham Signal Box, redeveloped in conjunction with the also listed International Modernist railway station, provides a rare example of a railway environment unchanged other

than removal of a steam locomotive depot behind the signal box (Reeves *et al* 2020, p244).

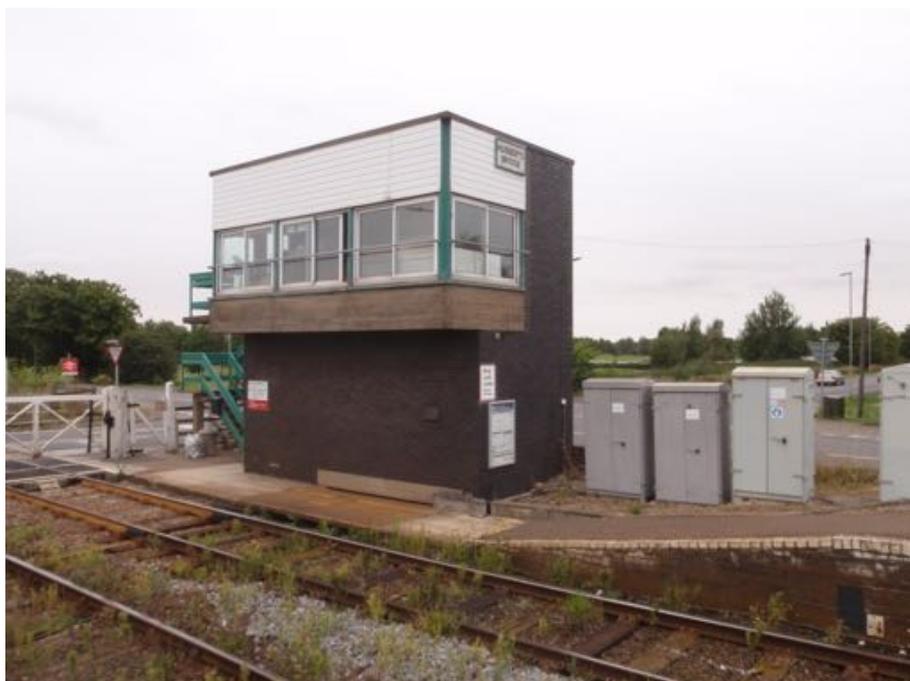
Figure A.65: Hubberts Bridge Signal Box. (Author 2015)

Administrative location: Lincolnshire, England. Constraints: Close. Design: BR(ER) n/s. Built: 1961. Listing: n/a. Status: Use ML. Future/use: Short term. Heritage value: Modified (replacement uPVC cladding and entrance door), aesthetic (unique 1960s design), communal (level crossing). Overall condition: Good. Reuse potential: Accessible. Relocatable: No. Risk: Weather.

Unapologetically Modernist, this bespoke building is an anomaly. The location is bleak, controlling a level crossing at a crossroads where the railway runs through dreary fenland countryside between a main road and a drain river. There seems to be no reason to have a bespoke design at this location, yet despite a lack of reason, the structure exists and is possibly more attractive than most observers would admit.

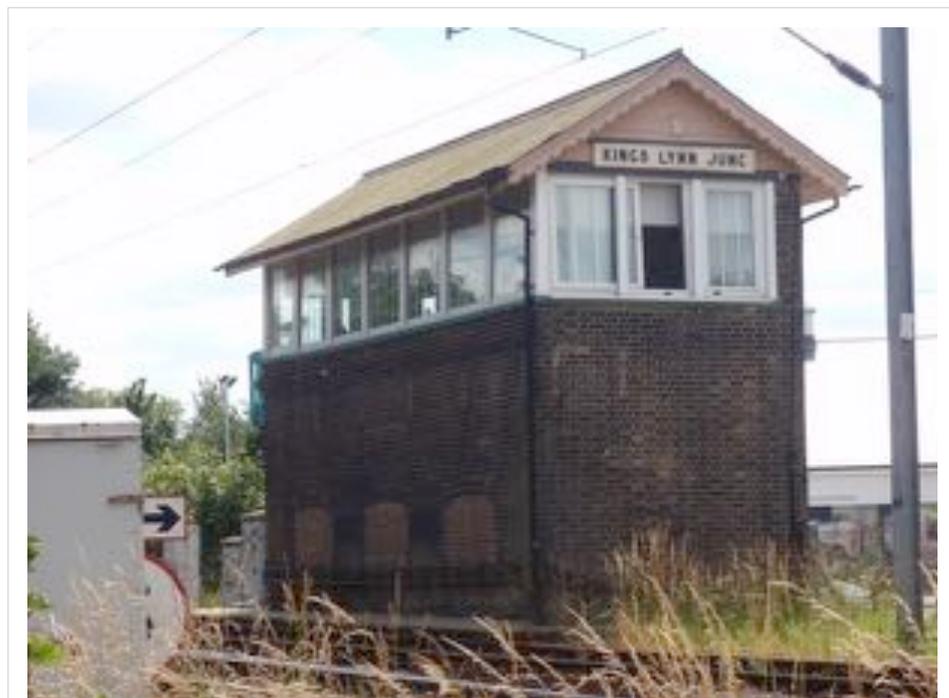
Figure A.66: Kings Lynn Junction Signal Box. (Author 2016)

Administrative location: Norfolk, England. Constraints: Close. Design: GER 2. Built: c1880. Listing: n/a. Status: Use ML. Future/use: Short term. Heritage value: Modified (replacement uPVC windows,

replacement timber staircase). Overall condition: Fair. Reuse potential: Accessible. Relocatable: No. Risk: Deliberate.

Conventionally being next to a level crossing strengthens public awareness of a signal box, yet Kings Lynn Junction Signal Box presents as a large, obviously railway building with hard to identify heritage value looming over a supermarket car park. In effect, this is a building with some heritage merit that feels out of context.

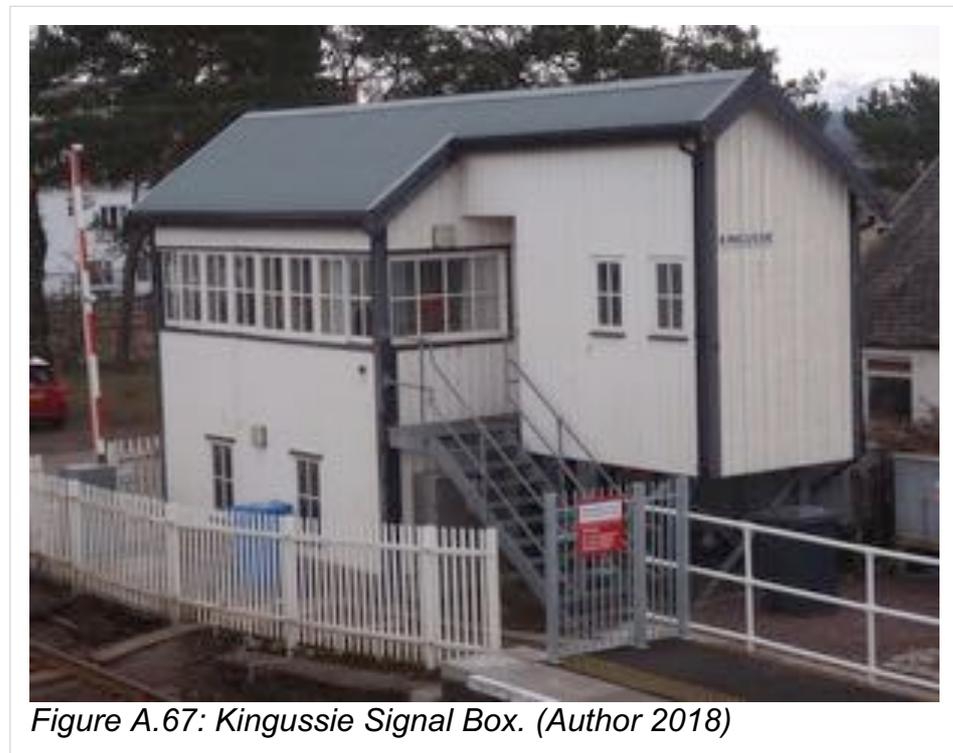
Figure A.67: Kingussie Signal Box. (Author 2018)

Administrative location: Highland, Scotland. Constraints: Close. Design: McK&H 3 [Highland]. Built: Unknown. Listing: B [G]. Status: Use ML. Future/use: Short term. Heritage value: Modified (replacement steel staircase, extended), communal (level crossing). Overall condition: Good. Reuse potential: Accessible. Relocatable: Yes. Risk: Weather.

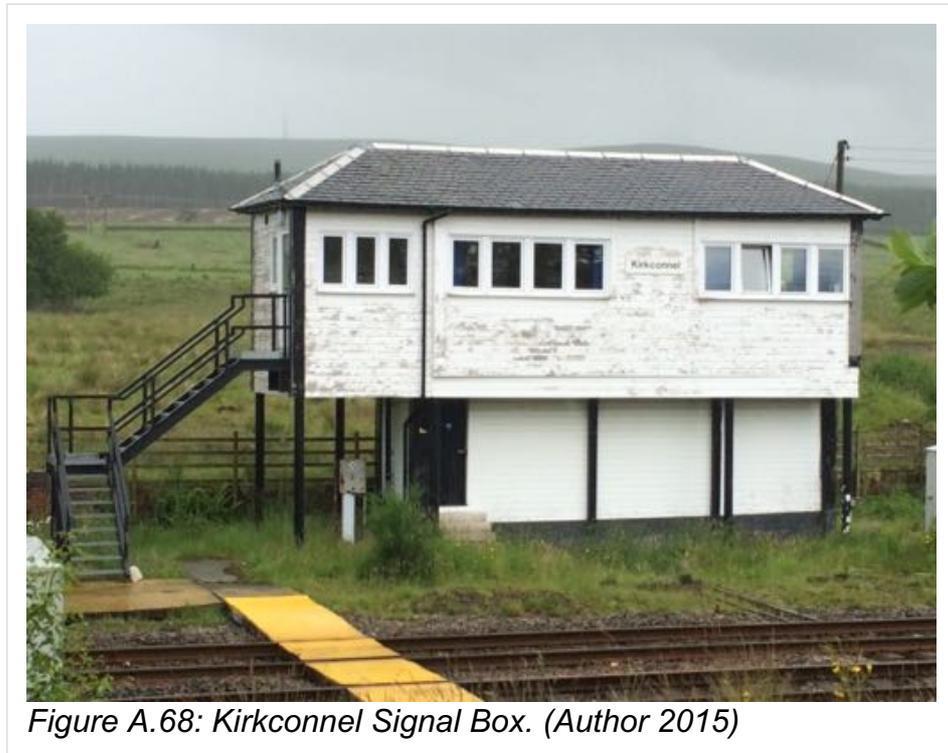
A.2.68 Kirkconnel Signal Box

Administrative location: Dumfries & Galloway, Scotland. Constraints: Distant. Design: GSWR 7. Built: 1911. Listing: n/a. Status: Use ML. Future/use: Short term. Heritage value: Degraded (utilitarian extension, replacement uPVC windows, replacement steel staircase). Overall condition: Fair. Reuse potential: Poor. Relocatable: No. Risk: Normal.

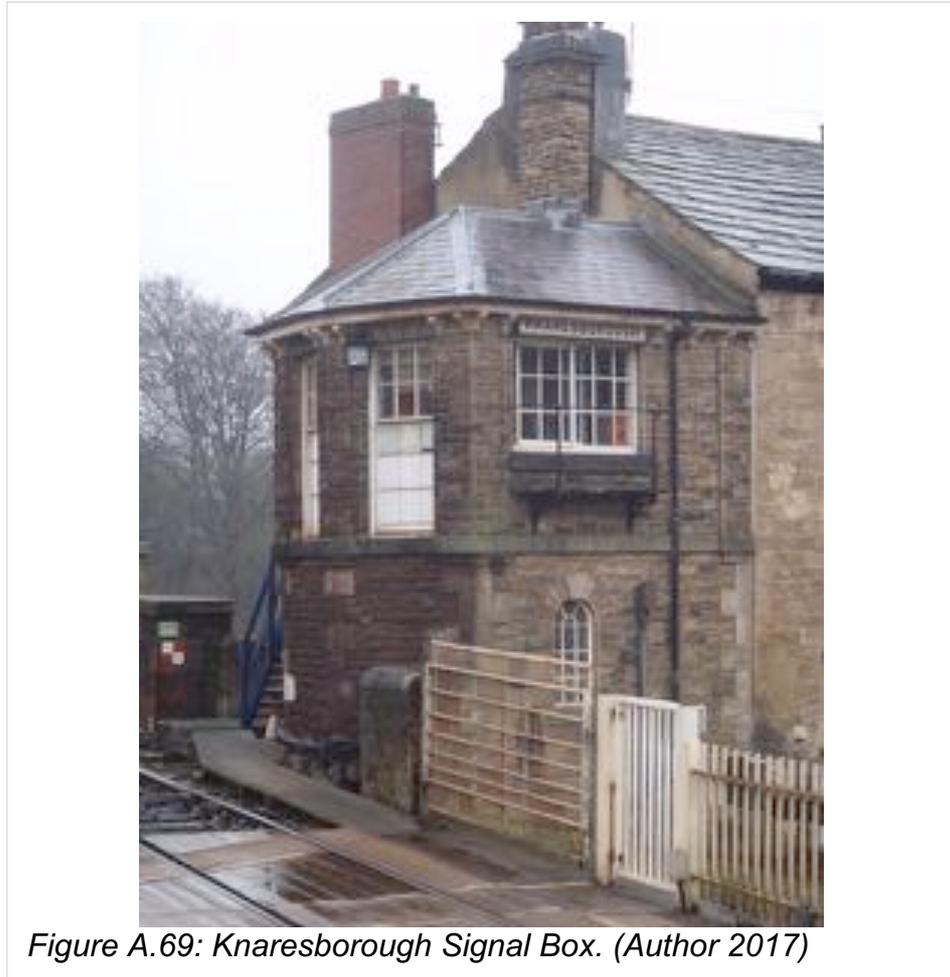
Administrative location: North Yorkshire, England. Constraints: Close. Design: NER bespoke. Built: c1873. Listing: II. Status: Use ML.

Future/use: Short term. Heritage value: Modified (replacement timber staircase), aesthetics (unusual end of terrace design), communal (public location). Overall condition: Good. Reuse potential: Good. Relocatable: No. Risk: Normal.

Despite being in a very public location, along with a sense of spectacle from being next to the viaduct over the River Nidd, the end of terrace morphology of Knaresborough Signal Box means it will be remarkably easy for a casual observer to be unaware of the building function. The accessible location with views over the River Nidd suggests potential for an imaginative reuse.

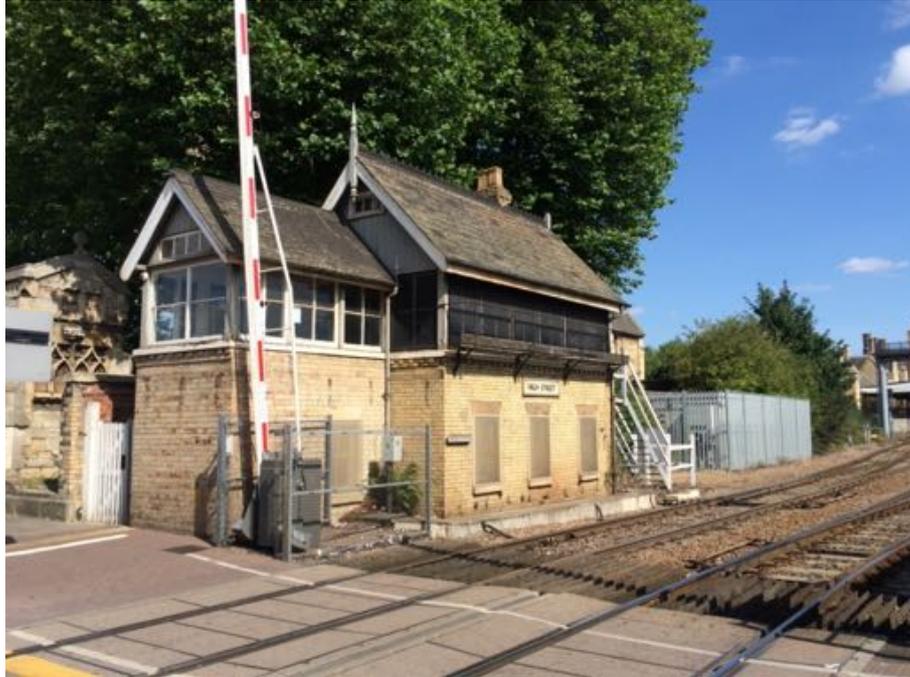
Figure A.70: Lincoln High Street Signal Box. (Author 2015)

Administrative location: Lincolnshire, England. Constraints: Reasonable. Design: GNR 1. Built: 1874. Listing: II. Status: OOU ML.

Future/use: Mothballed. Heritage value: Modified (replacement steel and timber staircase), communal (level crossing). Overall condition: Fair. Reuse potential: Accessible. Relocatable: No. Risk: Deliberate.

As befits the ‘engineer’s vernacular’, construction of this signal box is in a standard design, other than an extension added in 1925, although unusually in London stock bricks rather than the Fletton bricks more usually used for masonry signal box construction. The list entry notes the very public location.

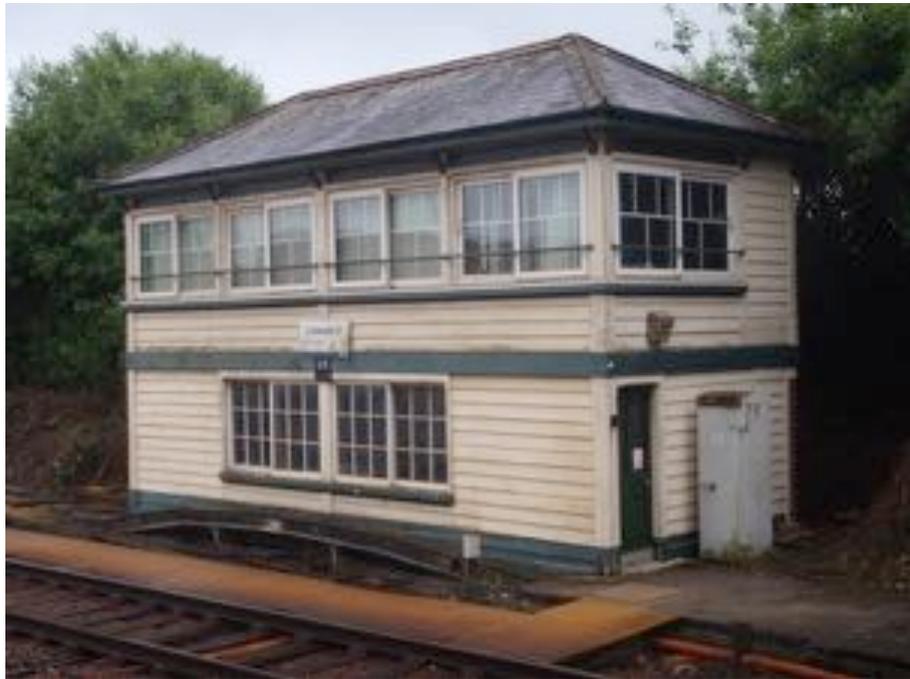
Figure A.71: Liskeard Signal Box. (Author 2018)

Administrative location: Cornwall, England. Constraints: Reasonable. Design: GWR 27c. Built: 1915. Listing: n/a. Status: Use ML. Future/use: Short term. Heritage value: Modified (replacement uPVC windows), possible communal (visible location). Overall condition: Fair. Reuse potential: Poor. Relocatable: Yes. Risk: Possible deliberate.

Visible from publicly accessible areas across the railway provides a modicum of public awareness for Liskeard Signal Box. As an unlisted

building, that the replacement uPVC windows are to the original window pattern shows sympathetic treatment of the building.

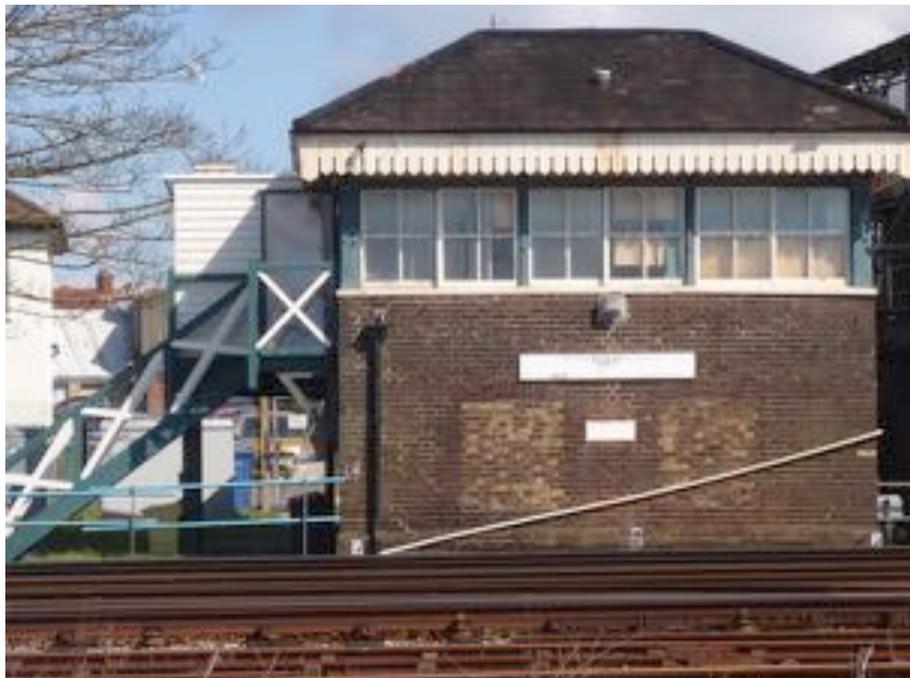
Figure A.72: Littlehampton Signal Box. (Author 2016)

Administrative location: West Sussex, England. Constraints: Close. Design: LBSCR 2a. Built: 1886. Listing: II. Status: Use ML. Future/use: Short term. Heritage value: Original (staircase seems modified, nominally to original design), communal (public location). Overall condition: Deficient, timber superstructure in poor condition. Reuse potential: Accessible. Relocatable: Difficult. Risk: High.

Next to a road and visible from across the railway makes for some public perception of Littlehampton Signal Box. There are elements of heritage originality, and the quaint decorative valancing characteristic of the LBSCR 2a design will appeal for those seeking ornate Victorian decorative style. More pragmatic observers will note how the addition of services devalues the front elevation despite other efforts to maintain heritage detailing.

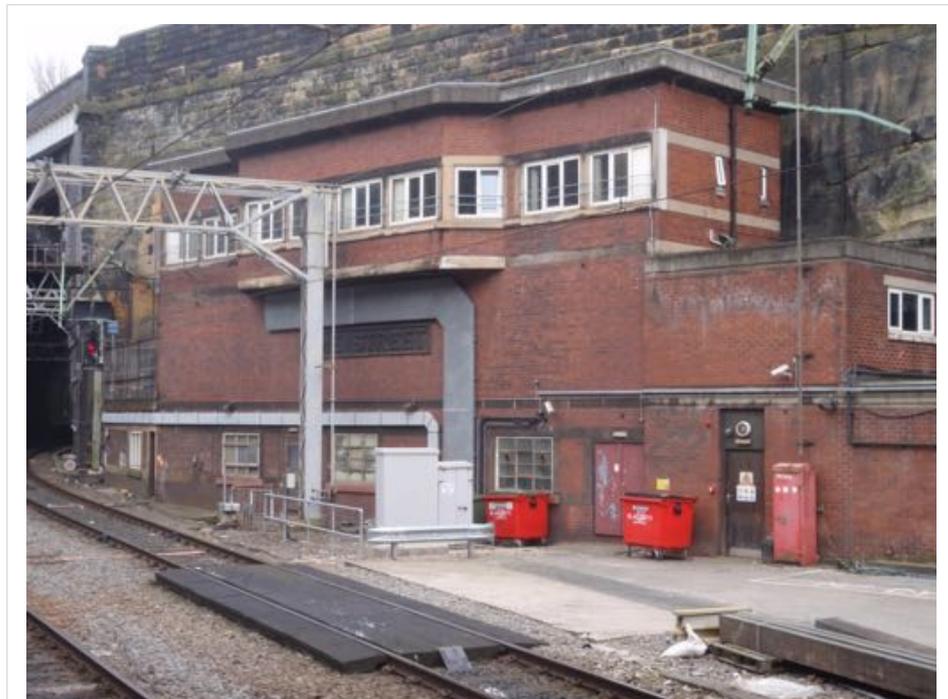
Figure A.73: Liverpool Lime Street Signal Box. (Author 2016)

Administrative location: Liverpool, England. Constraints: Close. Design: LMS 13. Built: 1948. Listing: II [GV]. Status: Use ML. Future/use: Short term, since closed (2018). Heritage value: Modified (some replacement

uPVC windows). Overall condition: Fair. Reuse potential: Poor. Relocatable: No. Risk: Normal. Comment: Conversation.

While not specifically mentioned in the listing, Liverpool Lime Street Signal Box comes within the curtilage of the grade II listed station and within the buffer zone for the Liverpool World Heritage Site. The design is a relatively rare late 1940's design, started by the LMS and completed by BR, that bears comparison with the other surveyed LMS 'austerity' designs from the era at Runcorn and Thornhill.

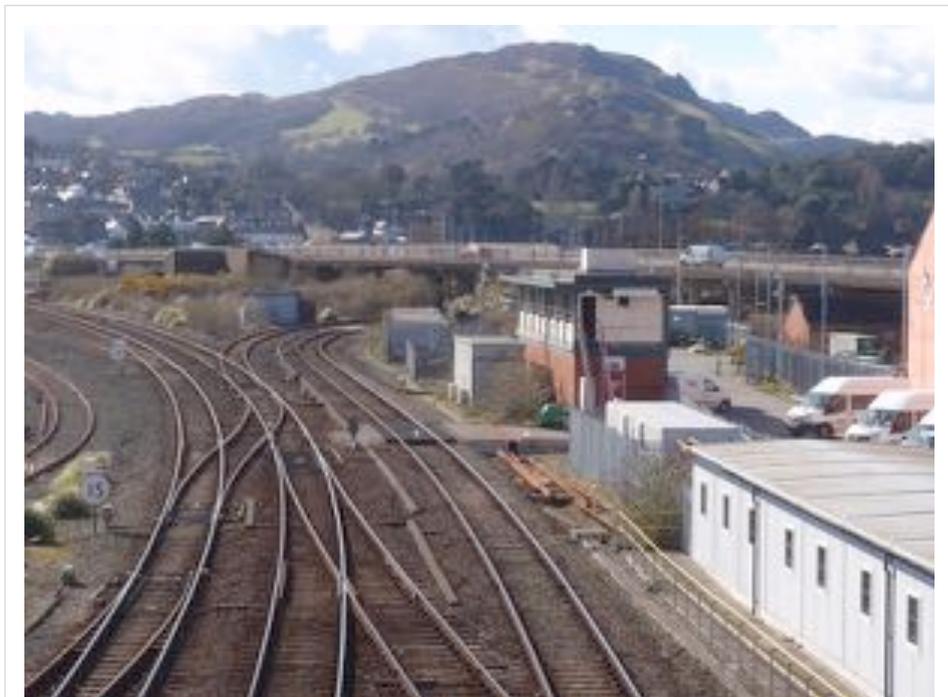
Figure A.74: Llandudno Junction Signal Box. (Author 2016)

Administrative location: Conwy, Wales. Constraints: Distant. Design: BR(LMR) 15. Built: 1985. Listing: n/a. Status: Use ML. Future/use: Short term. Heritage value: Modified (lower half of box built 1980 with superstructure assembled from second-hand sections). Overall condition: Fair. Reuse potential: Accessible. Relocatable: Partially. Risk: Normal.

Signal Box is an interesting hybrid made up of relocated operating level on a new locking room standing in front of the since demolished original LNWR 4. With limited opportunity for public observation, the main heritage value is the hybrid nature of this partially relocated building.

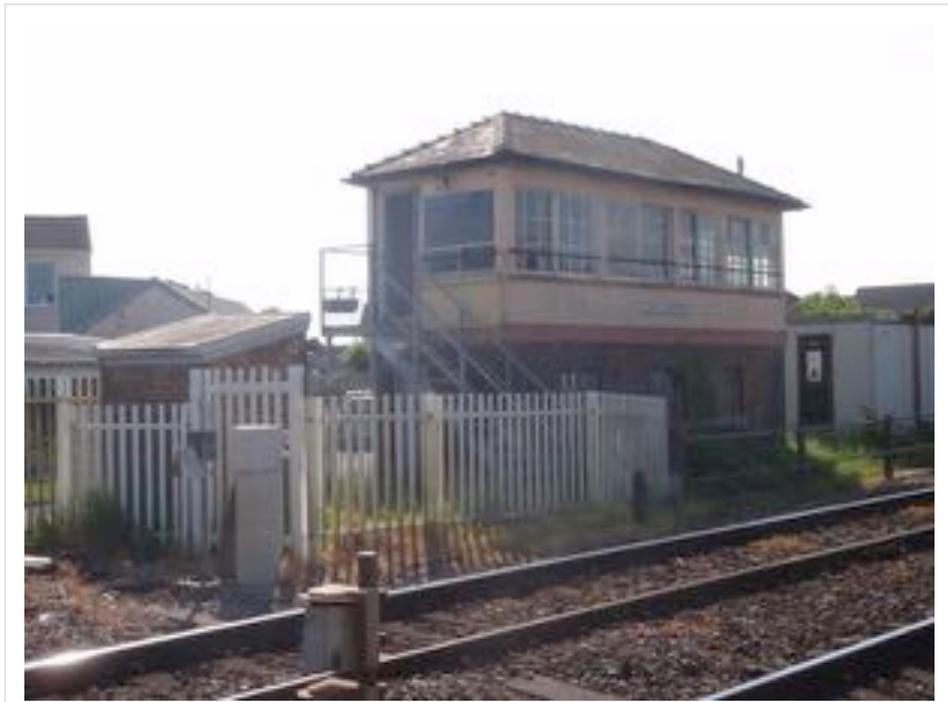
Figure A.75a: Llanelli West Signal Box. (Author 2018)

Administrative location: Carmarthenshire, Wales. Constraints: Close. Design: GWR 2. Built: 1877. Listing: II. Status: OOU ML. Future/use: Mothballed. Heritage value: Modified (replacement steel staircase), communal (level crossing, local interest including MP). Overall condition: Fair. Reuse potential: Accessible. Relocatable: Partially. Risk: Deliberate. Comment: Conversation.

Besides the public awareness from the closed Llanelli West Signal Box being adjacent to a level crossing, there is acknowledged public interest, apparently including from the constituency MP, in conservation of the building. One interesting feature is the chamfered plan at the east end of the building, built to accommodate a since removed siding serving

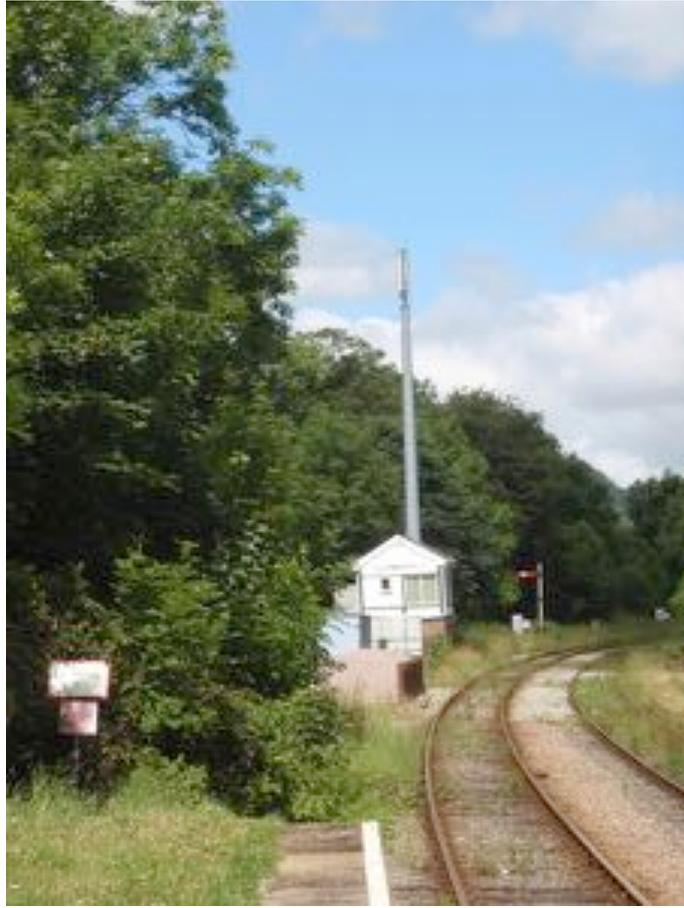
Figure A.76: Llanrwst Signal Box. (Author 2017)

Administrative location: Conwy, Wales. Constraints: Distant. Design: LNWR 4. Built: 1880. Listing: n/a. Status: Use ML. Future/use: Short term. Heritage value: Degraded (replacement uPVC cladding to superstructure, replacement uPVC windows, replacement steel staircase). Overall condition: Fair. Reuse potential: Poor. Relocatable: Partially. Risk: Normal.

Originally Llanrwst North Signal Box, Llanrwst Signal Box shows minimal substantive heritage value or potential for public awareness despite the location of Llanrwst close to the Snowdonia National Park. This building is another building analogous to Kirkconnel Signal Box, as somewhere inside the uPVC is the original building carrying out the same function and displaying a strong narrative of functional building ethos.

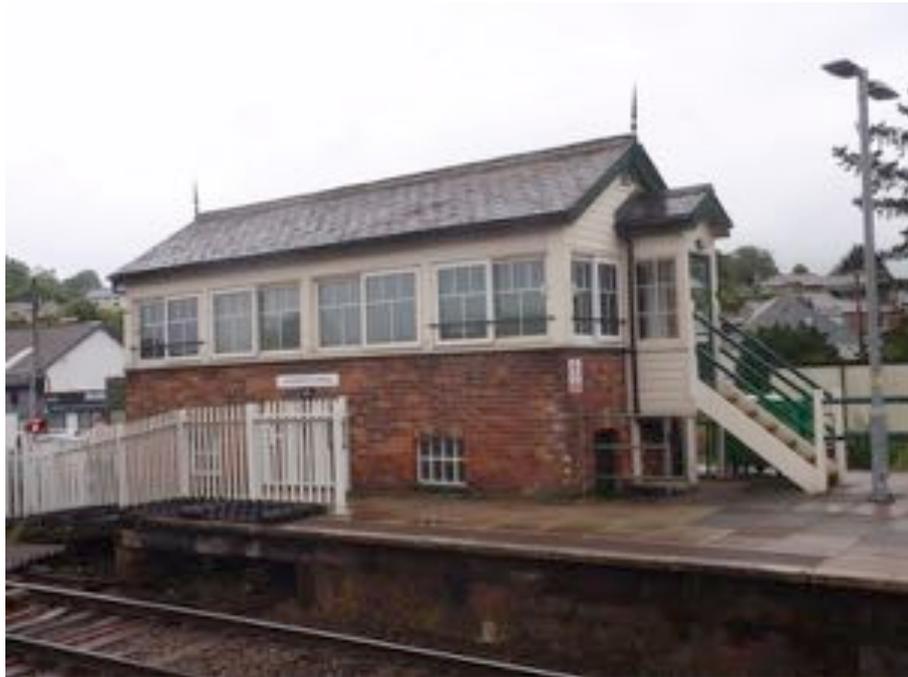
Figure A.77: Lostwithiel Signal Box. (Author 2018)

Administrative location: Cornwall, England. Constraints: Close. Design: GWR 5. Built: 1893. Listing: II. Status: Use ML. Future/use: Short term. Heritage value: Modified (replacement uPVC windows, possibly replacement timber staircase), communal (level crossing). Overall condition: Fair. Reuse potential: Accessible. Relocatable: No. Risk: Weather.

Being both next to a level crossing and access to one of the station platforms, there will be considerable public awareness of Lostwithiel Signal Box. In a comparable manner to Liskeard Signal Box, replacement uPVC windows to the original window pattern shows sympathetic treatment of this building.

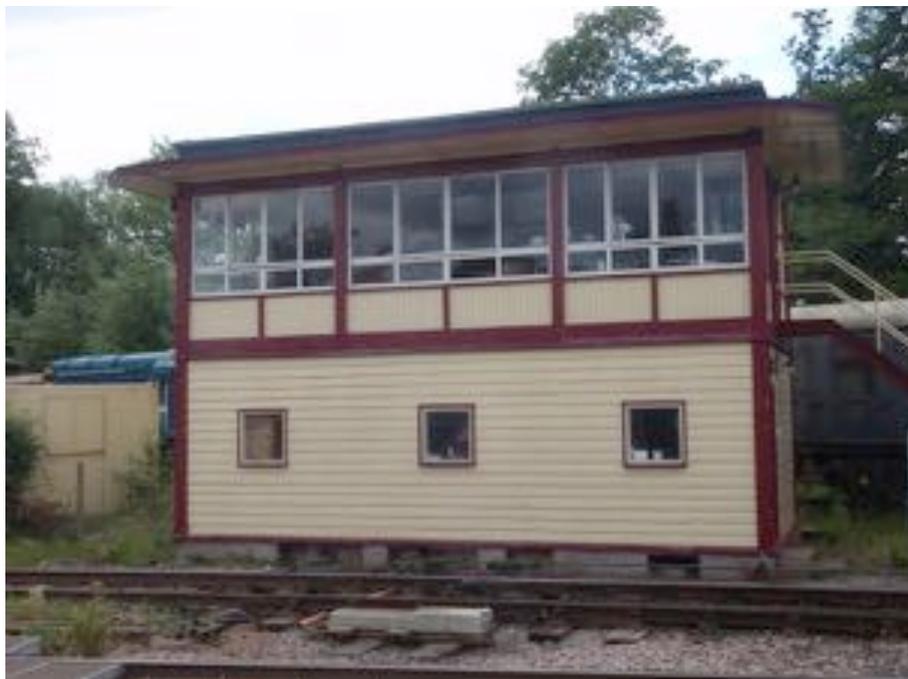
Figure A.78: Lydney Junction (Heysham Harbour) Signal Box. (Author 2017)

*Administrative location: Gloucestershire, England. Constraints: Close.
Design: BR(LMR) 15. Built: 1970/1996. Listing: n/a. Status: Use HR.*

Future/use: Heritage operational. Heritage value: Modified (replacement steel staircase), communal (level crossing). Overall condition: Good. Reuse potential: None. Relocatable: None, relocated 1996. Risk: Deliberate.

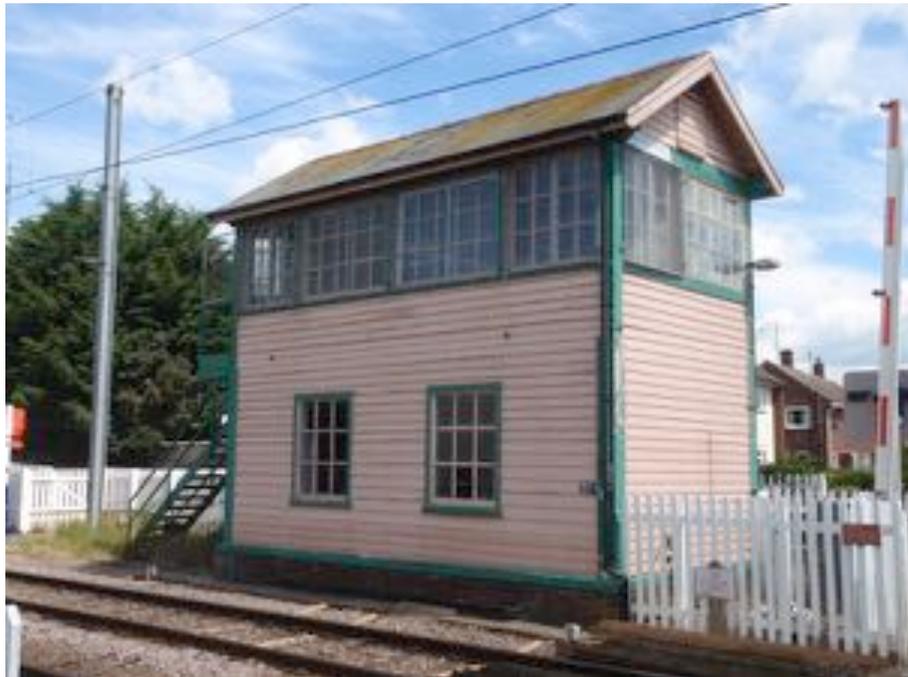
Figure A.79: Magdalen Road [Watlington] Signal Box. (Author 2016)

Administrative location: Norfolk, England. Constraints: Close. Design: GCR 5. Built: unknown/1927. Listing: n/a. Status: Use ML. Future/use: Short term. Heritage value: Modified (replacement uPVC windows, replacement steel staircase), communal (level crossing). Overall

condition: Deficient. Reuse potential: Accessible. Relocatable: Yes, previously relocated by LNER. Risk: Deliberate. Comment: Conversation.

Magdalen Road Signal Box is the oldest extant relocated signal box, being a Great Central Railway design now positioned on Great Eastern Railway territory and thereby an exemplar for relocation of a signal box away from the original geographical area. Besides this anomaly of relocation, positioned next to a level crossing and access to a station platform means that there will be considerable public awareness of this signal box.

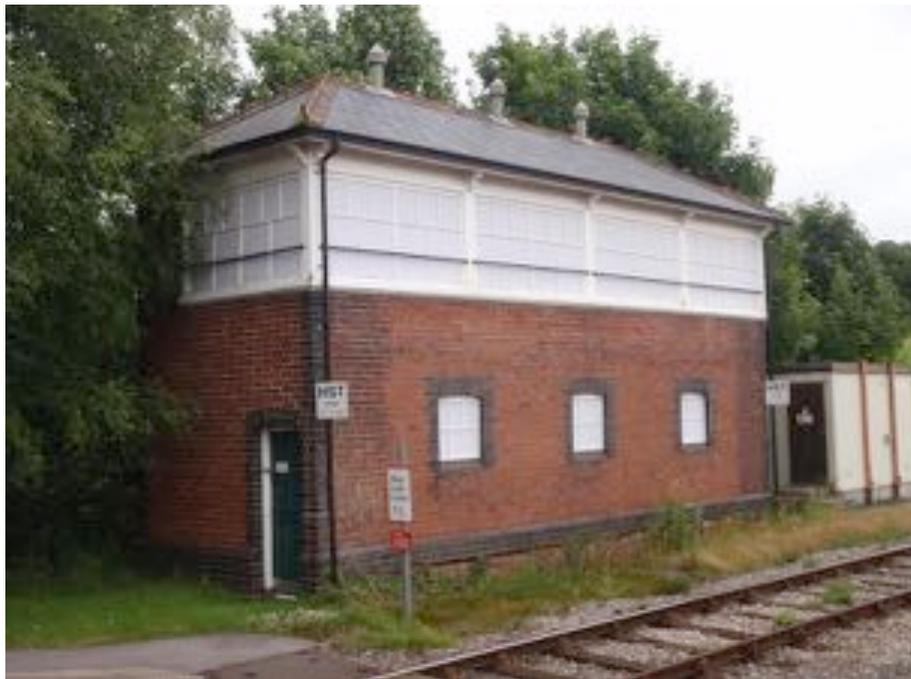
Figure A.80: Maiden Newton Signal Box. (Author 2016)

Administrative location: Dorset, England. Constraints: Close. Design: GWR 7d. Built: 1921. Listing: II [G]. Status: OOU ML. Future/use: Mothballed. Heritage value: Original, communal (group value with station). Overall condition: Fair. Reuse potential: Accessible. Relocatable: No. Risk: Deliberate. Comment: Conversation.

Treated by the local planning department as within the curtilage, and thereby one of the 'subsidiary buildings' of the listed railway station, the location of Maiden Newton Signal Box by the public foot crossing means that there will be a reasonable awareness of this building within the attractive station setting. Maiden Newton was, until 1975, a junction station for a branch line, the closure post-dating the main Beeching closures so attracting more publicity.

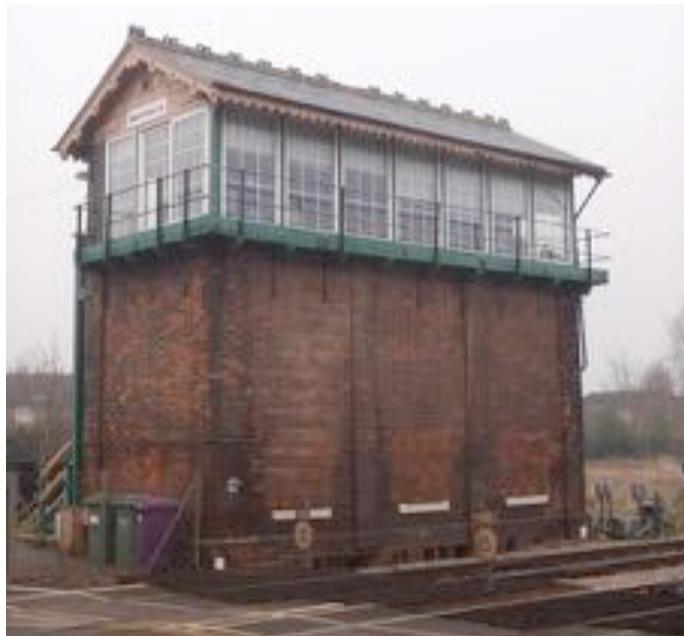
Figure A.81a: March East Junction Signal Box. (Author 2018)

Administrative location: Cambridgeshire, England. Constraints: Reasonable. Design: GER 6 [S&F]. Built: 1885. Listing: II. Status: Use ML. Future/use: Short term. Heritage value: Degraded (replacement uPVC windows, replacement timber staircase, toilet block extension), communal (level crossing). Overall condition: Fair. Reuse potential: Accessible. Relocatable: No. Risk: Weather.

Tall, imposing, and next to a busy level crossing suggests potential for considerable public awareness of March East Junction Signal Box. Although strictly applying the heritage value shows as degraded, the sympathetic treatment of the replacement uPVC windows and

replacement staircase in a layout matching the original have only a marginal impact on heritage value, with the high-level rear toilet block extension being the only modification that detracts from the heritage value.

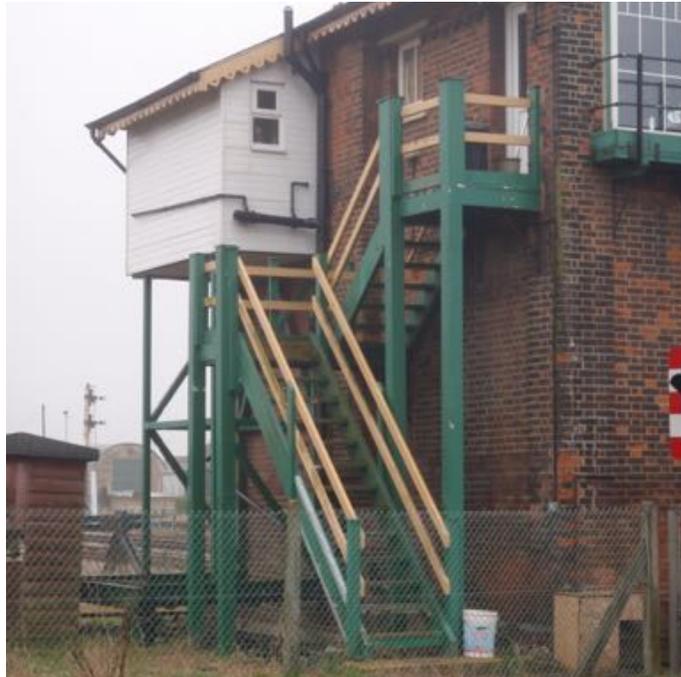
Figure A.81b: Rear elevation of March East Junction Signal Box, showing high-level toilet block extension and supporting structure. (Author 2018)

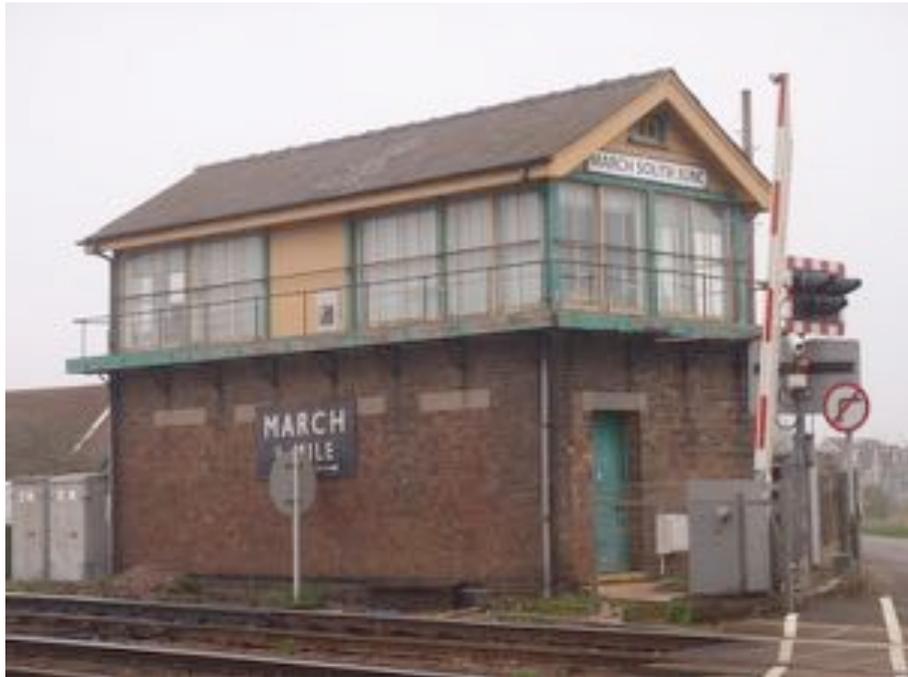
Figure A.82: March South Junction Signal Box. (Author 2018)

Administrative location: Cambridgeshire, England. Constraints: Reasonable. Design: LNER 11a. Built: 1927. Listing: n/a. Status: Use ML. Future/use: Short term. Heritage value: Modified (replacement timber staircase), communal (level crossing). Overall condition: Fair. Reuse potential: Accessible. Relocatable: No. Risk: Weather.

Adjacent to a level crossing strengthens public awareness of March South Signal Box, although compared with the more imposing March East Junction neighbour, the more modest building dimensions and less busy road crossing the level crossing means this signal box will always be the forgotten neighbour. However, there is a modicum of heritage value in the rare survivor for this design.

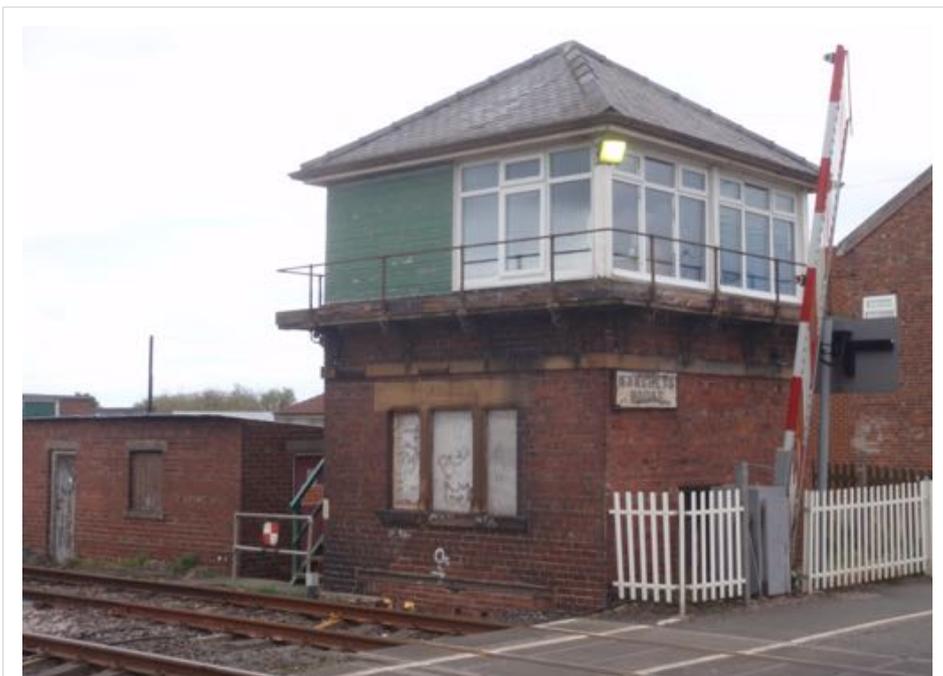
Figure A.83: Marcheys House Signal Box. (Author 2019)

Administrative location: Northumberland, England. Constraints: Close. Design: NER N2+. Built: 1895. Listing: n/a. Status: Use ML. Future/use: Short term. Heritage value: Modified (replacement uPVC windows,

replacement galvanised steel staircase), communal (level crossing). Overall condition: Fair. Reuse potential: Accessible. Relocatable: Difficult. Risk: High.

Adjacent to a level crossing will give some public awareness of Marcheys House Signal Box, although taking together the modified heritage value and overall building condition means the public perception may lead to recognition more than appreciation.

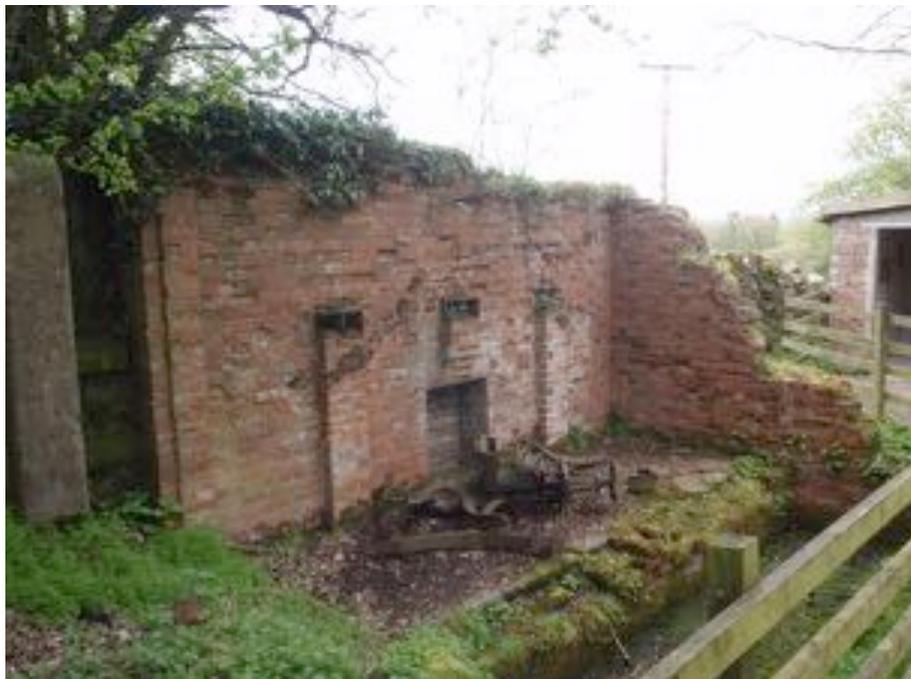
Figure A.84: Merrygill Signal Box. (Author 2017)

Administrative location: Cumbria, England. Constraints: Close. Design: NER, design unknown and assumed to S4. Built: 1925? Listing: n/a. Status: OOU IS. Future/use: Remnants. Heritage value: Degraded (missing everything other than parts of plinth and some equipment), communal (preserved as remnant on public footpath along former trackbed). Overall condition: Remnants. Reuse potential: None. Relocatable: None. Risk: Normal.

conservationist. There is an information display by these remnants to inform people using the footpath that now occupies the former railway.

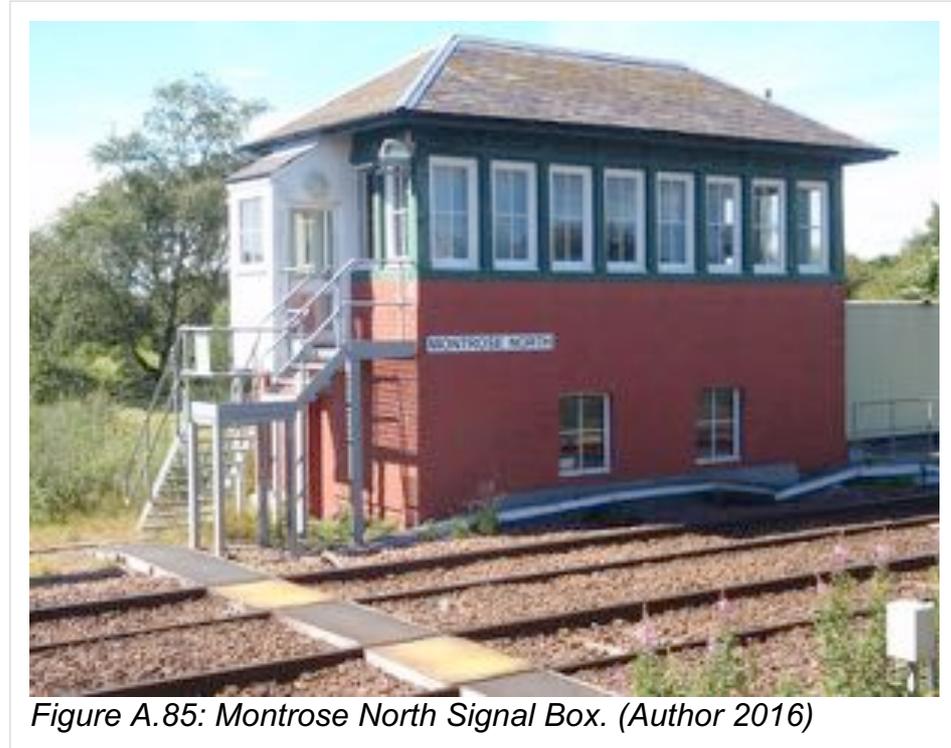
A.2.85 Montrose North Signal Box

Administrative location: Angus, Scotland. Constraints: Close. Design: NBR 1. Built: 1881. Listing: C. Status: Use ML. Future/use: Medium term. Heritage value: Modified (replacement uPVC windows, replacement steel staircase). Overall condition: Fair. Reuse potential: Poor. Relocatable: No. Risk: High.

Besides the obvious modifications, use of masonry paint on Montrose North Signal Box presents that same mixed success noted for Dunkeld & Birnam Signal Box, a well-maintained appearance while potentially distorting conservation values. Public perception for Montrose North Signal Box will mostly be from the main road next to the railway.

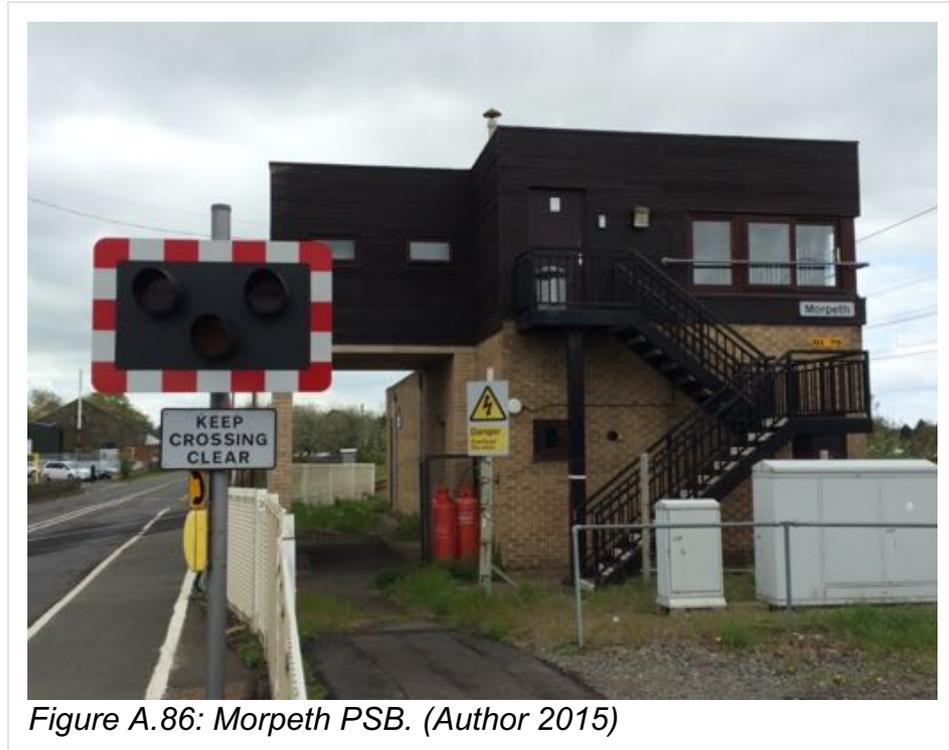
Administrative location: Northumberland, England. Constraints: Reasonable. Design: BR(ER) 20. Built: 1978. Listing: n/a. Status: Use

ML. Future/use: Long term. Heritage value: Modified (replacement uPVC windows, replacement steel staircase), communal (level crossing). Overall condition: Good. Reuse potential: Accessible. Relocatable: None. Risk: Deliberate.

Representing the last iteration of British Rail (Eastern Region) designs, only a few of the BR(ER) 20 design were constructed for resignalling schemes outside the remit of larger area signalling centres. As these lines are now under the control of the new regional operating centres, most BR(ER) 20s are redundant, with the main purpose of those that survive to provide local supervision of level crossings.

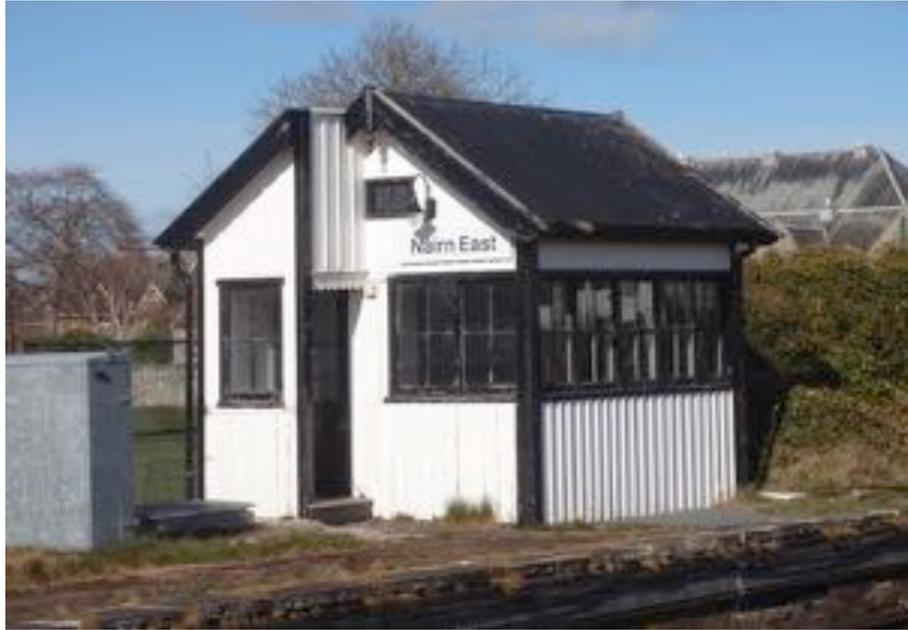
Figure A.87: Nairn East Signal Box. (Author 2018)

Administrative location: Highland, Scotland. Constraints: Reasonable. Design: McK&H 3 [Highland]. Built: 1891. Listing: B [G]. Status: OOU ML. Future/use: Mothballed. Heritage value: Original. Overall condition: Good. Reuse potential: Accessible. Relocatable: Yes. Risk: Normal. Comments: Heritage value enhanced as surviving Highland 'pair'.

Unlike most main line railways, the Highland Railway was extensively single track with longer than normal passing loops, so the railway had an unusual method of signalling, with boxes at each end of the passing loop to control points and signals, with the communication instruments in the main station building, the porter signaller moving between the signal boxes as required (Nock 1973, p128). Nairn East and West are amongst the last surviving examples of this peculiar Highland Railway signalling installation.
