**CONSERVATION OF FUNCTIONAL
HERITAGE RAILWAY BUILDINGS
AS AN ARCHETYPE FOR THE
CONSERVATION OF FUNCTIONAL
HERITAGE BUILDINGS**

CHRISTOPHER DIETMAR REEVES

A thesis submitted in partial fulfilment
of the requirements of the University
of Northumbria at Newcastle for the
degree of Doctor of Philosophy

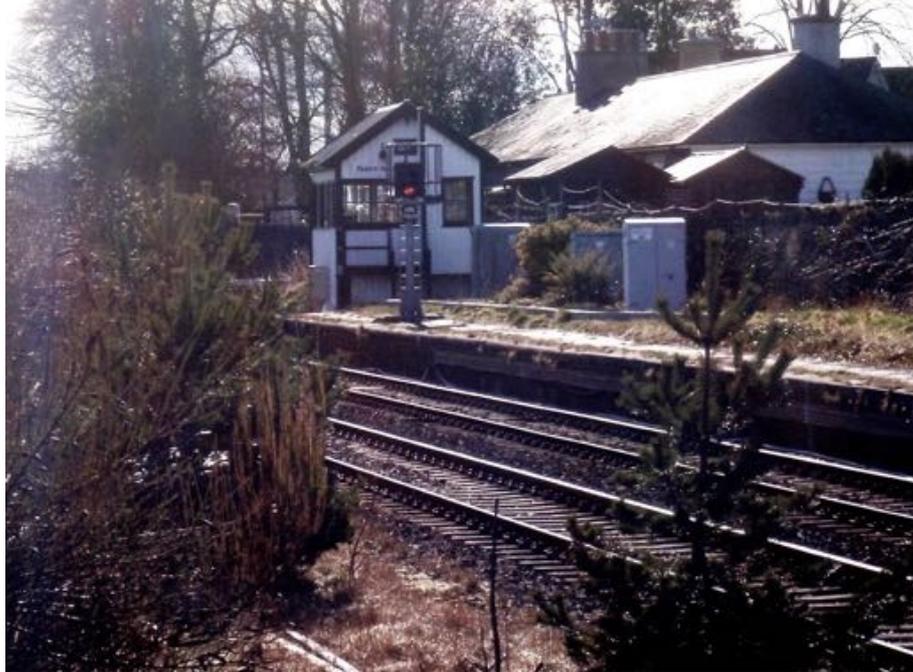
Figure A.88: Nairn West Signal Box. (Author 2018)

Administrative location: Highland, Scotland. Constraints: Distant. Design: McK&H 3 [Highland]. Built: 1891. Listing: B [G]. Status: OOU ML. Future/use: Mothballed. Heritage value: Original. Overall condition: Good. Reuse potential: Accessible. Relocatable: Yes. Risk: Normal. Comments: Heritage value enhanced as surviving Highland 'pair'

Less accessible than its counterpart means it is hard to recognise the significance of Nairn West Signal Box being part of a Highland 'pair'.

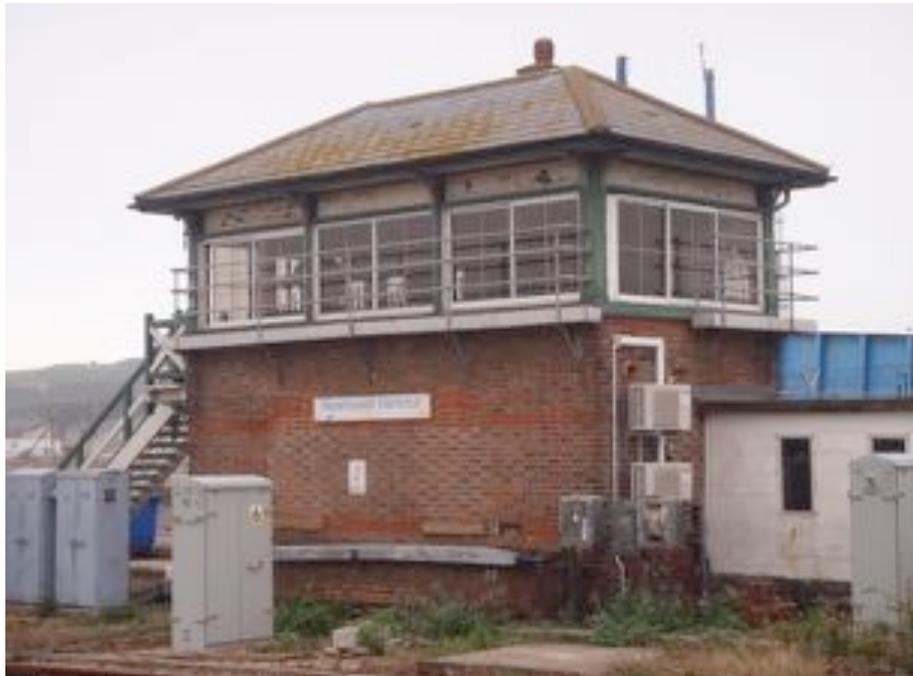
Figure A.89: Newhaven Harbour Signal Box. (Author 2016)

Administrative location: East Sussex, England. Constraints: Close. Design: S&F 5 [LBSCR]. Built: 1886. Listing: n/a. Status: Use ML. Future/use: Short term, since demolished (2020). Heritage value:

Modified (replacement uPVC windows, replacement timber staircase). Overall condition: Fair. Reuse potential: Poor. Relocatable: Partially. Risk: Weather.

Located within a partially controlled area, Newhaven Harbour Signal Box had minimal public observation and conservation value will depend upon any intrinsic heritage value of the building. The most obvious heritage value is a tangible link with the now obsolete traditional of 'boat trains' (Simmons & Biddle 2000, p36), although the link is tenuous.

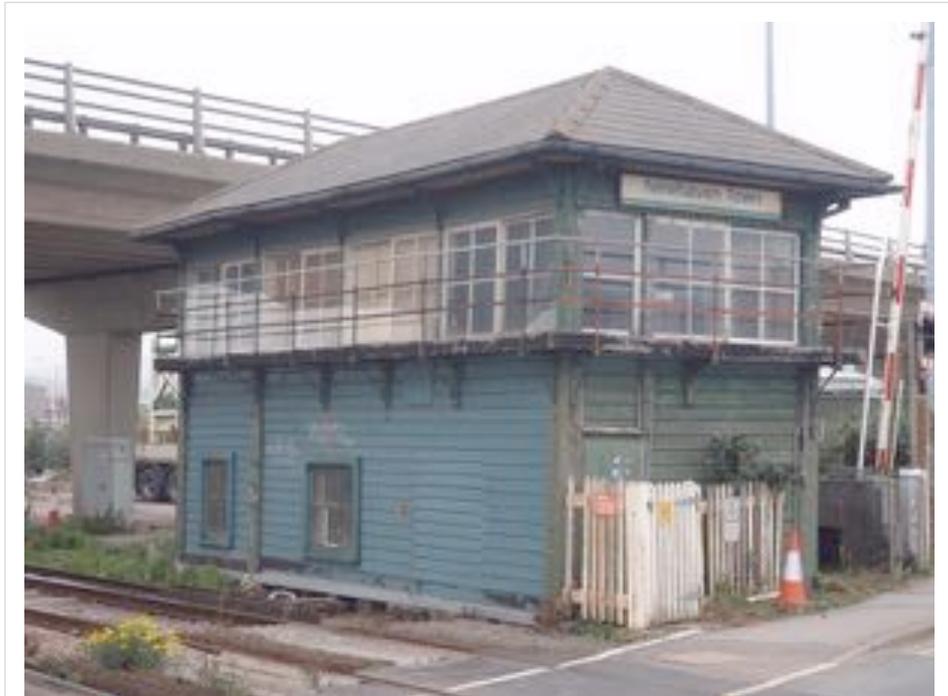
Figure A.90: Newhaven Town Signal Box. (Author 2016)

Administrative location: East Sussex, England. Constraints: Close. Design: S&F 5 [LBSCR]. Built: 1879. Listing: n/a. Status: Use ML. Future/use: Short term, since demolished (2020). Heritage value: Modified (brick extension to rear, replacement timber staircase), communal (level crossing). Overall condition: Deficient, structural movement. Reuse potential: Accessible. Relocatable: Partially. Risk: High.

Being next to a level crossing strengthened public awareness of Newhaven Town Signal Box. With minimal maintenance pending closure, demolition was inevitable as the main body of the signal box appears to be structurally deficient and a tentative analysis suggests that the brick-built toilet block extension to the rear elevation was effectively propping up the main building.

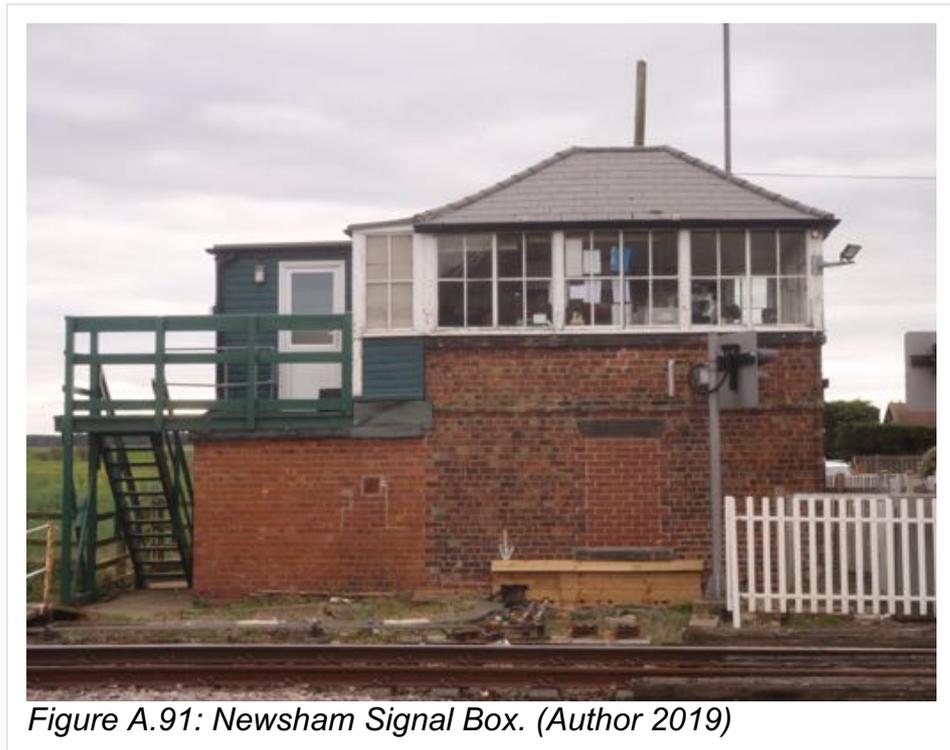
Figure A.91: Newsham Signal Box. (Author 2019)

Administrative location: Northumberland, England. Constraints: Reasonable. Design: NER N1. Built: Unknown. Listing: n/a. Status: Use ML. Future/use: Short term. Heritage value: Degraded (replacement uPVC windows, replacement galvanised steel, uPVC clad toilet block extension), communal (level crossing). Overall condition: Fair. Reuse potential: Accessible. Relocatable: No. Risk: High.

Adjacent to a level crossing strengthens public awareness of Newsham Signal Box. However, the location and degraded heritage value of the building does not support any significant heritage recognition.

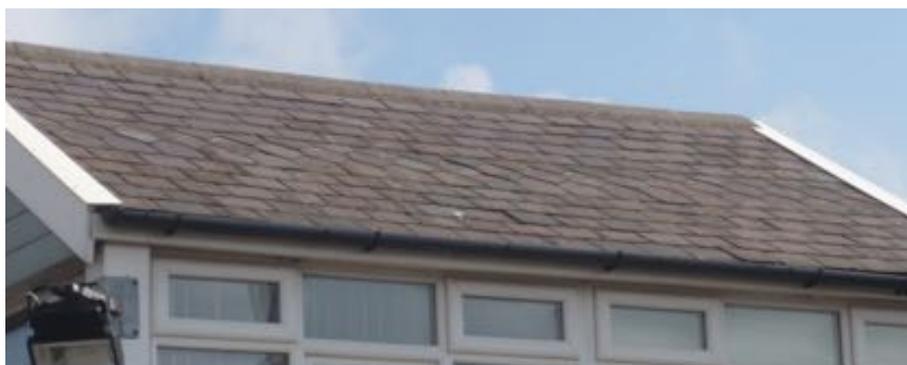
Figure A.92b: Roof detail for North Seaton Signal Box, retaining the diamond slate detailing redolent of original detailing despite the otherwise substantial evidential degrading. (Author 2019)

Kirkconnel Signal Box, as somewhere inside this mixture of uPVC is the original building carrying out the same function and displaying a strong narrative of functional building ethos. One, almost charming, anomaly in this uncompromising updating is the slate roof finish preserving the original diamond slate detailing.

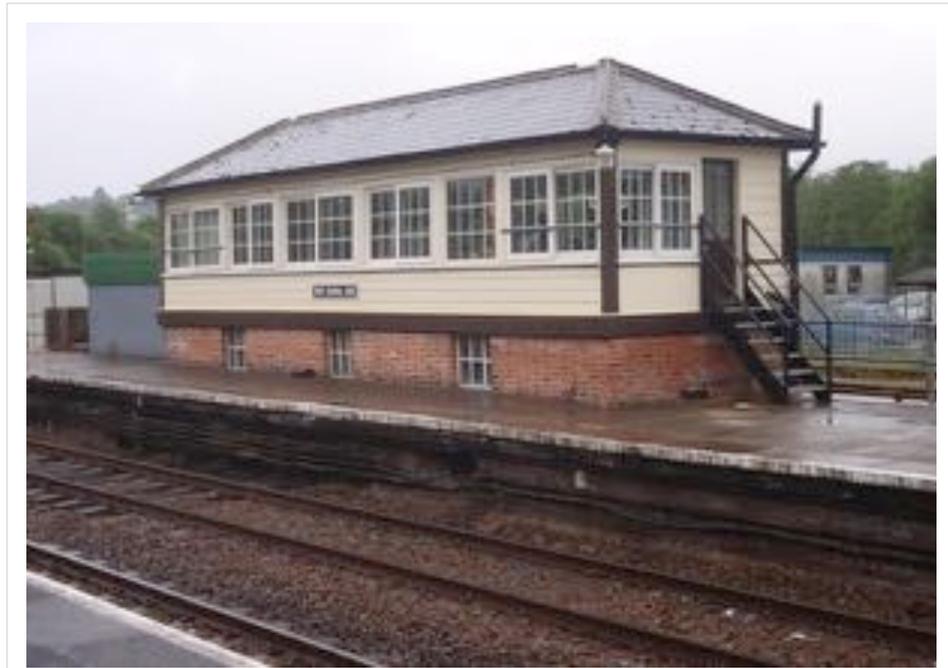
Figure A.93: Par Signal Box. (Author 2018)

Administrative location: Cornwall, England. Constraints: Close. Design: GWR 2. Built: c1879. Listing: II. Status: Use ML. Future/use: Short term. Heritage value: Modified (replacement uPVC windows, replacement steel staircase), communal (station location). Overall condition: Good. Reuse potential: Accessible. Relocatable: No. Risk: Weather.

The end of platform location will provide marginal public awareness for Par Signal Box, enhanced as very visible looking west from where passengers will congregate. This is another signal box where replacement uPVC windows to the original window pattern shows sympathetic treatment of the building.

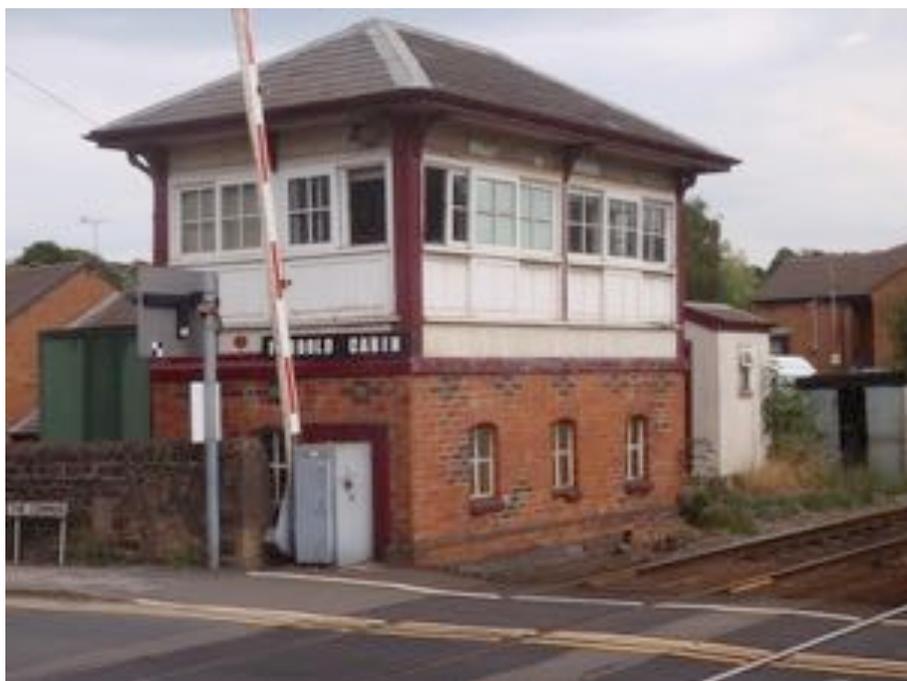
Figure A.94: Parbold Signal Box. (Author 2018)

Administrative location: Lancashire, England. Constraints: Close. Design: S&F [LYR]. Built: 1877. Listing: II. Status: Use ML. Future/use: Short term. Heritage value: Modified (replacement timber staircase), communal (level crossing). Overall condition: Fair. Reuse potential: Accessible. Relocatable: Partially. Risk: Normal.

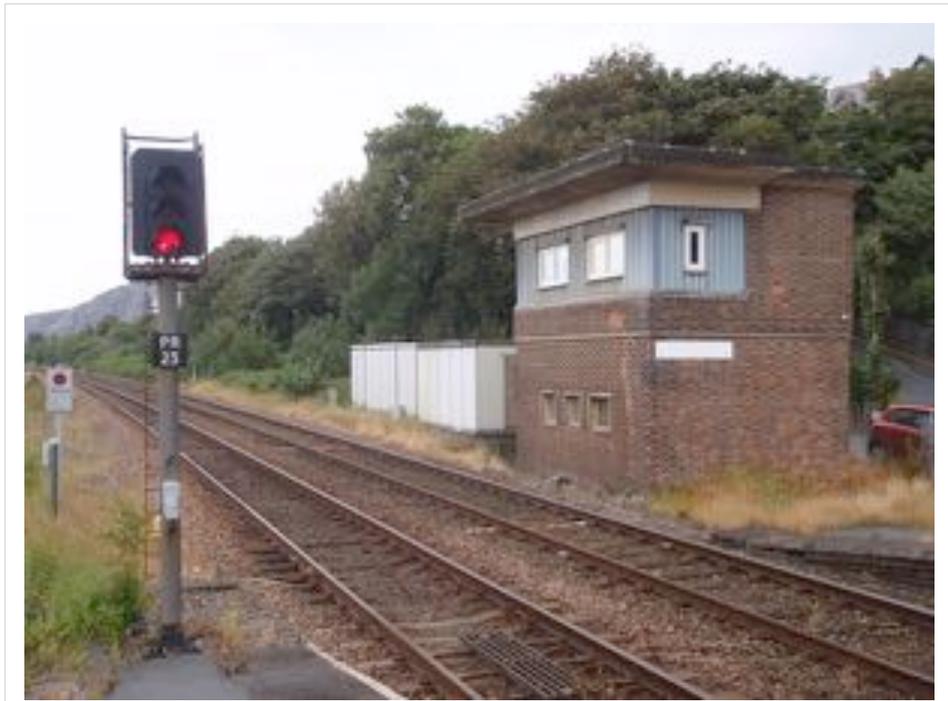
Figure A.95: Penmaenmawr Signal Box. (Author 2017)

Administrative location: Conwy, Wales. Constraints: Close. Design: BR(LMR) 14. Built: 1952. Listing: n/a. Status: Use ML. Future/use: Short term. Heritage value: Modified (replacement uPVC and profiled sheet infill windows), historical (replaced original signal box implicated

in fatal accident). Overall condition: Fair (structural movement). Reuse potential: Accessible. Relocatable: No. Risk: Weather.

Strongest public perception of Penmaenmawr Signal Box will be from the adjacent road, although most likely this is another easy to overlook 1950s building with, in this case, structural problems. The design is rare and driving the reason for construction was a fatal accident that had similarities with the Ais Gill Disaster associated with Garsdale Signal Box (Wilson 1951, pp12-3).

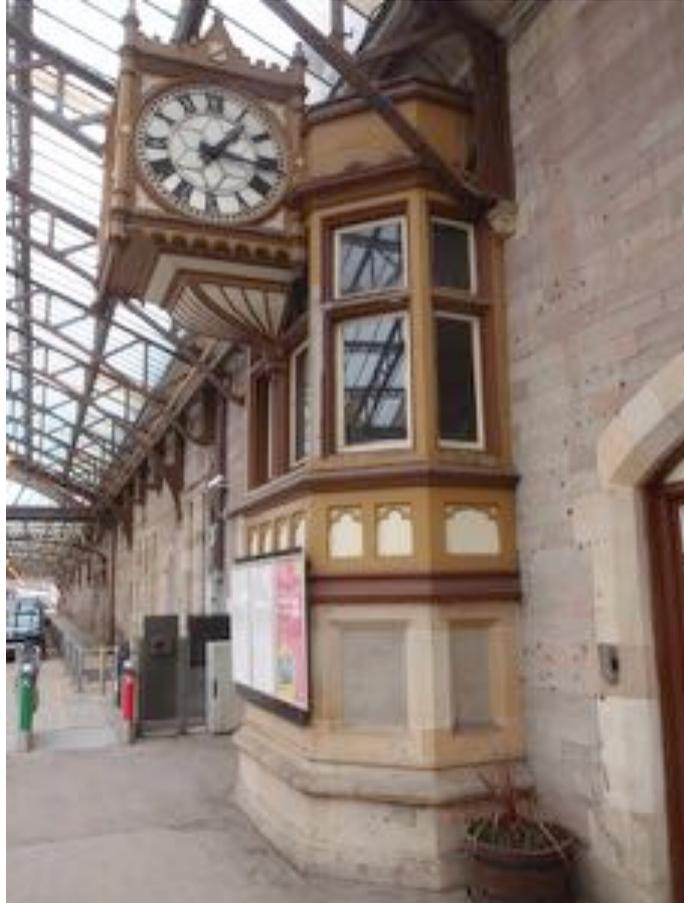
Figure A.96: Perth Down Centre Signal Box. (Author 2018)

Administrative location: Perth & Kinross, Scotland. Constraints: Close. Design: Caledonian bespoke. Built: 1886. Listing: B [G]. Status: OOU ML. Future/use: Mothballed. Heritage value: Original, communal (station location). Overall condition: Good. Reuse potential: Good. Relocatable: No. Risk: Normal. Comment: Conversation.

The closed Perth Down Centre Signal Box once served a similar function to Carlisle No 4 or York Platform, being one of several mechanical signal boxes controlling trains at this busy location, and it

is equally unlikely that casual observers will recognise that this attractive structure integral to Perth Railway Station was once a signal box.

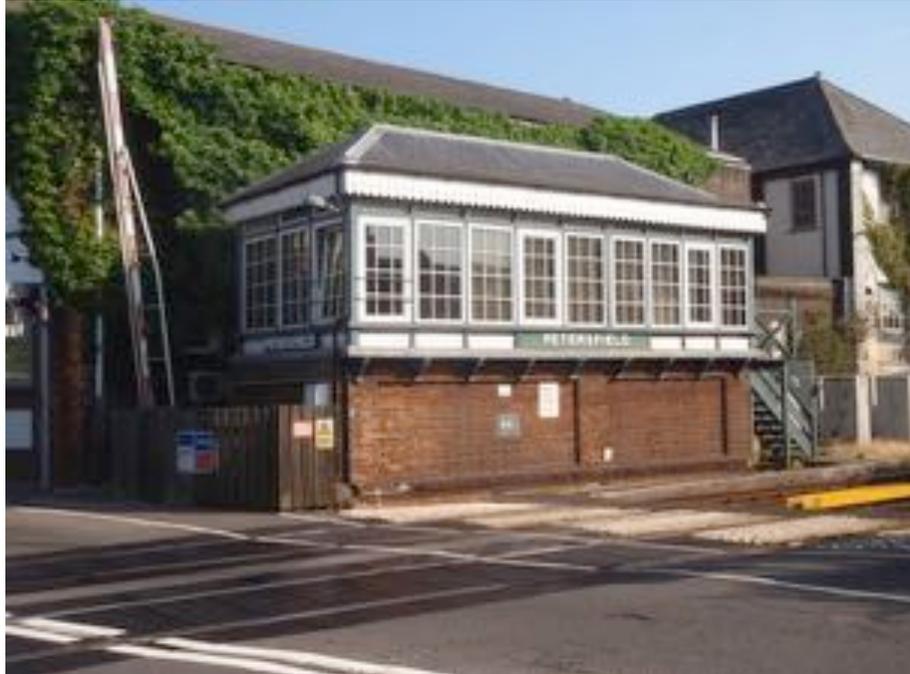
Figure A.97: Petersfield Signal Box. (Author 2018)

Administrative location: Hampshire, England. Constraints: Reasonable. Design: LSWR 3a. Built: 1880s. Listing: II [GV]. Status: Use ML. Future/use: Long term. Heritage value: Modified (replacement uPVC windows, replacement timber staircase), communal (level crossing). Overall condition: Good. Reuse potential: Accessible. Relocatable: No. Risk: Normal.

In making the case for listing, Minnis (2012, p20) describes Petersfield Signal Box as a particularly striking and well-preserved example of a design hitherto not presented by listing. Nevertheless, in 2020 the

custodians, Network Rail, were in pre-application discussion with South Downs National Park and East Hampshire council concerning complete demolition for a new level crossing pedestal base (Private Eye 2020, p23), with Network Rail counterintuitively justifying complete demolition to prevent vandalism (*ibid*). Paradoxically, being next to the level crossing in contention strengthens public awareness of this signal box.

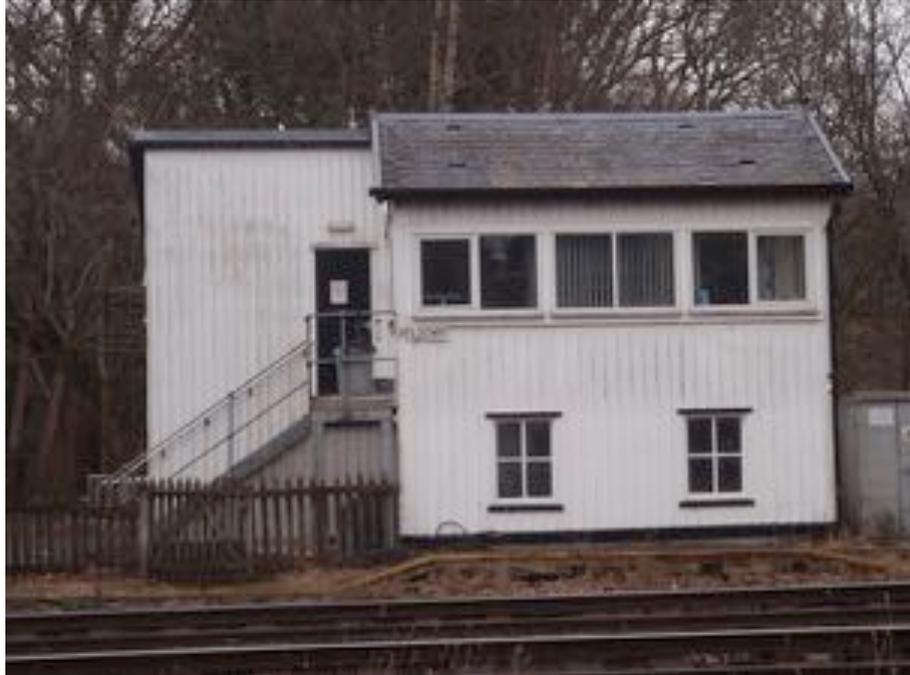
Figure A.98: Pitlochry Signal Box. (Author 2018)

Administrative location: Perth & Kinross, Scotland. Constraints: Close. Design: Highland. Built: 1911. Listing: A [G]. Status: Use ML. Future/use: Short term. Heritage value: Degraded (partially replacement uPVC windows, replacement steel staircase, extended), communal (station location). Overall condition: Good. Reuse potential: Accessible. Relocatable: Yes. Risk: Weather.

This signal box is an enigma. Individually the modifications reduce the heritage value, plus the toilet block extension is, in the same way as Kingussie Signal Box, slightly awkward. Taken together, this detracts from the heritage value even if the extension design matches the main

building design style and is thereby an effective part of the building narrative. Yet the signal box forms a group with the Grade A listed station as integrated railway environment.

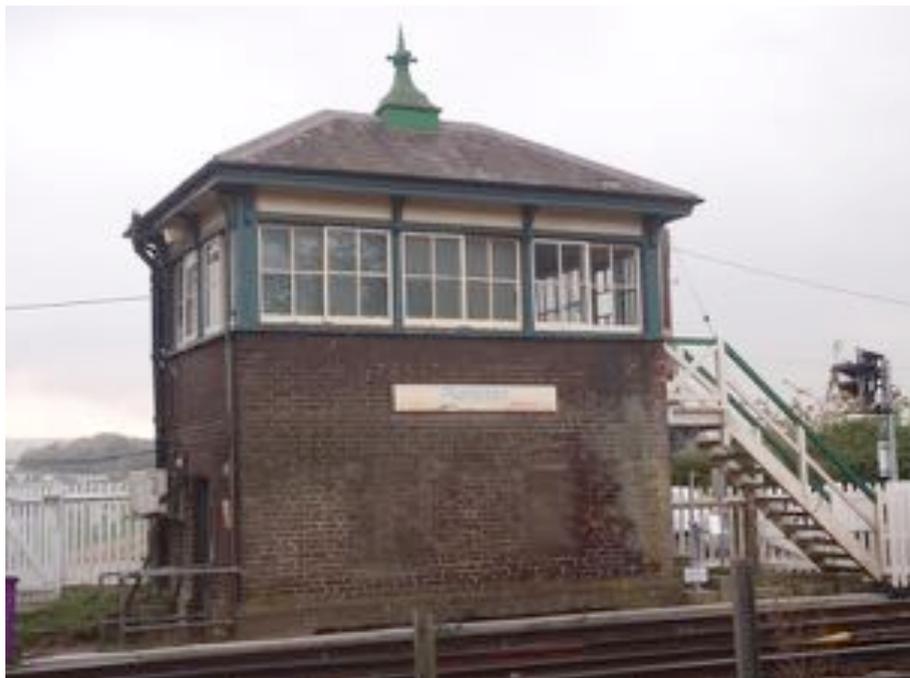
Figure A.99: Plumpton Signal Box. (Author 2016)

Administrative location: East Sussex, England. Constraints: Close. Design: LBSCR 2b. Built: 1891. Listing: II. Status: OOU ML. Future/use: Mothballed. Heritage value: Modified (replacement timber staircase), communal (level crossing). Overall condition: Good. Reuse potential: Accessible. Relocatable: Difficult. Risk: Normal.

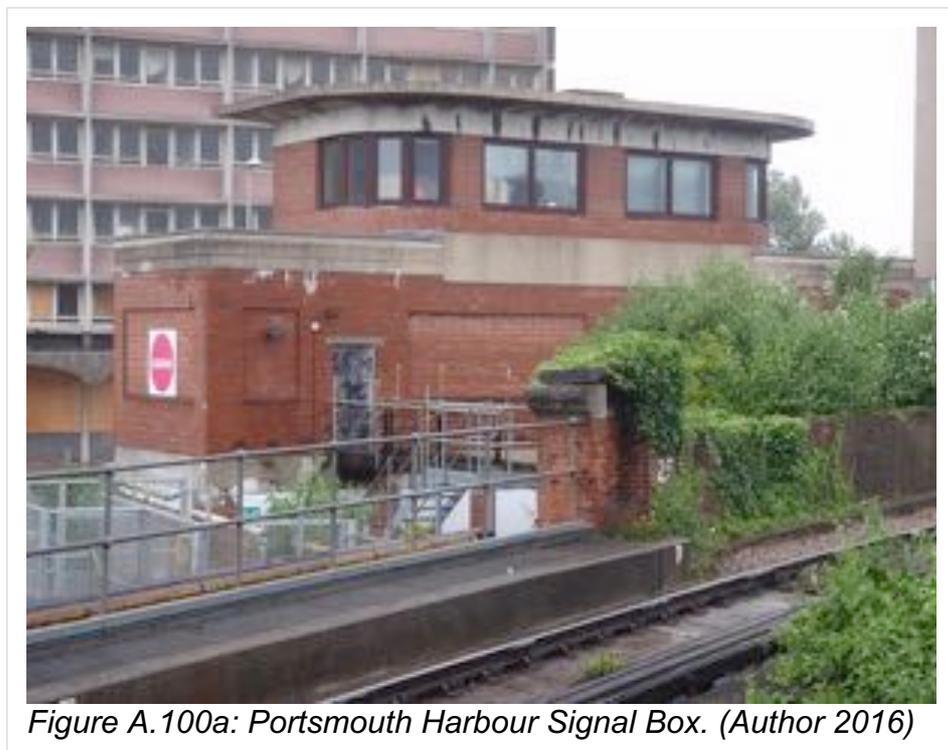
Figure A.100a: Portsmouth Harbour Signal Box. (Author 2016)

Administrative location: Portsmouth, England. Constraints: Close. Design: SR 13. Built: 1946. Listing: n/a. Status: OOU ML. Future/use: Mothballed. Heritage value: Original, communal (street presence). Overall condition: Good. Reuse potential: Good, street level apparent conversion to (unlet) retail units. Relocatable: No. Risk: High.

Presumably after modifications to the railway station track layout, Portsmouth Harbour Signal Box is slightly remote from the railway and presents a limited public perception at track level. However, the viaduct location of this station means that the street level elevation of this signal box has recognised potential for reuse as retail units.

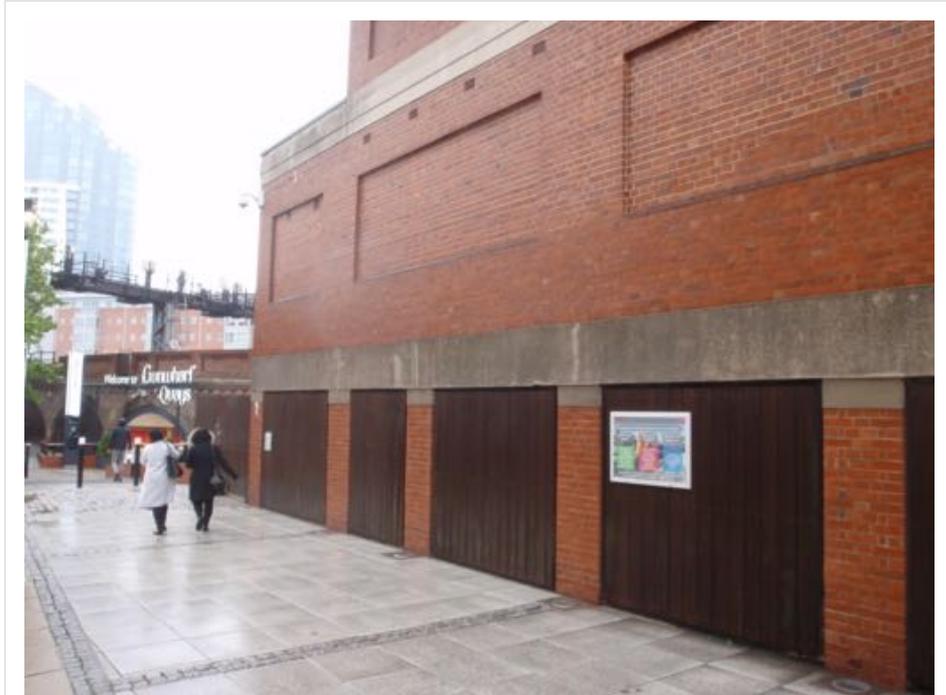
Figure A.100b: Street level view of Portsmouth Harbour Signal Box, showing voids with potential for retail use. (Author 2016)

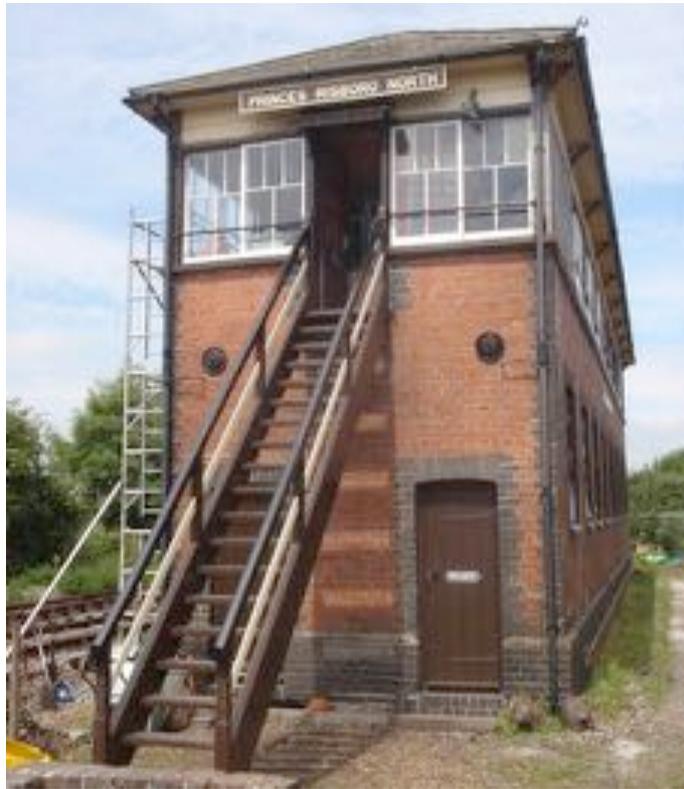
Figure A.101a: Princes Risborough North Signal Box. (Author 2018)

Administrative location: Buckinghamshire, England. Constraints: Close. Design: GWR 7b. Built: 1905. Listing: II. Status: HR. Future/use: Heritage operational. Heritage value: Modified (replacement timber staircase to original design), communal (station location). Overall condition: Fair, under restoration. Reuse potential: None. Relocatable: None. Risk: Deliberate. Comment: Conversation.

Although slightly remote from the station, Princes Risborough North Signal Box is enough of a visibly imposing structure to unmistakably present as heritage railway infrastructure. In the custodianship of a heritage railway since 2013, for users of this heritage railway the

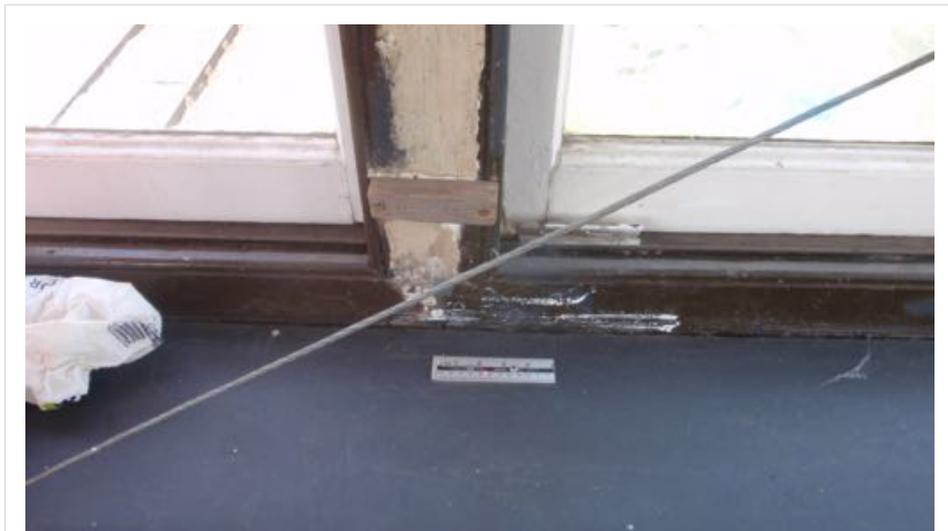
For the same price it is often easier to build something new, except that politics can get in the way and there is a realisation that, 'we do the best with what we have or there would be nothing'. When the society moved into the signal box, they found timber framing was either missing or a lot of the remaining timber was rotten. As Network Rail place a higher priority on keeping trains running than listed buildings, there was a fear that any structural movement compromising safe working of the trains would entail immediate demolition with paperwork to follow.

Figure A.101c: Movement prevention and monitoring using tension wire and tell-tale ruler with laser spot, Princes Risborough North Signal Box. (Author 2018)

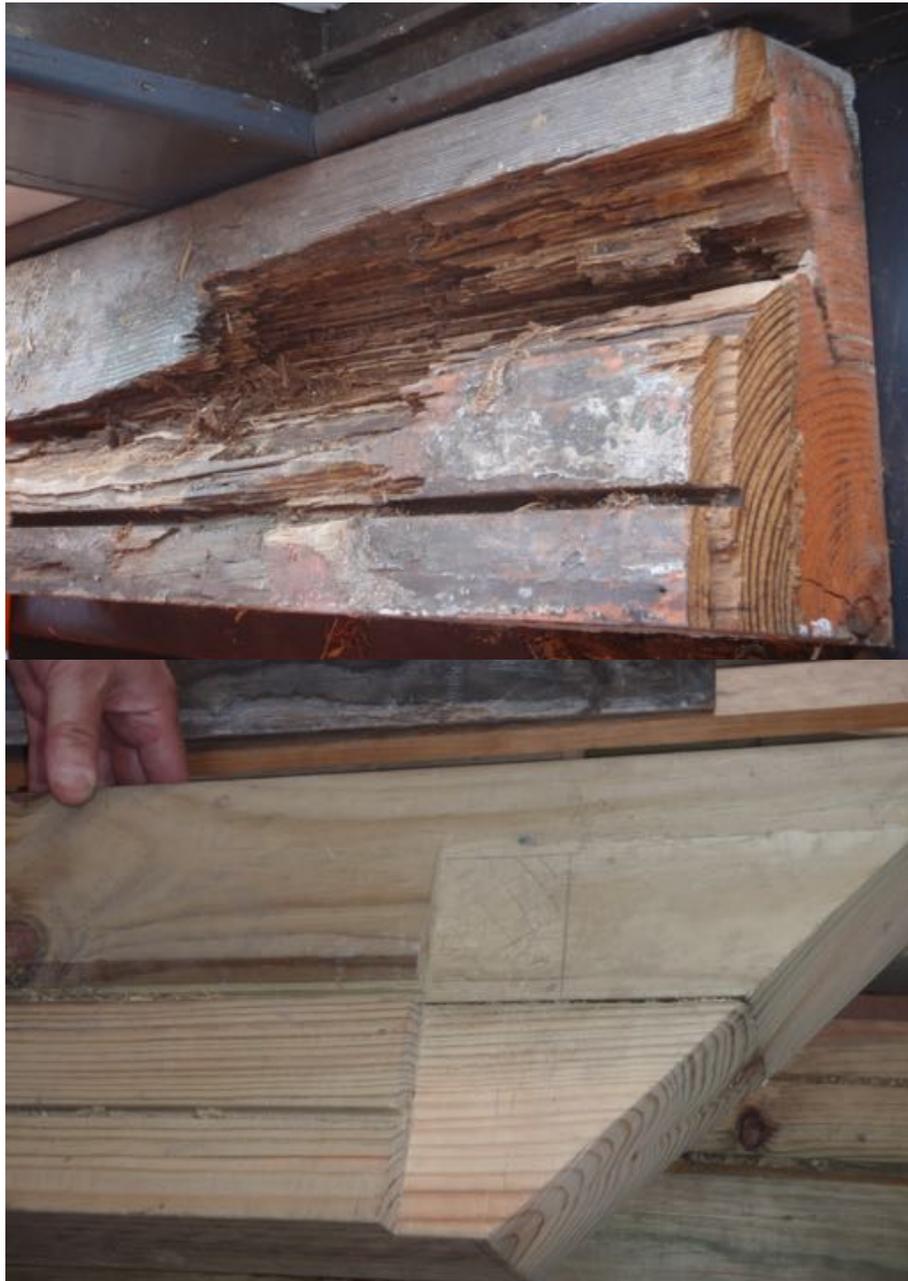
Figure A.101d: Rotten timber frame sections used as a pattern for fabrication of replacement timber frame sections, Princes Risborough North Signal Box. (Author 2018)

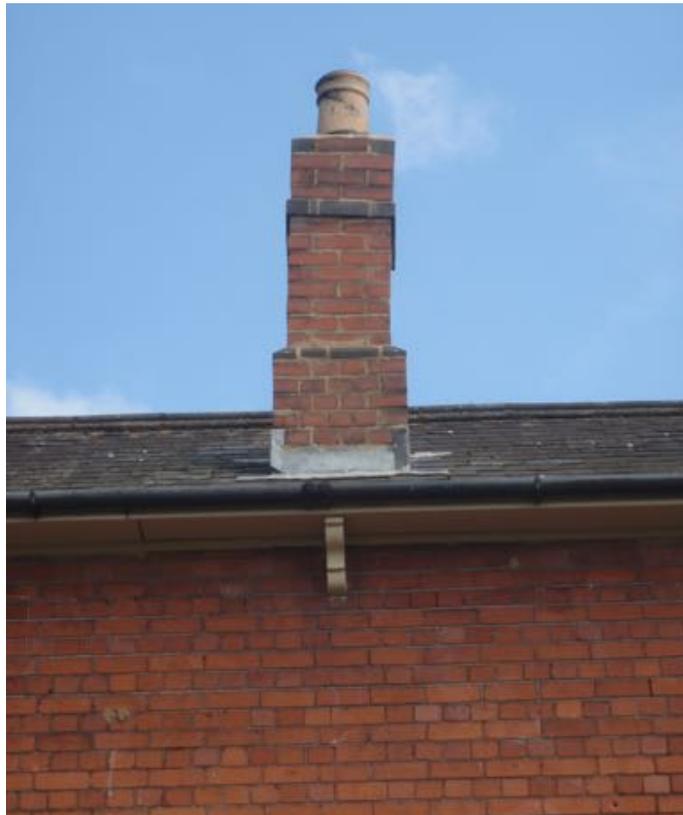
The chimneys were another problem. Capping of the south chimney occurred in the 1970s and rebuilt in the 1990s. In 2017 the north chimney needed stabilising to avoid collapse, and there was a conscious decision to keep a pre-existing lean for authenticity.

Figure A.101e: Chimney rebuilt with pre-existing lean for authenticity, Princes Risborough North Signal Box. (Author 2018)

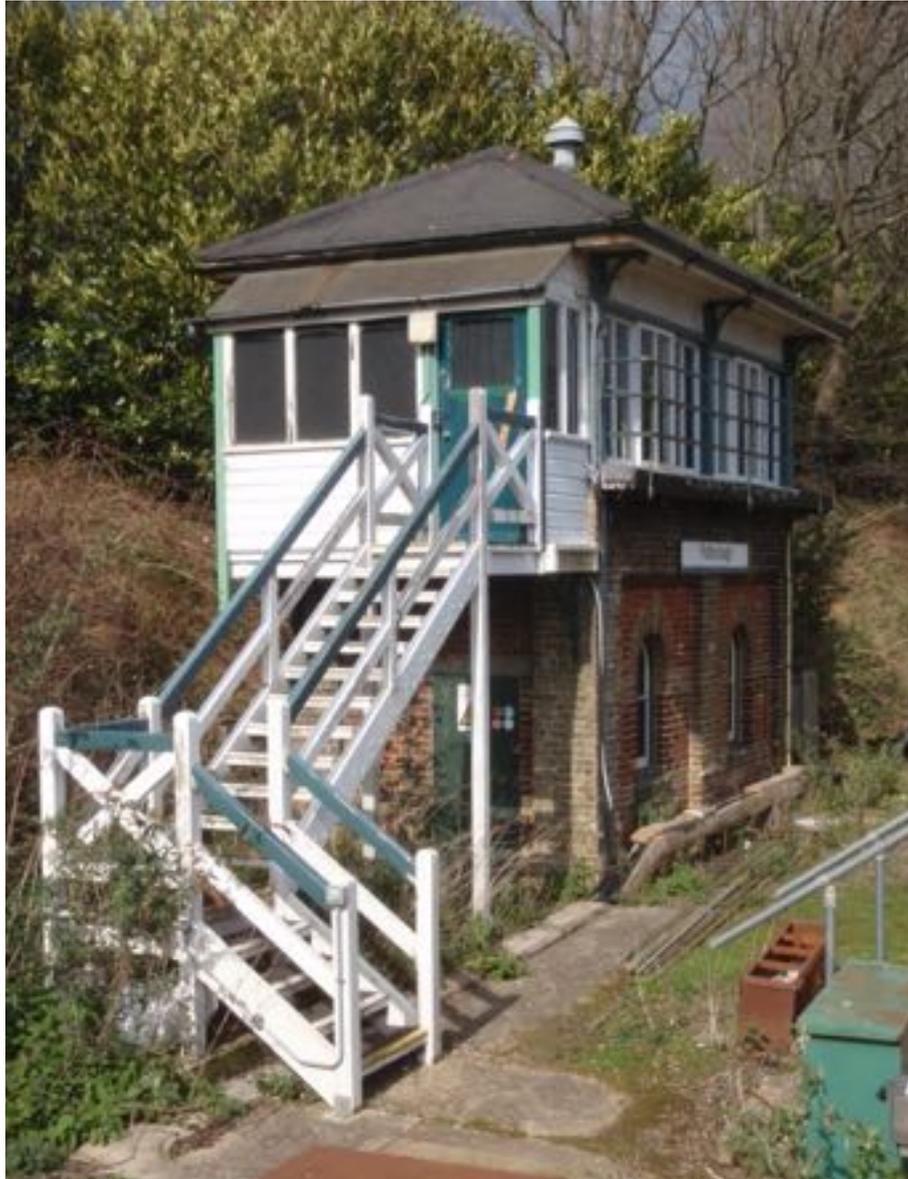
Figure A.102a: Pulborough Signal Box. (Author 2016)

Administrative location: West Sussex, England. Constraints: Close. Design: S&F 5 [LBSCR]. Built: 1878. Listing: II. Status: OOU ML. Future/use: Mothballed. Heritage value: Modified (porch/toilet added before 1930s, replacement staircase). Overall condition: Fair. Reuse potential: Poor. Relocatable: Difficult. Risk: Normal.

Slightly set back from one of the station platforms after removal of the bay platform³⁰ following closure of the Midhurst Branch Line in 1955 and removal of the goods yard (Cobb 2005, p62), the pretty, other than the insensitive additional porch, Pulborough Signal Box is slightly remote from direct public awareness, although continues to have a group value with the attractive station.

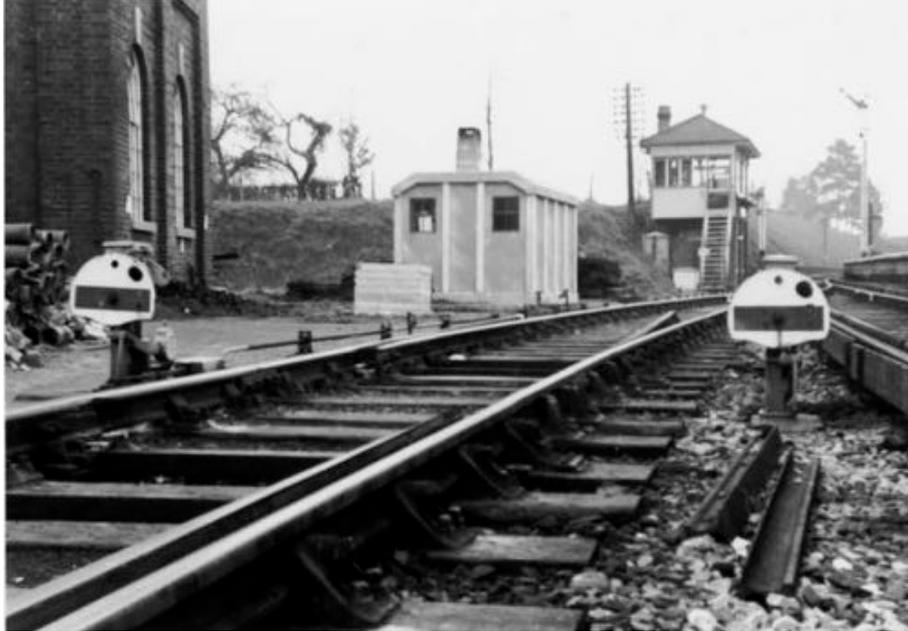
Figure A.102b: Pulborough Signal Box. Seemingly taken in 1938 after electrification of the Arun Valley main line, this photo shows the original context, with goods yard and bay platform for Midhurst branch line. This photo provides evidence of the porch addition before 1938. (Photo unknown, used by permission of Adrian Vaughan Collection)

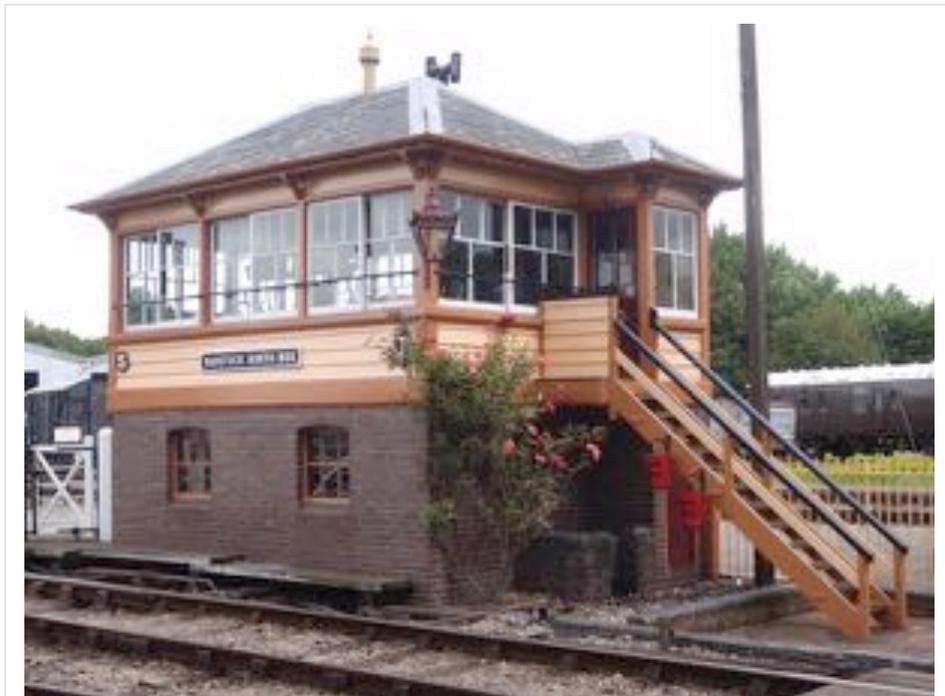
Figure A.103: Radstock North Signal Box as relocated to the Great Western Society at Didcot. (Author 2016)

Administrative location: Oxfordshire, England. Constraints: Close. Design: GWR 27c. Built: 1909/1985. Listing: n/a. Status: Use HR. Future/use: Museum and heritage operational. Heritage value: Modified (modern brickwork plinth, timber staircase matches original), communal (museum location). Overall condition: Good. Reuse potential: None. Relocatable: None, relocated 1985. Risk: Normal.

Radstock North Signal Box is the other relocated heritage signal box at this heritage railway centre, in this case the signal box displayed in a middle 20th Century condition. For the visitor, this very well-presented display within a fascinating heritage site will evoke a keen sense of public awareness in the signal box, yet it is probable that the display presents an idealised version of the period. Furthermore, brickwork detailing for the reconstructed locking room shows notable differences compared with early 20th Century, although it is probable that most visitors will be unaware of this subtlety.

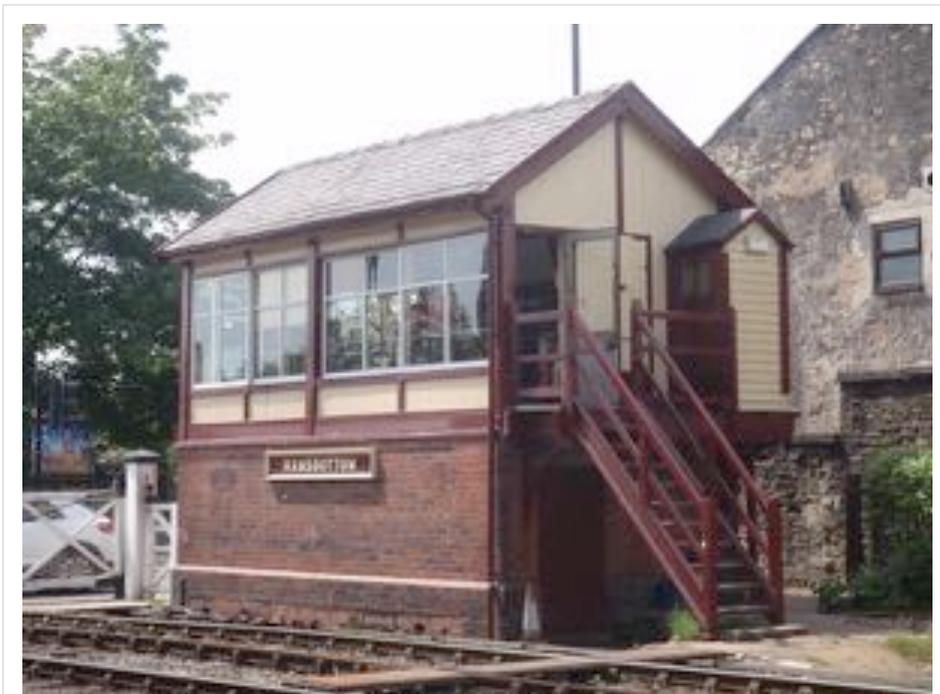
Figure A.104: Ramsbottom Signal Box. (Author 2018)

Administrative location: Bury, England. Constraints: Close. Design: LMS 11c. Built: 1938. Listing: n/a. Status: Use HR. Future/use: Heritage operational. Heritage value: Modified (replacement steel staircase with timber treads), communal (level crossing). Overall condition: Good. Reuse potential: None. Relocatable: None. Risk: Possibly deliberate.

Being next to a level crossing strengthens public awareness of this signal box, augmented by a strong incentive for the heritage railway to present an attractive face in a very public place to enhance the narrative they are trying to present.

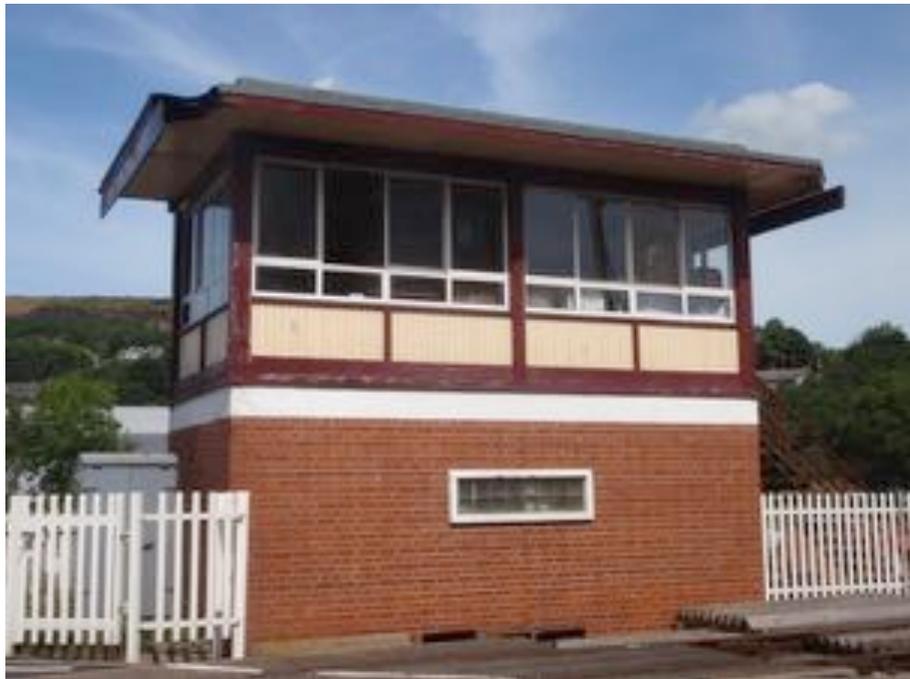
Figure A.105: Rawtenstall West Signal Box. (Author 2018)

Administrative location: Lancashire, England. Constraints: Close. Design: BR(LMR) 15. Built: 1957. Listing: n/a. Status: Use HR. Future/use: Heritage operational. Heritage value: Modified (replacement steel staircase with timber treads), communal (level crossing). Overall condition: Fair. Reuse potential: None. Relocatable: None. Risk: Normal.

Being next to a level crossing strengthens public awareness of this signal box, although not as close to the railway station as Ramsbottom Signal Box so the distinctive 1950s style of Rawtenstall West Signal Box fulfils a strongly functional purpose rather than selling the heritage railway narrative.

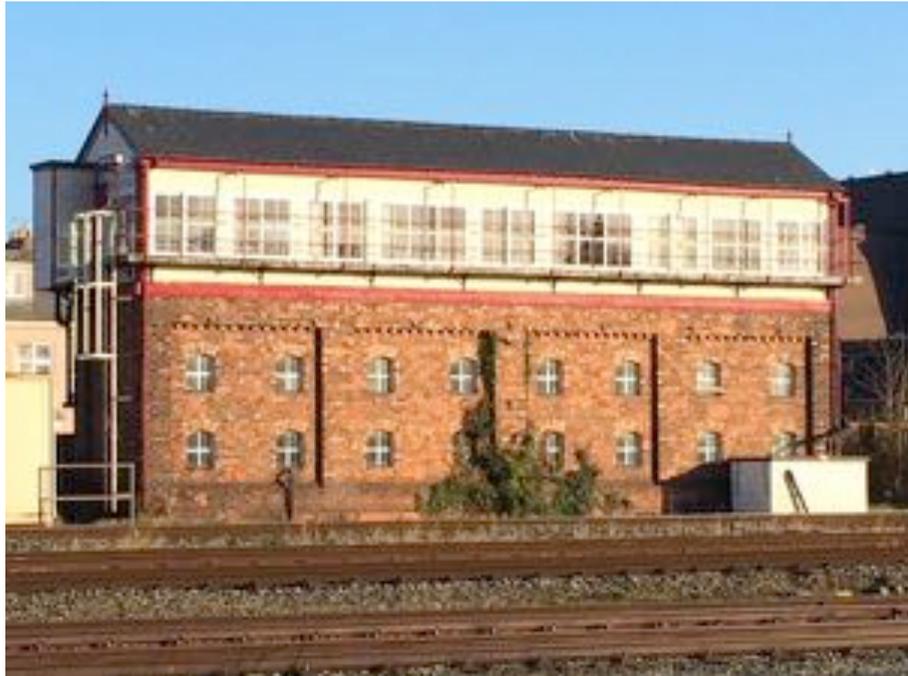
Figure A.106: Rhyl No 1 Signal Box. (Author 2016)

Administrative location: Denbighshire, Wales. Constraints: Close. Design: LNWR 4. Built: 1900. Listing: II. Status: Use ML. Future/use: Short term, since closed (2018). Heritage value: Modified (additional steel external ladder), communal (large building in public place). Overall condition: Fair. Reuse potential: Accessible. Relocatable: No. Risk: Weather.

Easternmost of the two signal boxes at Rhyl and latterly the only one in operation, Rhyl No 1 Signal Box is modestly sized for a LNWR 4 design. Visually remote from the main part of the railway station by a road overbridge, main public awareness will be from the rear, where it backs onto a car park.

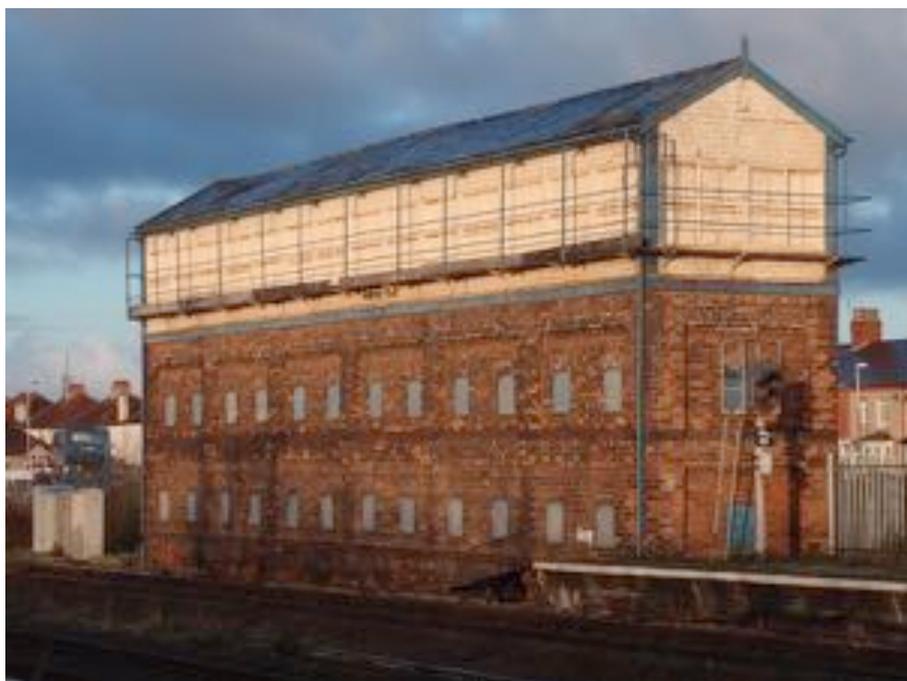
Figure A.107: Rhyl No 2 Signal Box. (Author 2016)

Administrative location: Denbighshire, Wales. Constraints: Close. Design: LNWR 4. Built: 1900. Listing: II. Status: OOU ML. Future/use: Mothballed. Heritage value: Modified (additional steel external ladder), communal (large building in public place). Overall condition: Derelict, station staff comment that the floors are, "gone through". Reuse potential: Accessible. Relocatable: No. Risk: Weather. Comment: Conversation.

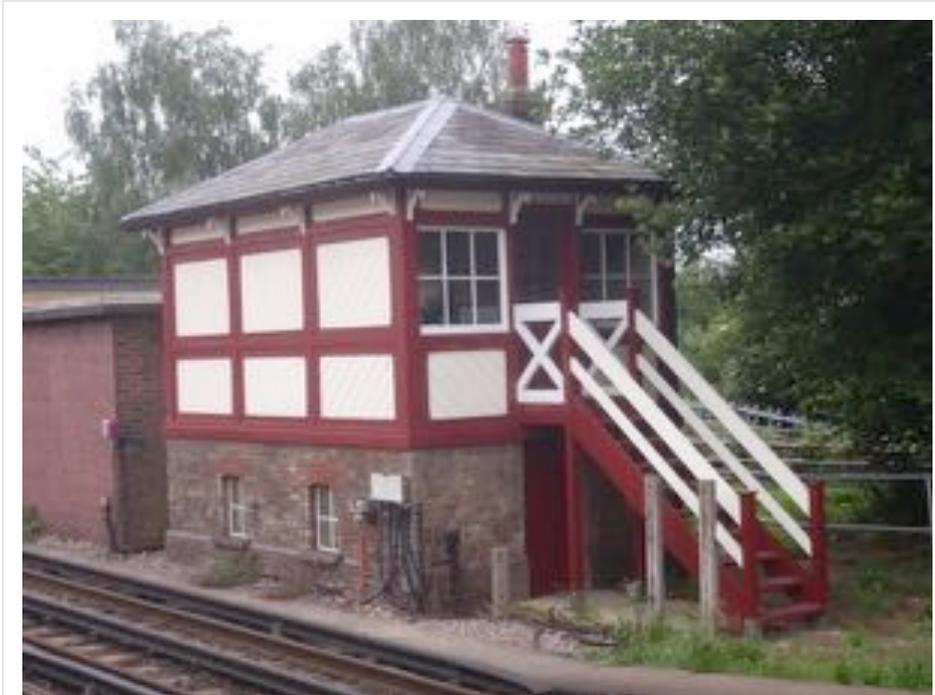
Figure A.108a: Ruislip Signal Box. (Author 2018)

Administrative location: Hillingdon, England. Constraints: Reasonable. Design: Metropolitan 2. Built: 1904. Listing: II [G]. Status: OOU LR.

Future/use: Mothballed. Heritage value: Modified (apparently replaced timber staircase). Overall condition: Good. Reuse potential: Poor. Relocatable: Partially. Risk: Normal.

Carefully conserved yet presenting a strongly incongruous impression within the London Underground environment and rather out of an immediate public awareness.

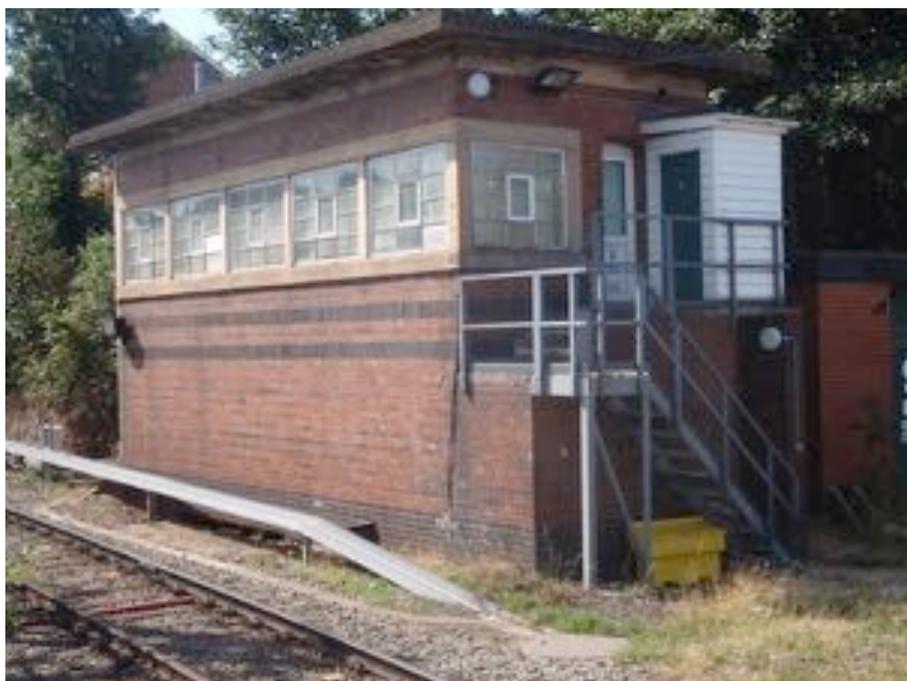
Figure A.109: Runcorn Signal Box. (Author 2018)

Administrative location: Halton, England. Constraints: Reasonable. Design: LMS 13. Built: 1940. Listing: II. Status: OOU ML. Future/use: Mothballed. Heritage value: Degraded (replacement uPVC opening lights, replacement steel staircase, toilet block extension), communal (station location). Overall condition: Fair. Reuse potential: Accessible. Relocatable: No. Risk: Weather.
