**CONSERVATION OF FUNCTIONAL
HERITAGE RAILWAY BUILDINGS
AS AN ARCHETYPE FOR THE
CONSERVATION OF FUNCTIONAL
HERITAGE BUILDINGS**

CHRISTOPHER DIETMAR REEVES

A thesis submitted in partial fulfilment
of the requirements of the University
of Northumbria at Newcastle for the
degree of Doctor of Philosophy

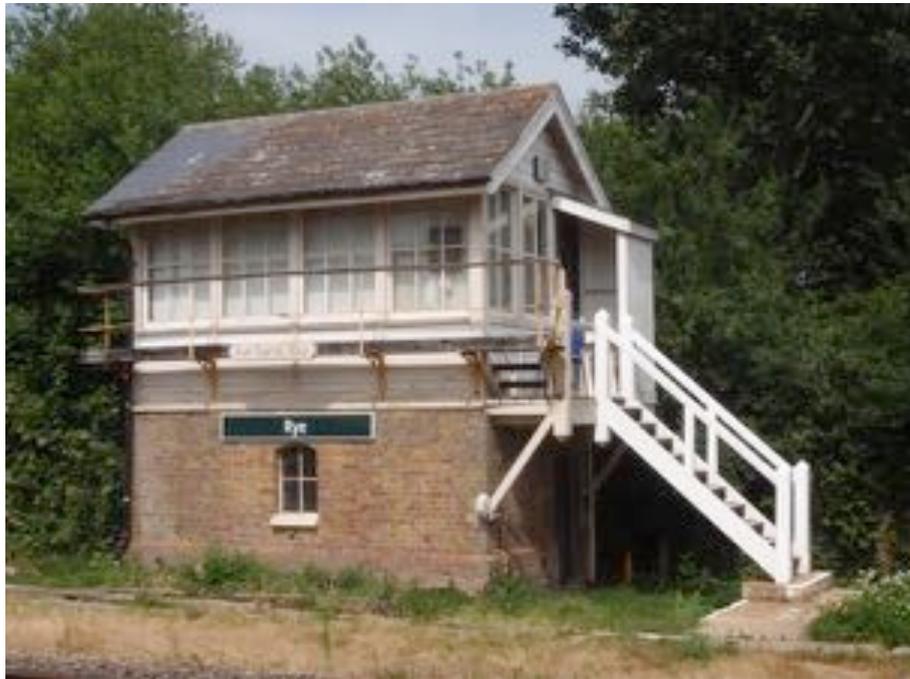
Figure A.110 Rye Signal Box. (Author 2018)

Administrative location: East Sussex, England. Constraints: Reasonable. Design: S&F 12a. Built: 1894. Listing: II [GV]. Status: Use ML. Future/use: Long term. Heritage value: Modified (replacement

timber staircase), communal (station location). Overall condition: Fair. Reuse potential: Accessible. Relocatable: None. Risk: Normal.

Being directly opposite the main station building and one of the platforms ensures a strong public awareness of this well conserved building.

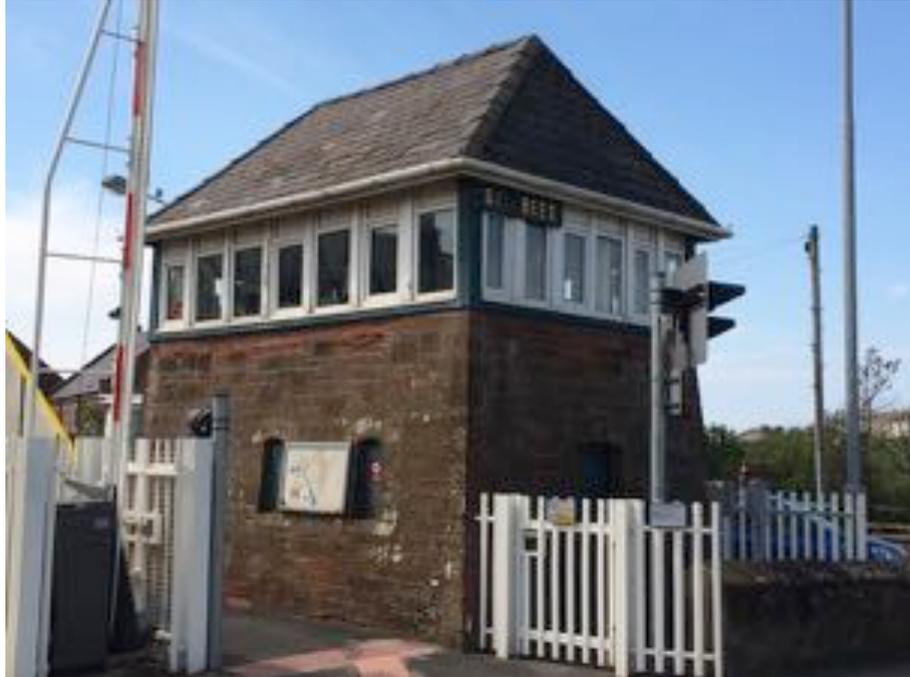
Figure A.111: St Bees Signal Box. (Author 2016)

Administrative location: Cumbria, England. Constraints: Close. Design: Furness 3+. Built: 1891. Listing: II. Status: Use ML. Future/use: Short term. Heritage value: Modified (replacement uPVC windows, replacement steel staircase), aesthetic (unique architect design), communal (level crossing). Overall condition: Fair. Reuse potential: Accessible. Relocatable: Difficult. Risk: Weather.

Located next to a level crossing and access to one of the station platforms will promote considerable public awareness of the architect designed St Bees Signal Box. Degrading the finesse of this design, constructed with local sandstone with a slight batter that gives an enhanced impression of solidity, is an insensitive replacement of the

original windows with uPVC framed substitutes. The replacement steel staircase also feels insensitive, although less offensive than the windows.

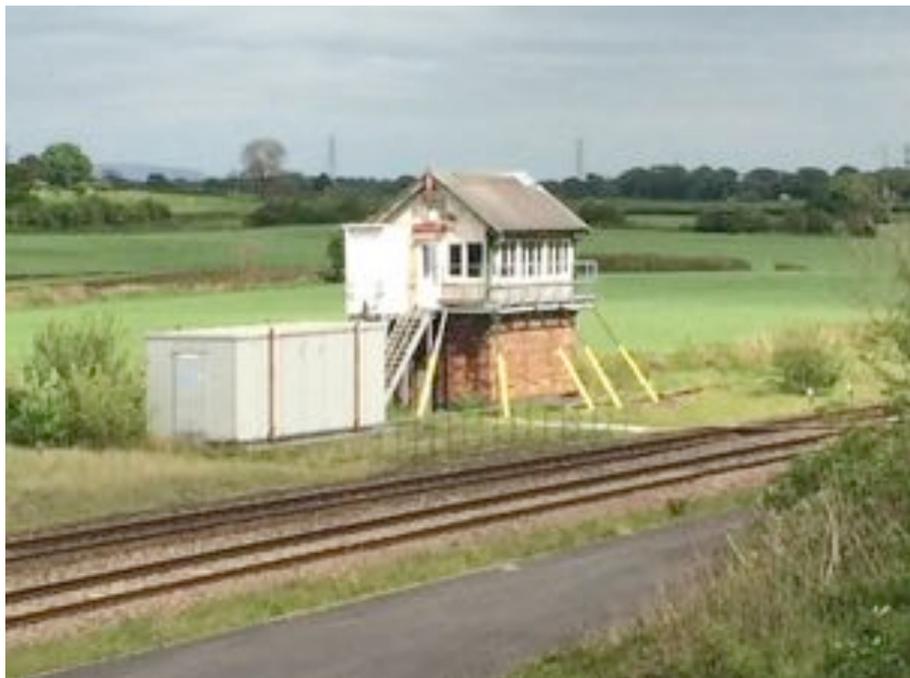
Figure A.112: Salwick No 2 Signal Box. (Author 2016)

Administrative location: Lancashire, England. Constraints: Distant. Design: RSCo [LYR]. Built: 1889. Listing: n/a. Status: Use ML. Future/use: Short term, since demolished (2017). Heritage value: Modified (uPVC replacement windows, replacement steel staircase). Overall condition: Deficient, propped. Reuse potential: Poor. Relocatable: Partially. Risk: Normal.

Clearly on a minimal maintenance regime pending replacement by replacement of signalling between Preston and Blackpool, Salwick Signal Box when surveyed displayed a degraded evidential value and a location remote from public access presented no communal value.

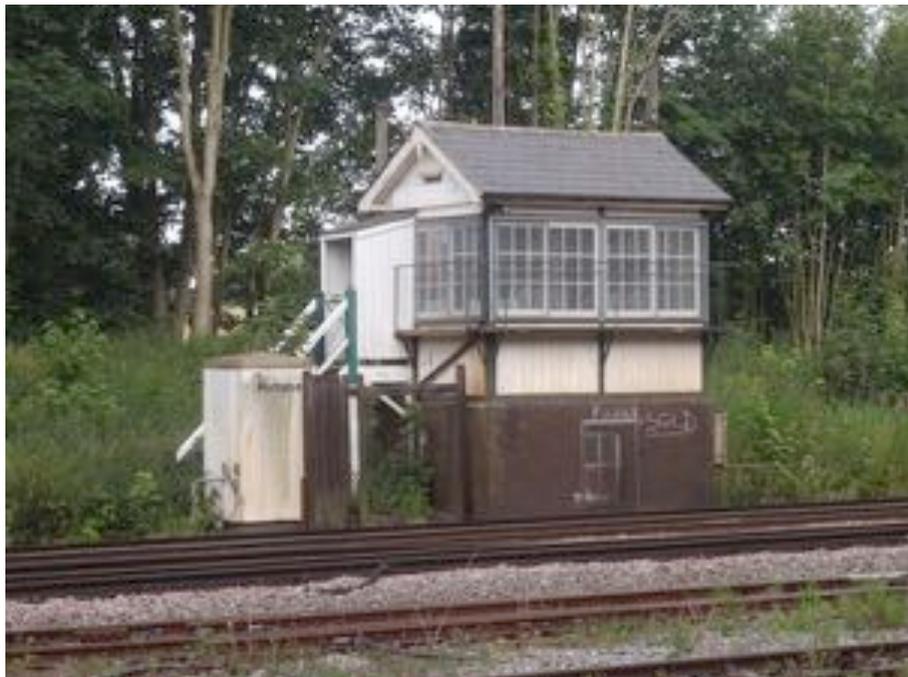
Figure A.113: Shepherds Well Signal Box. Notice the 'for sale' and 'sold' graffiti. (Author 2018)

Administrative location: Kent, England. Constraints: Reasonable. Design: LCDR. Built: c1878. Listing: II. Status: OOU ML. Future/use: Mothballed. Heritage value: Modified (replacement timber staircase). Overall condition: Fair. Reuse potential: Accessible. Relocatable: Partially. Risk: Normal. Comment: Conversation.

As an anomaly of spellings, the station of Shepherds Well serves the village of Shepherdswell, and Shepherds Well Signal Box follows this anomaly. Best viewed from a restricted location within the grounds of an adjacent heritage railway will limit public awareness. Noted is the faintly ironic graffiti for this disused building.

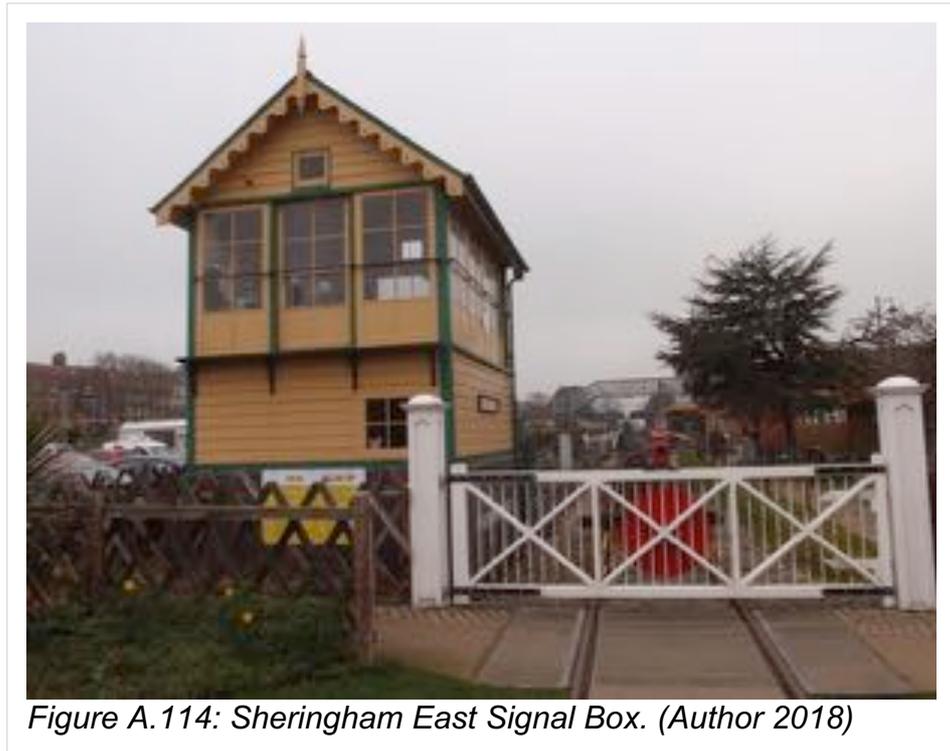
A.2.114 Sheringham East Signal Box

Administrative location: Norfolk, England. Constraints: Close. Design: MGNR 1. Built: 1906. Listing: n/a. Status: OOU HR. Future/use: Railway offices. Heritage value: Modified (modern brickwork to half plinth/locking room, replacement timber staircase to match original), communal (station location). Overall condition: Good. Reuse potential: None. Relocatable: None. Risk: High.

Next to a level crossing, public car park and heritage railway circulation area means that there will be considerable public awareness of Sheringham East Signal Box. The location, in effect a gateway to the heritage railway, means that the heritage railway has a considerable incentive to ensure a high standard of presentation for the building

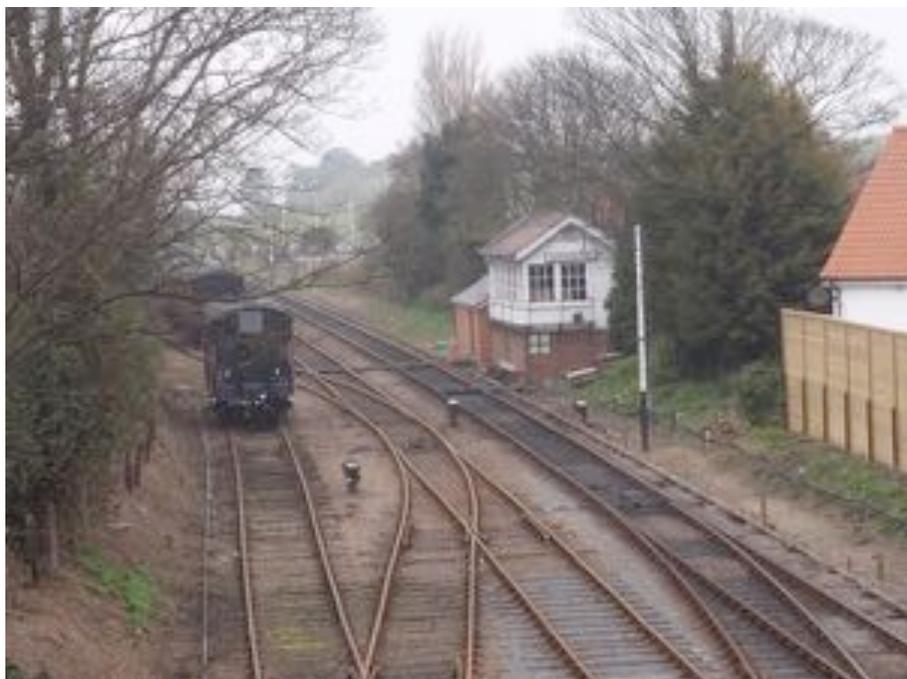
Figure A.115: Sheringham West (Wensum Junction) Signal Box. (Author 2018)

Administrative location: Norfolk, England. Constraints: Distant. Design: GER 7. Built: Unknown/1985. Listing: n/a. Status: Use HR. Future/use: Heritage operational. Heritage value: Modified (modern brickwork plinth). Overall condition: Good. Reuse potential: None. Relocatable: None, relocated 1985. Risk: Weather.

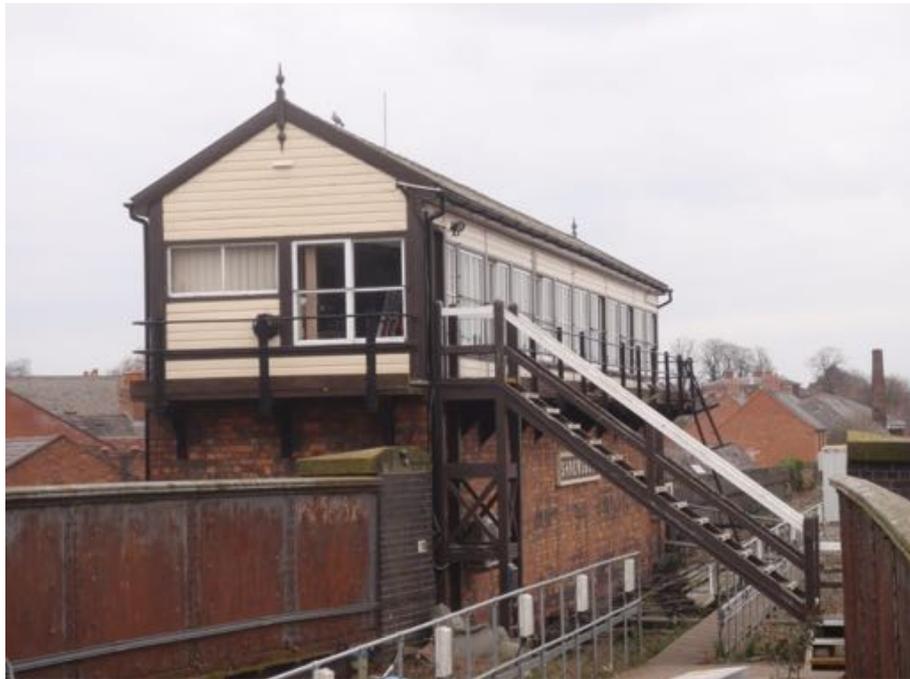
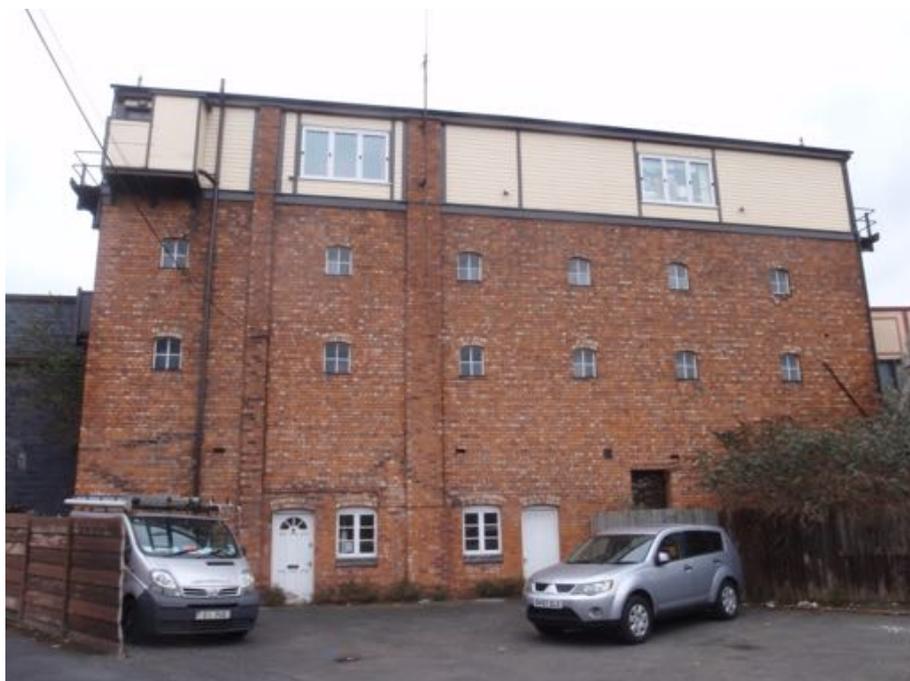
Figure A.116a: Shrewsbury Crewe Junction Signal Box as seen from Shrewsbury Railway Station. (Author 2016)

Figure A.116b: Shrewsbury Crewe Junction Signal Box as seen from street level. (Author 2016)

From platform level at the north end of Shrewsbury Railway Station, Shrewsbury Crewe Junction Signal Box appears to be a modest size compared with the substantial size normally associated with LNWR 4 signal boxes. However, seen from street level the signal box has a substantial presence.

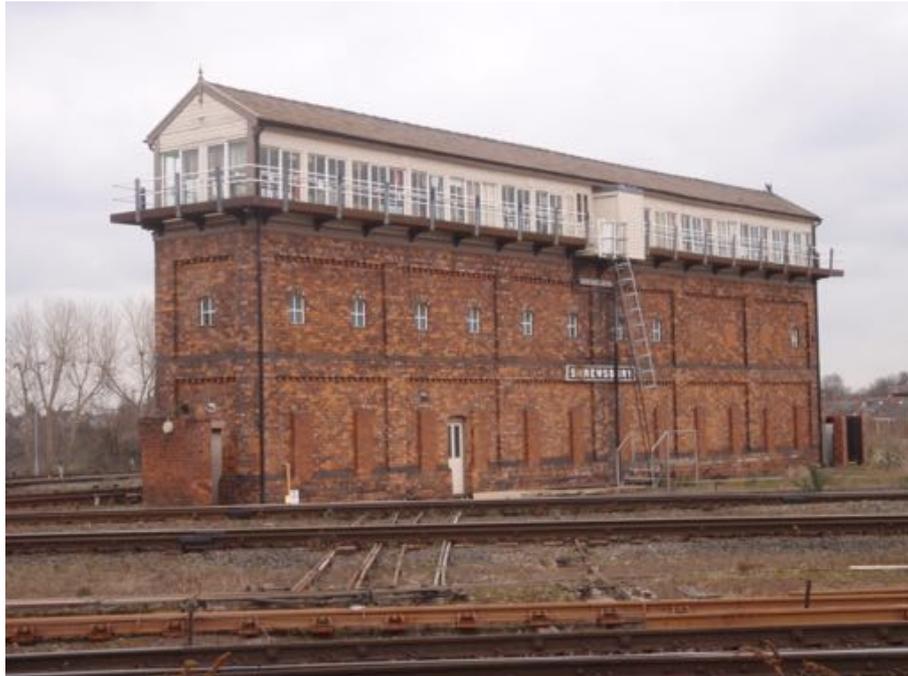
Figure A.117: Shrewsbury Severn Bridge Signal Box. (Author 2016)

Administrative location: Shropshire, England. Constraints: Reasonable. Design: LNWR 4. Built: 1903. Listing: II. Status: Use ML. Future/use: Long term. Heritage value: Modified (supplementary steel external ladder, communal (largest surviving mechanical signal box in Europe). Overall condition: Fair. Reuse potential: Poor. Relocatable: None. Risk: Normal.

in operation in Europe”. Notice the retrofit fire escape ladder and buttressed closing to the ground floor windows.

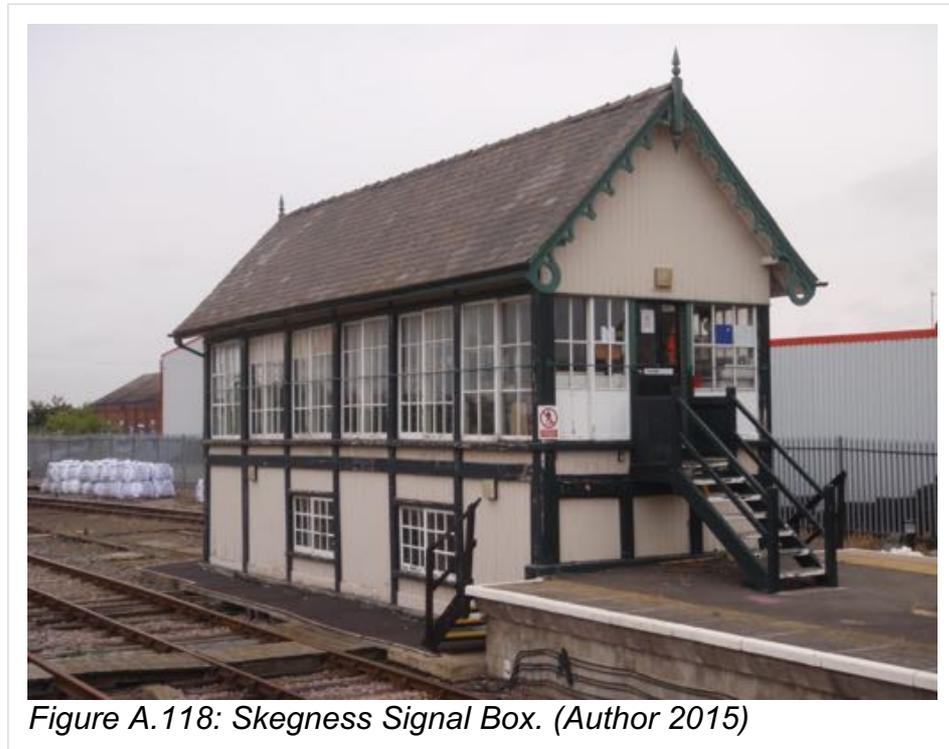
Figure A.118: Skegness Signal Box. (Author 2015)

Administrative location: Lincolnshire, England. Constraints: Reasonable. Design: GNR 1. Built: 1901. Listing: II. Status: Use ML. Future/use: Short term. Heritage value: Modified (replacement timber staircase), communal (station location). Overall condition: Deficient. Reuse potential: Accessible. Relocatable: Yes. Risk: Weather. Comment: Conversation.

An all-timber version of the GNR 1 design, thus showing the flexibility in standard designs for specific locations. Although the taxonomy survey gives a communal weighting for the station location, this is marginal as the signal box is remote from where passengers may circulate, and one can presume there is more drawing people to Skegness than the signal box.

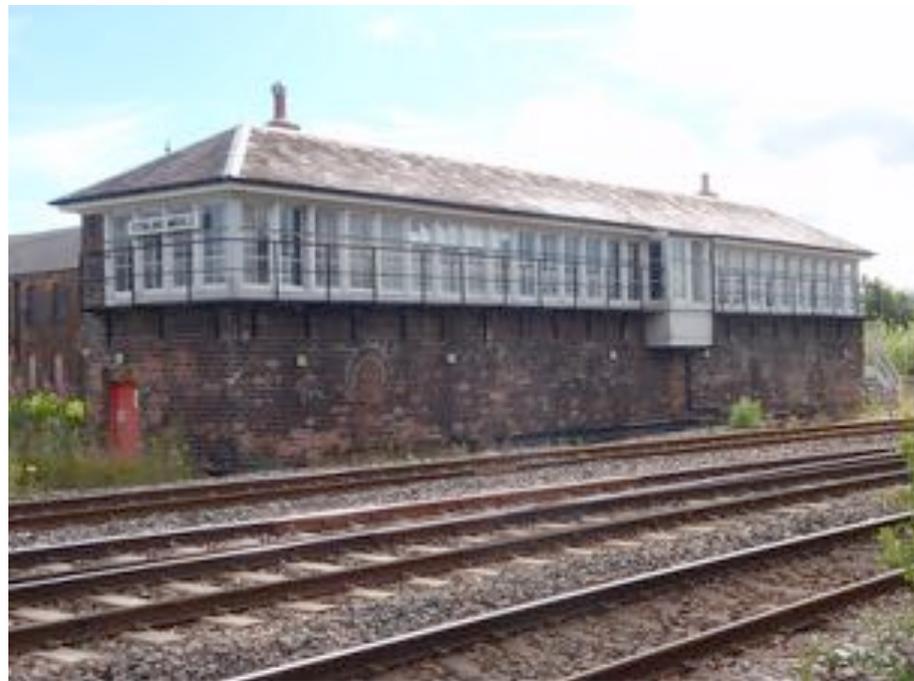
Figure A.120: Stirling Middle Signal Box. (Author 2016)

Administrative location: Stirling, Scotland. Constraints: Close. Design: Caledonian N2. Built: 1901. Listing: A [GV]. Status: Use ML. Future/use: Medium term. Heritage value: Modified (presumed replacement timber staircase), communal (public location). Overall

condition: Fair. Reuse potential: Accessible. Relocatable: No. Risk: Deliberate.

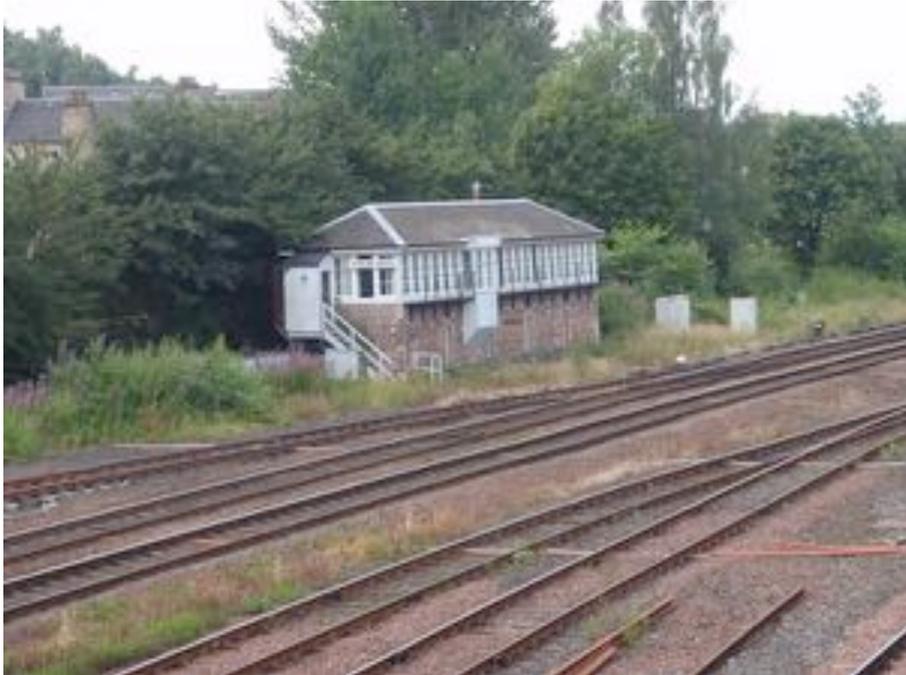
Figure A.121: Stirling North Signal Box. (Author 2016)

Administrative location: Stirling, Scotland. Constraints: Distant. Design: Caledonian N2. Built: 1900. Listing: A [GV]. Status: Use ML. Future/use: Medium term. Heritage value: Modified (presumed replacement timber staircase). Overall condition: Fair. Reuse potential: Possible accessible. Relocatable: No. Risk: Deliberate.

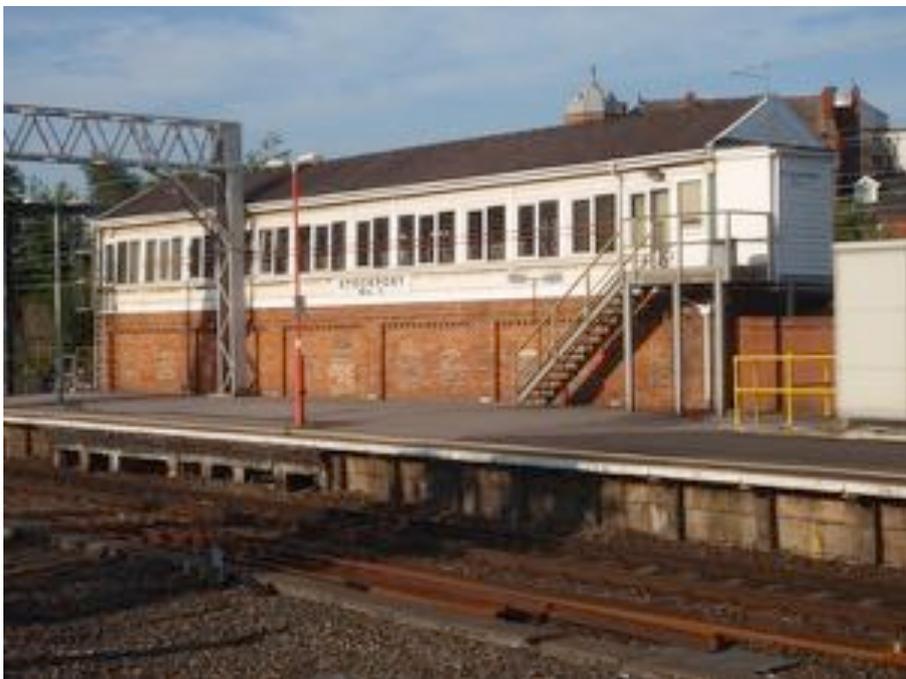
Figure A.122: Stockport No 1 Signal Box. (Author 2018)

Administrative location: Stockport, England. Constraints: Close. Design: LNWR 4. Built: 1884. Listing: n/a. Status: Use ML. Future/use: Medium term. Heritage value: Modified (replacement uPVC windows,

replacement steel staircase, supplementary steel fire escape), communal (station location). Overall condition: Good. Reuse potential: Accessible. Relocatable: No. Risk: Normal.

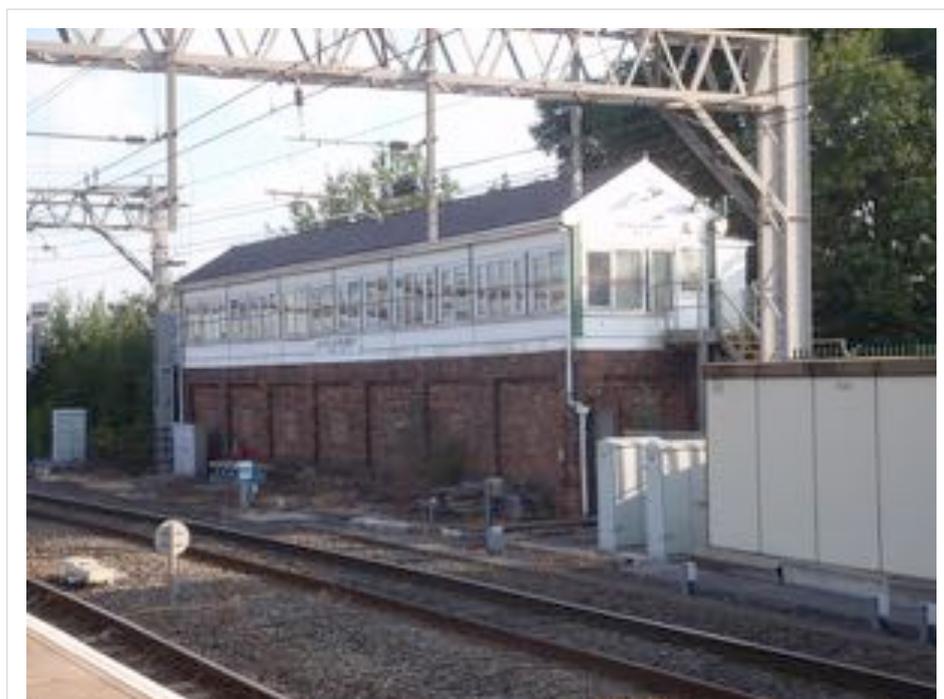
Figure A.123: Stockport No 2 Signal Box. (Author 2018)

Administrative location: Stockport, England. Constraints: Reasonable. Design: LNWR 4. Built: 1890. Listing: n/a. Status: Use ML. Future/use: Medium term. Heritage value: Modified (replacement uPVC windows, replacement steel staircase), communal (station location). Overall condition: Good. Reuse potential: Poor. Relocatable: No. Risk: Normal

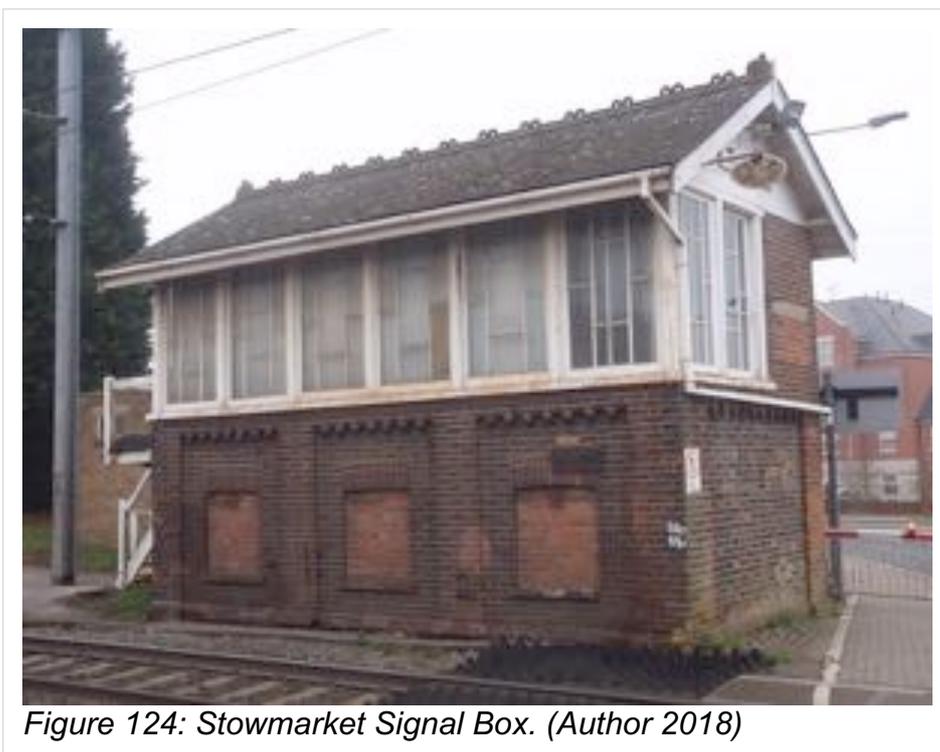
A.2.124 Stowmarket Signal Box

Administrative location: Suffolk, England. Constraints: Close. Design: GER 3. Built: c1882. Listing: n/a. Status: Use ML. Future/use: Short term. Heritage value: Modified (probably replacement timber staircase), communal (level crossing). Overall condition: Fair. Reuse potential: Accessible. Relocatable: No. Risk: Normal.

Being next to a level crossing there will be considerable public awareness of Stowmarket Signal Box. However, the building presents a dowdy appearance in a context changed from the time of construction, so the heritage value is hard to justify.

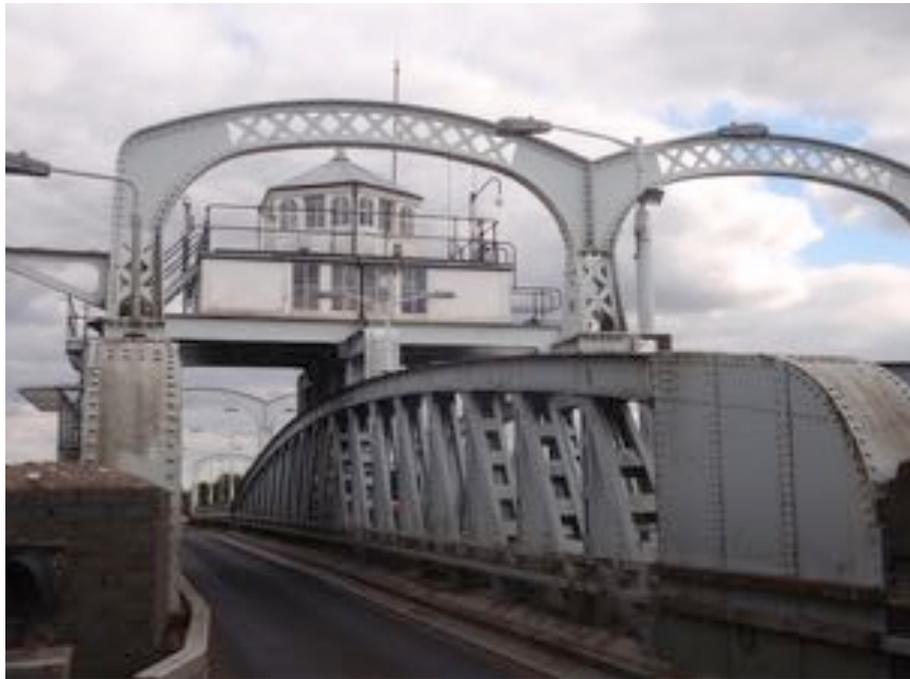
Administrative location: Lincolnshire, England. Constraints: Reasonable. Design: Midland bespoke. Built: 1897. Listing: II. Status: OOU IS. Future/use: Swing bridge control. Heritage value: Original, communal (public location). Overall condition: Fair. Reuse potential: None. Relocatable: None. Risk: Weather. Comments: Heritage value*

*unusual iron/steel superstructure, controls formerly mixed rail/road use
now only road swing bridge*

Figure A.125: Sutton Bridge Signal Box. This carriageway was that originally used by the railway. (Author 2018)

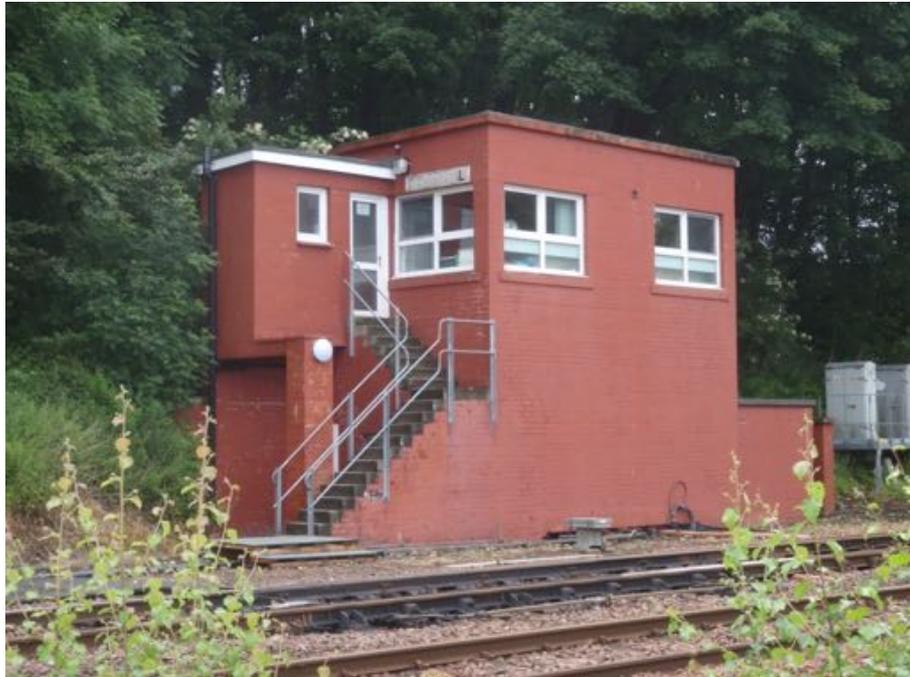
Figure A.126: Thornhill Signal Box. (Author 2015)

Administrative location: Dumfries & Galloway, Scotland. Constraints: Reasonable. Design: LMS 13. Built: 1943. Listing: n/a. Status: Use ML. Future/use: Short term. Heritage value: Modified (toilet block extension, replacement uPVC windows, replacement steel handrails), aesthetic (unusual austerity design), historical (local railway expansion for Second World War munitions factories). Overall condition: Good. Reuse potential: Poor. Relocatable: No. Risk: Normal.

increase in freight traffic that required an upgrade of signalling for the local railway system. Coupled with a link to local history, this austere, and extended with a toilet block, LMS 13 design has an aesthetic representative of the era.

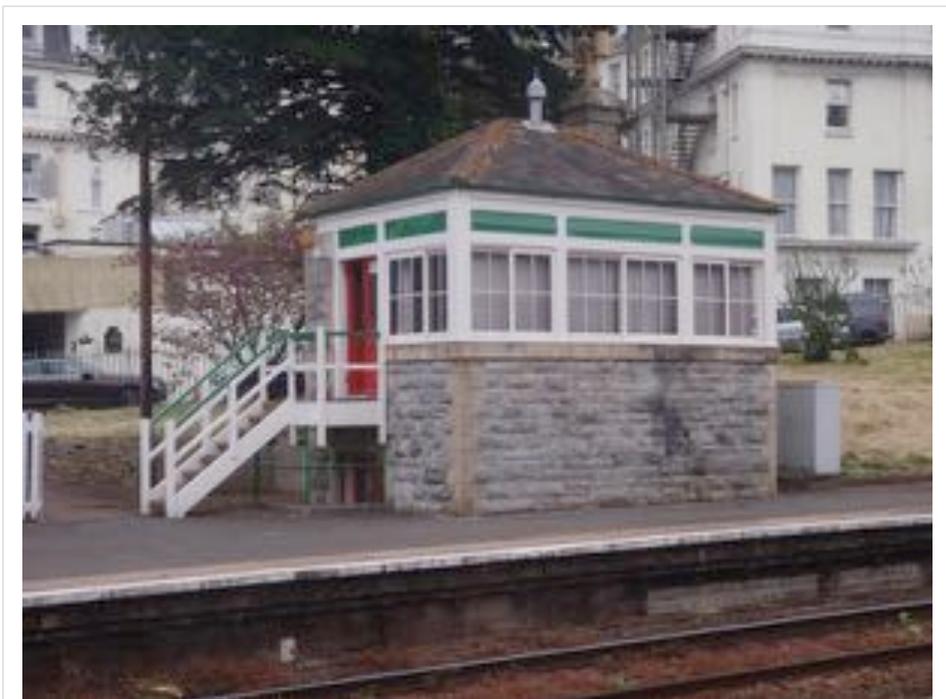
Figure A.128: Torquay South Signal Box. (Author 2018)

Administrative location: Torbay, England. Constraints: Close. Design: GWR n/s. Built: c1876. Listing: II. Status: OOU PR. Future/use: Office. Heritage value: Modified (probably replacement timber staircase),

aesthetic (stone construction), communal (station location). Overall condition: Good. Reuse potential: None. Relocatable: None. Risk: Weather.

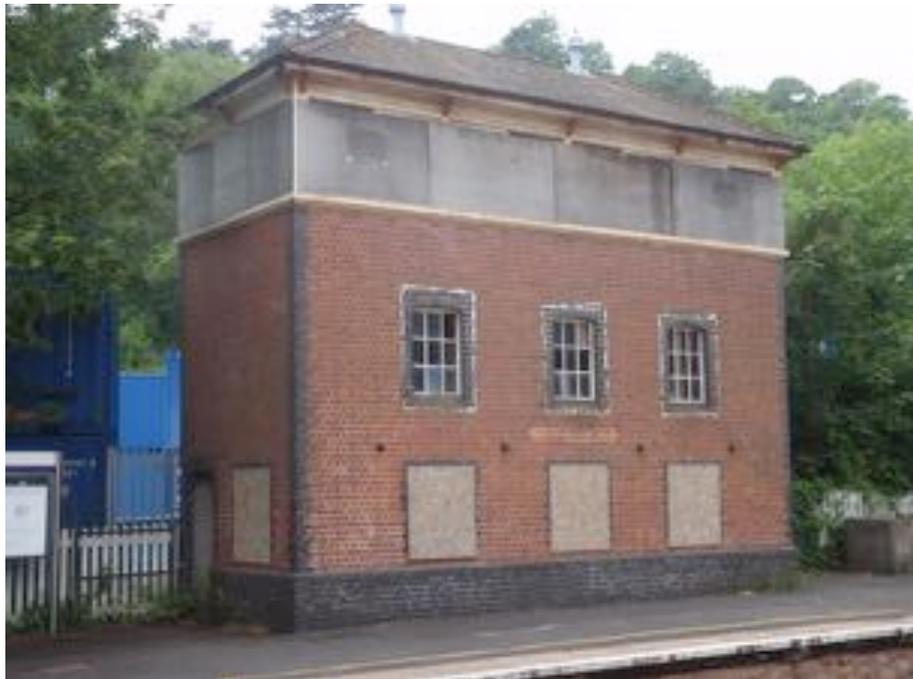
Figure A.129a: Torre Signal Box. (Author 2018)

Administrative location: Torbay, England. Constraints: Close. Design: GWR 7d. Built: 1921. Listing: II [GV]. Status: OOU ML. Future/use: Mothballed. Heritage value: Original, communal (station location). Overall condition: Deficient. Reuse potential: Reuse. Relocatable: No. Risk: Weather.

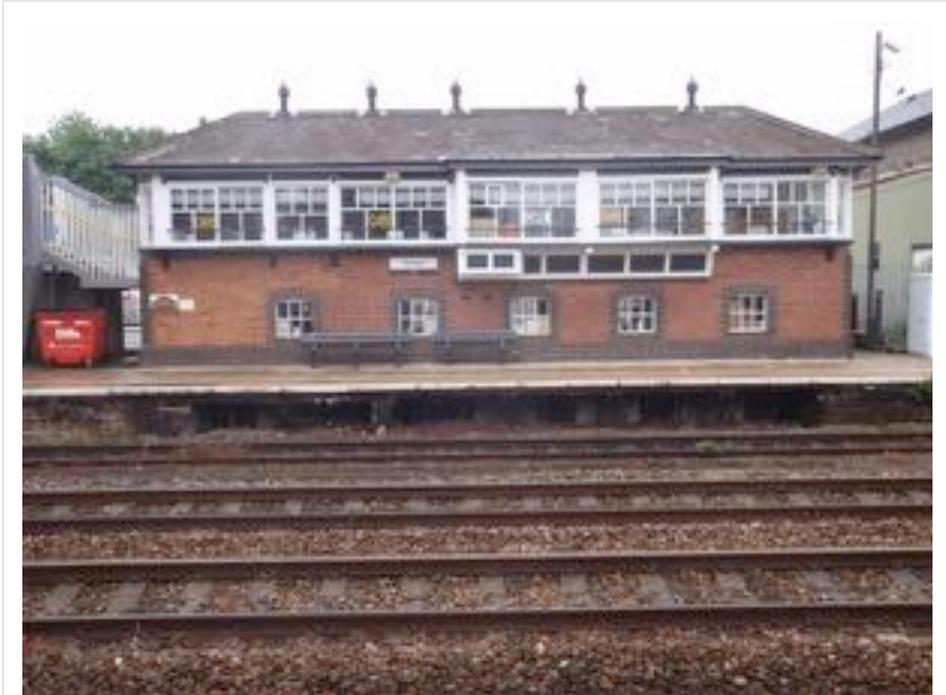
Figure A.130: Totnes Signal Box. (Author 2018)

Administrative location: Devon, England. Constraints: Close. Design: GWR 7d. Built: 1923. Listing: II. Status: OOU PR. Future/use: Café. Heritage value: Modified (replacement steel staircase), communal (station location). Overall condition: Fair. Reuse potential: None. Relocatable: None. Risk: Possible deliberate.

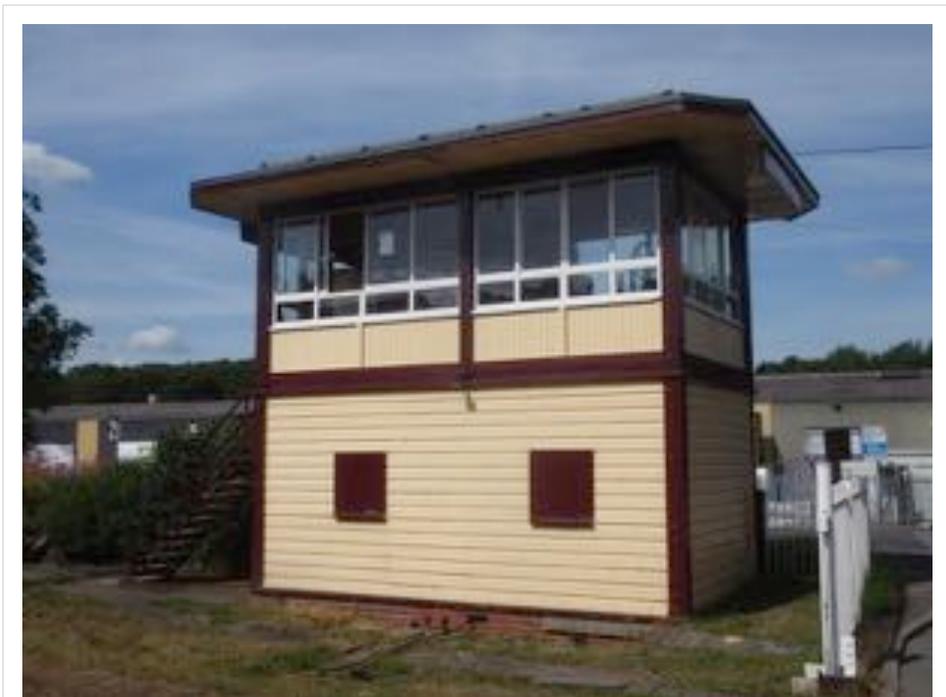
Figure A.131: Townsend Fold Signal Box. (Author 2018)

*Administrative location: Lancashire, England. Constraints: Close.
Design: BR(LMR) 15. Built: 1959. Listing: n/a. Status: Use HR.
Future/use: Heritage operational. Heritage value: Modified*

(replacement steel staircase with timber treads), communal (level crossing). Overall condition: Good. Reuse potential: None. Relocatable: None. Risk: Deliberate.

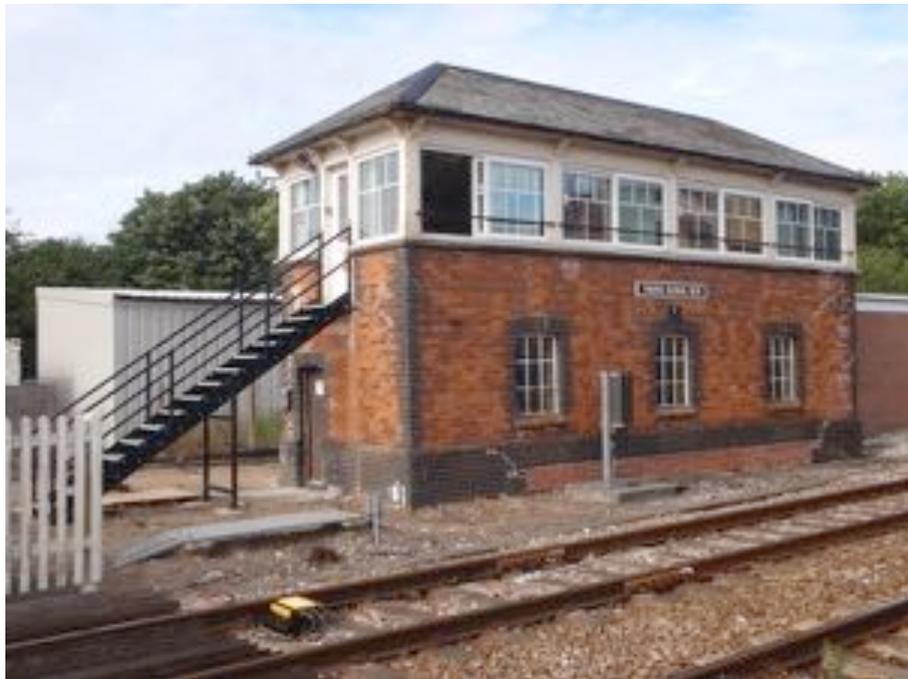
Figure A.132: Truro Signal Box. (Author 2016)

Administrative location: Cornwall, England. Constraints: Close. Design: GWR 7a. Built: 1899. Listing: n/a. Status: Use ML. Future/use: Short term. Heritage value: Modified (replacement uPVC windows, replacement steel staircase), communal (level crossing). Overall condition: Deficient, structural movement. Reuse potential: Accessible. Relocatable: No. Risk: Deliberate.

Formerly Truro East Signal Box, being next to a level crossing and within a station environment strengthens public awareness of Truro Signal Box. However, structural movement and obvious modifications degrade the conservation value of the building.

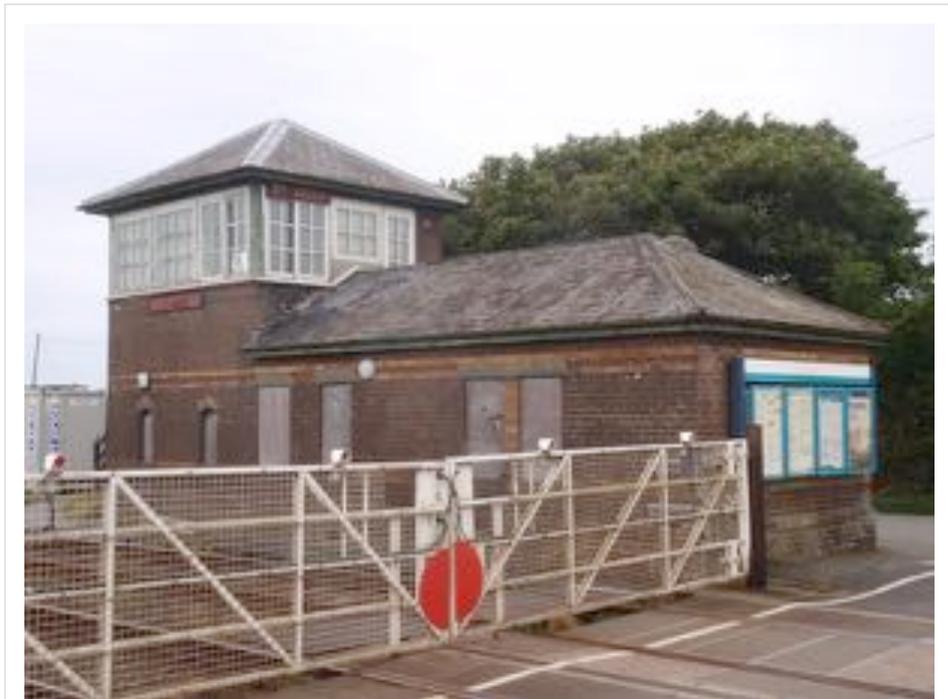
Figure A.133: Ty Croes Signal Box. (Author 2017)

Administrative location: Isle of Anglesey, Wales. Constraints: Close. Design: CHR/LNWR. Built: 1872. Listing: II. Status: Use ML. Future/use: Short term. Heritage value: Modified (replacement timber staircase), communal (level crossing). Overall condition: Fair. Reuse potential: Accessible. Relocatable: No. Risk: Weather.

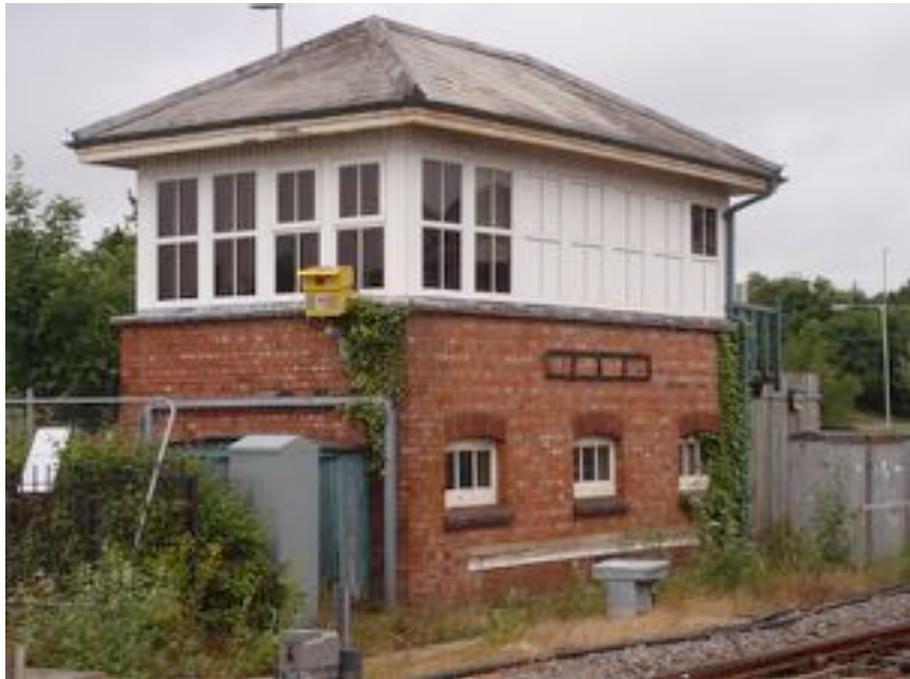
Administrative location: Dorset, England. Constraints: Close. Design: LSWR 4. Built: 1928. Listing: n/a. Status: Use ML. Future/use: Short term. Heritage value: Modified (replacement uPVC windows, replacement galvanised steel staircase), communal (public location).

Overall condition: Fair. Reuse potential: Accessible. Relocatable: Partially. Risk: Deliberate.

Figure A.135a: Wareham Signal Box. (Author 2016)

Next to the former level crossing, now in use as a foot crossing, an access road and overlooked by the station footbridge means that there will be some public awareness of Wareham Signal Box. However, in terms of sensitivity to original design, the former goods shed now converted into an architect's office is an exemplar of what is possible with a functional building.

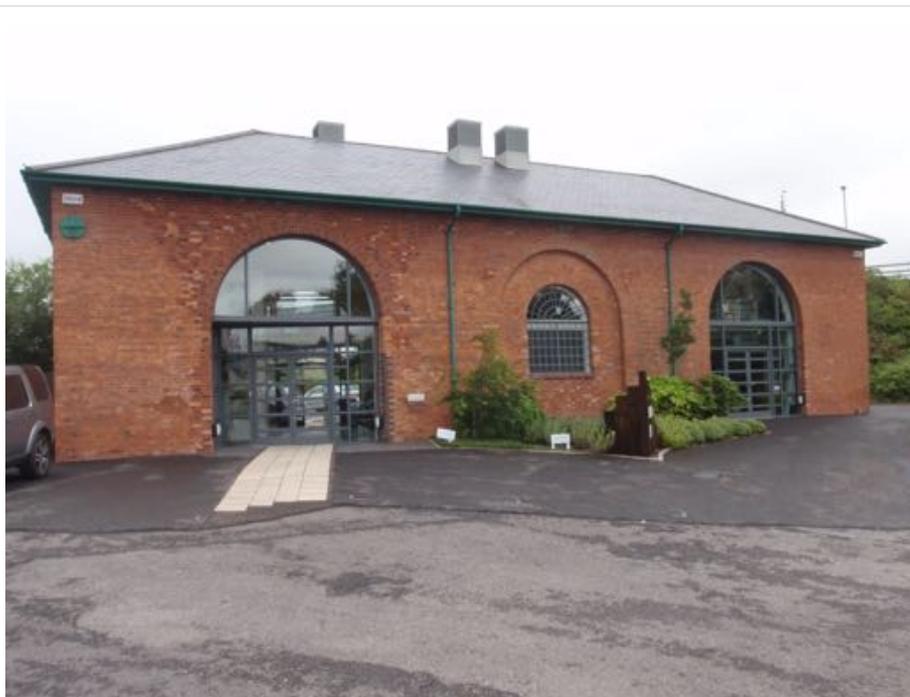
Figure A.135b: Former goods shed at Wareham now in use as an architect's office. (Author 2016)

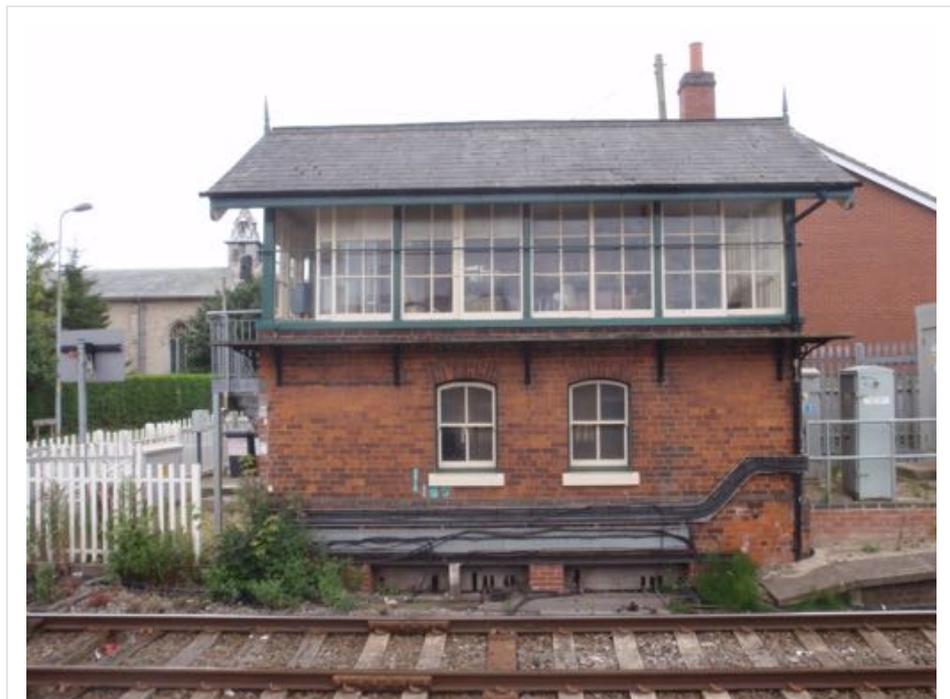
Figure A.136: Wainfleet Signal Box. (Author 2015)

Administrative location: Lincolnshire, England. Constraints: Close. Design: GNR 1. Built: 1882. Listing: II. Status: Use ML. Future/use: Short term. Heritage value: Modified (replacement steel staircase), communal (level crossing). Overall condition: Fair. Reuse potential: Accessible. Relocatable: Partially. Risk: Weather.

Another variant, with the more usual style of brickwork, of a GNR 1 design. While listed and retaining much of the original aesthetic, noteworthy is the extent of modification required to adapt this signal box for use by the modern railway.

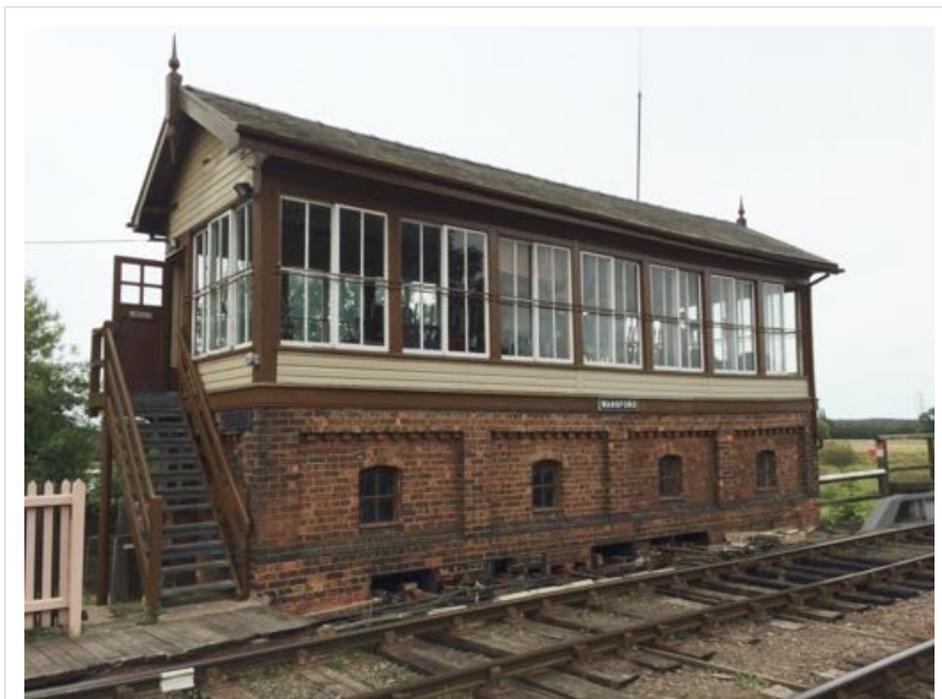
Figure A.137: Wansford Signal Box. (Author 2015)

Administrative location: Peterborough, England. Constraints: Close. Design: LNWR 5. Built: 1907. Listing: II. Status: Use HR. Future/use: Heritage operational. Heritage value: Modified (replacement timber staircase), communal (station location). Overall condition: Good. Reuse potential: None. Relocatable: None. Risk: Normal.

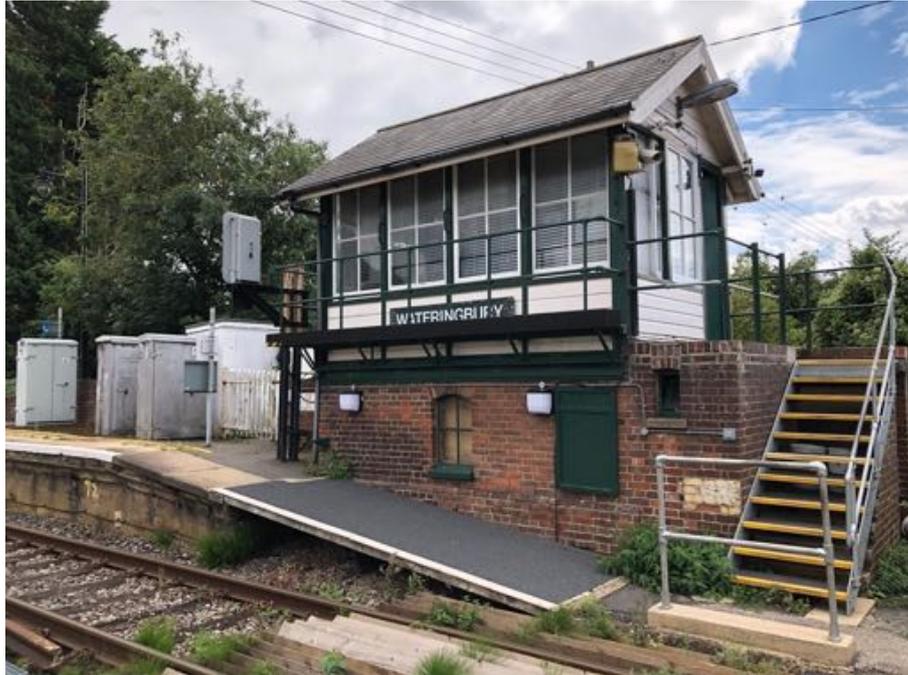
Administrative location: Kent, England. Constraints: Close. Design: S&F 12a. Built: 1893. Listing: II [GV]. Status: Use ML. Future/use: Long term. Heritage value: Modified (replacement uPVC windows, replacement steel staircase), communal (level crossing). Overall condition: Fair. Reuse potential: Accessible. Relocatable: None. Risk: Deliberate.

Figure A.138: Wateringbury Signal Box. (Reeves, L., 2018)

Being next to both a level crossing and access to one of the station platforms, there is scope for considerable public awareness of this signal box, although the modifications diminish some of the heritage value.

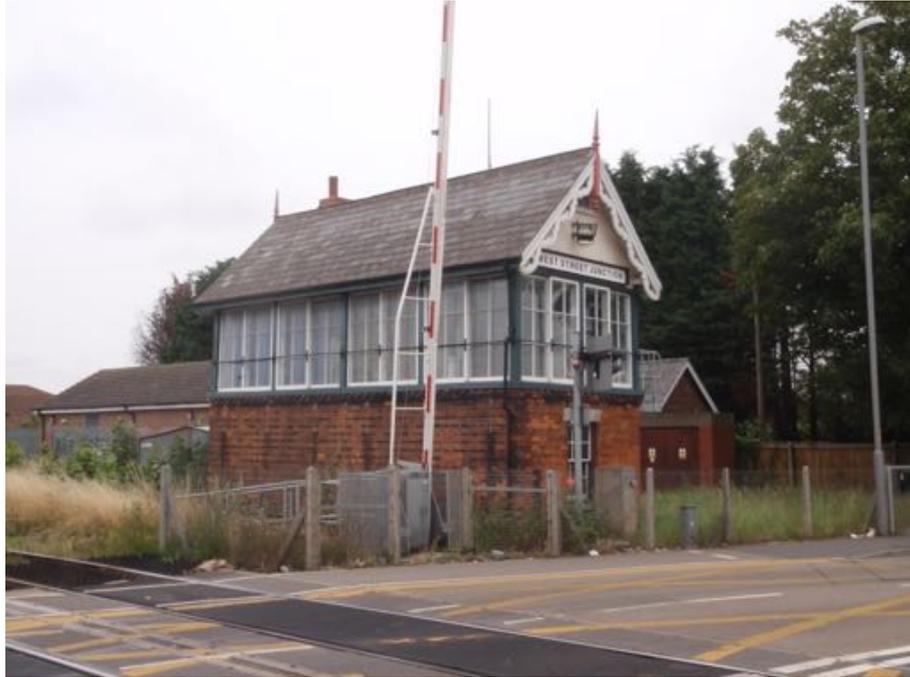
Administrative location: Lincolnshire, England. Constraints: Reasonable. Design: GNR 1. Built: 1874. Listing: II. Status: Use ML. Future use: Short term. Heritage value: Modified (replacement steel staircase), communal (level crossing). Overall condition: Fair. Reuse potential: Accessible. Relocatable: Partially. Risk: Deliberate.

Next to Boston Railway Station, which with the rundown of railways in Lincolnshire presents as an austere shadow of a former grandeur, this signal box feels isolated compared with the amount of railway it once supervised. However, even if the setting feels bleak, the location of this building by the level crossing allows for a strong public perception of communal weighting in assessing the heritage value.

Figure A.139: West Street Junction Signal Box. (Author 2015)
