**CONSERVATION OF FUNCTIONAL
HERITAGE RAILWAY BUILDINGS
AS AN ARCHETYPE FOR THE
CONSERVATION OF FUNCTIONAL
HERITAGE BUILDINGS**

CHRISTOPHER DIETMAR REEVES

A thesis submitted in partial fulfilment
of the requirements of the University
of Northumbria at Newcastle for the
degree of Doctor of Philosophy

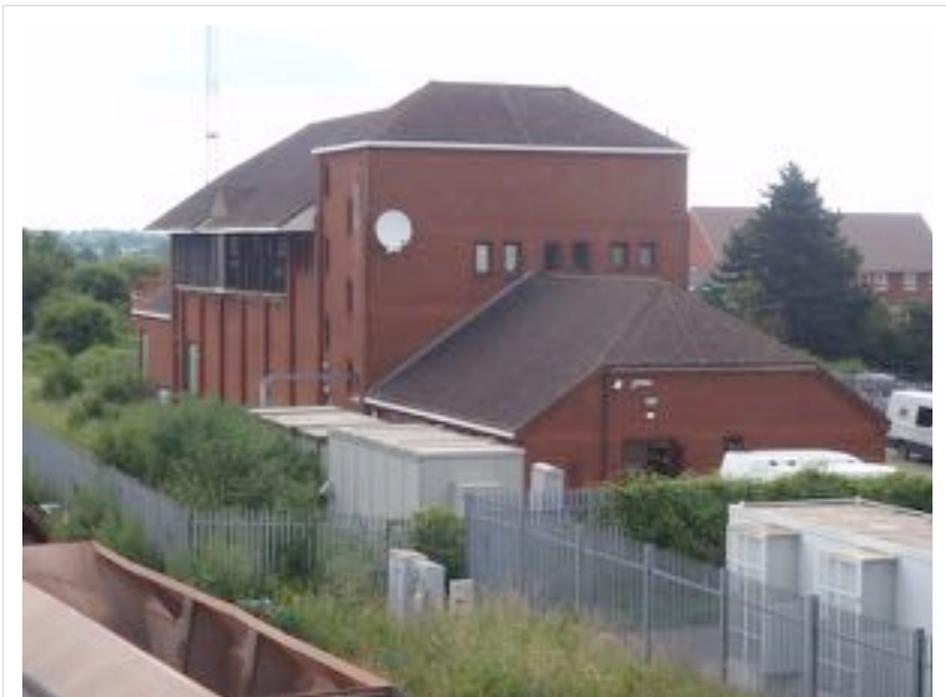
Figure A.140: Westbury PSB. (Author 2016)

Administrative location: Wiltshire, England. Constraints: Distant. Design: BR(WR) PB. Built: 1984. Listing: n/a. Status: Use ML. Future/use: Medium term. Heritage value: Original, aesthetic (unusual

bespoke design). Overall condition: Good. Reuse potential: Accessible. Relocatable: No. Risk: Normal.

Mixing an imposing multistorey massing, steep roof pitch and high security fencing, the signallers nicknamed Westbury PSB 'Colditz Castle' after the similarly massed and secure famous German castle (Allen & Woolstenholmes 1991, pp112-3). While facing the railway, its set back location surrounded by vegetation and a more modern housing estate, plus the actual design, makes this an ambiguous building.

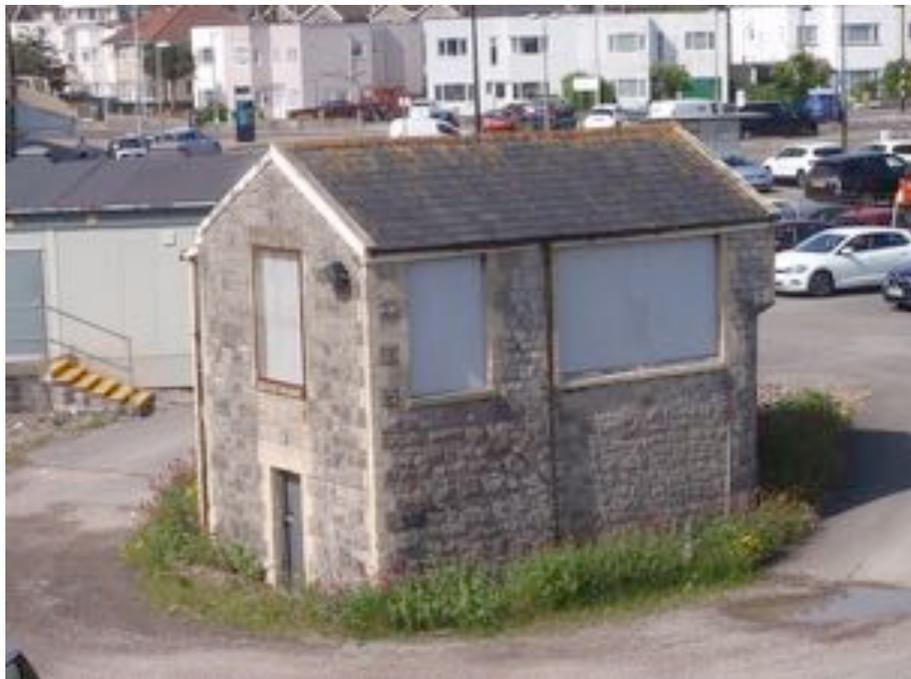
Figure A.141: Weston-Super-Mare Signal Box. (Author 2018)

Administrative location: North Somerset, England. Constraints: Close. Design: BER. Built: c1866. Listing: II. Status: OOU ML. Future/use: Mothballed. Heritage value: Modified (staircase missing, windows boarded up). Overall condition: Deficient. Reuse potential: Accessible. Relocatable: Difficult. Risk: Deliberate.

Believed to be the oldest surviving extant signal box, the location of Weston-Super-Mare Signal Box in a railway staff car park and deficient

condition means that it will be difficult for the public to have any awareness of this deeply significant building.

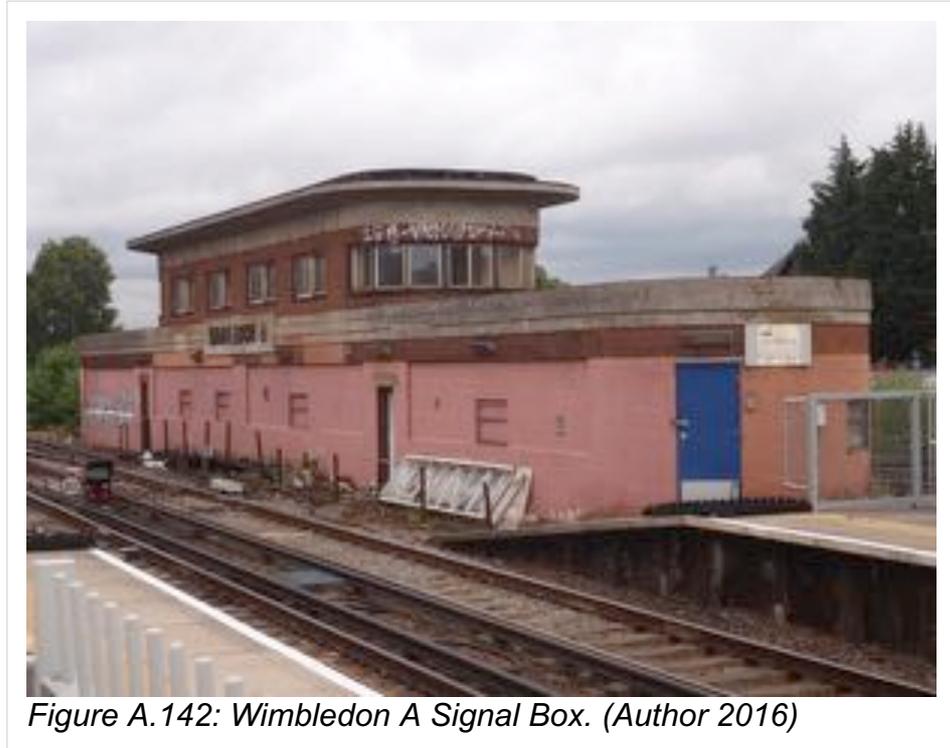
A.2.142 Wimbledon A Signal Box

Administrative location: Merton, England. Constraints: Reasonable. Design: SR 13. Built: 1948. Listing: n/a. Status: OOU ML. Future/use: Signalling and telecoms training. Heritage value: Modified (addition of steel fire escape), communal (station location). Overall condition: Fair. Reuse potential: None, in use for signalling and telecommunications training. Relocatable: No. Risk: Normal.

Completed by British Railways, Wimbledon A Signal Box is amongst the last of the elegant Type 13 signal box designs developed by the Southern Railway before replacement by designs such as the Type 16 seen at Dorchester South Signal Box. “Like a tiny ocean liner carried inland on a freak wave” (Wright 2013), located at the furthest end of Wimbledon Railway Station from the main station buildings limits public awareness, other than from those intent upon graffiti.

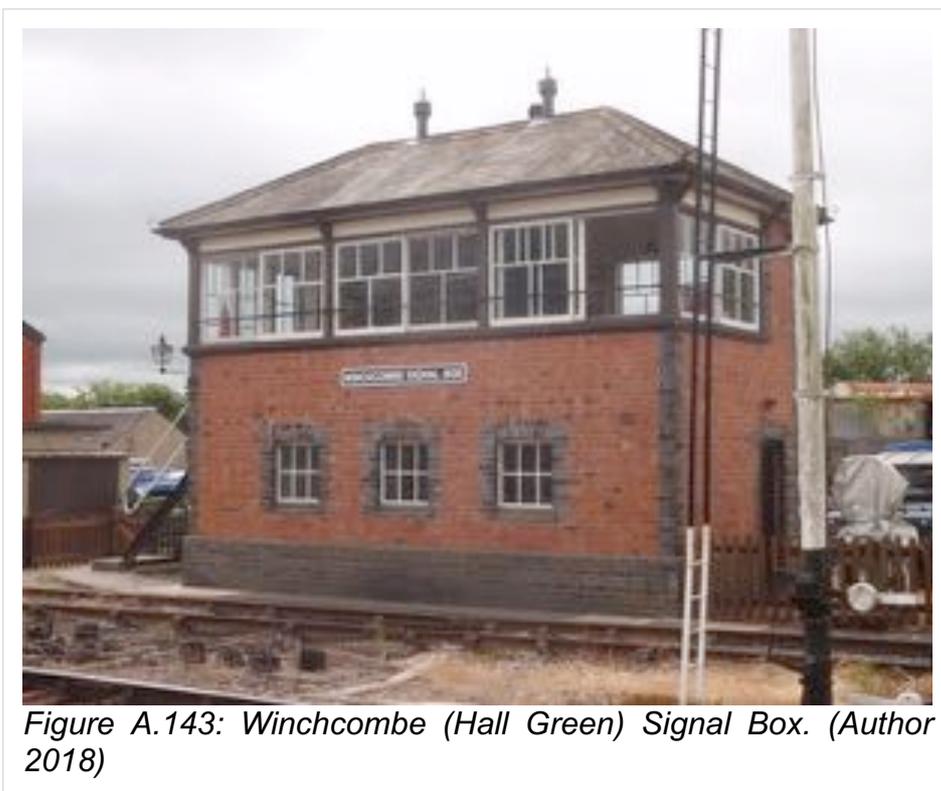
A.2.143 Winchcombe (Hall Green) Signal Box

Administrative location: Gloucestershire, England. Constraints: Close. Design: GWR 7d. Built: 1907/1987. Listing: n/a. Status: Use HR. Future/use: Operational heritage. Heritage value: Modified (brick plinth to match original, evidence suggests replacement timber staircase), communal (station location). Overall condition: Good. Reuse potential: None. Relocatable: None, relocated 1987. Risk: Deliberate. Comment: Conversation.

Careful relocation makes Winchcombe Signal Box a building conservation dilemma, especially as this relocation was to create a group with an equally carefully relocated station building, delivering a harmonious whole in an attractive village environment that augments the heritage railway experience.

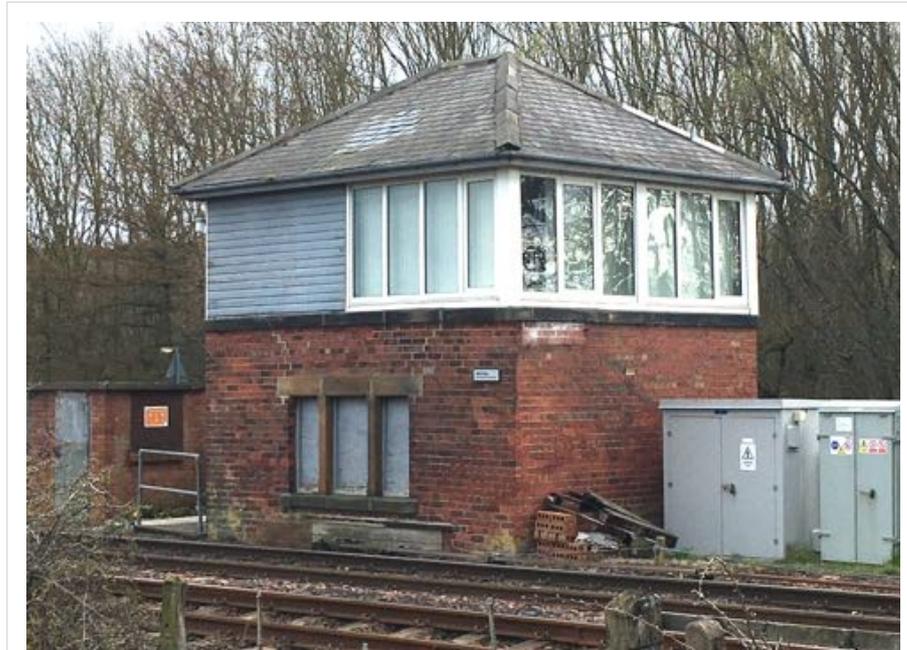
Administrative location: Northumberland, England. Constraints: Close. Design: NER N2+. Built: 1895. Listing: n/a. Status: Use ML. Future/use:

Short term. Heritage value: Modified (replacement uPVC windows, replacement timber staircase), communal (level crossing). Overall condition: Deficient. Reuse potential: Accessible. Relocatable: No. Risk: High.

Figure A.144a: Winning Signal Box. (Author 2019)

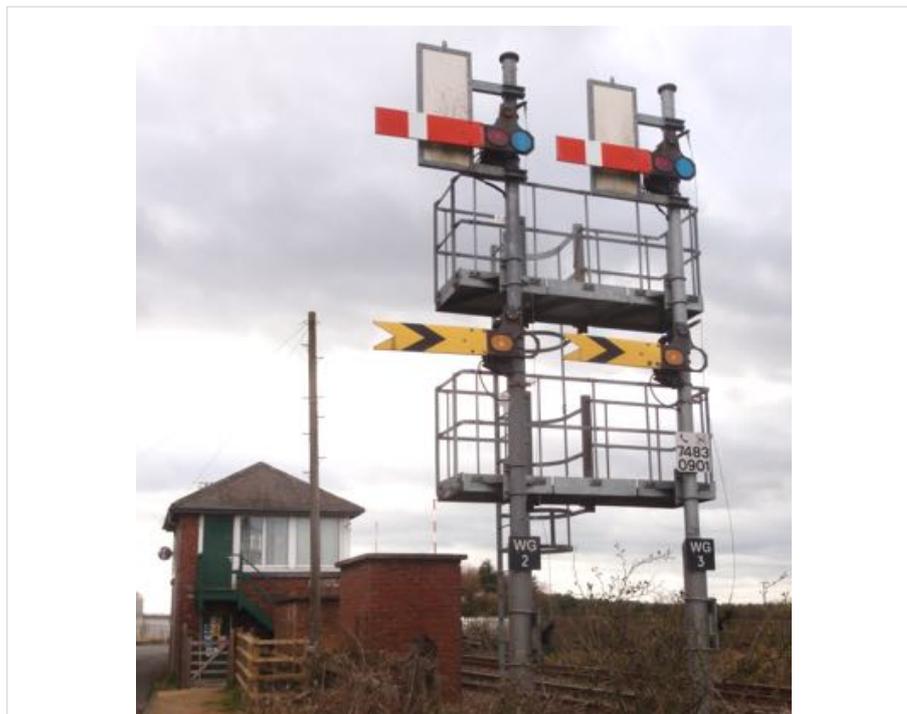
Figure A.144b: Winning Signal Box retains this noteworthy semaphore signal installation on modern posts. (Author 2019)

Being near a level crossing and next to a road might give some public awareness of Winning Signal Box, coupled with a nearby display concerning the local coal-mining heritage, although it is reasonable to assume there will be more awareness of the substantial semaphore signal gantry controlled by the signal box.

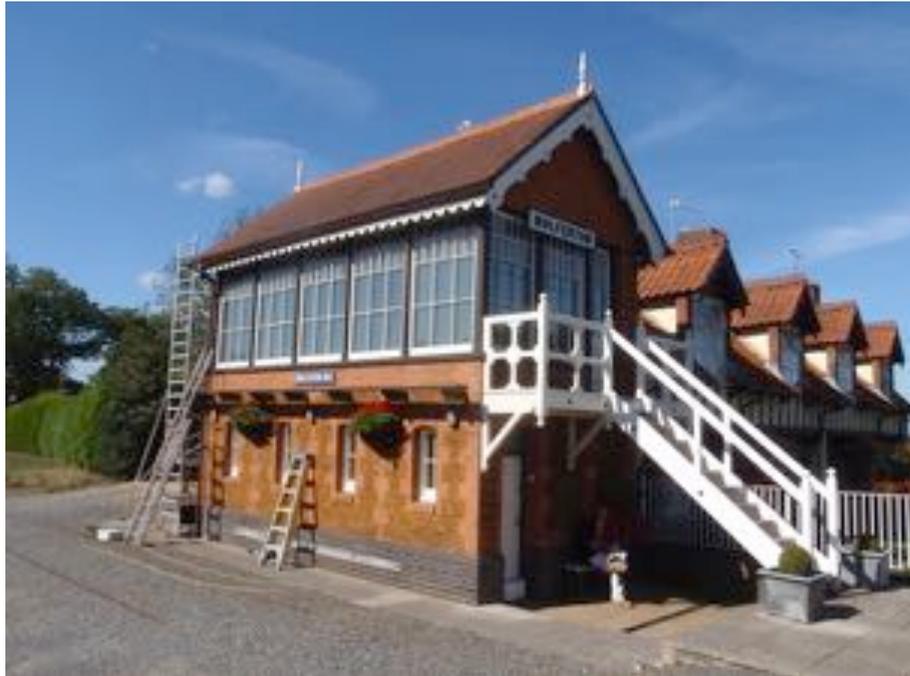
Figure A.145: Wolferton Signal Box. (Author 2018)

Administrative location: Norfolk, England. Constraints: Close. Design: GER 5. Built: 1897. Listing: II [G]. Status: OOU IS. Future/use: Museum. Heritage value: Original, historical plus communal (group value with former station on royal estate). Overall condition: Good. Reuse potential: None. Relocatable: None. Risk: Normal. Comment: Conversation.

The so-called 'royal' signal box, Wolferton Signal Box is on the Sandringham Estate and forms an attractive group with the closed railway station. Very well presented, the narrative of this signal box includes a record of royal and society arrivals.

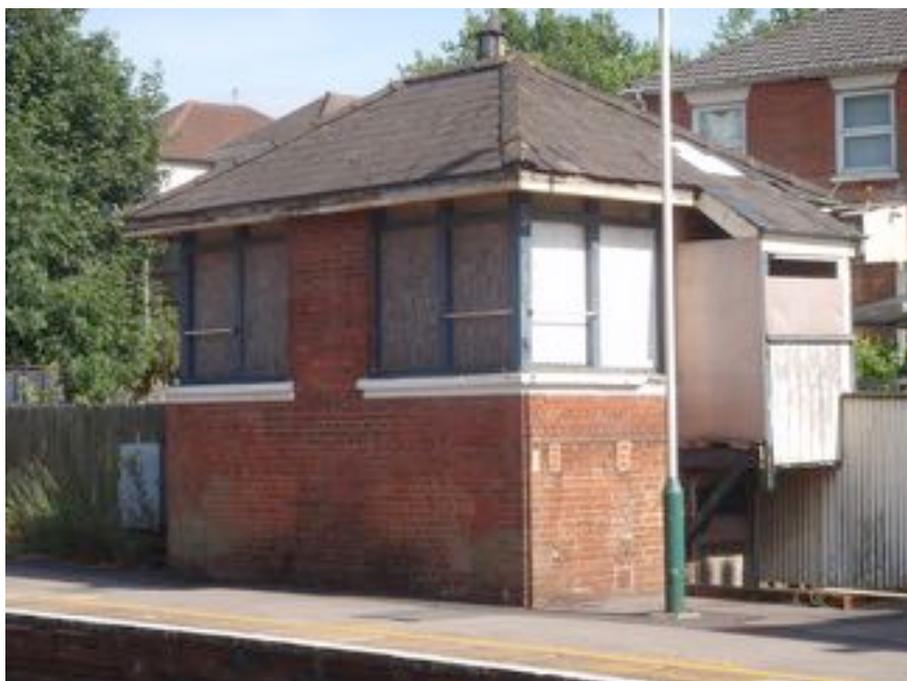
Figure A.146: Woolston Signal Box. (Author 2018)

Administrative location: Southampton, England. Constraints: Close. Design: LSWR 4. Built: 1901. Listing: II [GV]. Status: OOU ML. Future/use: Mothballed. Heritage value: Modified (staircase removed), communal (station location, apparently some community interest in restoration). Overall condition: Deficient. Reuse potential: Accessible. Relocatable: Difficult. Risk: Deliberate.

Although in a deficient condition, and modifications to protect the building adding to this condition, the platform location of Woolston Signal Box will provide a modicum of public awareness. There is local interest in protecting this building, which does have a group value with the station building.

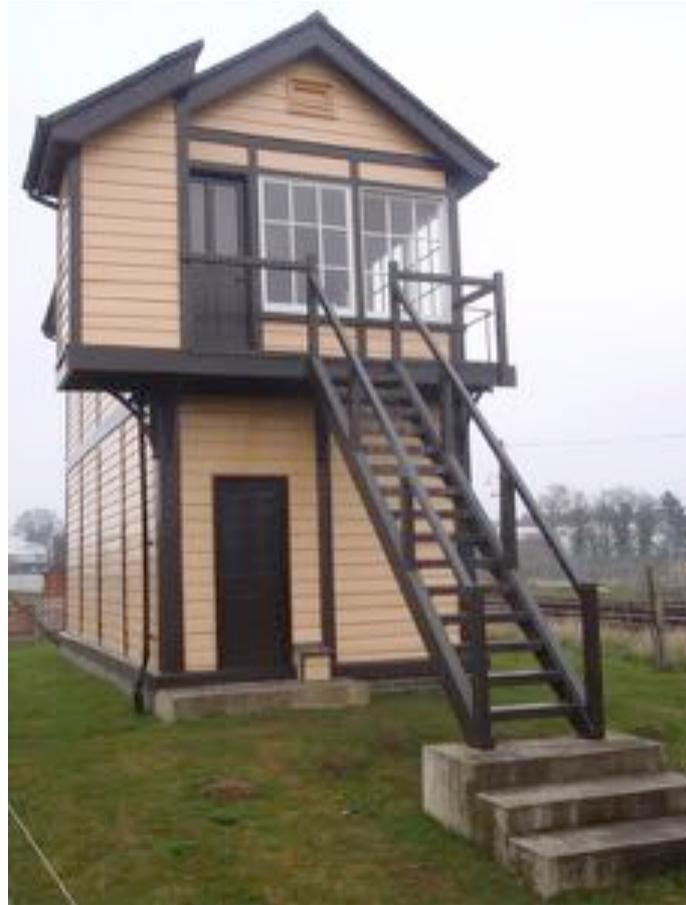
Administrative location: Norfolk, England. Constraints: Close. Design: GER 7. Built: 1900. Listing: II. Status: OOU HR. Future/use: Museum. Heritage value: Modified (probably replacement timber staircase to match original design), communal (museum location). Overall

condition: Good. Reuse potential: None. Relocatable: None, repositioned on site. Risk: Normal.

Figure A.147: Wroxham Signal Box. (Author 2018)

Conserved within a railway heritage centre as a signalling exhibit, public awareness of Wroxham Signal Box is deliberate and controlled. Significantly degrading the heritage value is a repositioning on site, moving the signal box back from the railway to improve the view drivers have of new signalling. Bower (2021, p17) describes how in 2000, Network Rail were planning to apply for listed building consent for demolition of the recently listed signal box to improve the signalling sightlines, and that protracted negotiations led, in 2007, to a repositioning on site by moving the building using air skates. This is a more subtle change than repositioning to a new site and gives all round access, yet this subtlety devalues the immediate trackside context that is part of the essential character for a mechanical signal box.

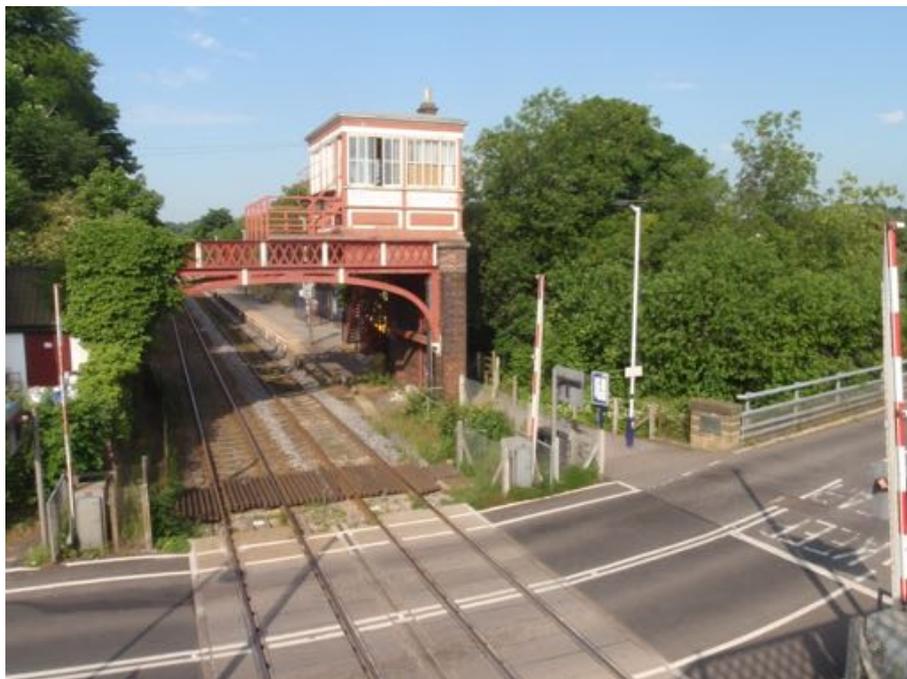
Figure A.148: Wylam Signal Box. (Author 2015)

Administrative location: Northumberland, England. Constraints: Close. Design: NER N5 overhead. Built: c1897. Listing: II. Status: Use ML. Future/use: Short term. Heritage value: Original. Aesthetic (unusual over track design), communal (level crossing). Overall condition: Fair. Reuse potential: Accessible. Relocatable: Partially. Risk: Normal.

One of three surviving overtrack signal boxes (Kay 2010). Described in section 3.4 are the dilemmas in conserving this signal box once it closes, defined as the unsolvable problems where contradictory agendas present in conservation. There is no question that the signal box occupies an attractive, riverside location in the heart of this Northumberland village. Furthermore, the constrained site suggests only a small original goods yard, with the railway environment not so degraded than surrounding many equivalent signal boxes, so the discussion in section 7.3 suggests that there is less of a case for justifying radical solutions to future conservation.

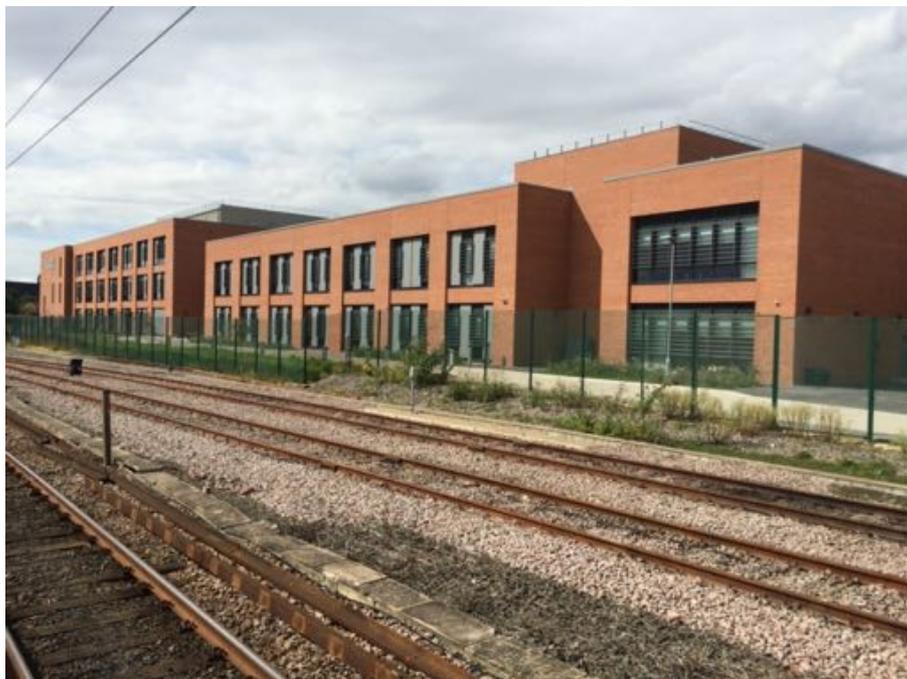
Figure A.149: York ROC. (Author 2015)

Administrative location: York, England. Constraints: Reasonable. Design: NR bespoke. Built: 2014. Listing: n/a. Status: Use ML. Future/use: Long term. Heritage value: Original. Overall condition: Good. Reuse potential: None. Relocatable: None. Risk: Normal.

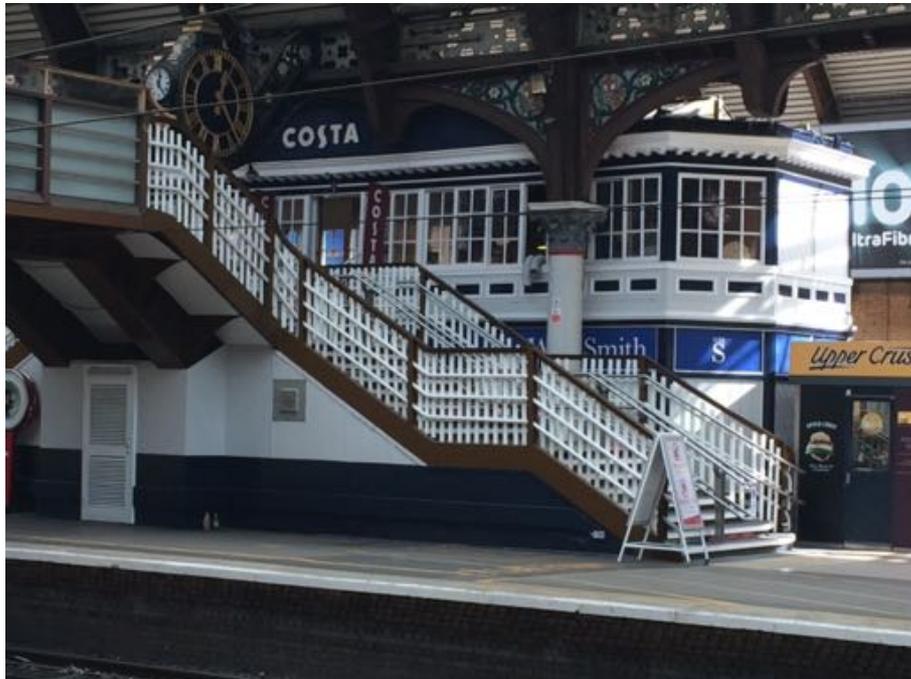
Administrative location: York, England. Constraints: Close. Design: NER bespoke. Built: 1907. Listing: II. Status: OOU PR. Future/use: Café/retail. Heritage value: Modified (conversion into café/retail),*

communal (station location). Overall condition: Good. Reuse potential: None. Relocatable: None. Risk: Normal.

Figure A.150: York Station Platform Signal Box. (Author 2015)

Displaced in 1951 by a power signalling system planned from before the Second World War to replace the substantial number of mechanical signal boxes controlling the railways around York, this attractive bespoke design survives in good condition by the fortuitous location in the main circulation area of York Railway Station. It is unlikely that anybody using the locking room shop or operating level café is aware of the former use as a signal box.
