Citation: Corradi, Marco, Tedeschi, Cristina, Binda, Luigia and Borri, Antonio (2008) Experimental evaluation of shear and compression strength of masonry wall before and after reinforcement: Deep repointing. *Construction and Building Materials*, 22 (4). pp. 463-472. ISSN 0950-0618

# **Experimental evaluation of shear and compression strength of masonry wall before and after reinforcement: deep repointing**

M. Corradi<sup>\*1</sup>, C. Tedeschi<sup>2</sup>, L. Binda<sup>3</sup> and A. Borri<sup>4</sup>

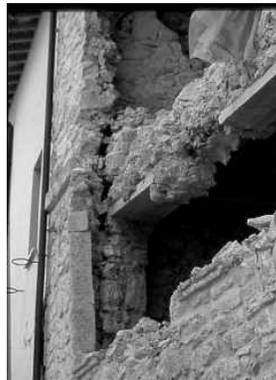
Figure 1 Double leaf wall

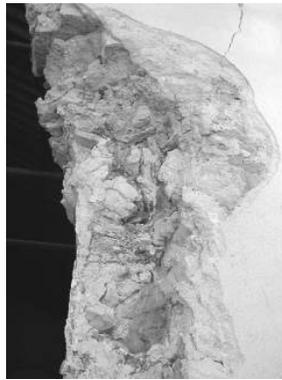
Figure 2 Effect of eccentric loading due to RC tie beam positioning.

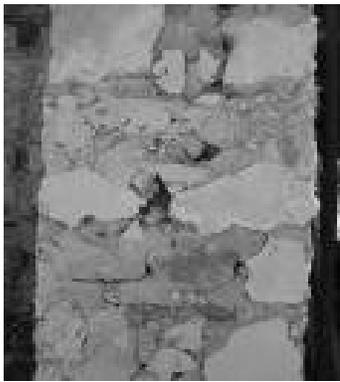
This large building in Trevi was built at the end of the 19<sup>th</sup> cent. as a dock for agricultural purposes. The plan is square and the dock is three floors high (Fig. 9c). The masonry is made with two leaves of roughly cut stones with a thickness of 670 mm. The chosen panels had some courses made with bricks at regular spacing. In the internal part of the wall section the mortar filled all the voids between the stones, but no connection was found between the two leaves of masonry.

Figure 9 a) Ponte di Postignano bulding; b) Farnetta building; c) Trevi building.

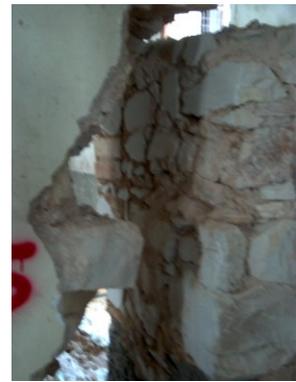
In Fig. 10a,b,c the section of the walls tested in the three chosen buildings is presented. As it can be seen the walls are made with a two leaf masonry and irregular stones.

Figure 10a,b,c Section analysis: a) Ponte di Postignano; b) Farnetta c) Trevi;
