Citation: Corradi, Marco, Speranzini, Emanuela and Alessio, Molinari (2022) A repair method of cracked shear walls with stainless steel. *Composite Structures*, 293. p. 115739. ISSN 0263-8223

A repair method of cracked shear walls with stainless steel rods and fibres

Marco Corradi^{a,b,*}, Emanuela Speranzini^b, Alessio Molinari^b

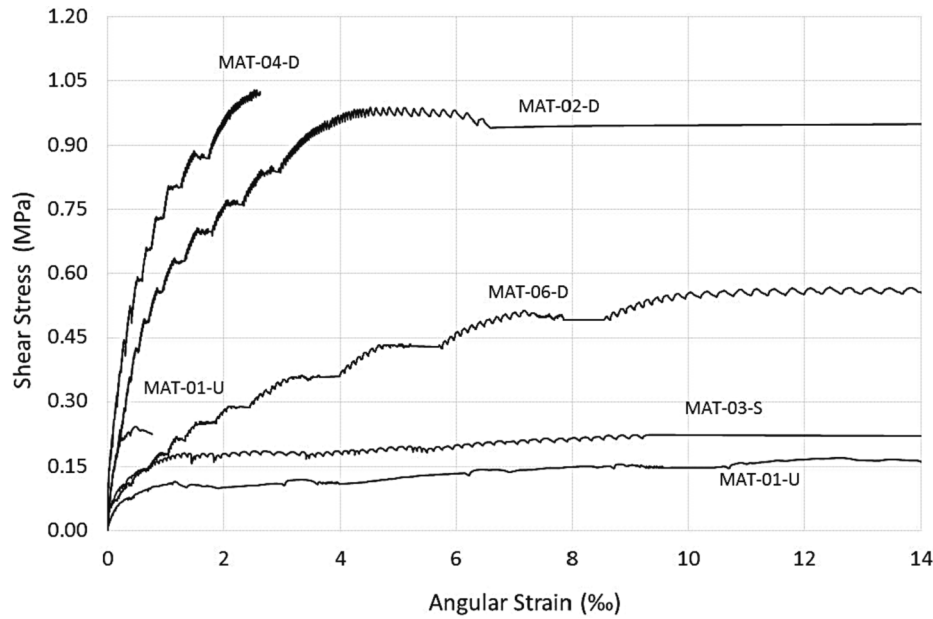
Fig. 9 shows the stress–strain curves for the repaired brickwork specimens and Table 5 the corresponding test results. The following is the comparison between the lateral load capacity from the reinforced and the repaired brickwork panels: it can be preliminarily noted that the average lateral load capacity of unreinforced, single-sided and double-sided reinforced walls were about 67, 110.6 and 202.4 kN, respectively (first experimental campaign).

With regard to MAT-01-U, MAT-03-S, MAT-06-S test results seem to demonstrate that ribbed rods were more effective than helical ones, as a bed joint repair method. These three panels have been repaired using helical (MAT-01-U, MAT-03-S) and ribbed rods (MAT-06-S), applied at

Fig. 9. Repaired brickwork wall panels: shear stress vs. angular strain envelope curves.

the un-reinforced side (on both sides for MAT-01-U, and on a single side for MAT-03-S and MAT-06-S). The lateral load capacity decreased of 33.6% (from 67 to 45.9 kN - MAT-01-U, and from 100.3 to 64.5 kN - MAT-03-S) for brickwork wall panels repaired with helical rods, while it increased of 31.2% (120.9 to 158.6 kN – MAT-06-S). The typical failure mode at the unreinforced side was due to ejection of mortar cover near the stainless steel rods and subsequent re-formation of the diagonal crack (Fig. 10).

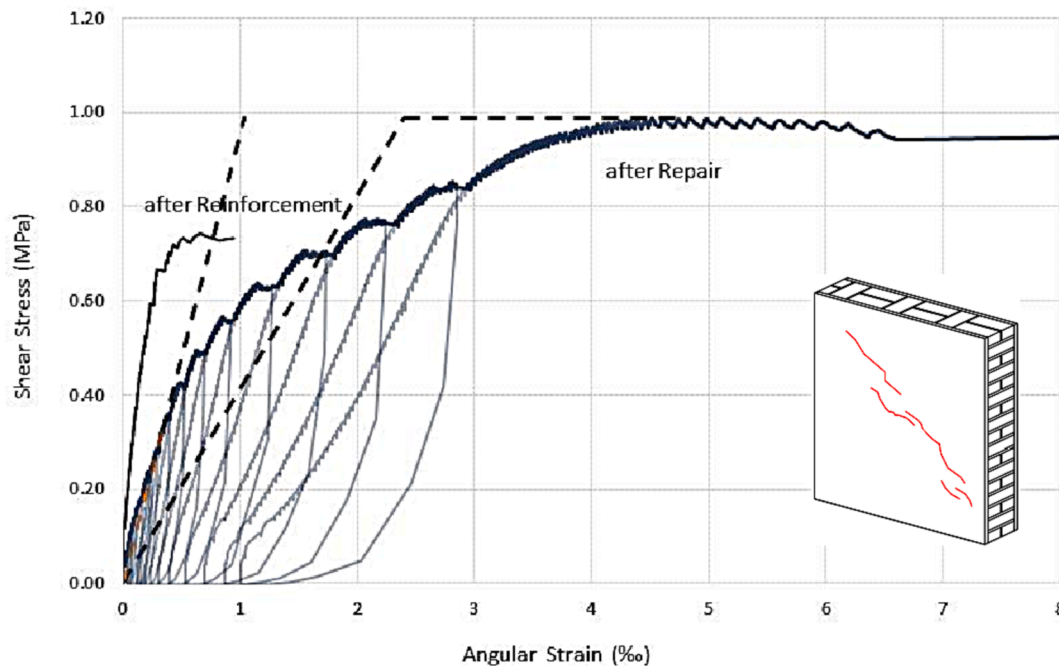
Table 5 also shows that the repair operations were able to significantly increase the original lateral load capacity for wall panels MAT-02-D (from 205 to 283 kN, Fig. 11) and MAT-04-D (119.8 to 281.7 kN, Fig. 12) compared to the lateral load capacity of reinforced walls. Both these panels were double-sided reinforced, but different repairs were used: panel MAT-02-D was repaired by sealing the diagonal crack with helical anchors, while ribbed stainless rods were used for MAT-04-D. The repair procedure was completed for both panels with a SRG jacketing of the area near the diagonal crack. While the first repair methods (helical anchors or ribbed stainless rods) were also used for the repair of the other panels, the SRG jacketing was only applied to these panels: it

Fig. 11. MAT-02-D tests: comparison between structural response after FRCM reinforcement and after repair.

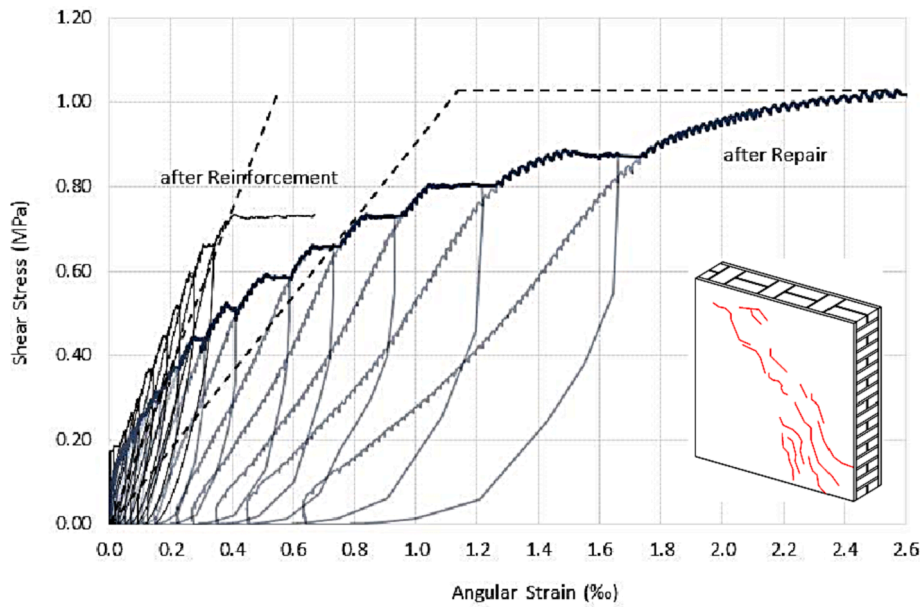
Fig. 12. MAT-04-D tests: comparison between structural response after FRCM reinforcement and after repair.

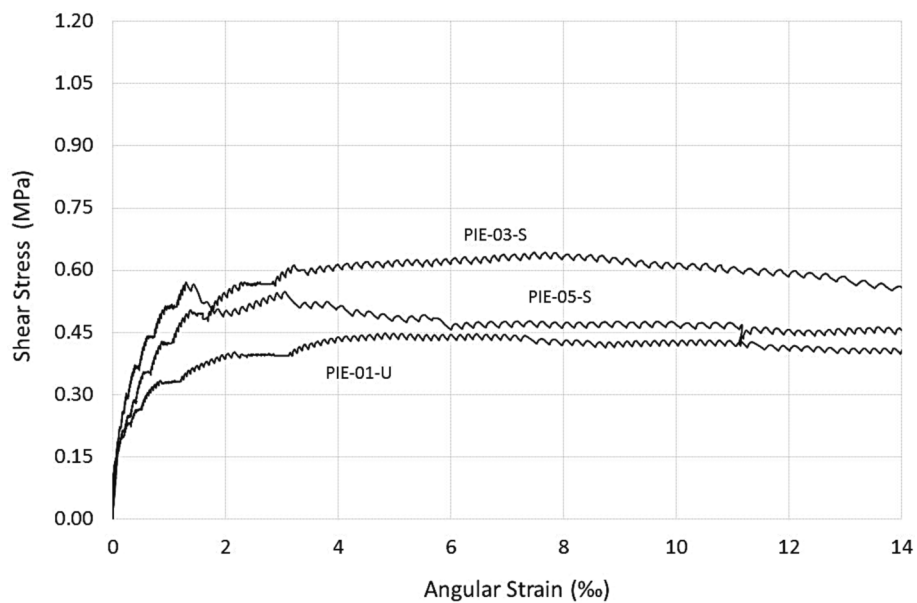
For stone work panels, the repair solutions resulted more effective, with load capacity increments ranging between 12.4% and 83.7% (Figs. 13 and 14). This seems the effect of the application of the SRG reinforcement. The fundamental contribution of the SRG is also confirmed by the analysis of the wall failure modes: only when the SRG

Fig. 13. Repaired stone masonry panels: shear stress vs. angular strain envelope curves.

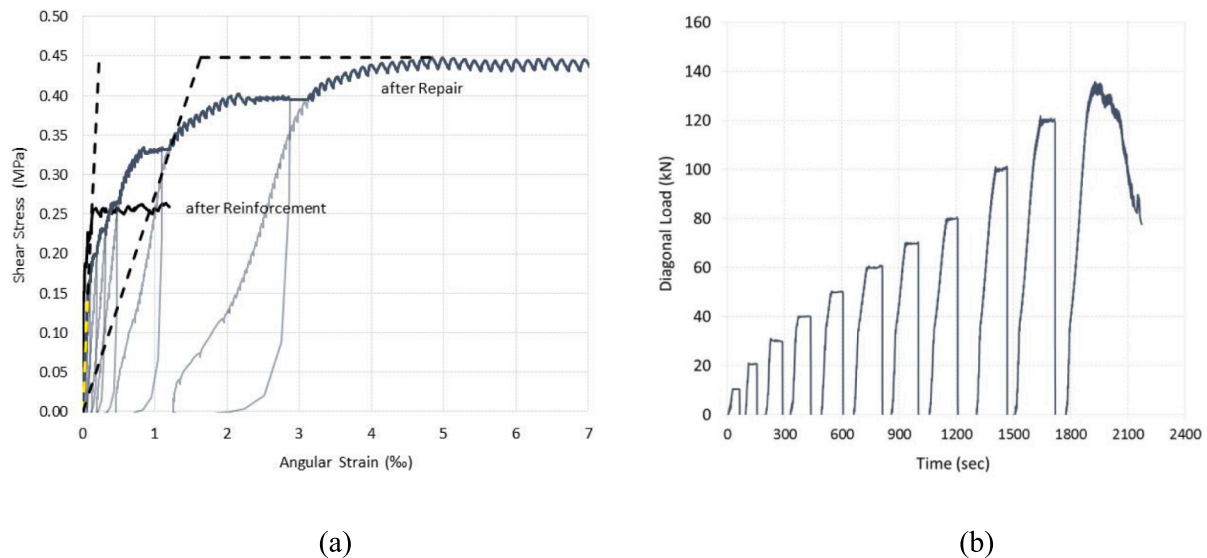
Fig. 14. PIE-01-U tests: (a) comparison between structural response after FRCM reinforcement and after repair, (b) loading protocol.
