Citation: Corradi, Marco, Castori, Giulio, Sisti, Romina, Borri, Antonio and Pesce, Giovanni (2019) Repair of Block Masonry Panels with CFRP Sheets. *Materials*, 12 (15). ISSN 1996-1944

Repair of Block Masonry Panels with CFRP Sheets

Abstract: In the 1980s, block masonry started to be widely used for new constructions in Italy's earthquake prone areas. However, recent seismic events demonstrated that block masonry buildings may need to be repaired after earthquakes due to cracking. Construction defects are the main cause for cracking of block work masonry. Carbon fiber reinforced polymer (CFRP) sheets have been used as a local repair method for non-defective and defective wall panels. An experimental program was formulated to investigate the shear behavior of block masonry walls repaired with CFRP sheets. A total of six wall panels were constructed in the laboratory and tested in shear (in-plane lateral loading). It was found that, although the control (non-defective) wall panels had a high ultimate load capacity, the use of CFRPs reduces the effects of construction defects and restores the lateral load capacity in non-defective walls. Overall, this research suggests that the use

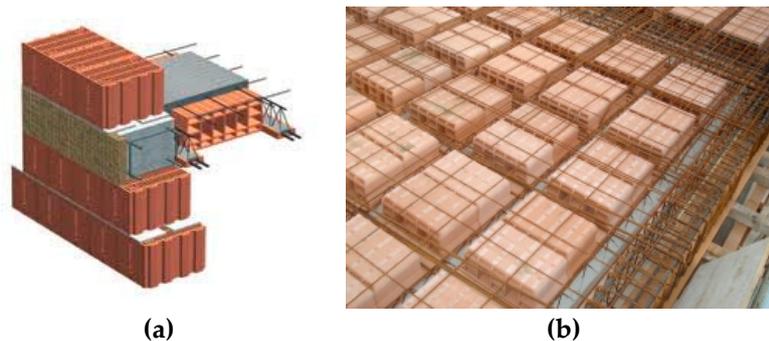
The typical construction method of hollow clay block masonry in Italy consists in the use of 25–40 cm thick blocks, to form a single-wythe wall, and a cement mortar. In order to reciprocally connect the walls, and prevent out-of-plane collapse mechanisms, the Italian Building Code requires the construction of ring beams at each floor level and at the eaves level. These are typically made of a reinforced concrete (RC) [31]. The horizontal and roof diaphragms are usually made of 1-way steel-reinforced concrete joists, tile hollow blocks and a 4–5 cm-thick slab reinforced with steel-wire mesh. The joists are fixed to the ring beams and both the ring beam and the slab are cast simultaneously (Figure 4). This construction method was very common in Umbria in the area struck by the 2016 earthquake.

Figure 4. (a) Detail of the area near the RC ring-beam, (b) a horizontal diaphragm and ring beams ready for casting.

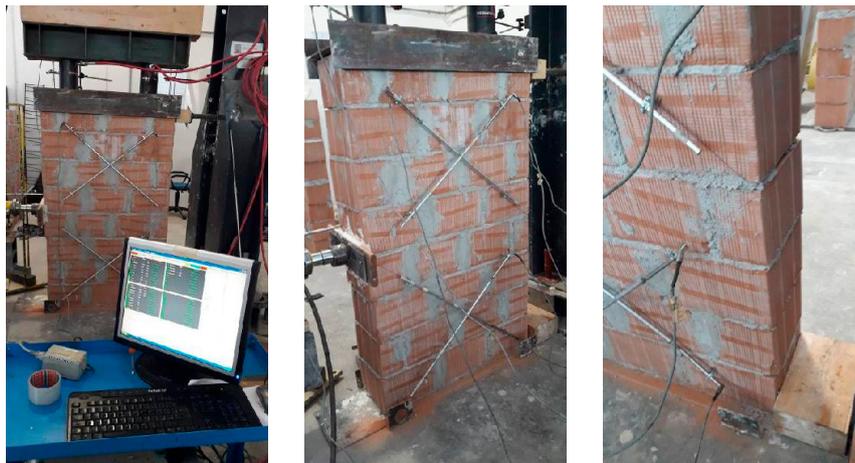
Following the initial application of the vertical load, up to the limit of 45 or 67.5 kN (corresponding to a compressive stress of 0.2 or 0.3 MPa, respectively), the shear horizontal load was applied in cycles of increased magnitude, up to failure (Figure 14). The overall structural response of the walls was very satisfactory, with high lateral load capacities varying between 150.55 and 182.98 kN, corresponding to a shear strength of 0.2493–0.3187 MPa. If these values are compared with the shear strength of other types of masonry (solid bricks, stonework, etc.), the hollow block masonry results are much stronger [39,40]. As soon as the principal tensile stress reaches the tensile strength of the cement mortar, a crack forms and failure occurs.

Figure 14. Non-defective wall panels.

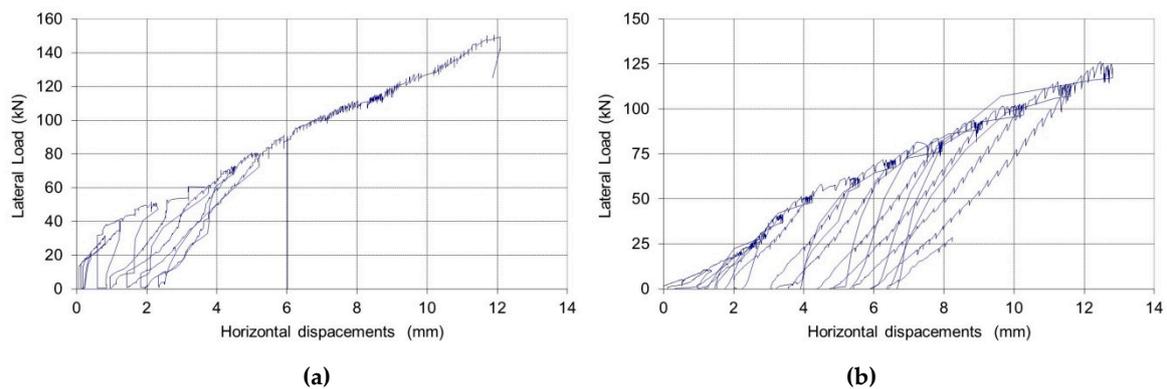
The panels’ response in terms of deformations (horizontal displacements of the LVDT D5 along the panel’s line of symmetry, exhibited a linear lateral load-horizontal displacement relationship for low horizontal loads, turning un-linear near the failure load. Figure 17a shows the lateral load vs. horizontal displacement for the non-defective (P1-ND-30).

Figure 17. (a) Lateral load vs. horizontal displacement for non-defective (P1-ND-30), and (b) for the defective panel (P5-DE-20).

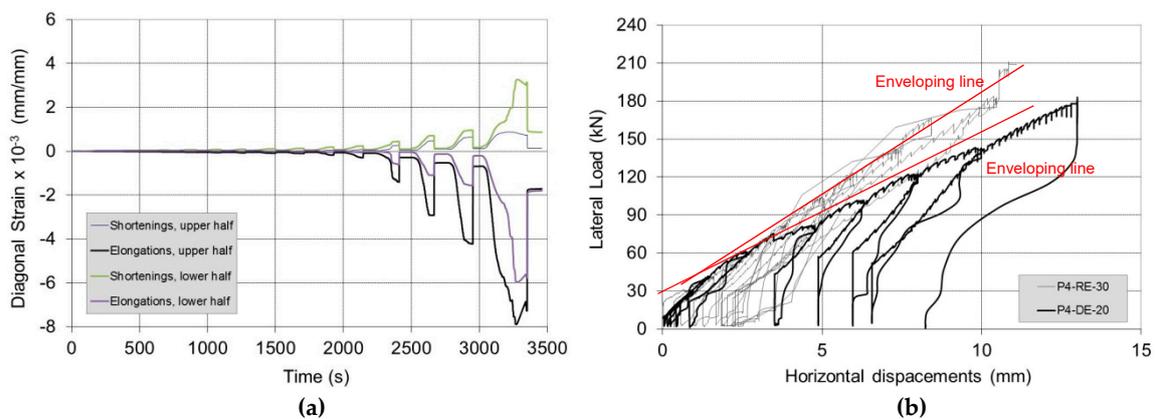
Figure 20. (a) Diagonal strains for Test No. P4-RE-30, (b) Panel No. 4, before (up to horizontal cracking) and after repair: lateral load vs. horizontal displacements.

Figure 20b compares the structural response of Panel No. 4 before and after repair. It can be noted how the application of the CFRP sheet caused an increase in the lateral capacity (although the vertical compressive stress was 0.2 MPa for the P4-DE-20 test and 0.3 MPa for the P4-RE-30 test). In terms of lateral stiffness, it is worth noting that the slopes of the enveloping lines of the curves are very similar. The CFRP repair did not change the shear stiffness of the panel, but only acted to prevent the re-opening of the bending horizontal crack.
