# Investigating the accelerated test condition to produce cracking failure of water ballast tank coatings

**Key words:** Corrosion, Hygrothermal cycling, Test protocols, Water ballast tanks.

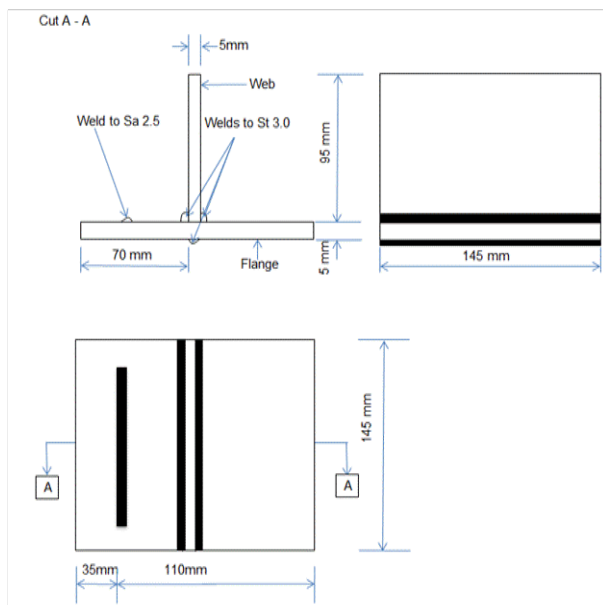
Fig. 1: T girder test specimens

The test specimen used was a mild steel T girder (i.e. a welded web and flange as shown in fig 1 above). The T girder dimensions of the web were 145 mm x 145 mm x 5 mm and the flange were 145 mm x 95 mm x 5 mm. These dimensions were selected to accommodate the maximum number of test specimens within the internal space of the oven. In-service cracking failures of WBT coatings are seen initiated on the welded joints especially at corners that are normally prepared by power tooling. Power tooling leaves a smoother surface which can reduce the adhesion of coatings to the substrate. However it tends to result in coatings having higher dry film thicknesses when applied due to stripe coating. Other areas such as the flat surfaces and welds on the flat surface are mostly prepared by grit blasting. Grit blasting leaves a roughened and clean adhesion surface for coating application. The effect of surface preparation and its perceived contribution to the coating cracking phenomena has been factored into the preparation of the test specimen. This was achieved by having 4 welds on the test specimen to simulate the effect of the in service surface preparation. 2 welds at the intersections of the flange and web, 1 on the underside of the web situated directly under the flange and another situated 35mm away from the edge of the flange. The surfaces on top of the T girder including the weld situated 35mm away from the edge of the flange were prepared by grit blasting to Sa 2.5. The surfaces on the underside of the flange, the welded joints at the intersection of the flange and web together with the weld on the underside of the flange were prepared by power tooling to St 3. The difference between Sa 2.5 and St 3 are shown below in table 1.

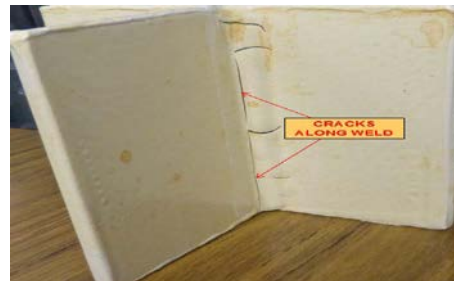
For formulation A, after just 1 accelerated test cycle, cracks were observed only on the welded joints at the intersection of the flange and web of the T girder as shown in Fig. 2. All 6 T girder test specimens for both dfts for this formulation exhibited cracks at this location.

Fig.2: T girder test specimen for formulation A displaying cracks along the welded joint

The results have shown that under laboratory conditions for all 4 coating formulations the implemented accelerated test conditions have produced cracks at the welded joints (i.e. corners) as seen in the in-service WBTs. Further validation of this experimental result is required. This is to ensure the validity of the accelerated test conditions used in this investigation before it can be considered as a reliable test protocol to assess the in service performance of the WBT coating. It is acknowledged that currently it would not be possible to draw any conclusive comparison between the performances of the coating formulation used under laboratory conditions with the in-service coatings due to the coating performance being formulation dependent. Therefore in the longer term it would be useful to investigate the performance of coatings having set formulations to enhance the life expectancy of the DH tankers and bulk carriers.
