Citation: Righetti, Luca, Corradi, Marco and Borri, Antonio (2015) Basalt FRP Spike Repairing of Wood Beams. *Fibers*, 3 (3). pp. 323-337. ISSN 2079-6439

Basalt FRP Spike Repairing of Wood Beams

Luca Righetti ^{1,*}, Marco Corradi ^{1,2} and Antonio Borri ²

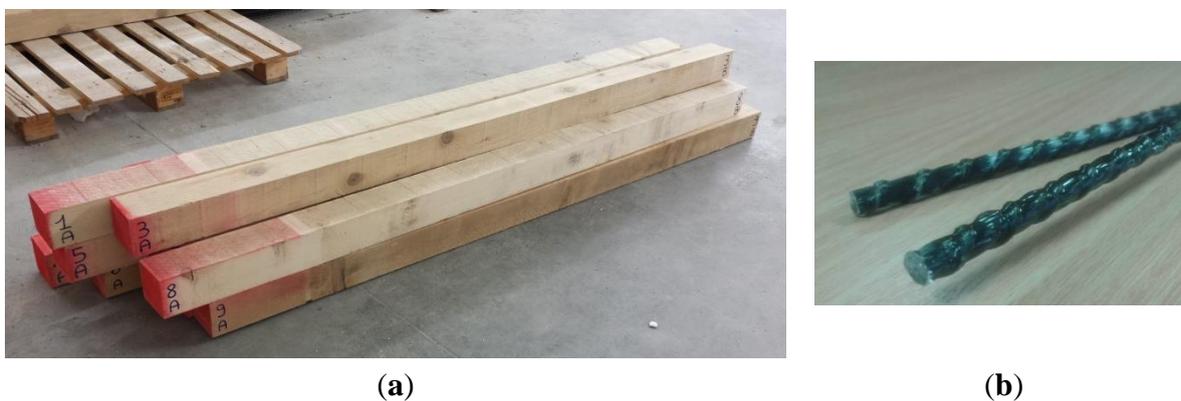
All beams were made of softwood (fir-wood). Tests were carried out on sharp-edged timber beams (Figure 4a) in fir wood (*Abies Alba*). All the timber beams had the same width (96 mm), height (96 mm) and length (2000 mm). The average weight density and moisture content were 417 kg/m³ (dev. 24 kg/m³) and 14.31% (dev. 0.89%), respectively. Moisture content was measured according to EN 13183-1: 2002 standard [27].

Figure 4. (a) Softwood beams; (b) BFRP spikes.

Due to its anisotropic behavior, seasoning of timber always causes split opening along the grain in structural timber beams. The prime objective of seasoning is to reduce the moisture content and increase mechanical properties. BFRP spikes (Figure 4b) were used here to restore the continuity of artificially damaged timber beams.

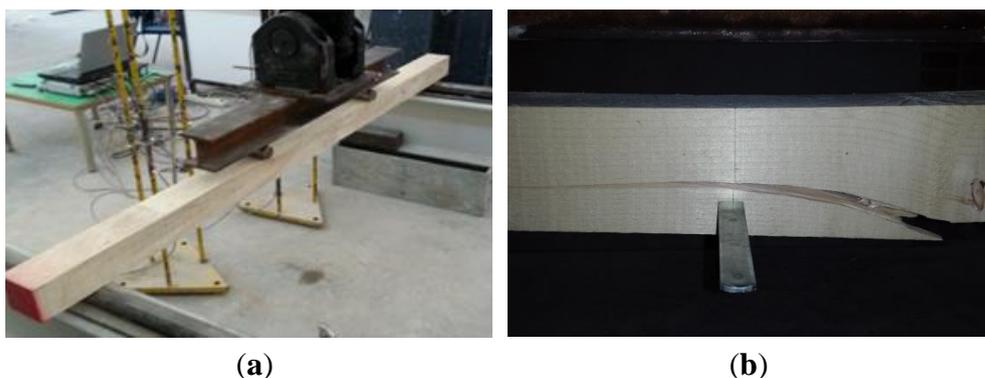
where l is the distance between the rollers; $F_2 - F_1$ is an increment of load on the straight-line portion of the load deformation curve; $w_2 - w_1$ is the increment of deformation corresponding to $F_2 - F_1$; b is width of cross section. In order to have a overall information of the stiffness properties of the timber beams it was decided to measure and calculate only the global modulus of elasticity evaluated according to Equation (11). The test setup is shown in detail in Figure 5a.

Figure 5. (a) Four-point-bending test setup; (b) Typical tensile failure mode of control beams near a knot or due to grain deviation.

Fourteen control beams were subjected to flexure in four-point-bending. These results have been reported only for the purpose of quantitatively calculating the effectiveness of the repair intervention through a comparison with the results of identical tests performed on the strengthened beams. Various modes of fracture were detected in the timber beams, but all on the tension side: simple tension, cross grain tension, knot influenced (Figure 5b). Knots and grain deviation highly influenced the propagation of the cracks for all control specimens. Deflection characteristics of the tested control beams are shown in Table 4, the average bending strength was 24.5 MPa (dev. 8.3 MPa) and the global modulus of elasticity was 5932 MPa (dev. 907 MPa).

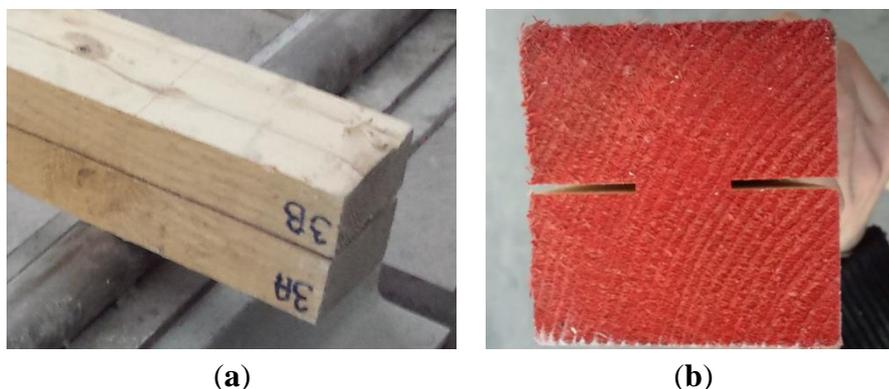
Six beams were subjected to four-point-bending after being artificially damaged: three timber beams were divided in-half and three were cut with two 35 mm horizontal notches (Figure 7). The control notched specimens (UN_1, UN_2 and UN_3) exhibited an average bending strength of 16.7 MPa and a global modulus of elasticity of 5622 MPa. Furthermore the failure of these specimens occurred in the area where bending moment is maximum. Fracture was influenced by the presence of the two notches: beams UN_1 and UN_3 failed due to separation of upper part half from lower half and subsequent tensile failure in tension side. This caused a significant reduction in beam capacity shifting from 12.1 (undamaged beams) to 8.3 kN (notched beams):

Figure 7. (a) Timber beams cut in half; (b) Notched beams.

BFRP spikes have been applied to cut-in-half (Figure 7a) and to notched beams (Figure 7b) with the aim to restore the continuity of damaged timber beams.

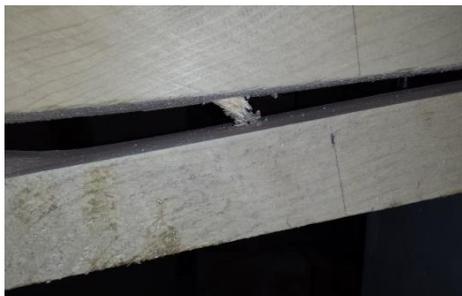
Figure 8. Pull out of the BFRP spike.

The repaired cut-in-half beams (RS_1, RS_2, RS_3, RS_4 and RS_5) exhibited an average bending strength of 15.0 MPa and a global modulus of elasticity of 4904 MPa. Failure, again knot influenced, occurred in the timber material on the tension side where the bending moment is maximal. After timber failure, the BFRP spikes did not exhibit any damage, but partially separated from the epoxy resin in the holes. Slippage was also generated by timber shear failure near the holes caused by the low shear strength of fir wood (Figure 8). Figure 9 shows the load-deflection response of control and repaired beams that were cut in half. The load-displacement graphs generally show that there is a large amount of vertical mid-span deflection even for low loads due to the slippage of the BFRP spikes.

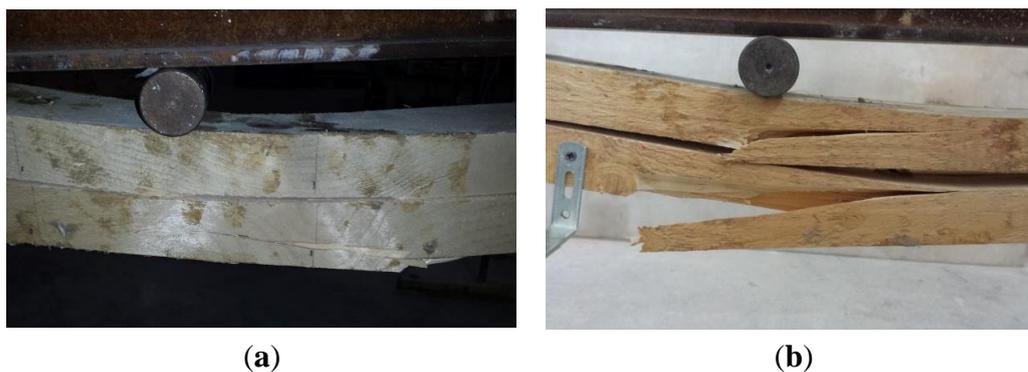
Figure 10. Timber tensile-flexural failures (beams that were cut in half): (a) in the lower half; (b) both in the lower and upper half.

failures on the lower half of the timber beam when subject to flexural loading. After this, a pseudo-ductile behaviour of the repaired beams has been recorded.
