Citation: Osofero, A I, Corradi, Marco, Benedetti, G and Ede, A N (2019) Use of natural resins in repairing damaged timber beams - An experimental investigation. IOP Conference Series: Materials Science and Engineering, 640. 012040. ISSN 1757-899X

## Use of natural resins in repairing damaged timber beams – An experimental investigation

**Key words:** bending capacity, damaged timber beams, environmental impact, natural resins, repair material

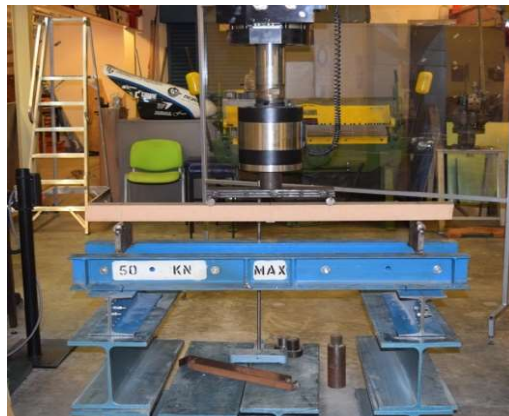
The test set up included an actuator and a testing steel frame with data acquisition system as shown in figure 1. To achieve four-point bending, a spreader beam which allowed the force from the actuator to be applied at two locations along the length of the beam was used. The tests were displacement controlled at a rate of 4 mm/min. Bending load was applied until failure for all beam specimens tested.

**Figure 1.** Test set-up (span between supports = 1004 mm and load span = 400 mm).

Bending tests were carried out over a span of 1000 mm. Supports were made of steel cylinders with a diameter of 25 mm and the distance between the two point loads was kept at 400 mm. The actuator, through which vertical load was applied on the spreader beam, which in turn apply two point loads on the beam specimens, is of the model 2518-113/UK068 and characterized by a 250 kN capacity load cell. The layout of the timber beam, supports and load application points are shown in figure 1.

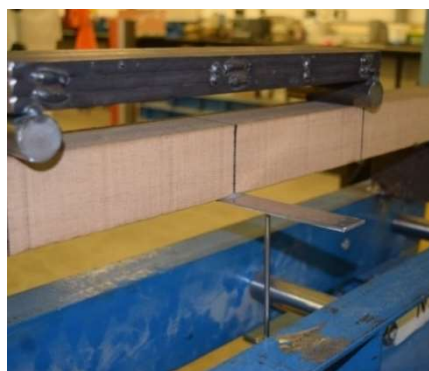
Linear Variable Displacement Transducer (LVDT) was used to measure maximum beam deflection (at mid-span) for every load increase as shown in figure 2. To attach the LVDT, a steel plate was glued to the tension side of the beam at the mid-span and the transducer sensor was set up such that it just touches the underside of the steel plate. The Instron machine and the linear transducer were then synchronized to ensure corresponding output at a frequency of 1 Hz were obtained.

**Figure 2.** Measurement of vertical deflection at mid-span using LVDT.

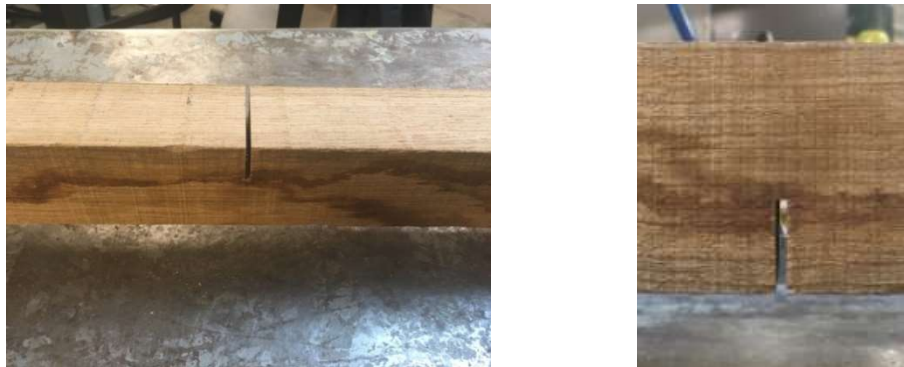
**Figure 3.** Damaged beam specimens (cut dimensions: 20 x 67 mm).

A total number of 15 small timber beams were tested in four-point bending. The timber beams were from European Oak (D30) with nominal dimensions of 67 x 67 x 1100 mm and approximate density of 670 kg/m<sup>3</sup>. Applied load and mid span displacement at failure were measured and recorded. Prior to testing, the beams were numbered, measured, weighed. The moisture content of each beam was also measured (table 1). Subsequently, controlled damage, represented by a machined cut of 2.85 mm thickness and 20 mm height were introduced in 12 of the beam specimens (figure 3), while the remaining three were used as control specimens.

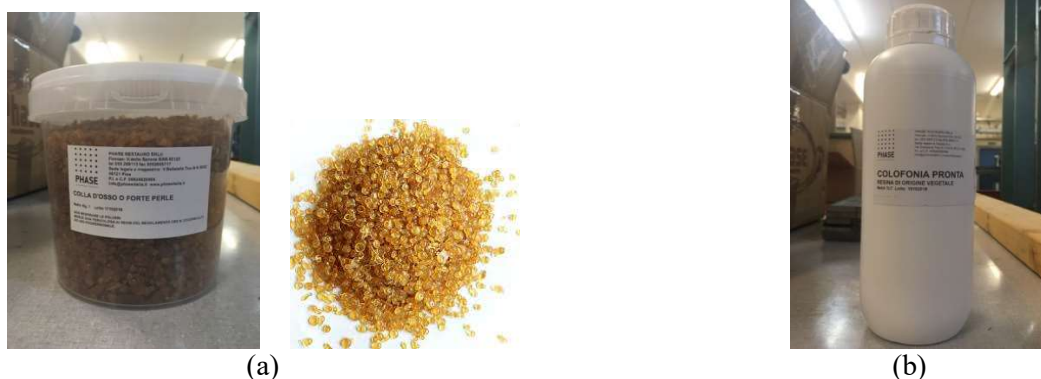
The resins used in this work were provided by Phase Italia, Pisa, Italy. The bone glue was supplied in form of pearls while the rosin (with its solvent - acetone) were provided in a liquid form (figure 4). Resins were prepared before they were used to repair damaged timber beams as detailed in the following sub-sections.

**Figure 4.** Natural resins used for repair: (a) Bone glue, (b) Rosin.

**4.1.1. Bone glue application.** The bone glue pearls were placed in a container with cold water (a part of glue to 4 parts of water). They were left in place until the pearls had absorbed all the water becoming swollen and softened. Subsequently, the glue was heated with the use of an electric cooker, making sure that the temperature of the resin remained between 50-60°C and until it completely melts, with a density similar to that of honey. The resin was then poured into the transverse cut when still hot and allowed to stand for about 14 days (for solidification) before the tests were performed. Tensile tests were performed on bone glue specimens. However, most of the specimens experienced varying degree of curvature when removed from the mold. An average value of about 1000 MPa was recorded for the Young's modulus ( $E_r$ ). Furthermore, this natural bone glue resin is largely characterized by a strong shrinkage, which could have compromised its ability to restore the continuity when used to seal crack in timber.

**4.1.2. Rosin application (RRT series).** The rosin, in their supplied state (liquid), was not suitable for beam repair. Therefore, they were mixed with the accompanying solvent (acetone) and left to rest in an open container. After about 24 hours, the solvent (acetone) was evaporated and the rosin had acquired a density similar to that of a myelose. The resulting product was then used to repair the damaged beams and tests were carried out after 14 days so as to allow the resin to set properly within the beam matrix. A typical Young's modulus ( $E_r$ ) for this type of resin is 200 MPa.
