7 **Basalt FRP spike repairing of wood beams**

8 **Luca Righetti ^{1,*}, Marco Corradi ^{2,3} and Antonio Borri ³**

This paper describes an experimental study on the use of basalt FRP (BFRP) spikes inserted into timber beams to restore the continuity of cracked and damaged sections. The repair technique consists in the application of 95 mm long BFRP spikes inserted into diagonal holes perforated in the timber beams at centre-to-centre distance of 200 mm. An artificially simulated cracking was produced by cutting in half and notching the wood beams. Repaired and control timber beams were carried out to four-point-bending test and results in terms of bending capacity and modulus of elasticity were compared to evaluate the effectiveness of the proposed repair technique. In comparison with the use of self-tapping screws this procedure may be of interest because of the lower Young's modulus of BFRP spikes (similar to the one of timber) and for lower stress concentration based on the larger dimensions of BFRP spikes.

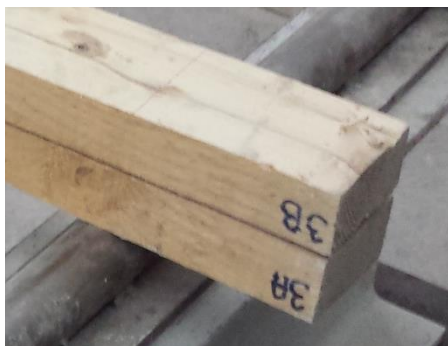
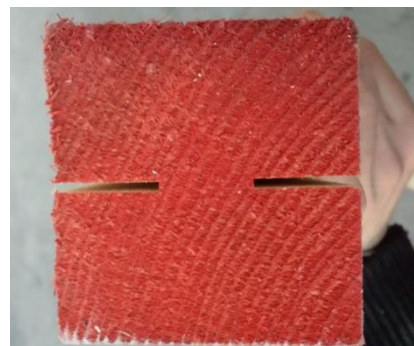
Figure 7. (a) Timber beams cut in half; (b) Notched beams.

Six beams were subjected to four-point-bending after being artificially damaged: three timber beams were divided in-half and three were cut with two 35 mm horizontal notches (Figure 7). The control notched specimens (UN_1, UN_2 and UN_3) exhibited an average bending strength of 16.66 MPa and a global modulus of elasticity of 5622 MPa. Furthermore the failure of these specimens occurred in the area where bending moment is maximum. Fracture was influenced by the presence of the two notches: beams UN_1 and UN_3 failed due to separation of upper part half from lower half

BFRP spikes have been applied to cut-in-half (Figure 7a) and to notched beams (Figure 7b) with the aim to restore the continuity of damaged timber beams.

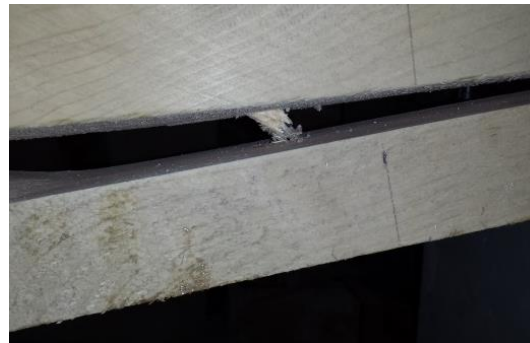
Figure 8. Pull out of the BFRP spike.

After an initial elastic phase, repaired beams (RS_series) exhibited a plastic behaviour. Increases of bending strength compared to control beams were limited due to low quality of timber material (fir wood) and separation of BFRP spikes from the epoxy resin. Beams RS_2 and RS_3 collapsed for a low bending load due the presence of a large knot defect in timber tension zone. The insertion of the BFRP spikes resulted in moderate enhancements in the beam ultimate capacity (+19.8 %) while more significant improvements in the stiffness were obtained (+325.7 %) and it is essentially due to the low values of stiffness of cut-in-half beams. However the insertion of the BFRP spikes did not cause the achievement of the values of the control timber beams in terms of bending capacity and stiffness.
