# Policy for conservation of heritage railway signal boxes in Great Britain

Christopher D. Reeves

Senior Lecturer in Building Surveying, Northumbria University

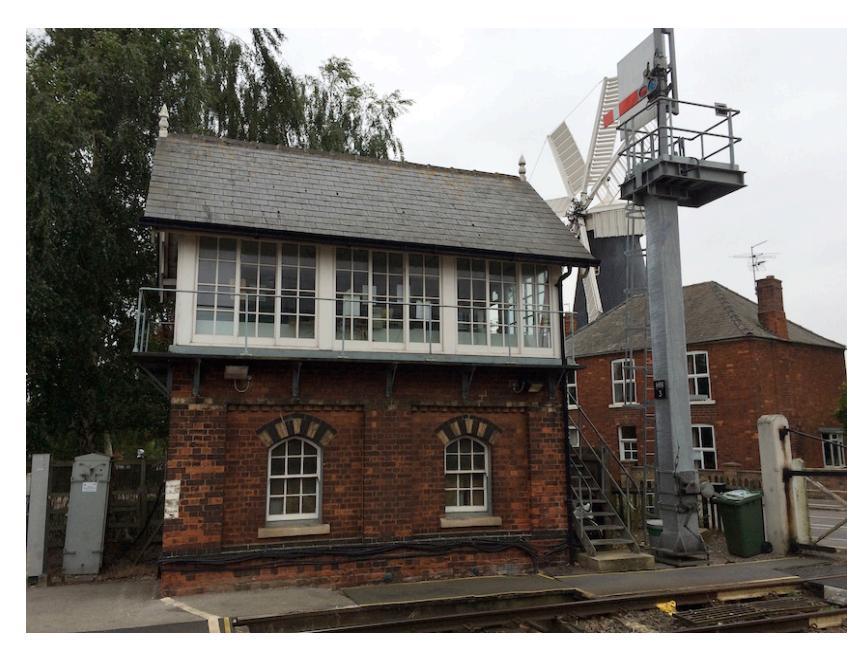
Figure 1: Heckington Signal Box (1876). This grade II signal box, with adjacent grade I windmill, almost represents an idealised English village environment. In this idealised world, the modern signal post is intrusive. © *Christopher Reeves*

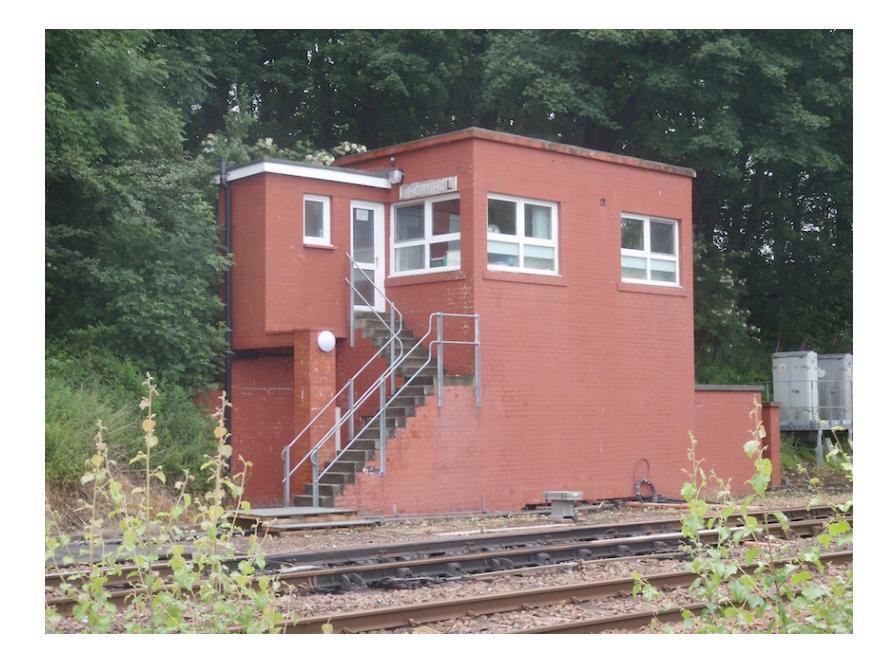
Figure 2: Thornhill Signal Box (1943). This signal box is an example of the austere designs for this era. The toilet facilities to the left are a later addition. © *Christopher Reeves*

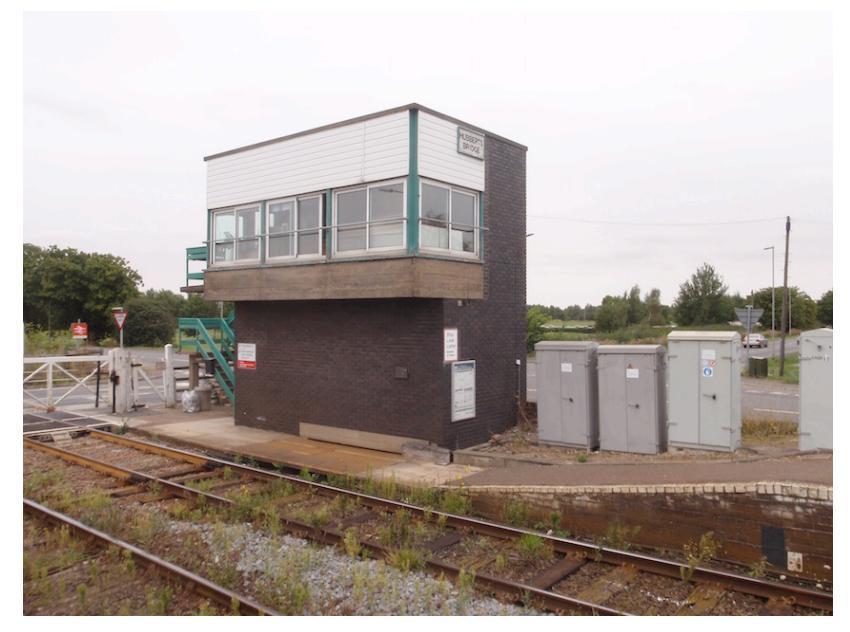
Figure 3: Hubberts Bridge Signal Box (1961). Possibly representing nearly the nadir of signal box design, this signal box is actually the next signal box along the line from Heckington. As an example of the era, arguably it is as worthy of preservation as it's prettier neighbour.

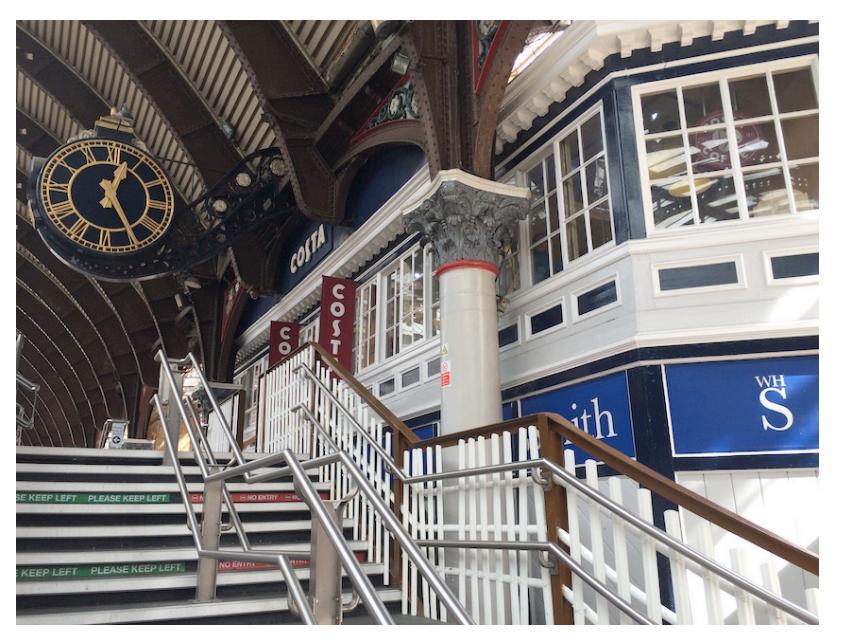
Figure 4a: York Platform Signal Box, operating floor (1907). With easy access from public circulation area by direct access from the footbridge, the operating floor of this signal box is in prime location for a café. © *Christopher Reeves*

An example of retail use is the former Platform Signal Box at York, listed Grade II\* as part of the station group listing. The former operating floor is at one end of the footbridge and the entire structure occupies a central location opposite the main station entrance, so both levels are within main passenger circulation areas. It is clear that the successful reuse of this former signal box, having a café on the operating floor (Figure 4a)<sup>52</sup> and a retail outlet occupying the locking room (Figure 4b), is entirely due to a prime location for commercial use.

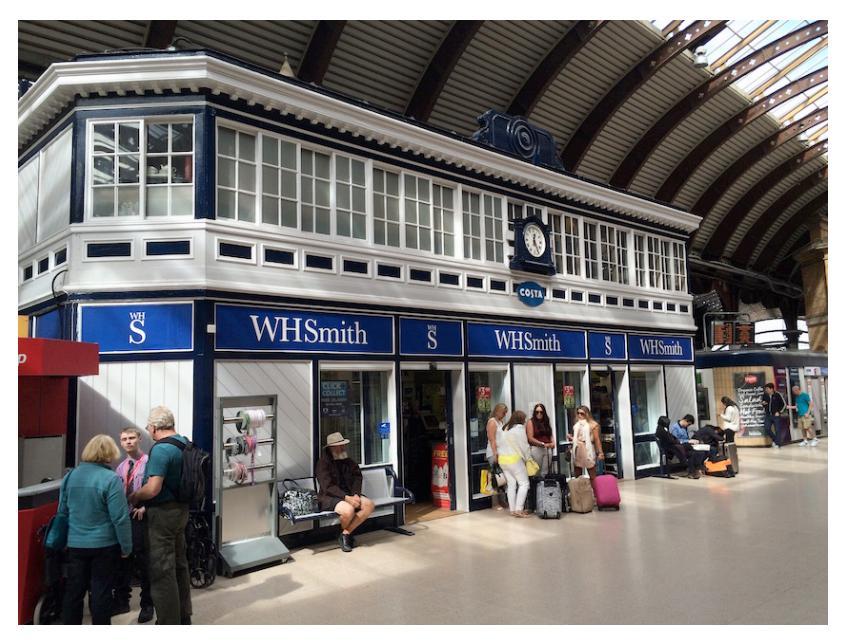
Figure 4b: York Platform Signal Box, rear elevation (1907). This rear elevation view illustrates how the locking room has become a retail unit within this circulation area for the station entrance. It is questionable how many of the station users in this illustration are aware that the retail unit and café was originally a signal box.

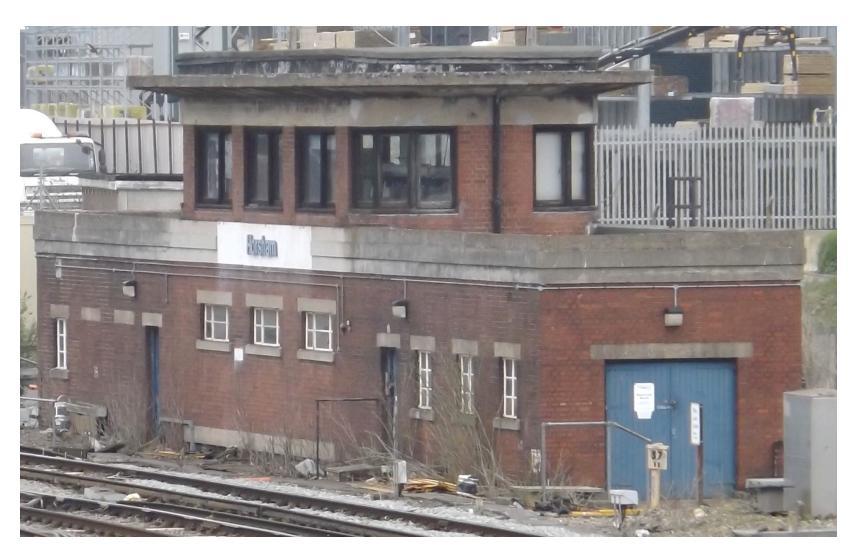
Figure 5: Horsham Signal Box (1938). The Southern Railway 'Type 13' signal box in International Modern style represents a conscious attempt at an attractive, modern design for interwar era signal boxes. © Edgepedia, Creative Commons Attribution

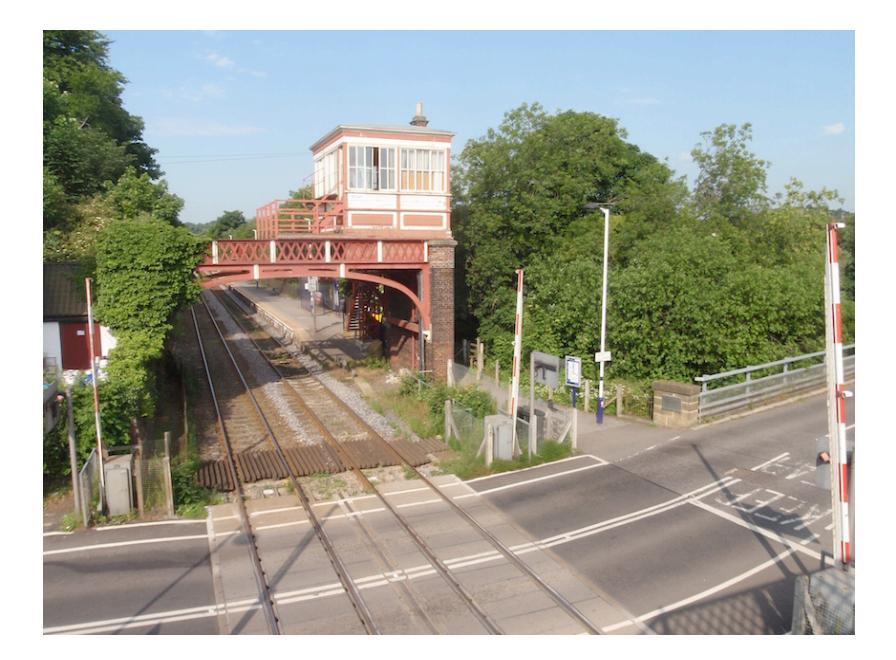
Figure 6: Wylam Signal Box (1897). This signal box is one of only three surviving UK over track designs. Notice the difficult access hindering any alternative reuse for this attractively situated signal box. Wylam, now a commuter village for Newcastle, has a strong connection with early railway history.

The 'Wylam question' is an unanswerable question defining the situation for many surviving signal boxes. Constructed circa 1897<sup>63</sup> by adapting a standard North Eastern Railway design to an over-track configuration, the signal box at Wylam in Northumberland is an unusual, esteemed structure in an attractive location. It is Grade II listed, yet effectively a wooden hut on an iron structure over a busy railway and thereby seemingly pointless other than as signal box (Figure 6). Even mothballing after the projected closure in 2020<sup>64</sup> carries problems, as the iron structure will be too close to power lines when planned electrification finally happens. Significantly, the listing does not mention an attractive riverside location or, should relocation be a possibility, that the articulate residents of Wylam will most likely have, I would expect following the precedent of Deeping Saint James, a vigorous opinion.
