# **EVALUATION OF EXPERIMENTAL METHODOLOGY TO ASSESS THE SEALING EFFICIENCY OF BACTERIA-BASED SELF-HEALING MORTAR : ROUND ROBIN TEST**

This study focuses on evaluating the suggested experimental methodology through a round robin test (RRT) among five laboratories within the framework of RILEM/TC 253 MCI (Micro-organisms-Cementitious Materials Interactions), WG4 (Engineered bacteria-based protective systems for cementitious materials) and it concerns only the part that examines the sealing efficiency. The testing sequence includes:

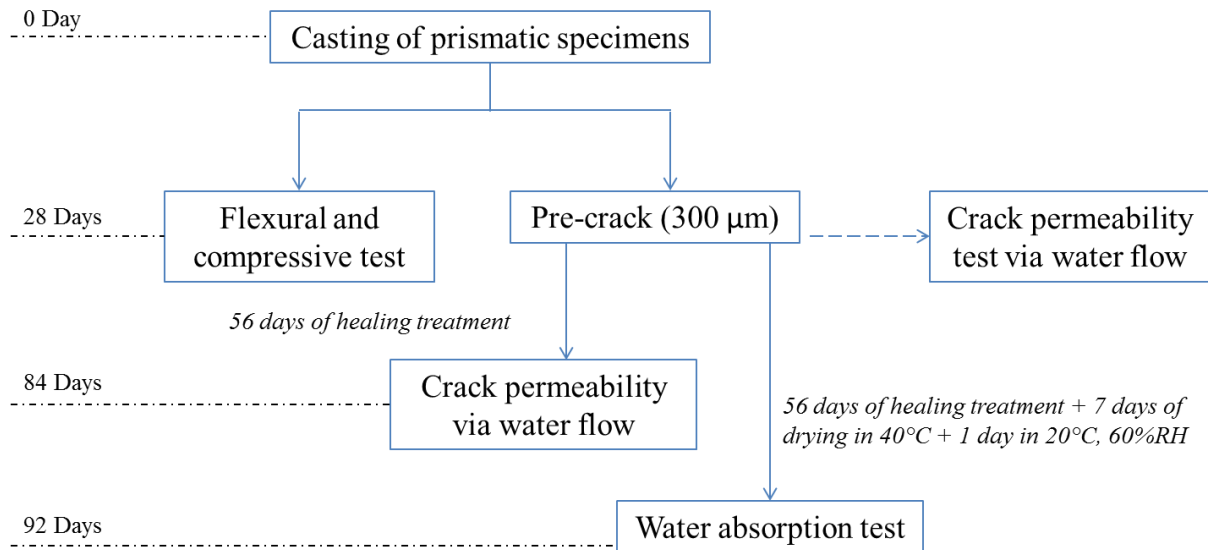
Figure 1. Schematic representation of experimental procedure that was followed in every laboratory starting at  $t=28$  days for each set of prisms received from TUD.

A schematic representation of the experimental procedure that was followed during this RRT in every laboratory for each set of mortar prisms received is shown in Figure 1.

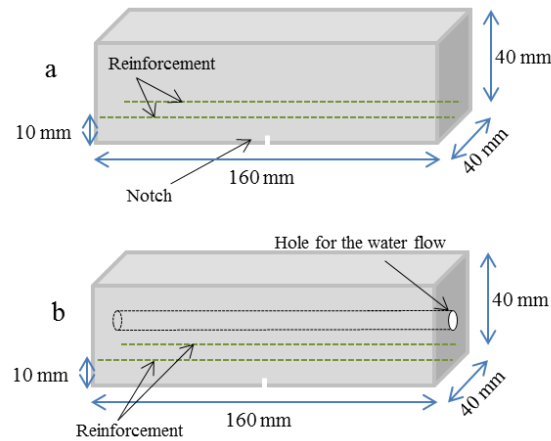
Figure 2. Typical prism: (a) for water absorption test and (b) for water flow test.

For material characterization of the hardened mortar, prisms (40 mm x 40 mm x 160 mm) were cast in accordance with EN 196-1 [2]. For the water absorption test, reinforced (two steel wires  $\phi 1$  mm) mortar prisms (40 mm x 40 mm x 160 mm) were cast (Figure 2a). For the water flow test, reinforced (two steel wires  $\phi 1$  mm) mortar prisms (40 mm x 40 mm x 160

mm) with a 5-mm diameter cylindrical hole in the centre were used (Figure 2b). A notch of approximately 2-3 mm deep was made in the middle of every reinforced prism at the age of 28 days.

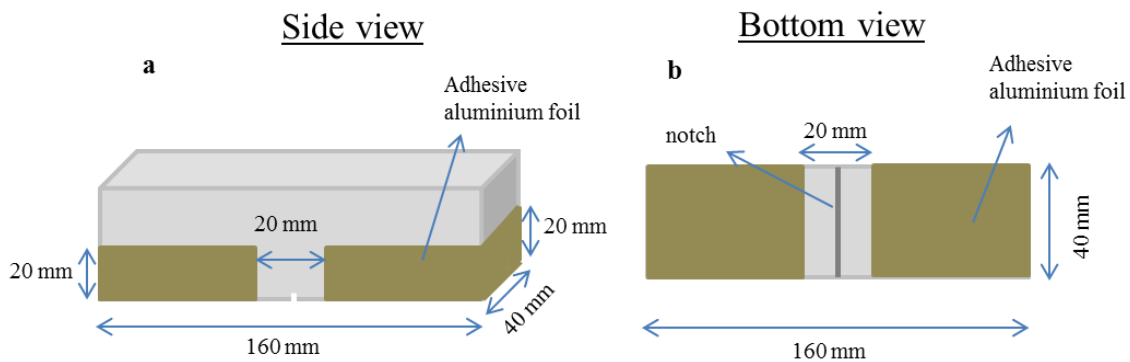
Figure 3. Water proofed specimen prepared for water absorption test: a) side view, b) bottom view.

Furthermore, another test was developed to investigate the ability of a cracked and healed specimen to absorb water. The procedure was based on the test described in EN 13057 [3]. During the test, the bottom of the specimens (the side with the notch) came into contact with water. The method used reinforced prismatic mortar specimens; non-cracked, cracked non-healed and cracked healed. Before testing, the specimens were kept at 40 °C for minimum 7 days, until a stable weight change was achieved. Then, the specimens were stored for 24h at 20 °C with 60 % relative humidity for one day. The specimens were weighed prior to the test. The test was carried out in a container and the specimens were standing on spacers, so that there was a gap between them and the bottom of the container. The water level in the container exceeded the bottom of the specimens by approximately 2-3 mm. Before the test, the specimens were partially waterproofed (with aluminium adhesive foil), as seen in Figure 3.

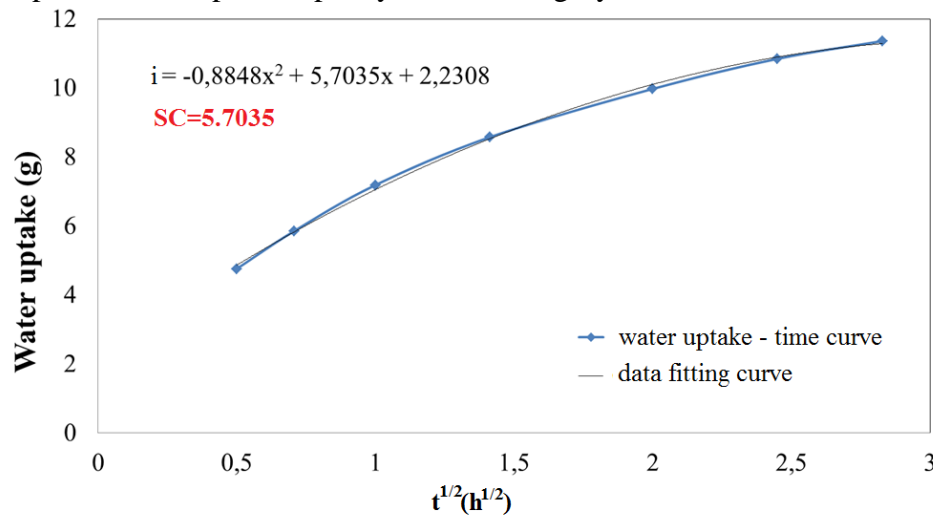
Figure 4. Typical graph obtained during water absorption test and polynomial data fitting curve.

Where  $i$ : the water uptake in g;  $t$ : time in h;  $SC$ : the sorption coefficient in  $gh^{-1/2}$  and  $A$  and  $B$  are constant. A typical curve that can be obtained during water absorption test is shown in Figure 4. After the completion of the test, the average  $SC$  (out of three specimens) of each specimens category (non-cracked, cracked non-healed and cracked healed) was calculated in order to compare the absorption capacity of each category.

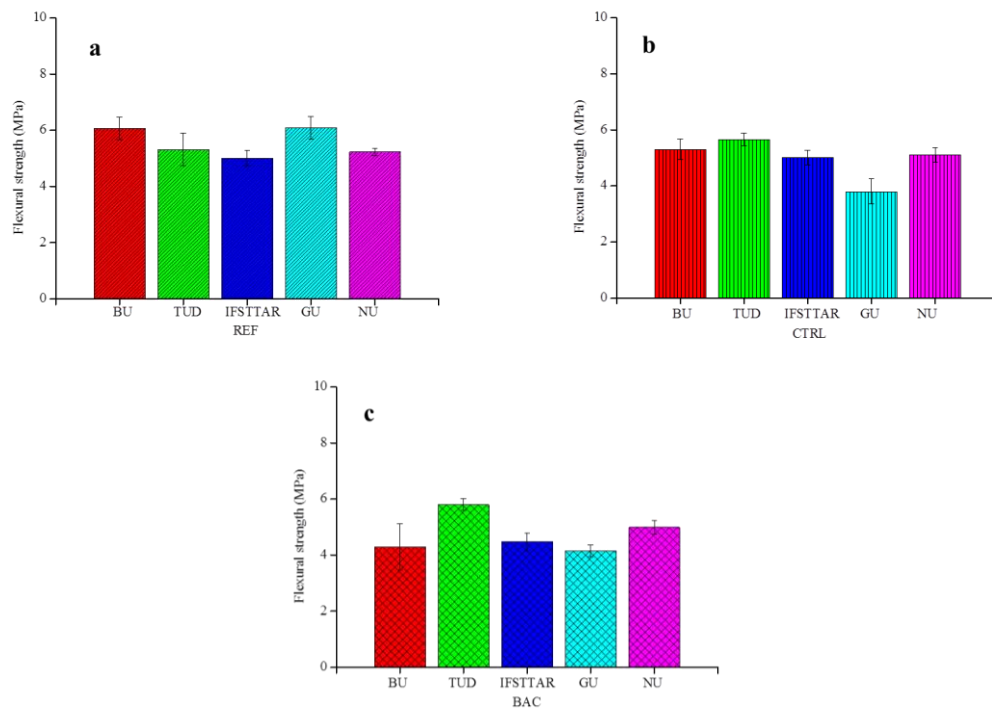
Figure 5. Flexural strength test results: a) REF specimens, b) CTRL specimens and c) BAC specimens.

The flexural strength results revealed that there was no significant difference among the three mixtures. In fact, most of the flexural strength values obtained varied between 4.5 and 6 MPa. In addition, not only the values obtained within each laboratory showed relatively low scatter but also the inter-lab variations were insignificant in view of observed standard deviations.

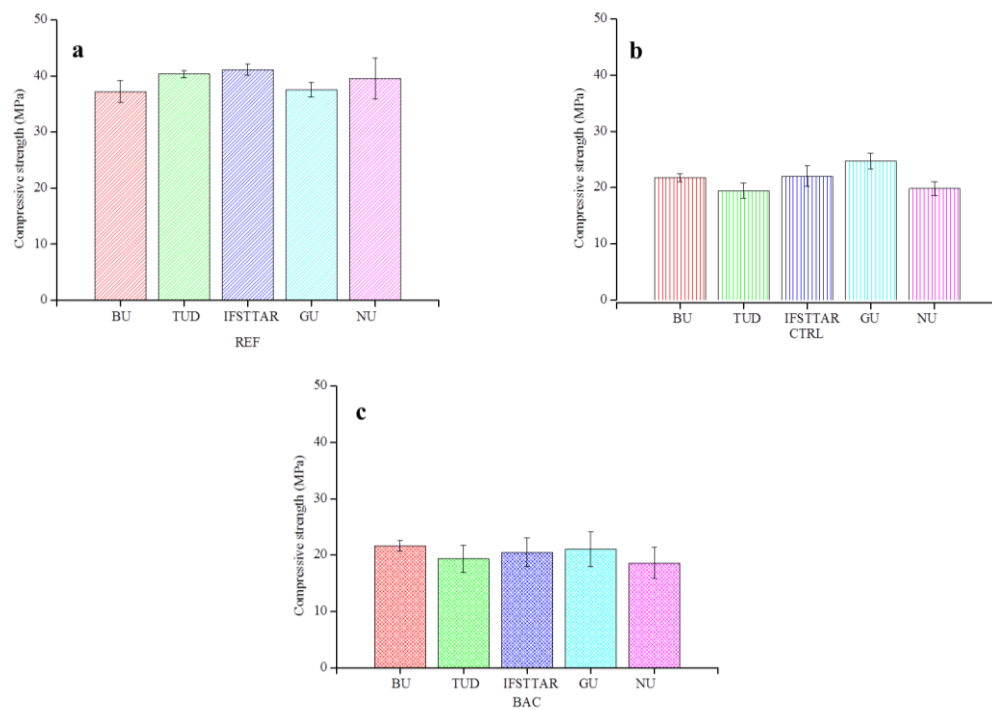
Figure 6. Compressive strength test results: a) REF specimens, b) CTRL specimens and c) BAC specimens.

The compressive strength results show the effect of the replacement of normal weight sand with LWA. Actually, the compressive strength of REF mixture on average was approximately 39 MPa, while CTRL and BAC specimens showed a reduction of almost 50%. However, the intra- as well as the inter-lab scatter was also relatively low.

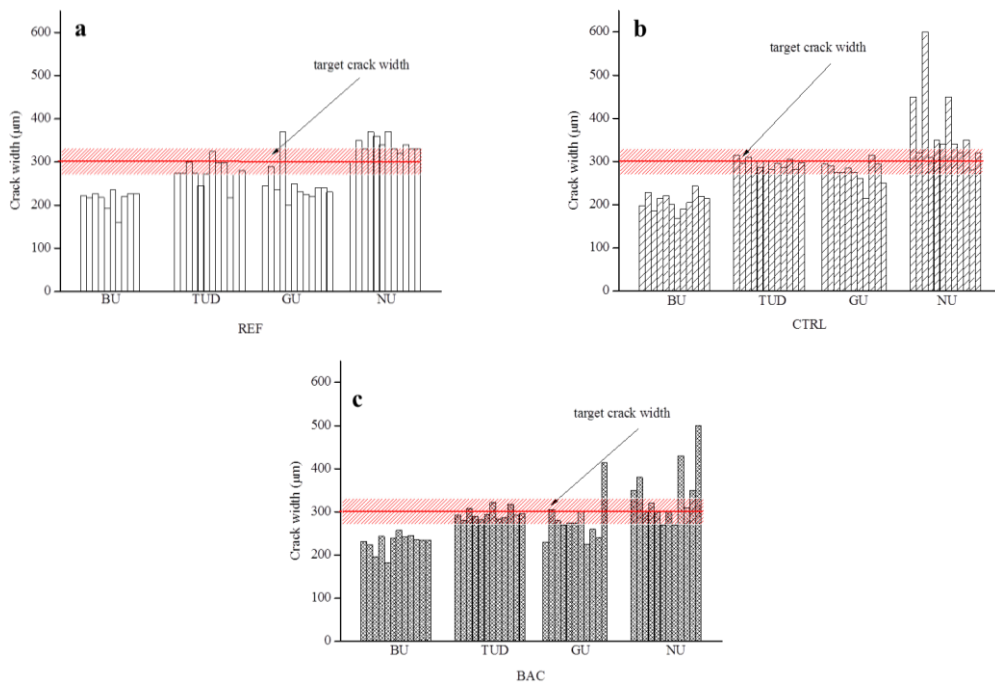
Figure 7. Crack width values after unloading: a) REF specimens, b) CTRL specimens and c) BAC specimens.

The intra-lab variation regarding the crack width values was relatively low, regardless the proximity to the target crack width value (300  $\mu\text{m}$ ). However, there was a high scatter of the results of the different participants, even within the same mixture. The differences in crack width values among the laboratories can be attributed to several reasons that are listed below:

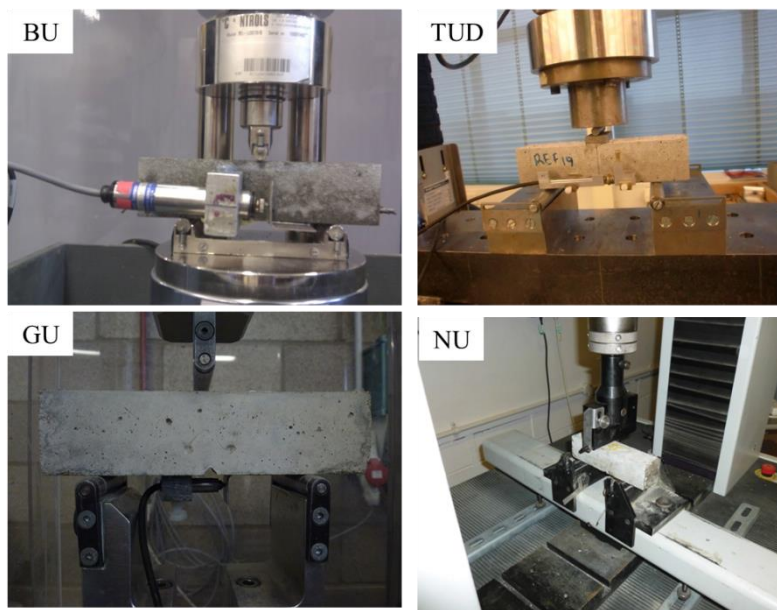
Figure 8. Set-ups of the different laboratories for crack introduction via 3-point-bending.

- The microscopic measuring method of the crack width differed for each laboratory.
- The crack width was controlled for TUD, GU and BU via LVDT sensors. However, the number of sensors and the position on the specimen varied. For example:
  - a. BU used one sensor on the front of the specimen.
  - b. TUD used two sensors on the front and back of the specimen,
  - c. GU used one sensor on the bottom of the specimen and
  - d. NU monitored indirectly the crack width; by conversion of the vertical displacement of the machine to the horizontal crack opening.

Even though every laboratory was targeting the same crack width, either the measuring position or the crack monitoring method were different. As a result, the average microscopic measurements among the laboratories was expected to show a high scatter.

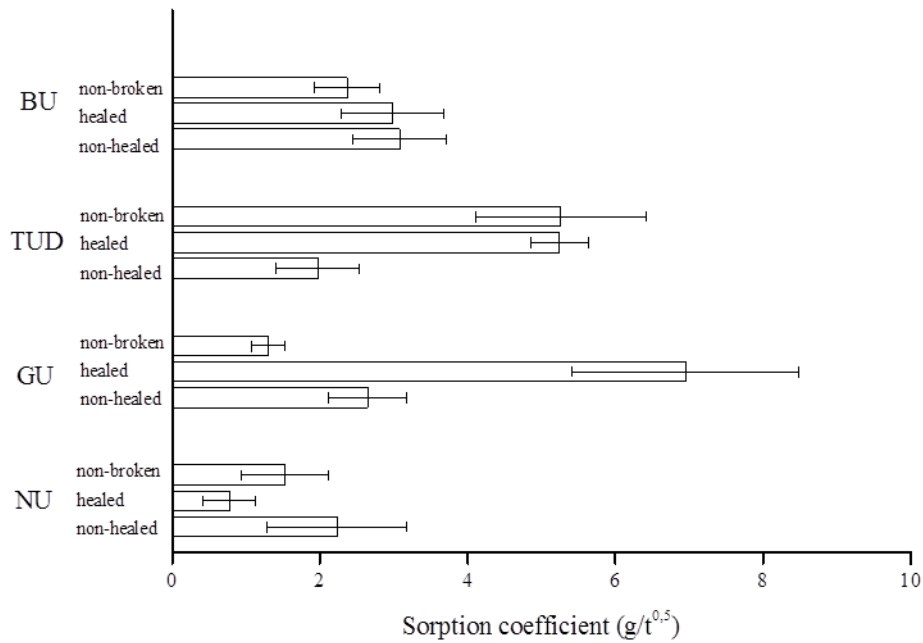
Figure 9. Average SC calculated from water absorption test - REF specimens.

The results of the water absorption test revealed a very random behaviour for all categories of specimens (REF, CTRL and BAC). In fact, the results showed:

- a relatively high standard deviation within the measurements of each individual laboratory,
- no clear trend in the values of sorption coefficient; for example  $SC_{\text{non-healed}} > SC_{\text{healed}} > SC_{\text{non-broken}}$

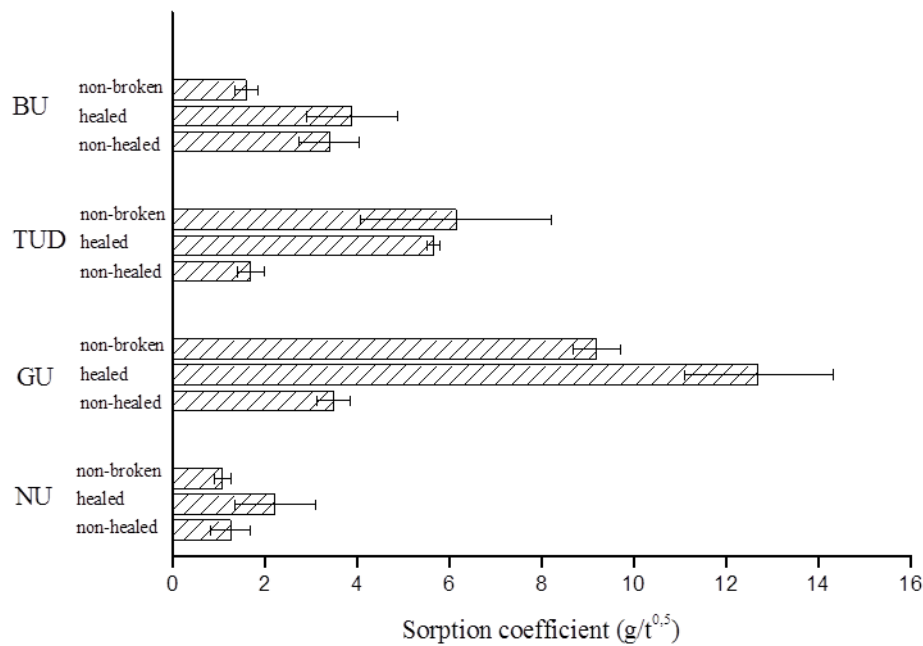
Figure 10. Average SC calculated from water absorption test - CTRL specimens.

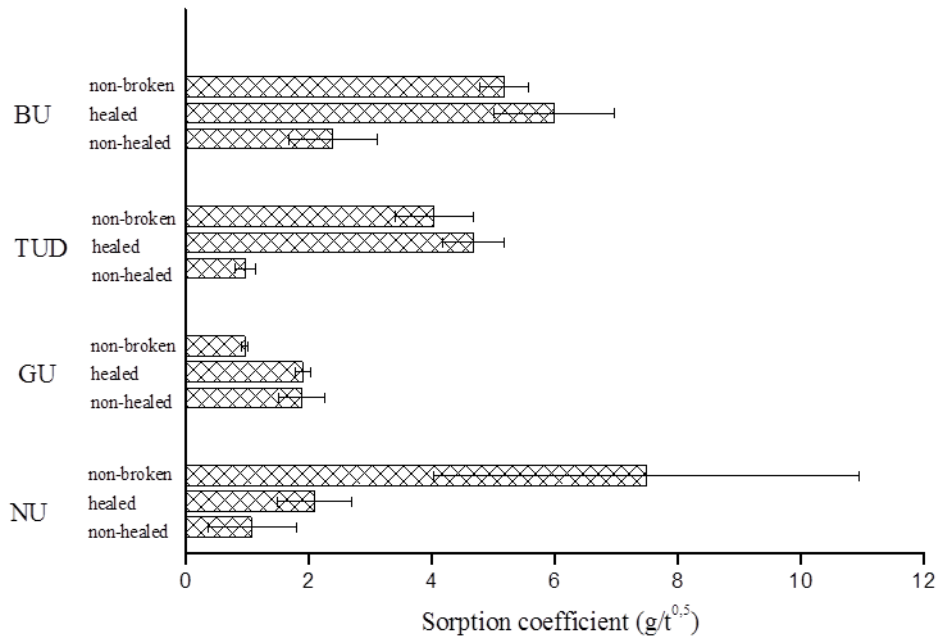
Figure 11. Average SC calculated from water absorption test - BAC specimens.

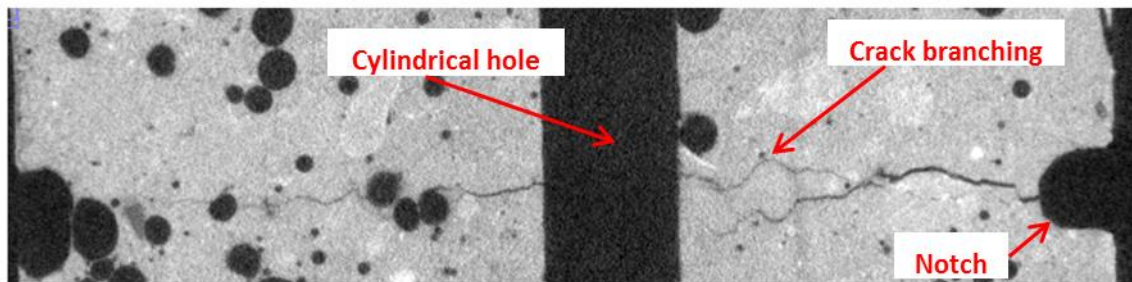
Figure 12. Computed Tomography (CT) image on a cracked mortar specimen with cylindrical hole showing crack branching

Even though every laboratory targeted the same crack width, large scatter in the measured values was observed. This is partly due to the position of the LVDT as mentioned earlier. Moreover, it was observed that the crack shapes/geometries were very often different even in intra-lab level. In some cases, there was also crack branching (Figure 12) at a height of some millimetres over the notches. The differences in the cracks can be explained by :
