The hydraulic characteristics of Roman lead water pipes: an experimental investigation

Abstract

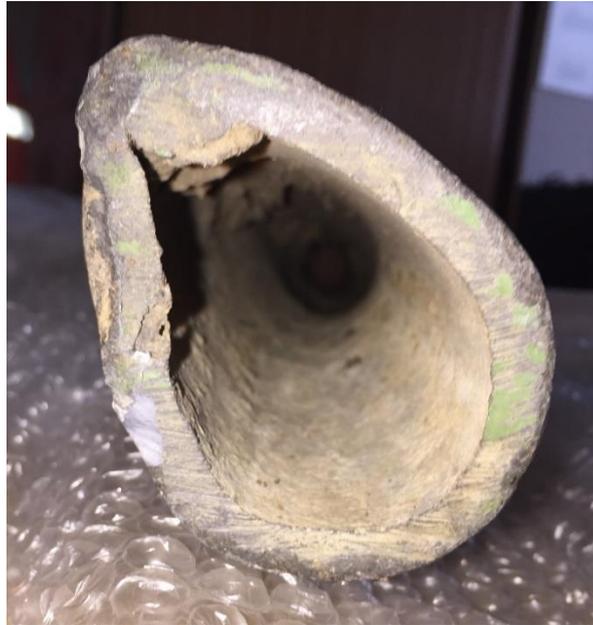
Figure 1: Example of a Roman lead water pipe formed from a sheet of metal with a soldered joint at the top. The pipe internal dimensions are 76 x 43 mm

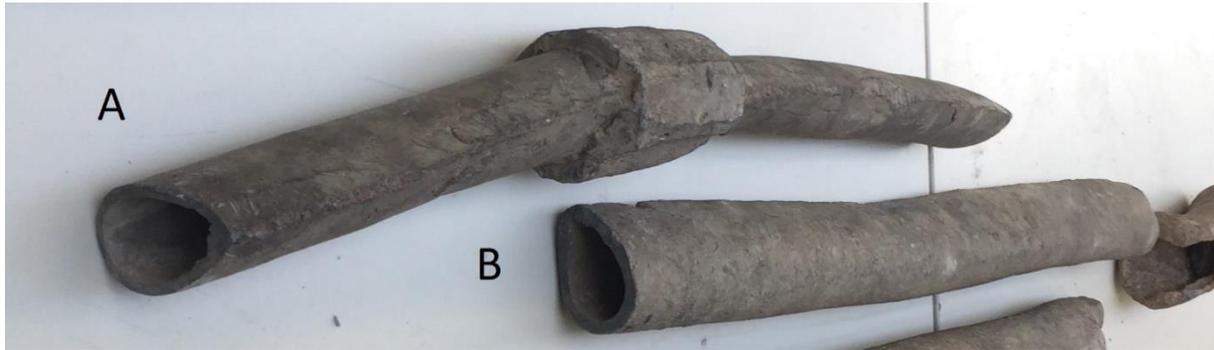
Figure 2: The two pipe sections tested: A - jointed pipe and B - non-jointed pipe. Both are sections from the same run of pipe at Red House Baths, Corbridge. The pipe sections shown are all approximately 1 m in length

Two broadly similar sections of pipe were considered, each approximately 1 m in length (Figure 2). These were both sections of the same 18.52 m length of pipe excavated and reported by (Daniels 1959). One section has a sleeve joint in its centre; the other does not. This gave the potential for examining the hydraulic significance of the joint as well as the pipe itself, by comparing the performance of the two specimens under similar conditions.

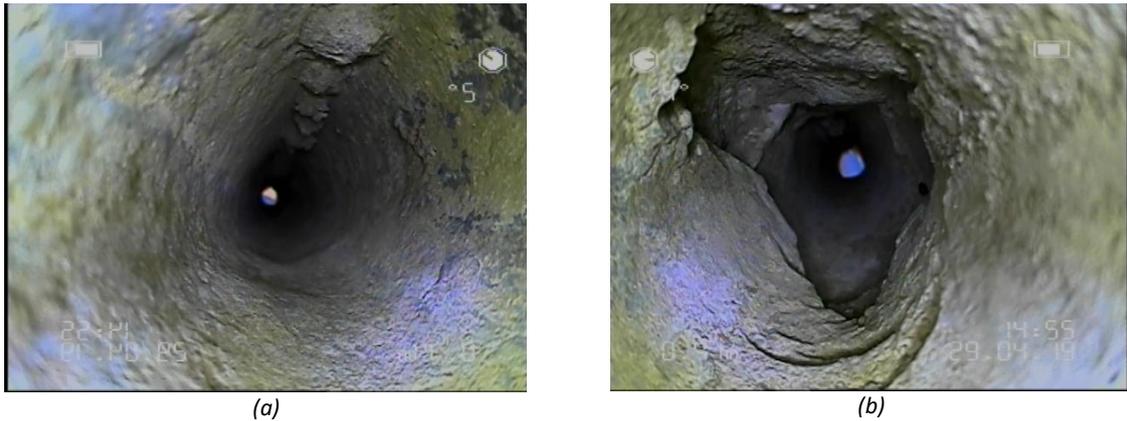
Figure 3: Endoscope images of (a) Non-jointed pipe showing the soldered seam at the top; and (b) the inside of the sleeve joint in the jointed Pipe

The interior of each specimen was examined by means of an endoscope (Figure 3). It is apparent that the interior of the pipe is very rough; Figure 3 (a) clearly shows the intrusion of lumps of the soldering material at the seam in the top of the pipe, presumably an artefact of its original manufacture. Figure 3 (b) shows that the sleeve joint is crudely made, with the ends of the pipe sections joined not meeting flush in its centre. All these features are likely to have a significant effect on the hydraulic performance of the pipe.

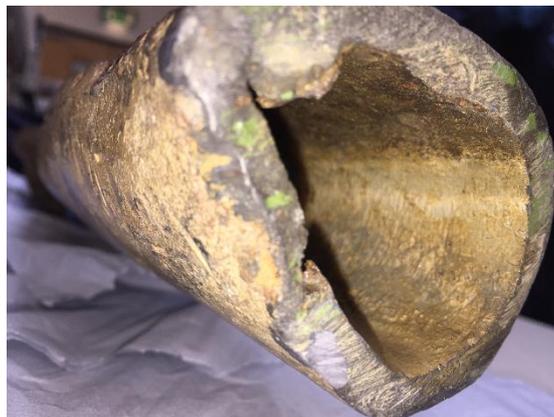
Figure 4: Distinctive sinter line observable in pipe. This indicates a substantial pattern of partially-full flow

A further feature of note is that the pipes had a noticeable deposit of sinter (limestone) over the lower part of their section, as shown in Figure 4. The distinctive ‘tide line’ at the top of this deposit is parallel to the pipe, indicating that it arose from the flowing partially full, leading to the sinter deposit on the lower, wetted section of the pipe, but not on the drier, top part. Had the sinter formed from standing water following the baths falling into disuse, the tide line would have been horizontal rather than parallel to the pipe; in any case, sinter precipitation is the result of degassing of CO₂ from the water, a process which is enhanced by turbulence and much more likely to occur in flowing than in standing water (Buhmann and Dreybrodt 1985, Sürmelihindi, Passchier et al. 2013). Partially full flow suggests that that the soldered joint may not have been wetted all that often, and so would have had little effect on the actual operation of the pipeline. The gradual build-up of sinter would, of course, have affected the hydraulic performance somewhat over time, changing the wall roughness.

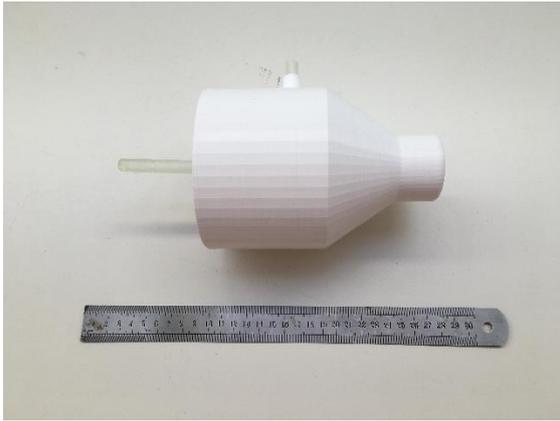
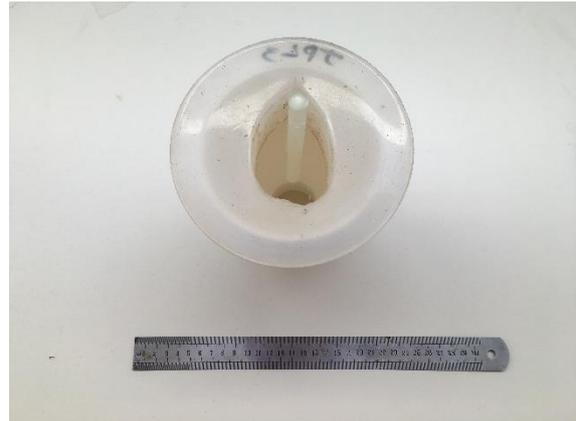
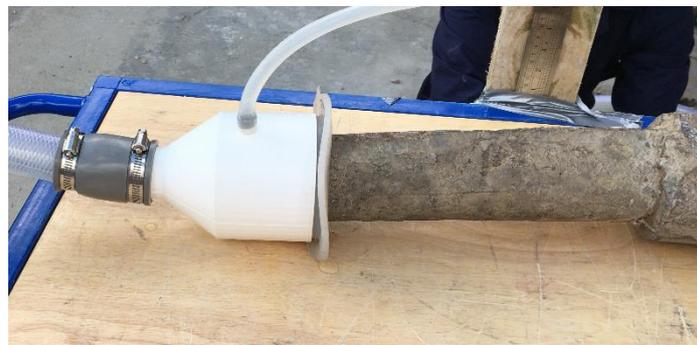
Figure 5: The 3D-printed connector and pressure measuring arrangement: (a) side view; (b) end view; (c) in situ on pipe

The pipes were linked to the experimental rig by means of 3D-printed connectors (Figure 5). These were based on the scans, which were used to create a 3D digital replica of each pipe end, and from these, individual slices were made to create 2D CAD drawings. The drawn cross-sections were decreased to 96% of their original size to ensure a tight seal and used to create plywood moulds for the casting of sealing pieces, using ECOFLEX silicon two-part mix. This created a soft seal on the outside of the pipes, where it would not interfere hydraulically or cause damage to the ancient artefacts. The soft seals were held in outer connectors that were drawn in SolidWorks and 3D-printed in PLA. These connected to the experimental pipework by means of jubilee clips. The connectors were fitted with L-shaped static tubes (Figure 5 and Figure 6), again drawn in SolidWorks and 3D-printed in Formlabs clear resin. These allowed static pressure measurements within the Roman pipe, having their end facing the flow capped off, but a series of pressure tapping holes around their circumference, normal to the direction of flow. The longitudinal length of the tube between the point where it emerged from the side of the connector and the static pressure tappings was 100 mm, and when connected to the pipe the pressure measurement point was around 60 mm away from the end of the lead; this was considered a reasonable distance away from the junction with the connector to avoid hydraulic effects of the joint, bearing in mind the already quite short length of the whole section of pipe. The connector and pressure tapping arrangement is shown in Figure 5. The effective length of each pipe section under test was therefore the measured distance between the centre lines of the static tube where they emerged from the side of the connectors, less 2 x 100 mm to allow for the L-piece at the pipe centre line.

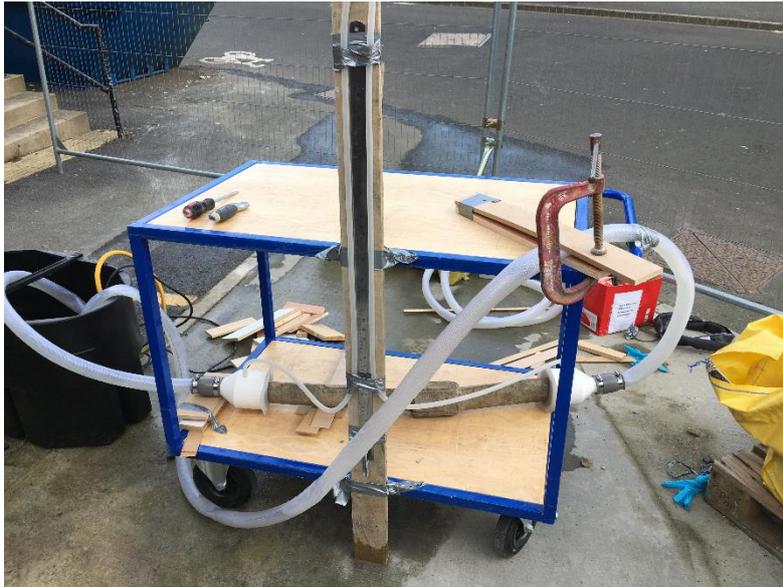
Figure 6: Overview of the experimental rig showing the jointed pipe under test, with manometer and flow control. To the left is the sump tank in which the pump was located

Flow was controlled by means of a G-clamp compressing the flexible hose attached to the pump (Figure 6); this simple arrangement allowed quite fine control. Flow was measured by recording the time taken to fill a 30 litre container, averaged over at least two similar readings. The static pressure difference between each end of the pipe section was measured using a simple manometer arrangement with a metre rule and flexible tubes taped securely in place (Figure 6). At the start of each test, air was carefully expelled from the manometer tubes, and the manometer reading was photographed three times to avoid difficulties in reading it caused by small water level fluctuations; the average reading was taken from three photographs.

A full view of the experimental arrangement is shown in Figure 6.

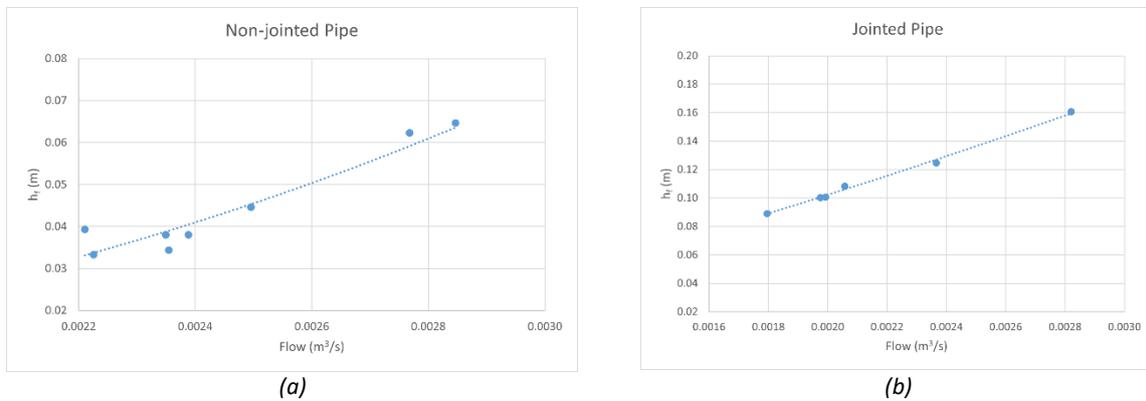
Figure 7: Plots of experimental observations for (a) Non-jointed and (b) Jointed Pipes

Results took the form of time for 30 litres of flow and the head difference between the pressure tappings at each end of the pipe. These were converted into flow rate and head loss (h_f) along the pipe. Results are shown in Table 2, together with calculated flow velocities and Reynolds numbers (Re) based on the hydraulic diameter of the relevant section of pipe, and are plotted in Figure 7.

It is apparent from Figure 7 (a) that in the case of the Non-Jointed Pipe, there is considerable scatter in the experimental results, particularly at the lower end of the flow readings. There are many possible reasons for this, including misreading the flow time, the flow volume or the head

It is clear that, as expected, the absolute values of head loss are much greater for the Jointed Pipe for given flows. This is no-doubt due to the losses attributable to the sleeve joint.

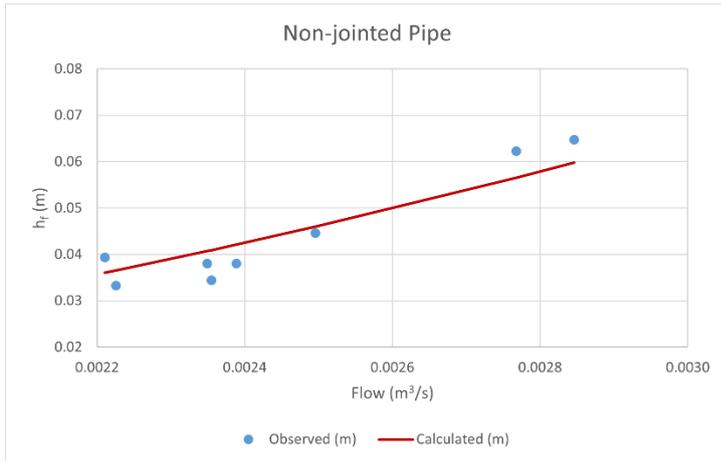
Figure 8: Observed and calculated head loss against flow for Non-jointed Pipe. Calculated values use the Darcy-Weisbach and Colebrook-White Equations, with $k_s = 0.9$ mm

Taking the non-jointed pipe section, it was assumed that all head loss over the test resulted from pipe friction loss as given by equations (1) and (2), and a curve fit was carried out to the experimental results, varying k_s until the best fit in terms of the minimum sum of residuals squared was obtained, residuals being the difference between the calculated head loss for the observed flow, and the observed head loss. This gave a fit with a correlation coefficient of 0.961 corresponding to a k_s value of 0.9 mm, which is indicative of a rough pipe. To put this in context, a value commonly used for a modern concrete pipe is 1.5 mm, and that for a PDPE pipe is typically 0.03 mm.

A plot of the curve-fit is shown in

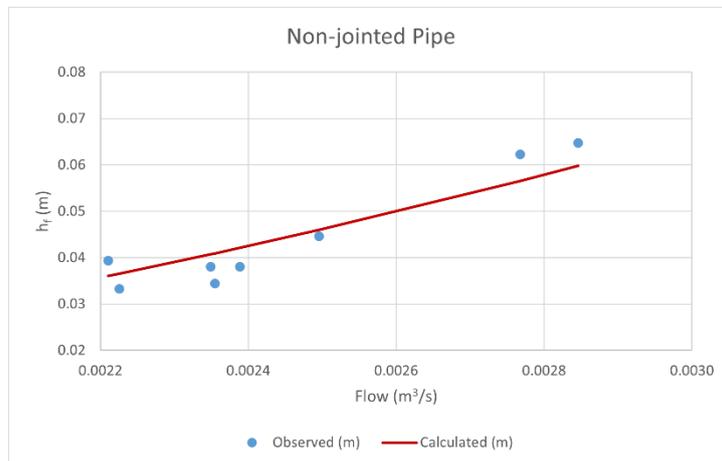
Figure 8: Observed and calculated head loss against flow for Non-jointed Pipe. Calculated values use the Darcy-Weisbach and Colebrook-White Equations, with $k_s = 0.9$ mm

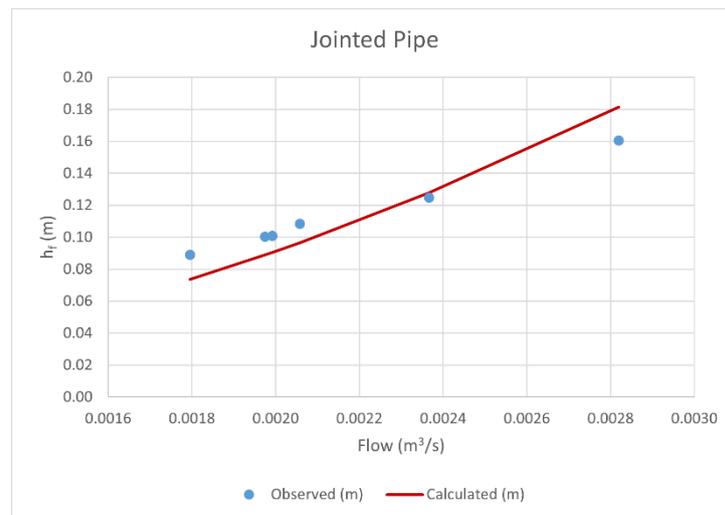
Figure 9: Observed and calculated head loss against flow for Jointed Pipe. Calculated values use the Darcy-Weisbach and Colebrook-White Equations, with $k_s = 0.9$ mm and $k_{\text{joint}} = 1.159$

A curve-fitting exercise was done as previously, this time varying the local loss coefficient for the joint until a good fit was obtained between observed and calculated head loss, as before. A joint local loss coefficient of 1.159 gave a R^2 correlation of 0.998. Results are plotted in Figure 9.
